Transport  
**Roads & Maritime  
Services**

# **BRIDGE INSPECTION PROCEDURE MANUAL**

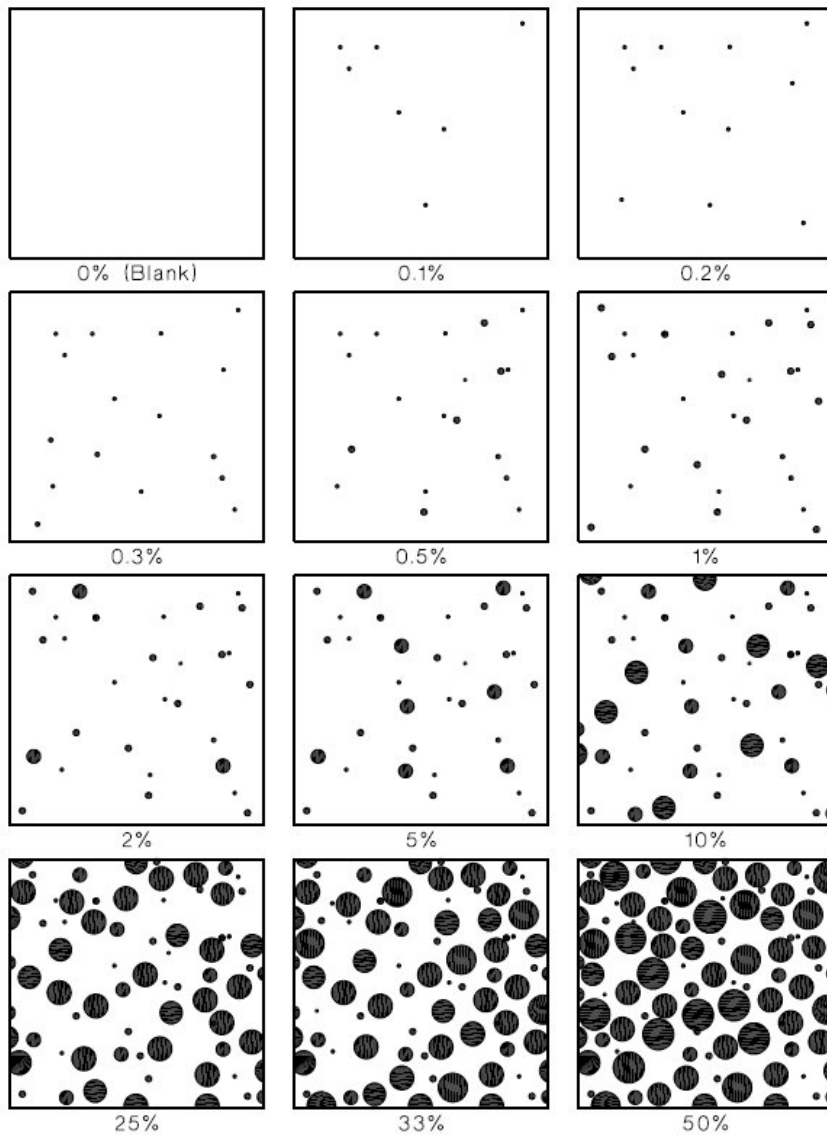
Schematic diagrammatic examples of estimating rust percentages  
(From AS/NZS 2312 : 2002)

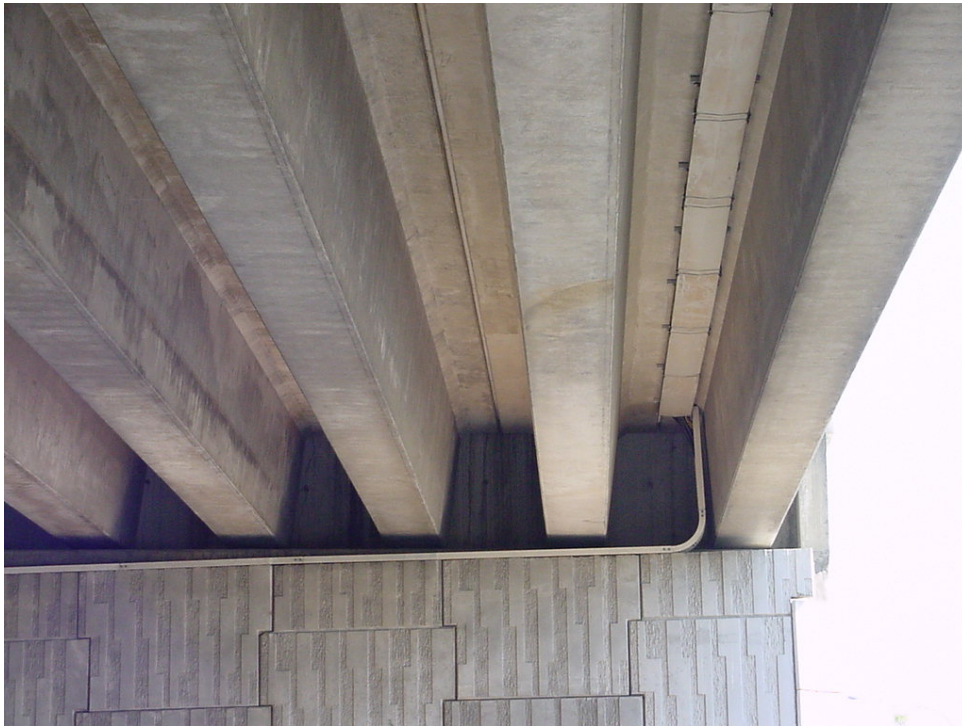
Prestressed girders in good condition

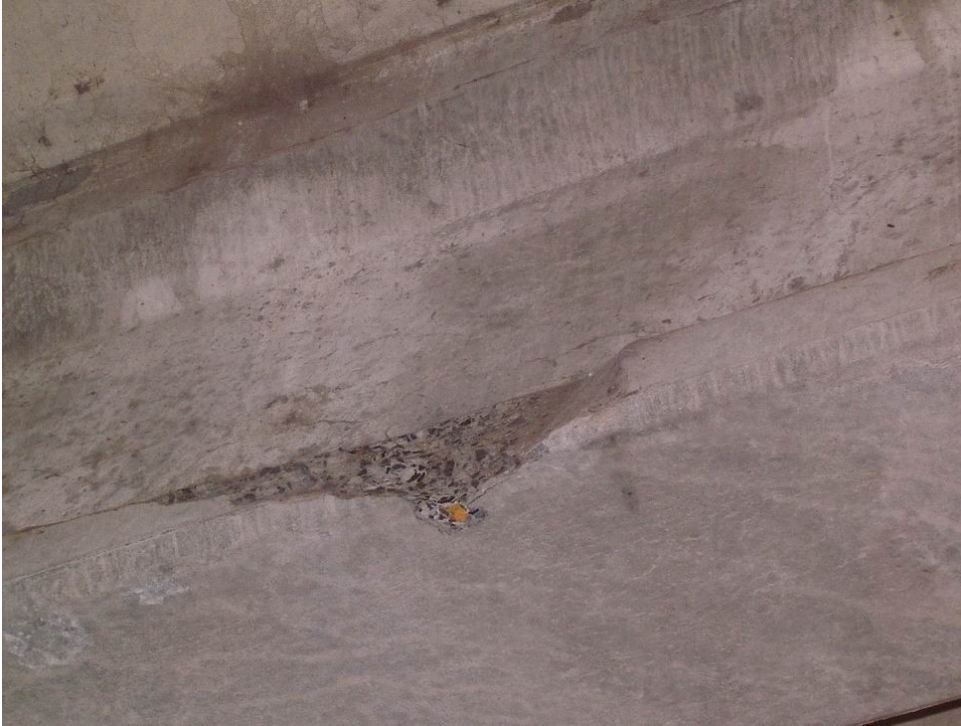
Minor spall in the prestressed girder bottom flange. No exposed reinforcement or prestressing strand.

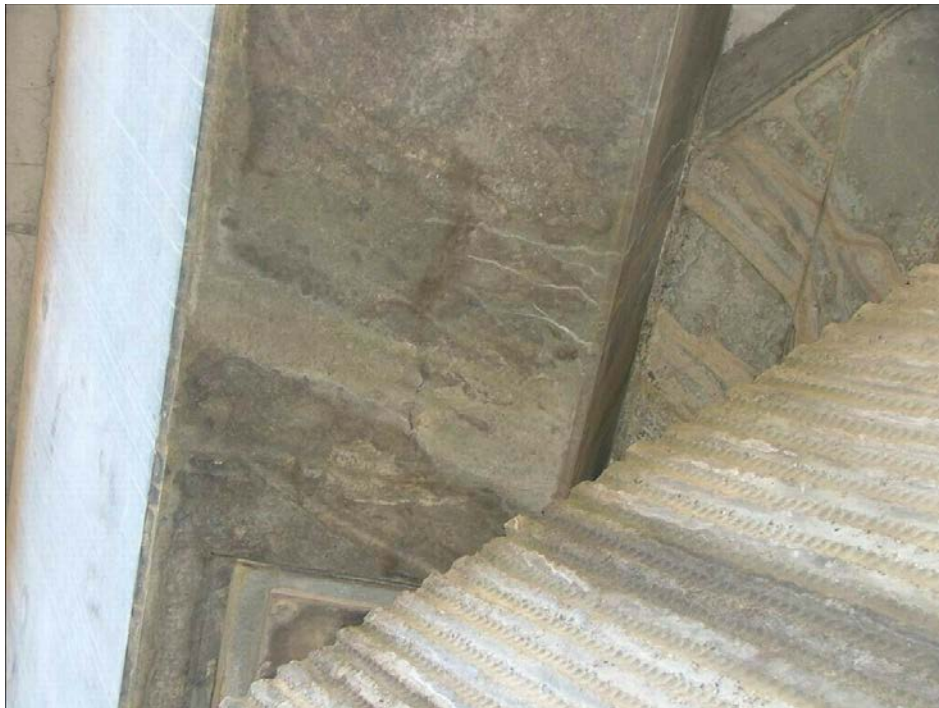
Short cracks and leaching on the soffit of prestressed trough girder

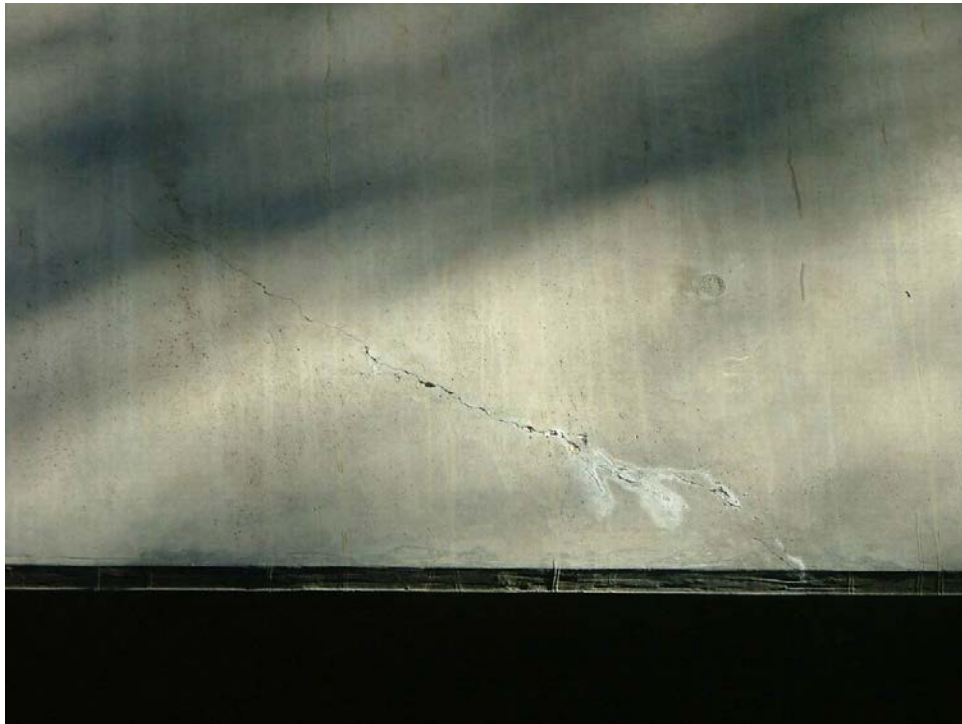
Diagonal cracking near pier 1, crack extending to the soffit.

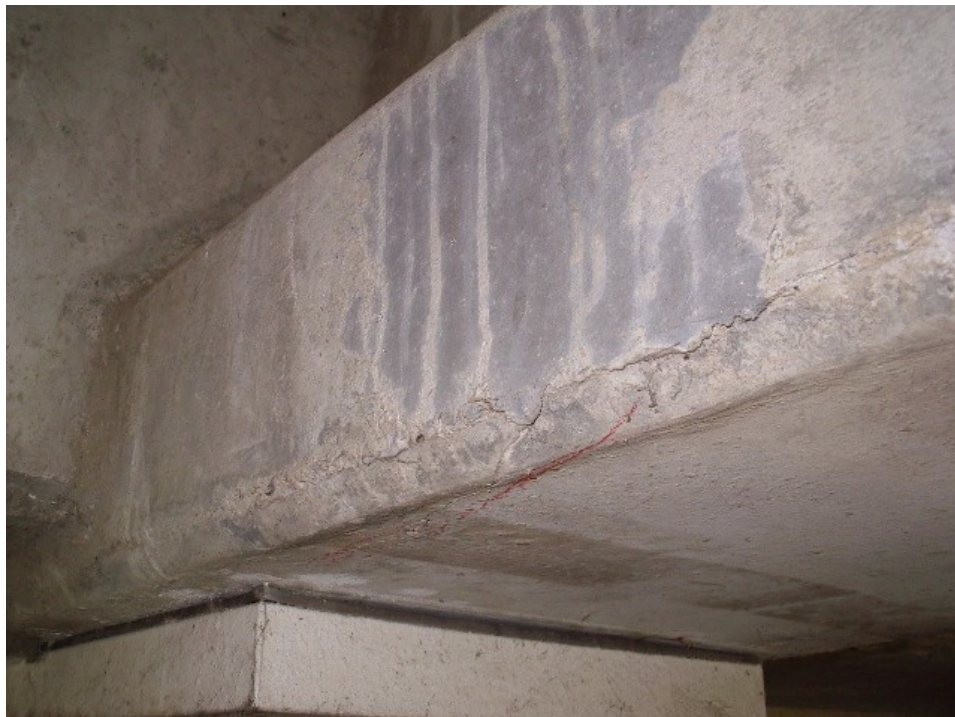
Longitudinal crack along the bottom flange corner near support.

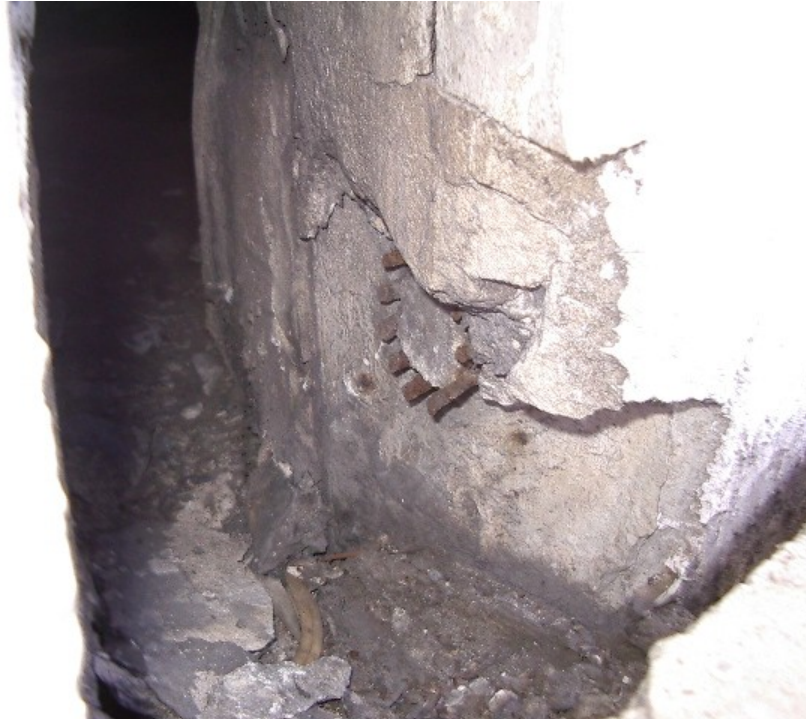
Prestressing anchorage exposed.

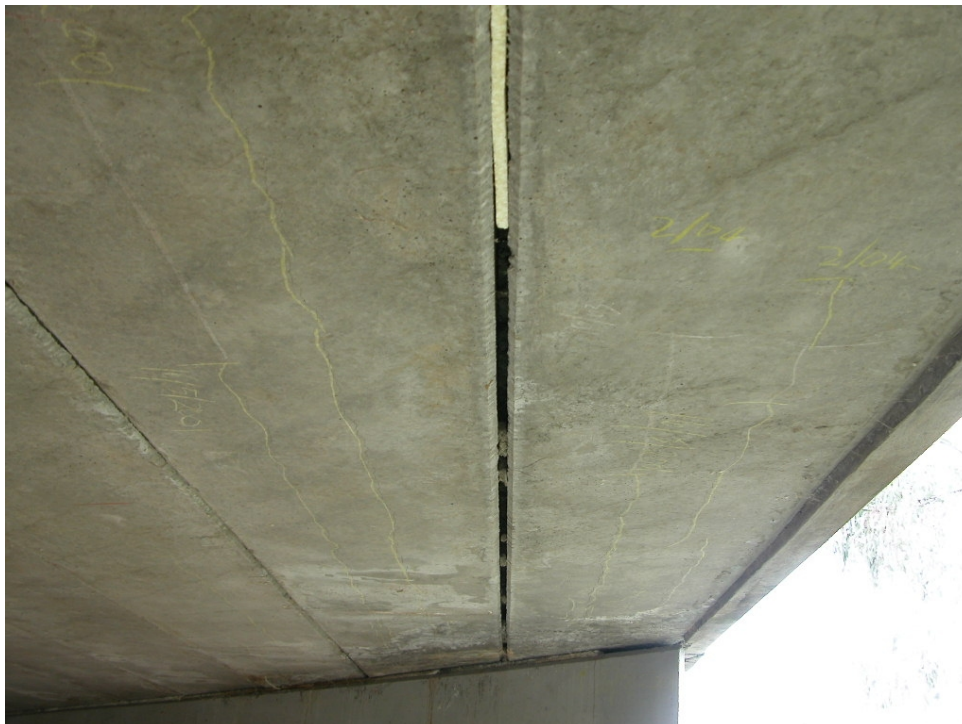
Longitudinal cracks along the middle of planks. Minor leaching at one end.

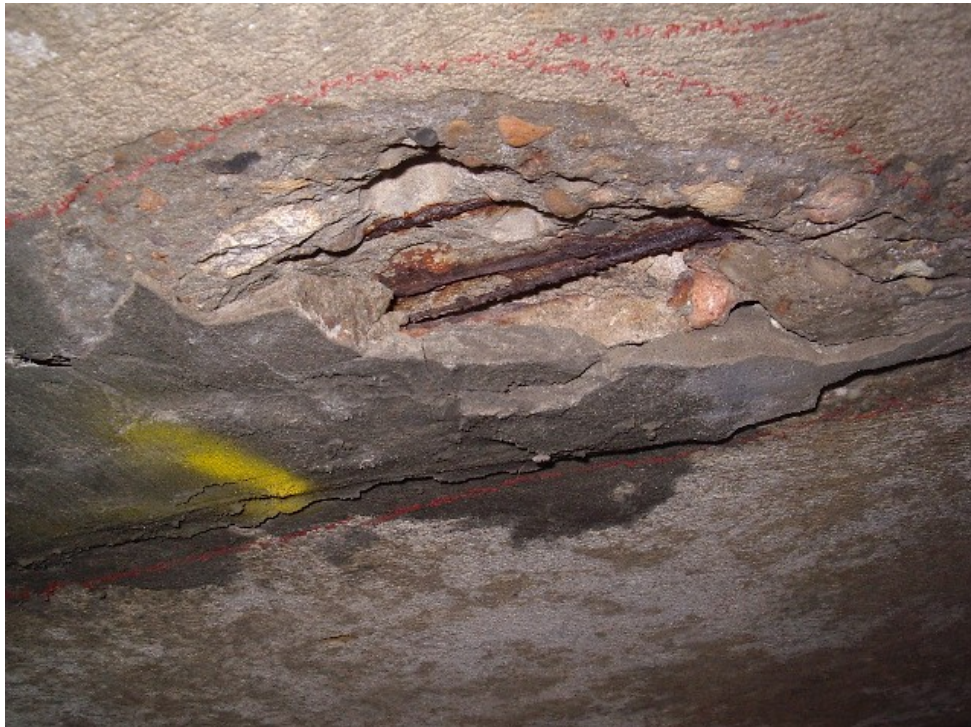
Spalling of a small area of plank soffit with exposed and corroding prestressing strands.

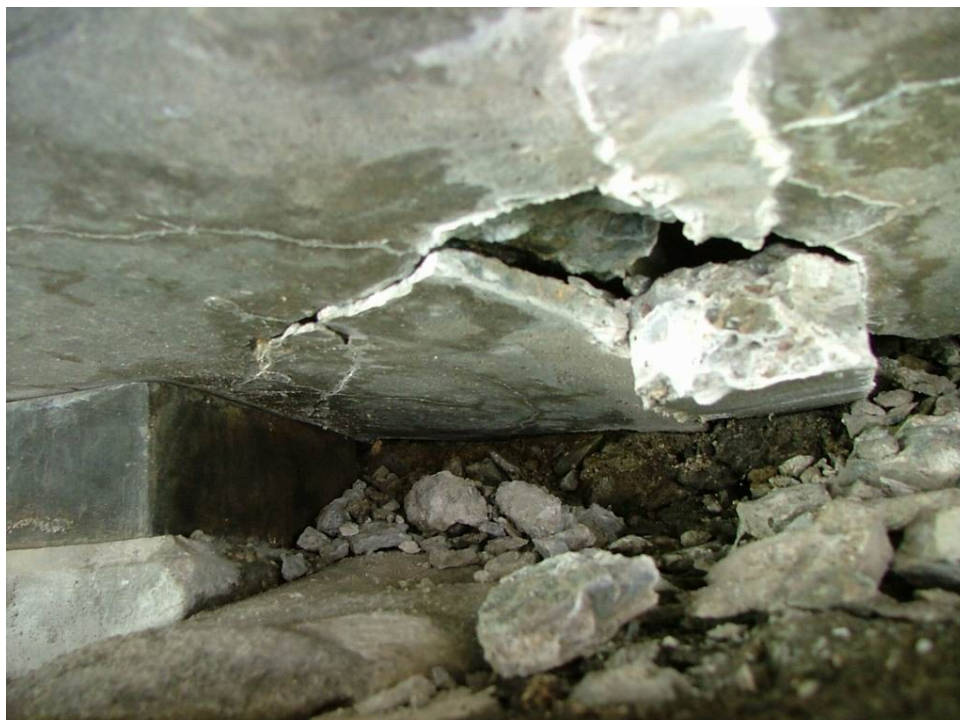
Badly deteriorated end of a prestressed plank girder at an abutment end.

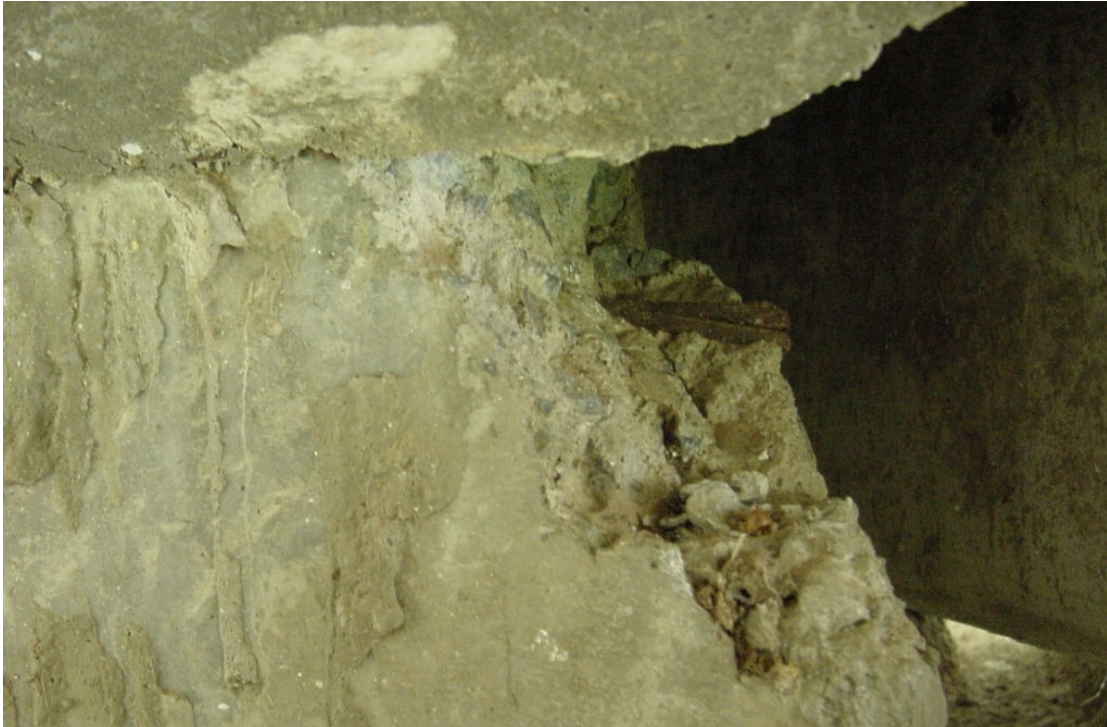
Cracked and spalled end of a 13.7m span pre-tensioned girder with exposed tendon.

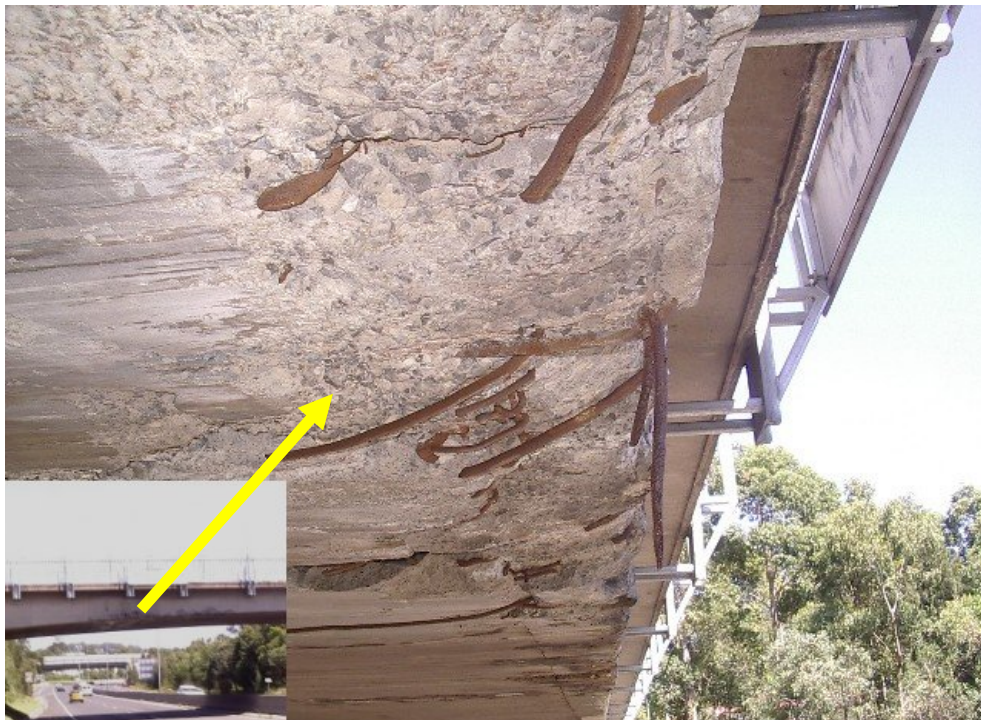
Overheight vehicle impact damage to bottom of prestress girder

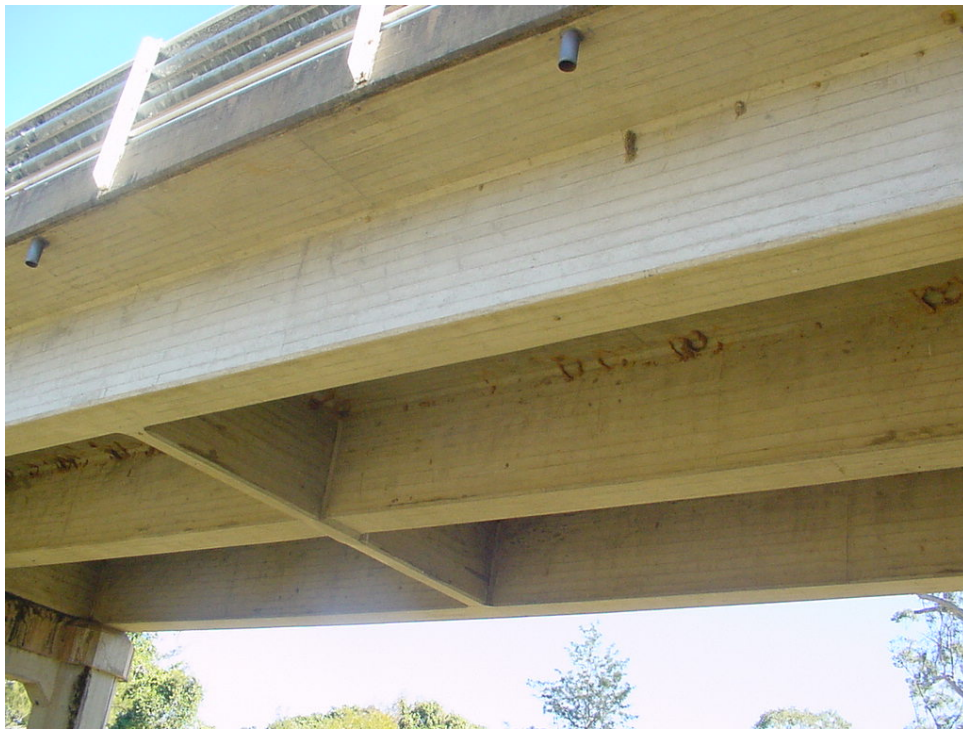
Concrete girders in good condition

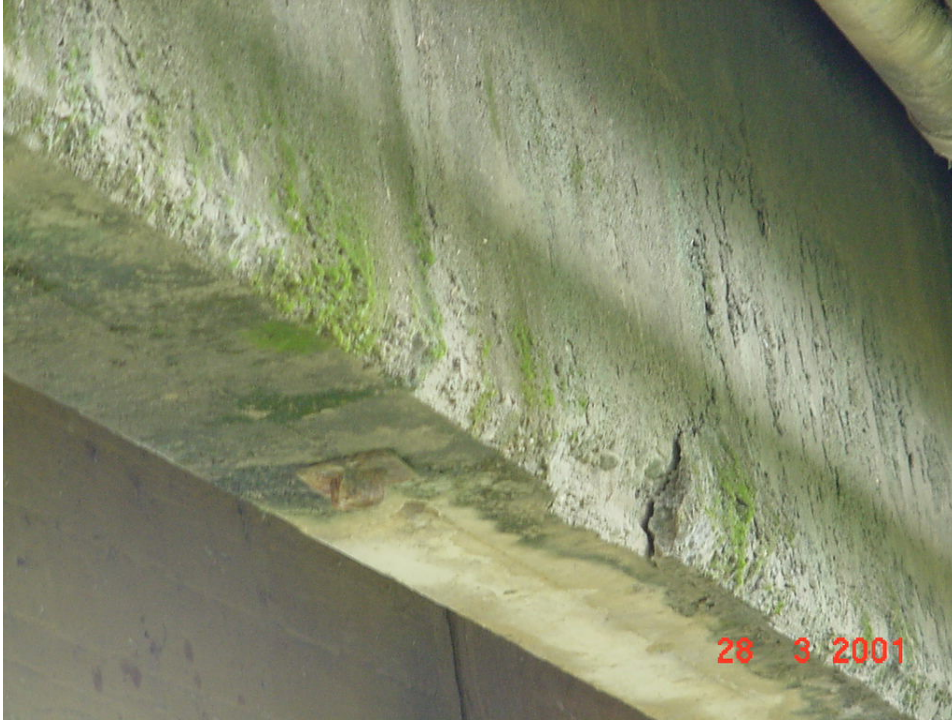
Minor cracks and spalls may be present but there is no exposed reinforcement or surface evidence of corrosion of reinforcement.

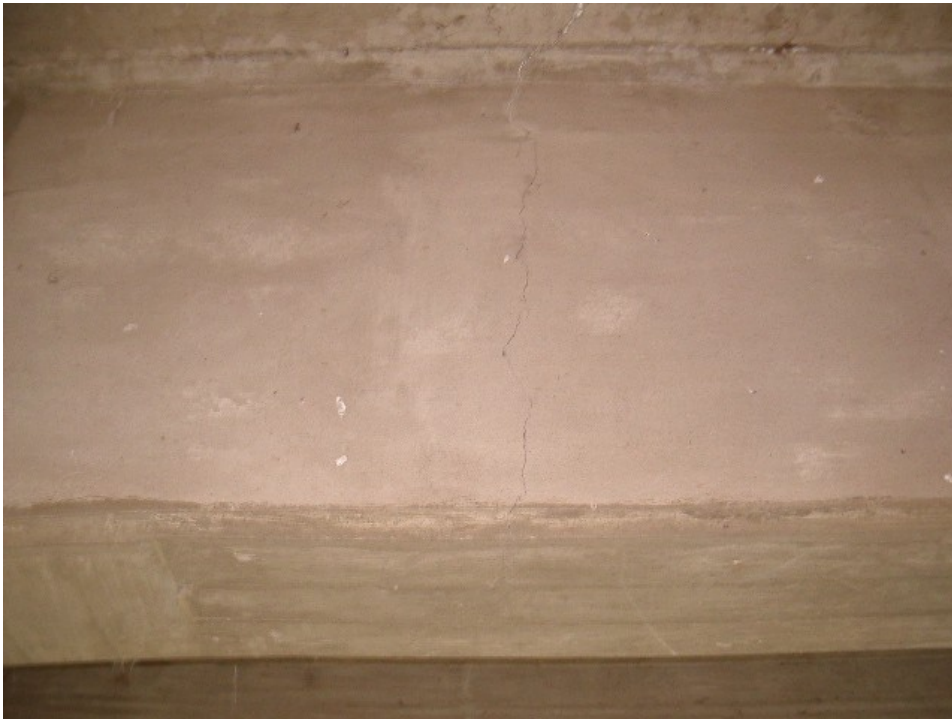
Reinforced beam with vertical crack.

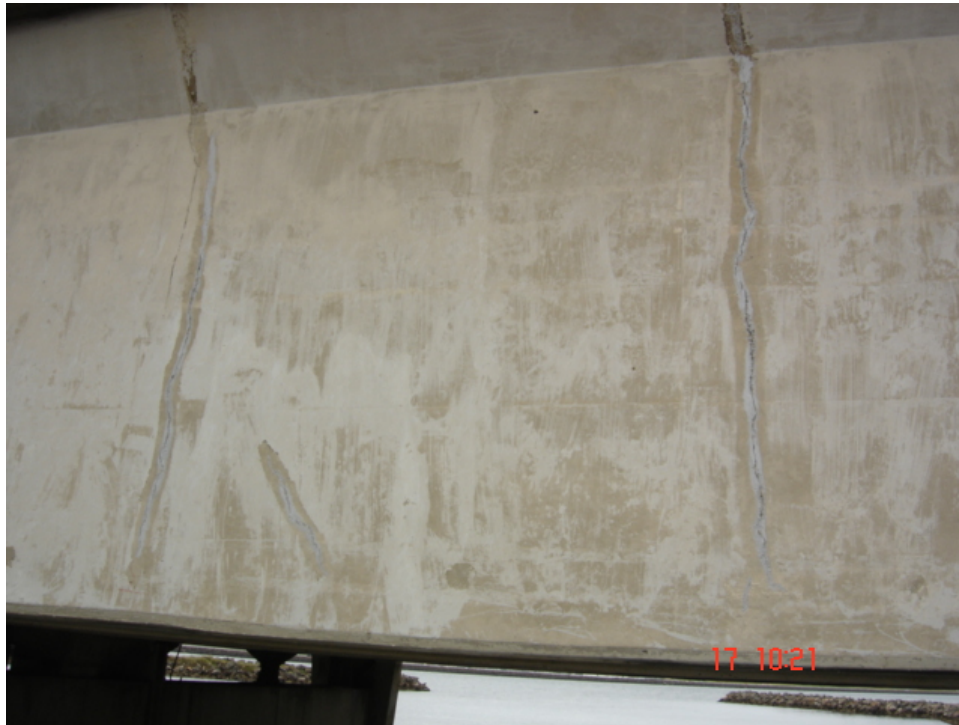
Cracks (previously repaired).

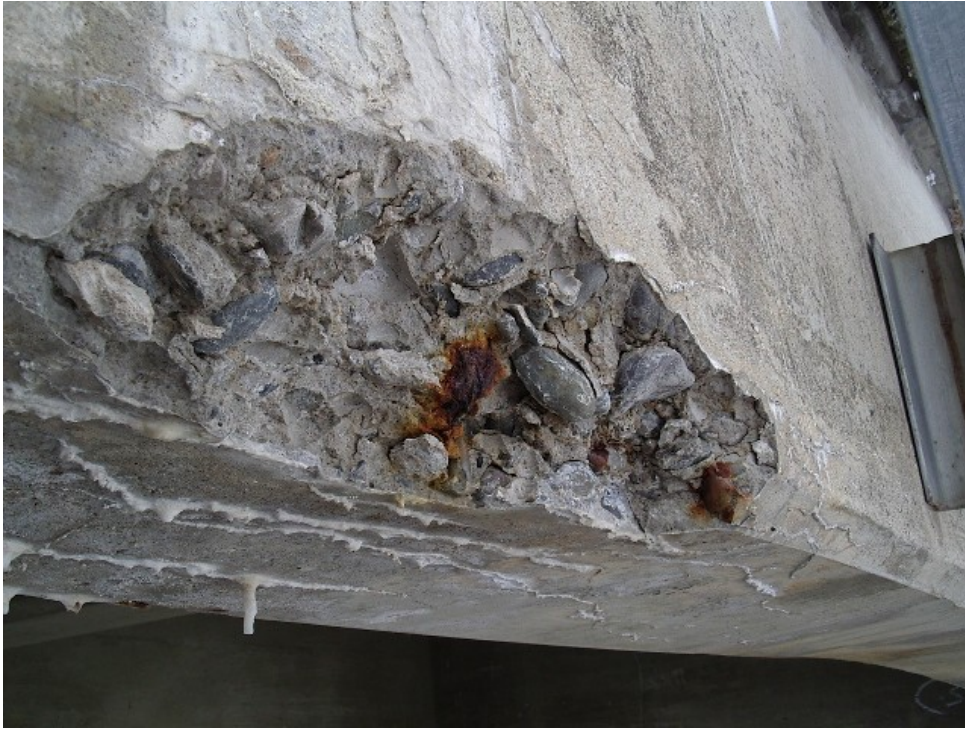
Spall on external girder. Exposed reinforcement with corrosion setting in.

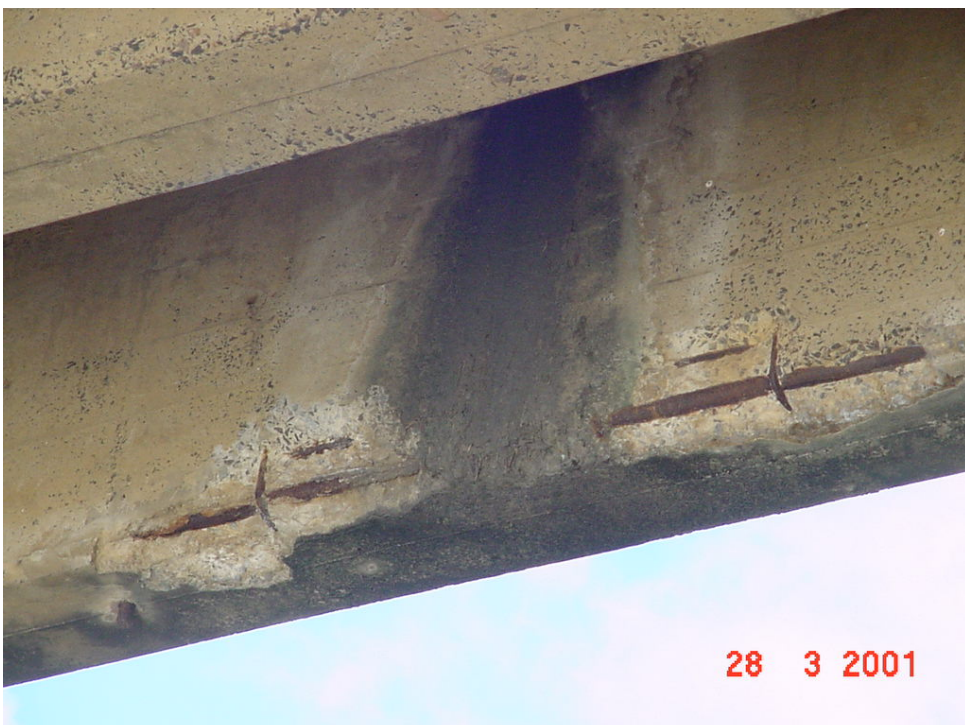
Bottom edge spalled. Exposed and corroding reinforcement with no significant loss of section.

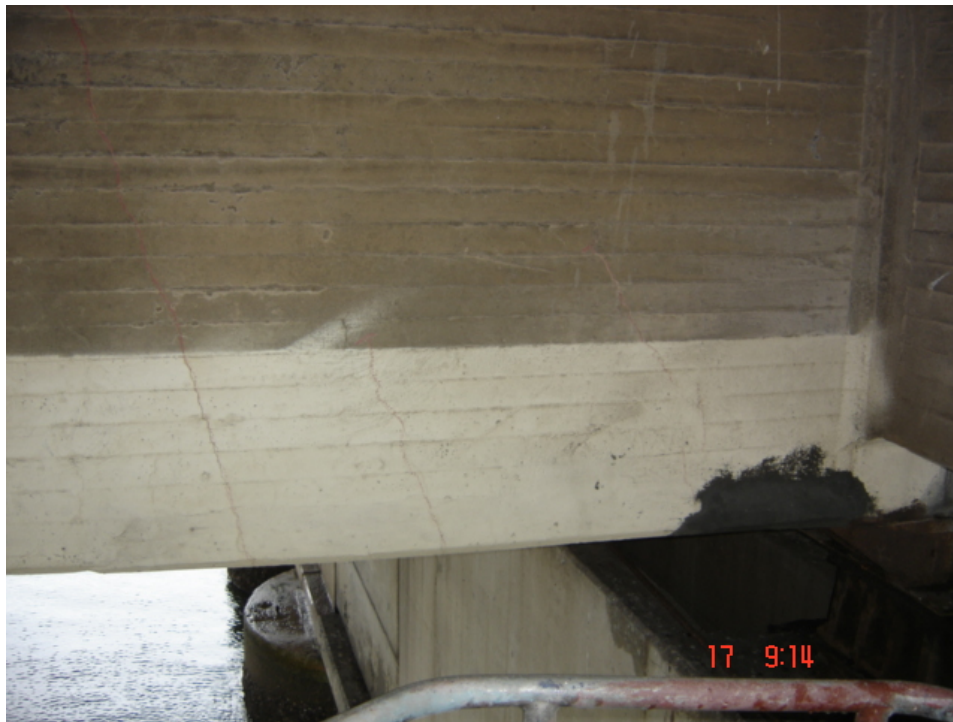
Diagonal shear cracks near support

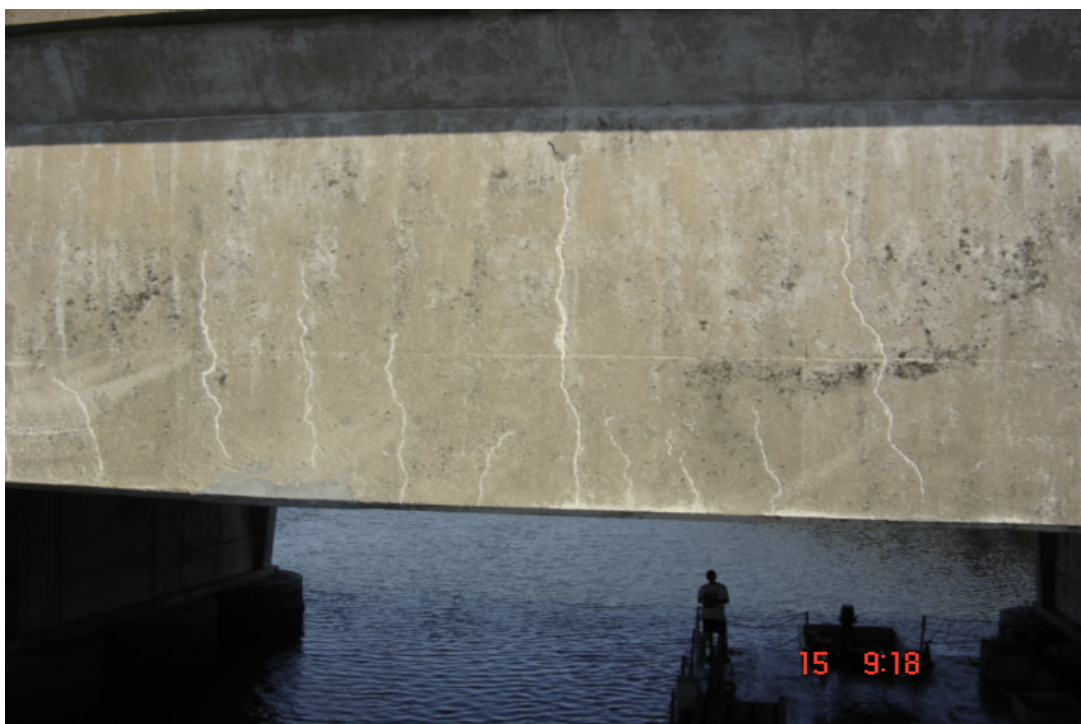
Typical flexural cracks 0.5 to 1.0mm wide at midspan with leaching through the cracks.

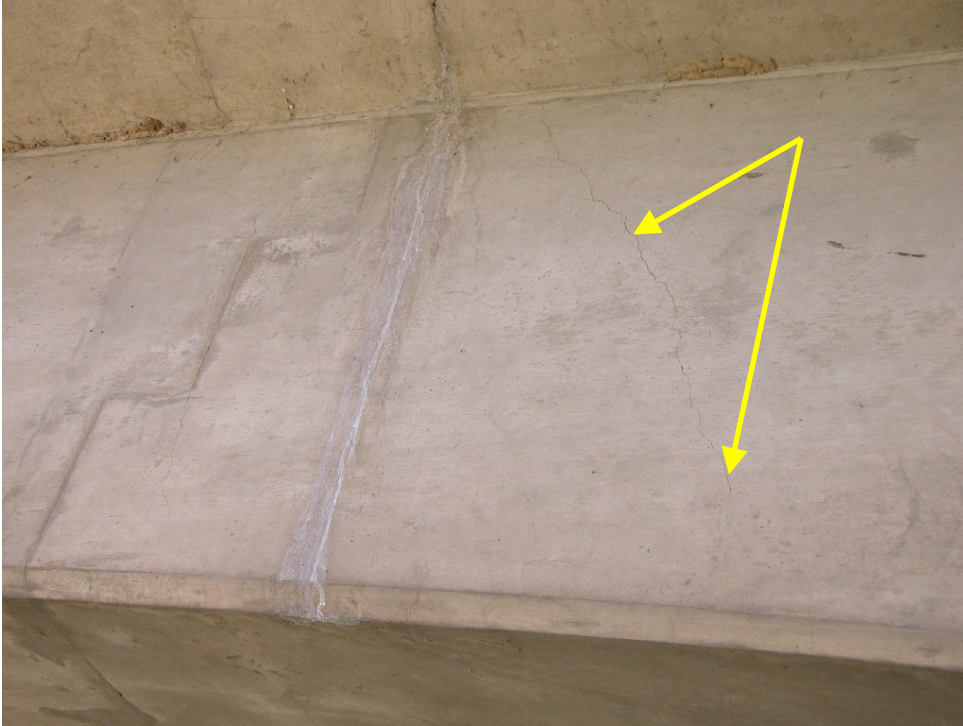
Diagonal crack near the support and construction joint.

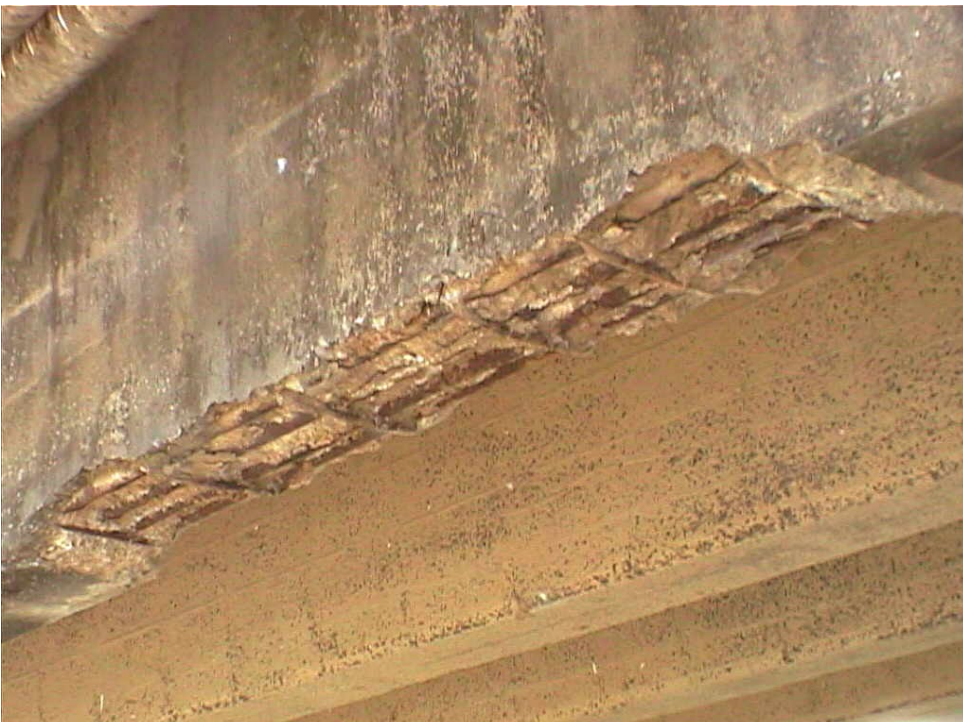
Severe spalling and delamination. Exposed and corroding reinforcement.

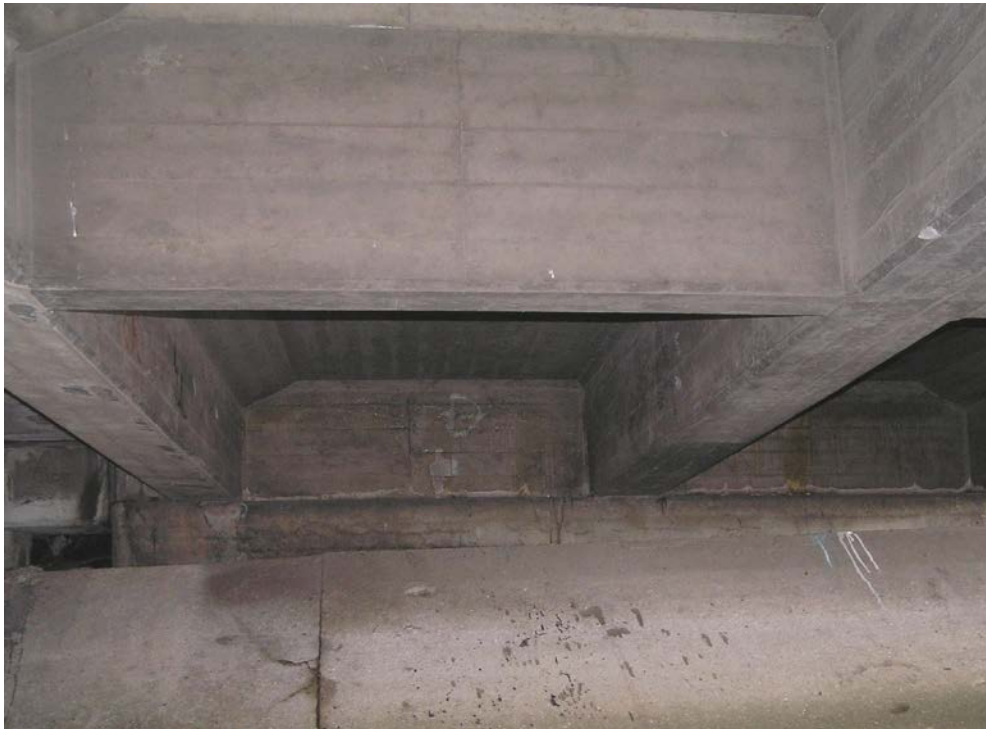
Cross girder in good condition.

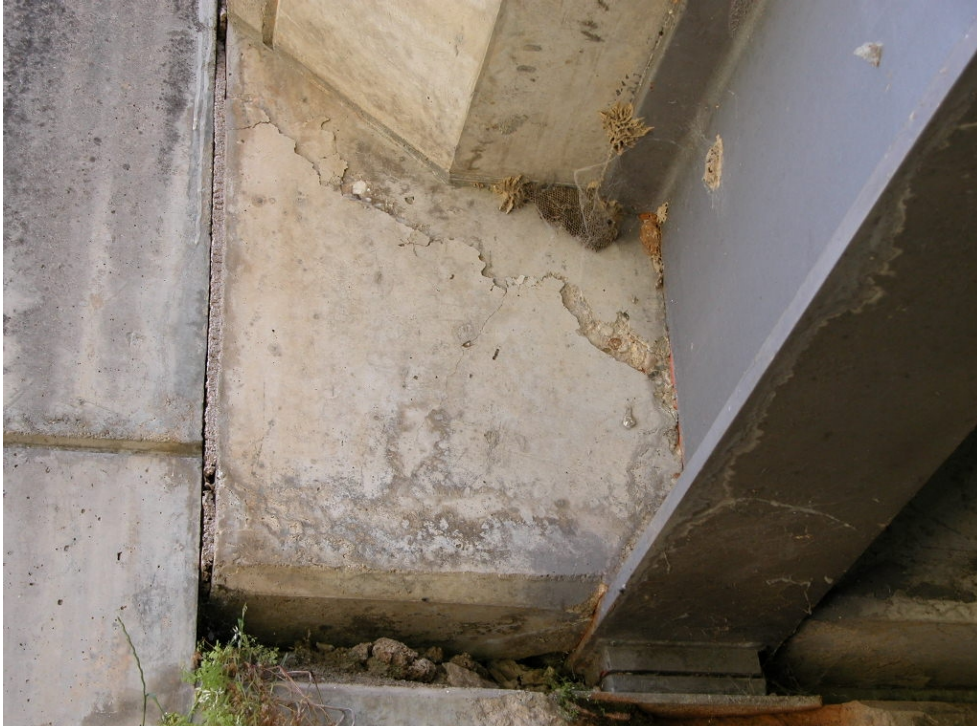
Significant crack ready to delaminate.

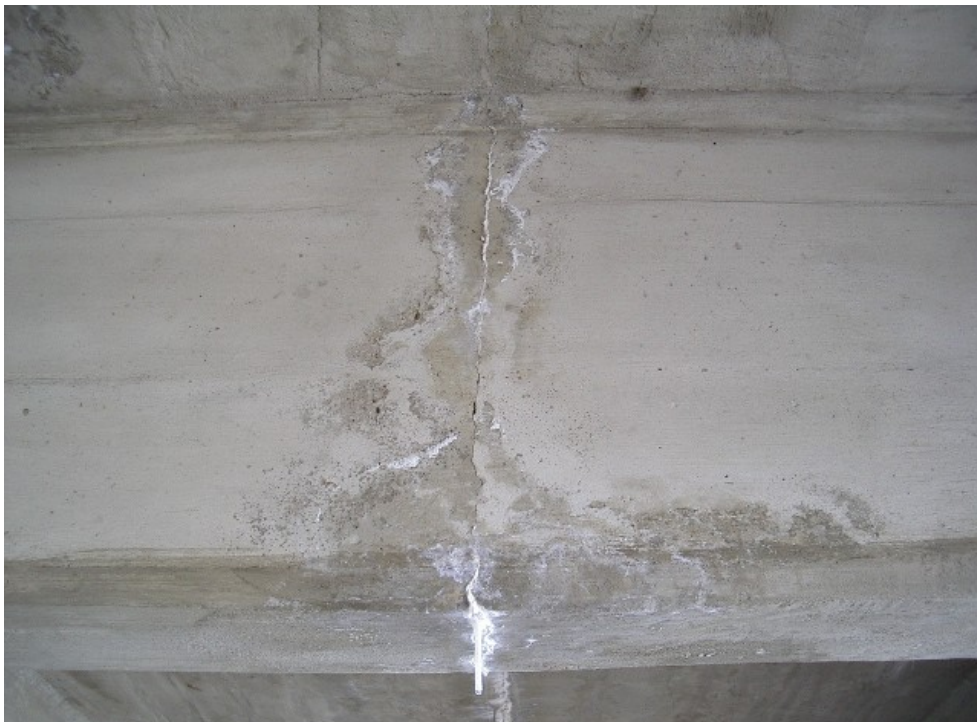
Significant moisture ingress and leaching at the construction joint of the cross girder. No evidence of corrosion.

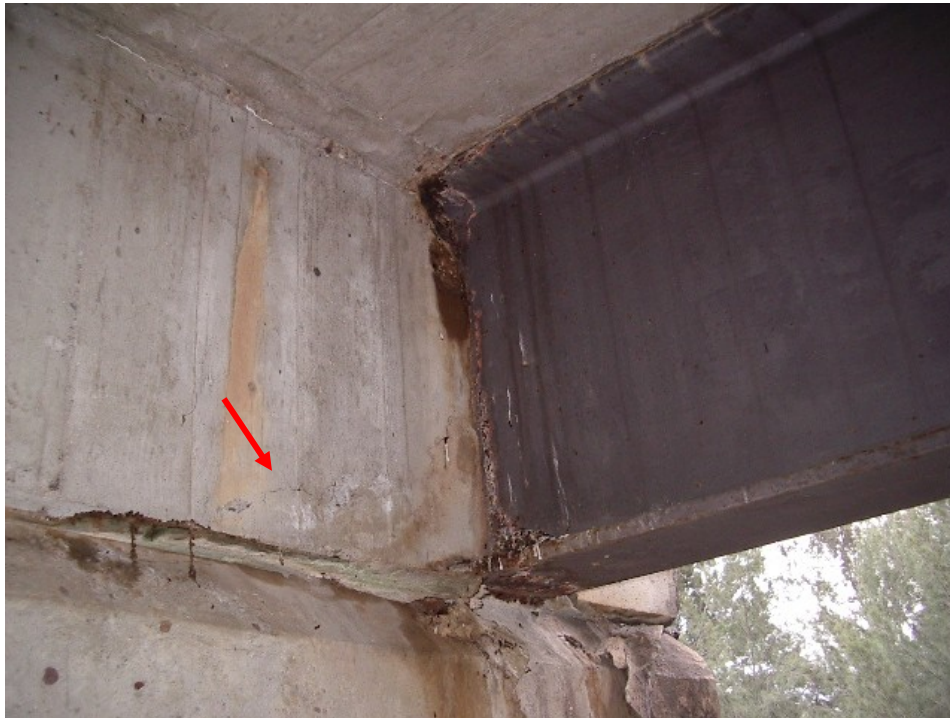
Cracked cross girder.

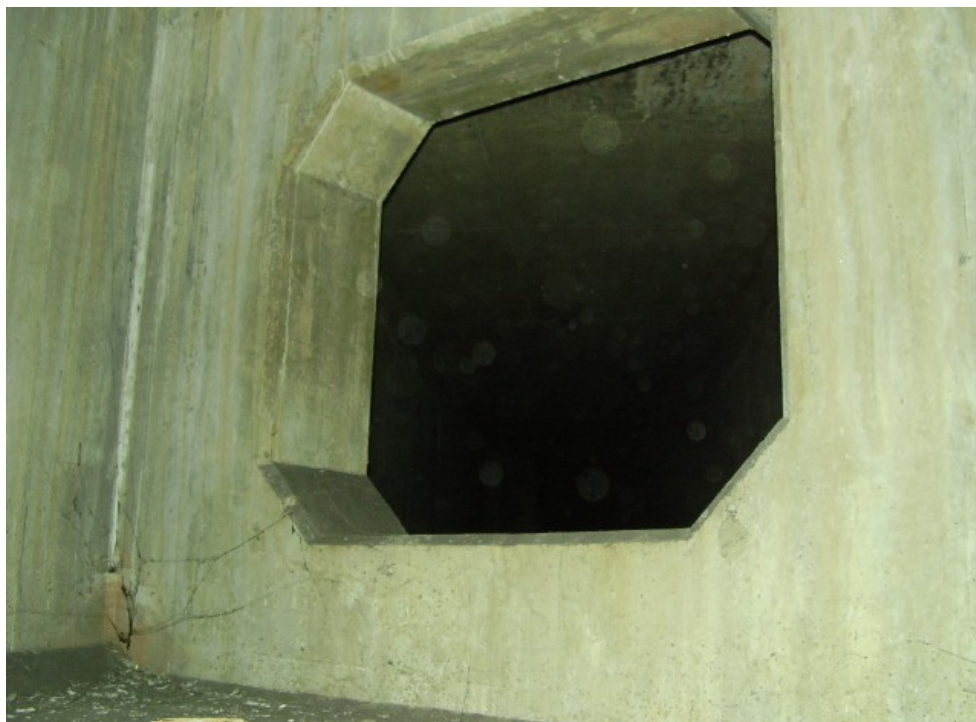
Cracked diaphragm with access hole.

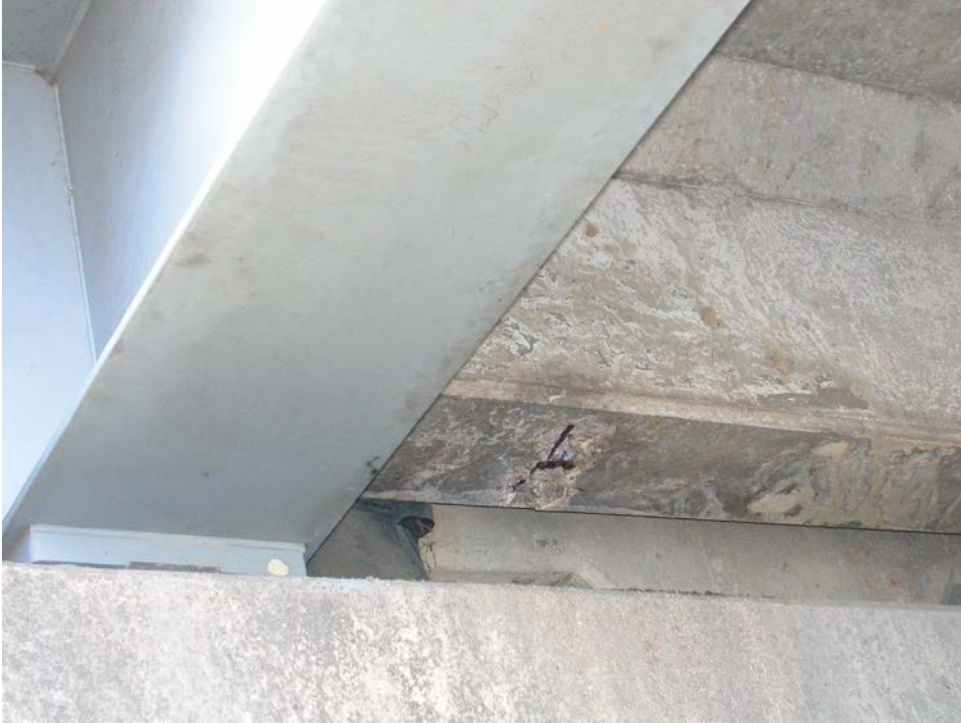
Minor spall with exposed reinforcement in the cross girder

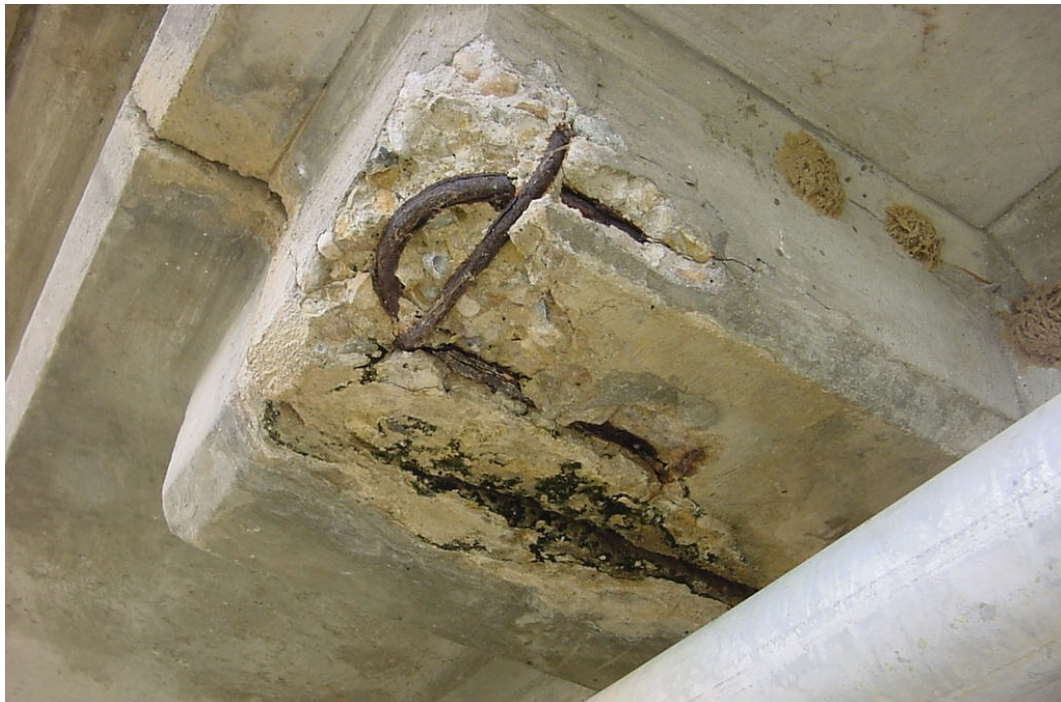
Spalled concrete with exposed reinforcement.

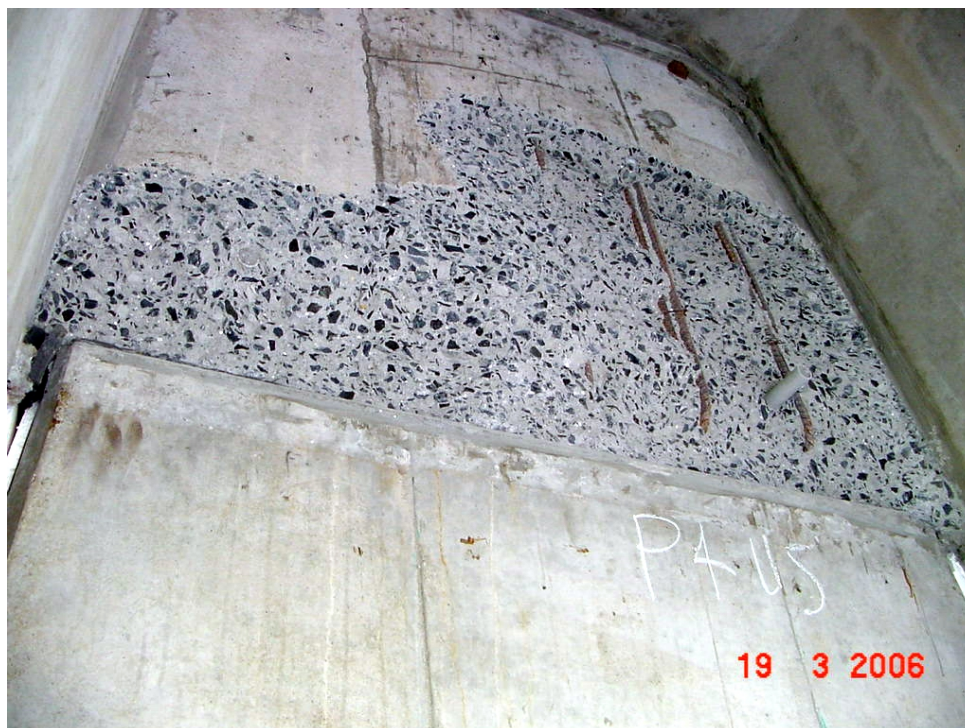
Extensive delamination and exposed reinforcement.

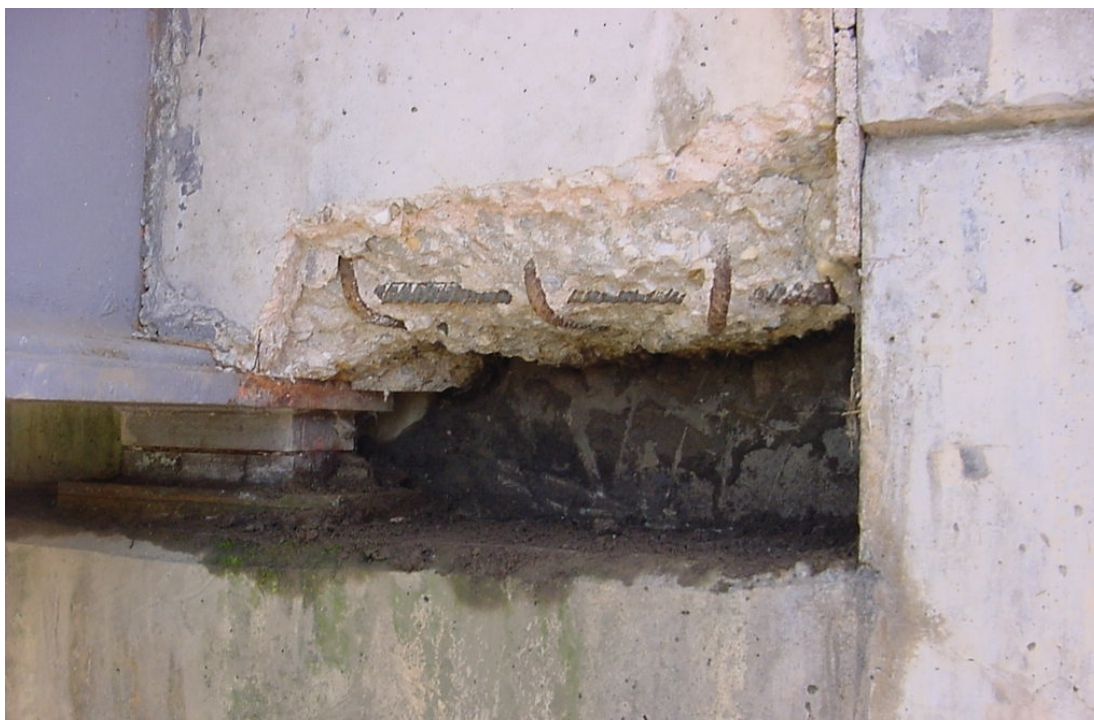
Significant spalling at the bottom of diaphragm. Exposed reinforcement.

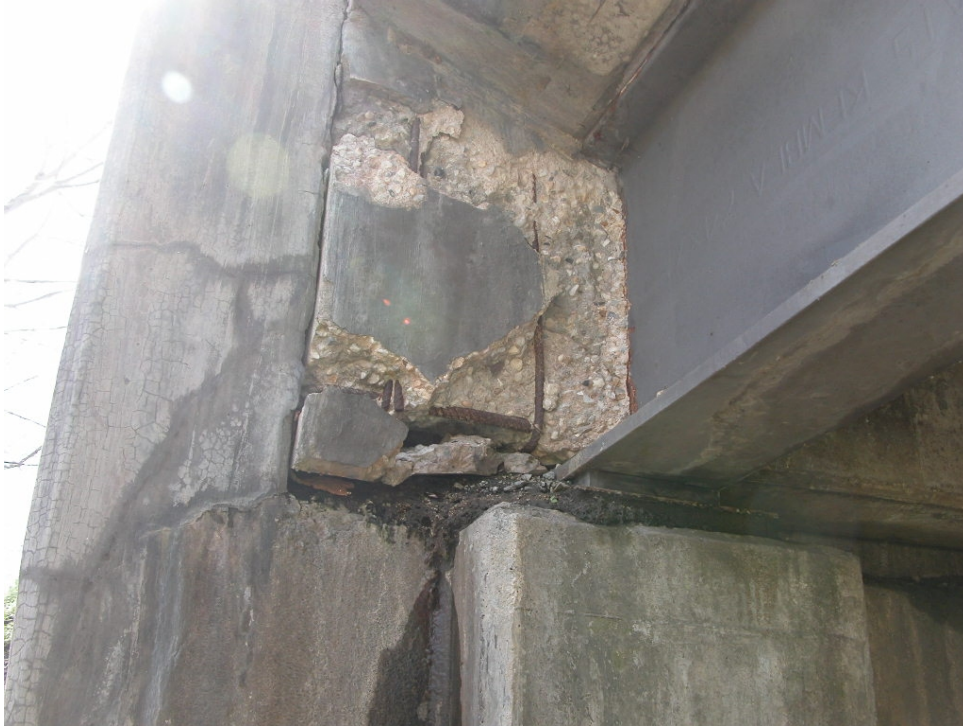
Crushed concrete diaphragm with exposed reo.
