Transport  
**Roads & Maritime  
Services**

# **BRIDGE INSPECTION PROCEDURE MANUAL**

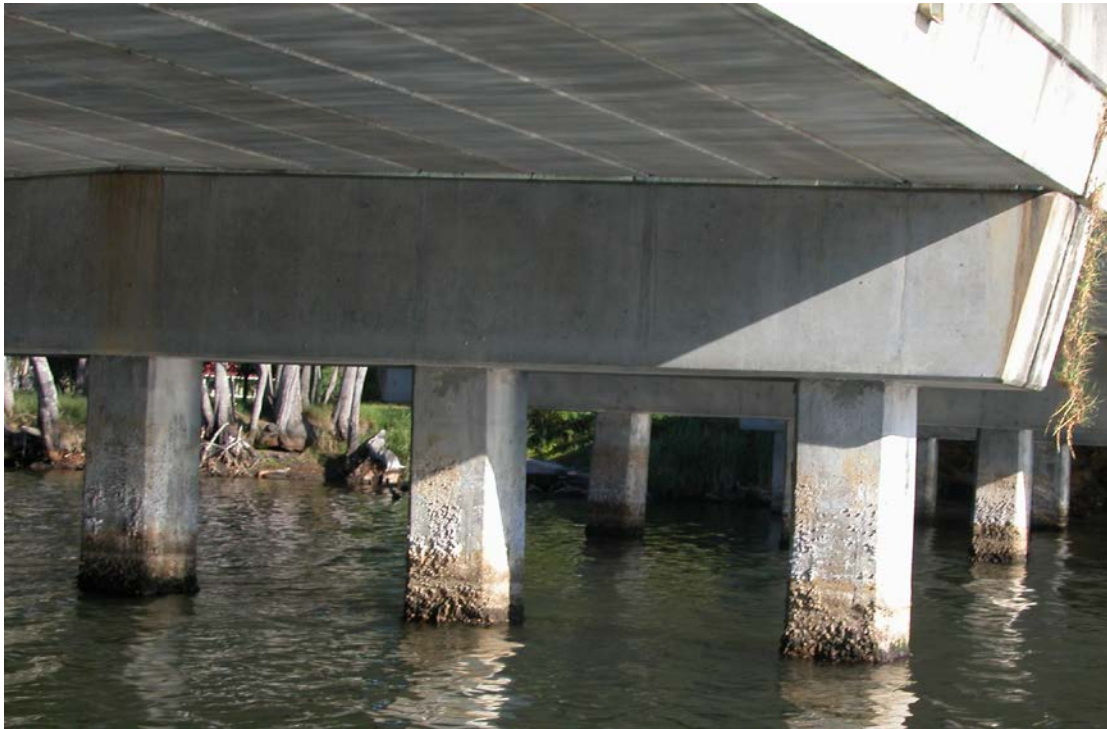
Concrete Headstock in good condition

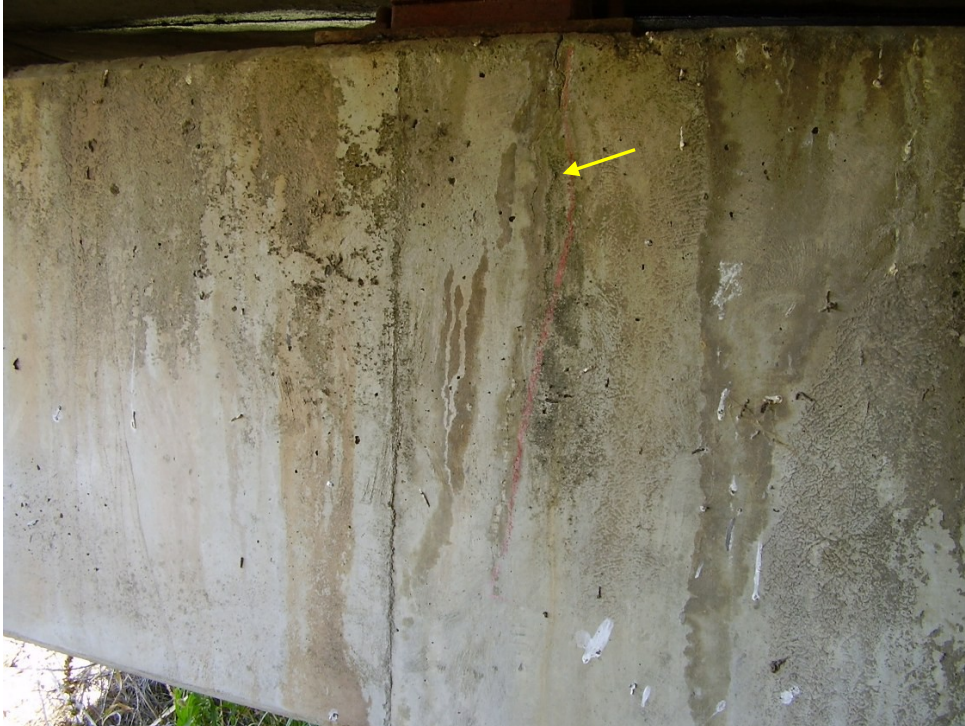
Vertical crack under the bearing

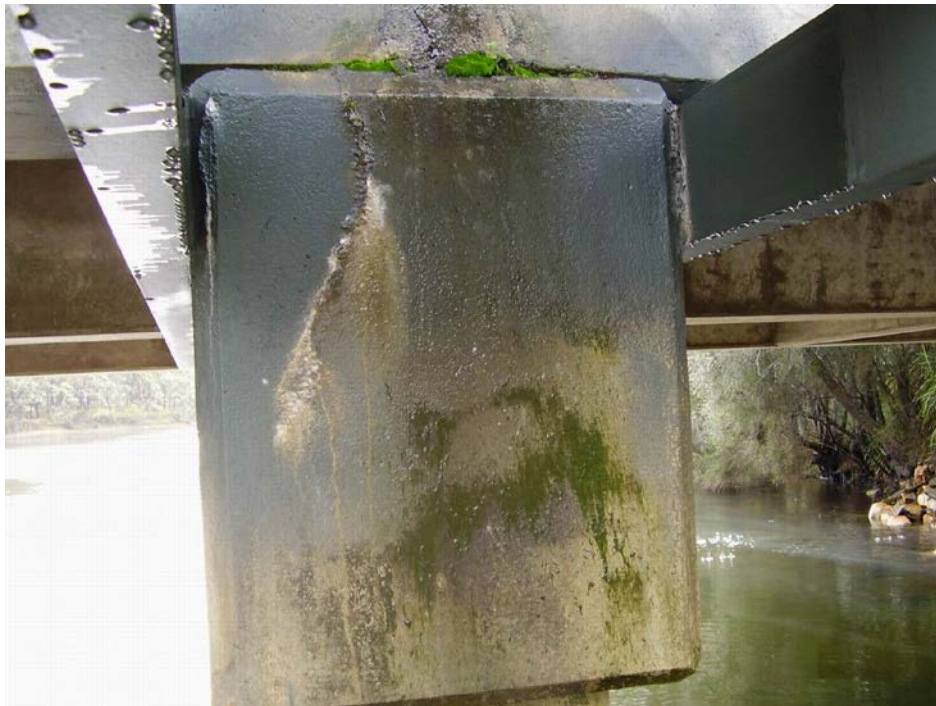
Crack with leaching on the end of headstock

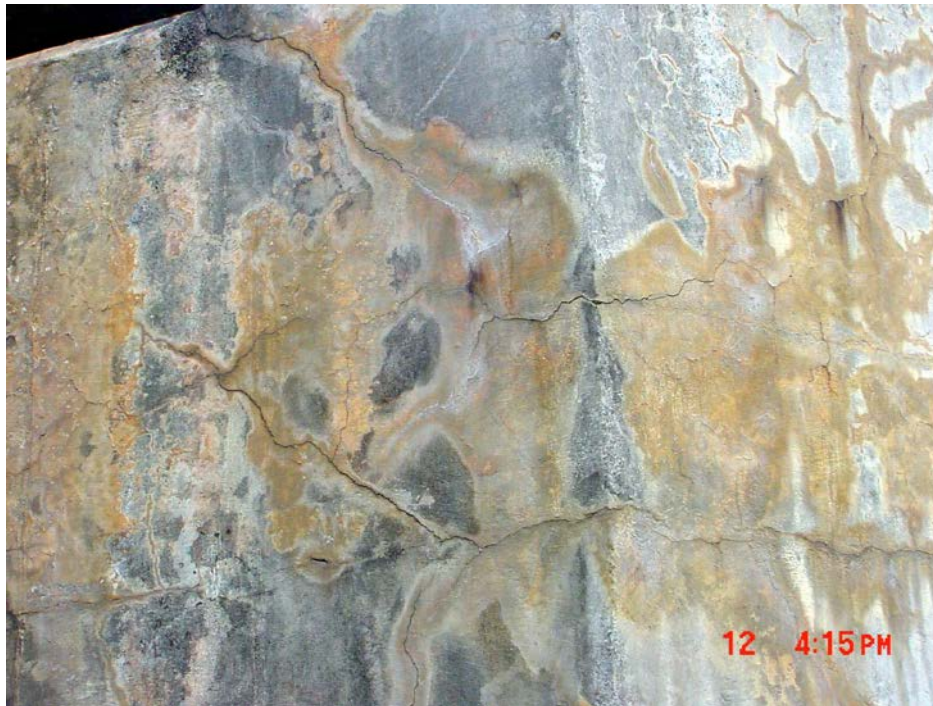
Severe AAR cracking on a headstock

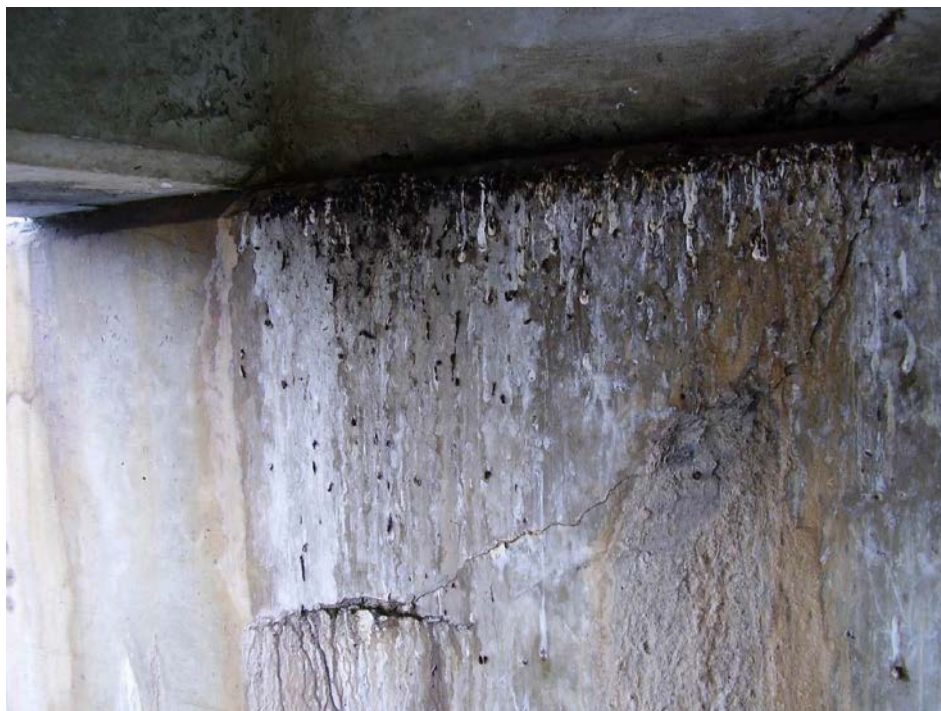
Significant crack with hollow sounding concrete behind the affected area.

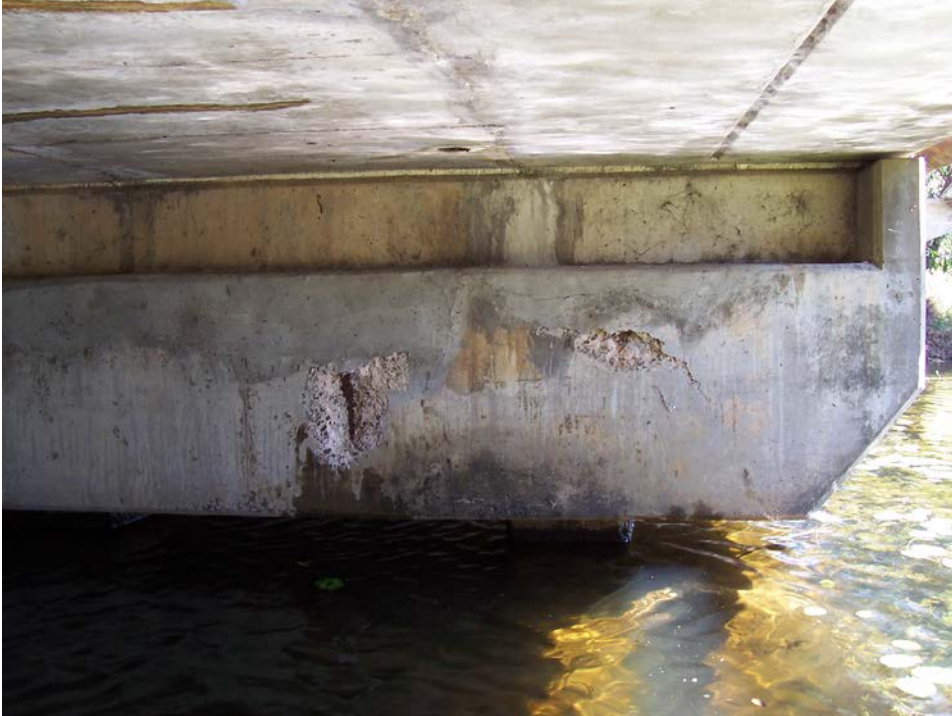
Spalling of the concrete with exposed reinforcement. Some previously repaired area cracking again.

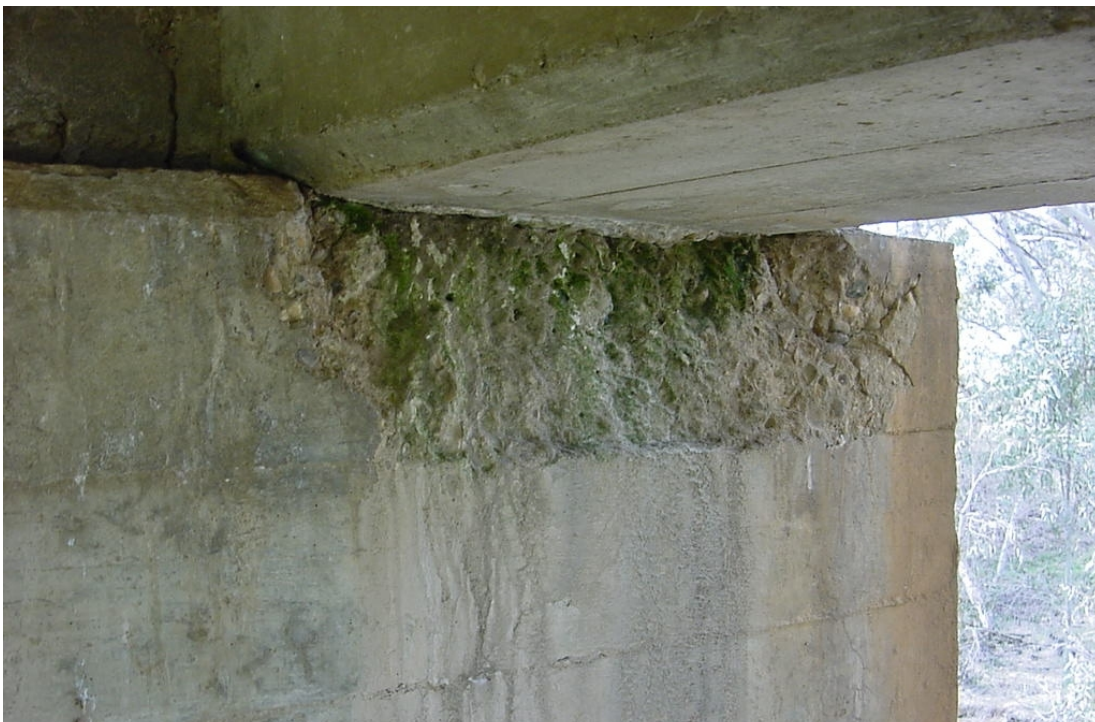
Significant spall under the beam on the headstock.

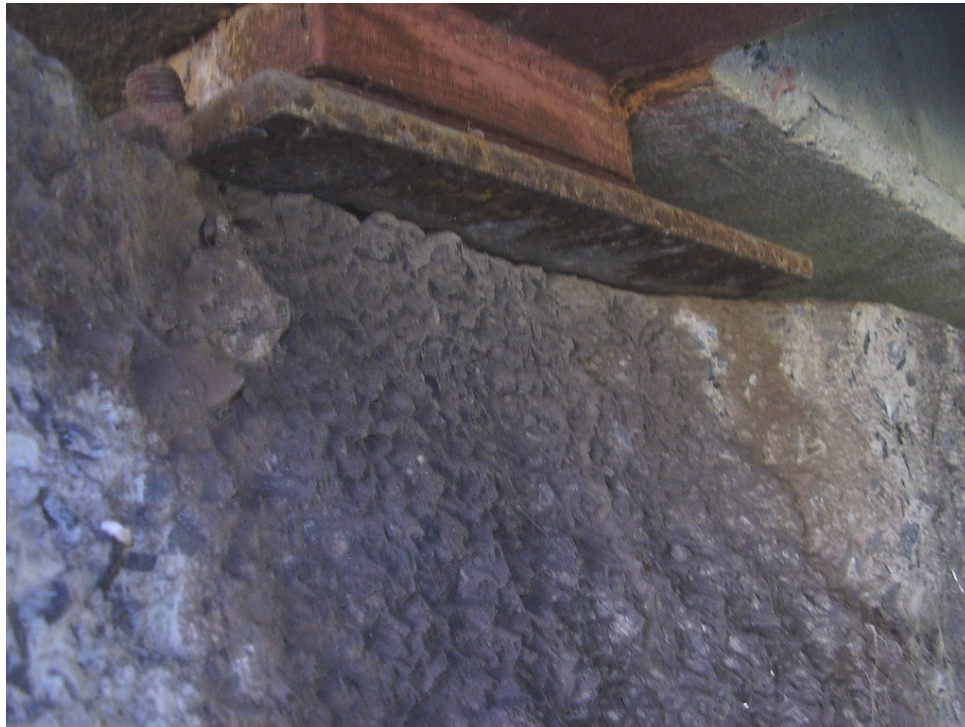
Significant spall under the bearing on the headstock. No exposed reinforcement in the headstock.

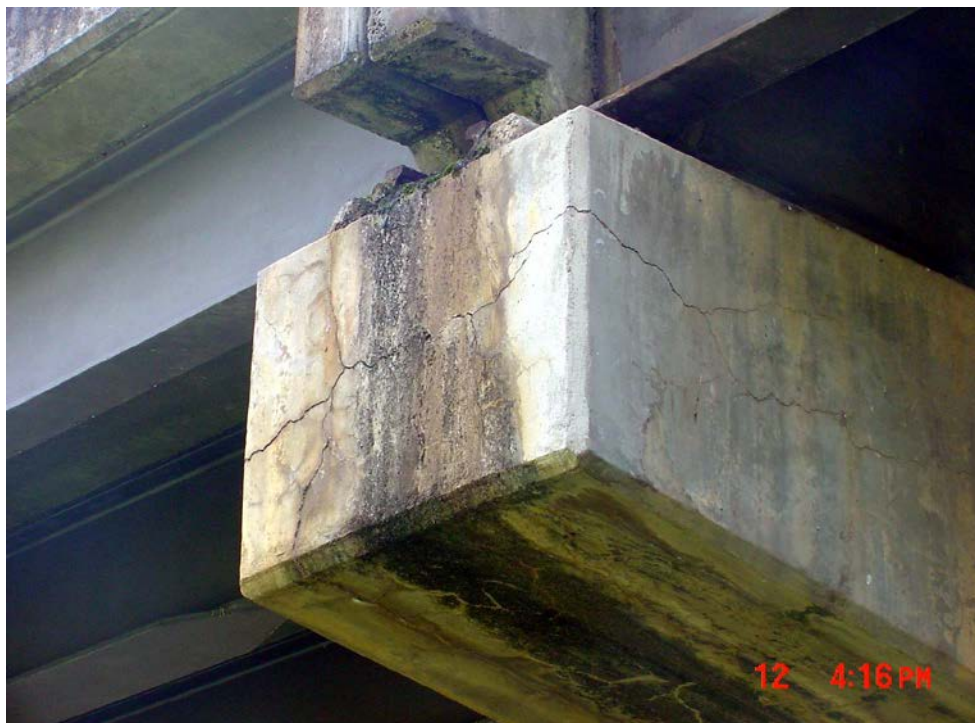
Significant cracking of the headstock in all faces. Pattern is typical of AAR.

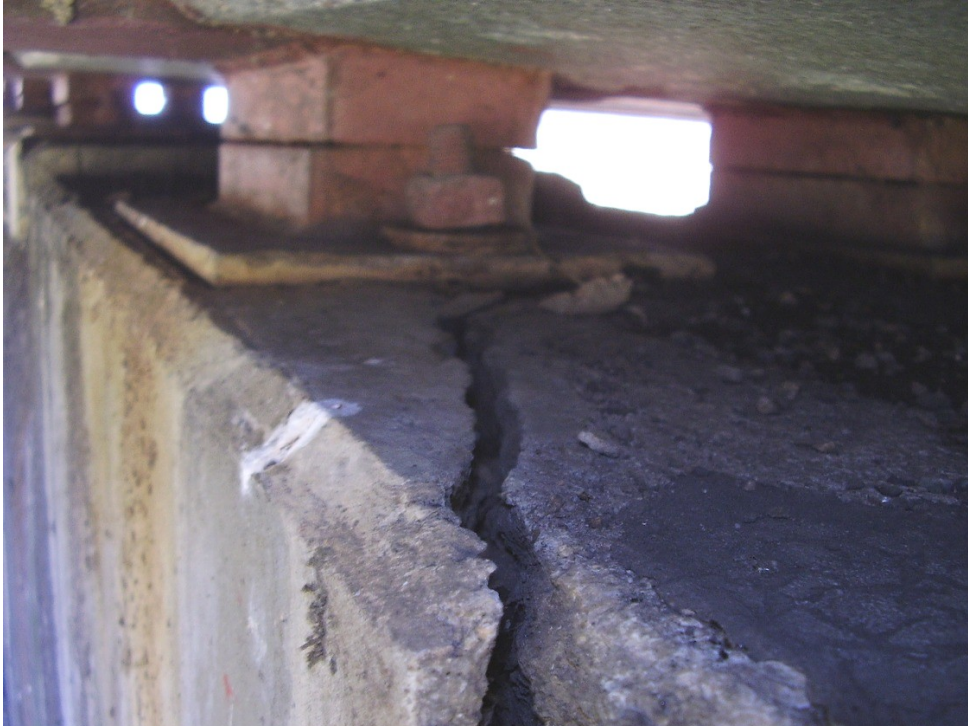
Wide crack splitting the headstock under the bearing

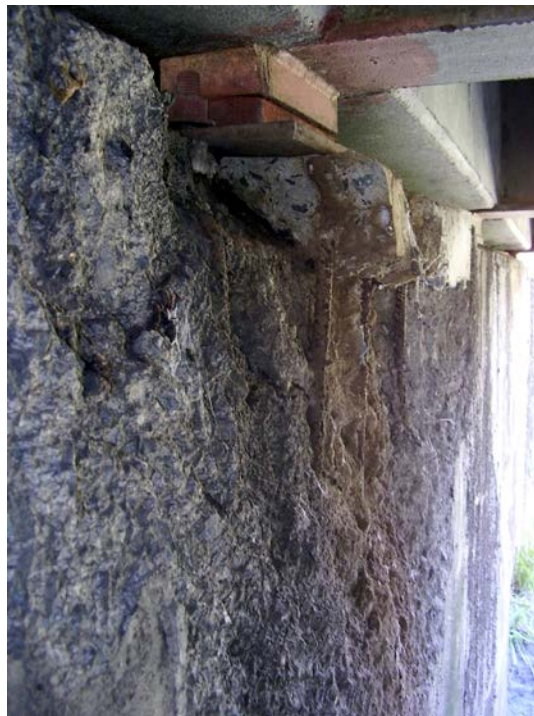
Local failure of the headstock under the bearing threatening support of the beam. Reinforcement and holding bolt exposed

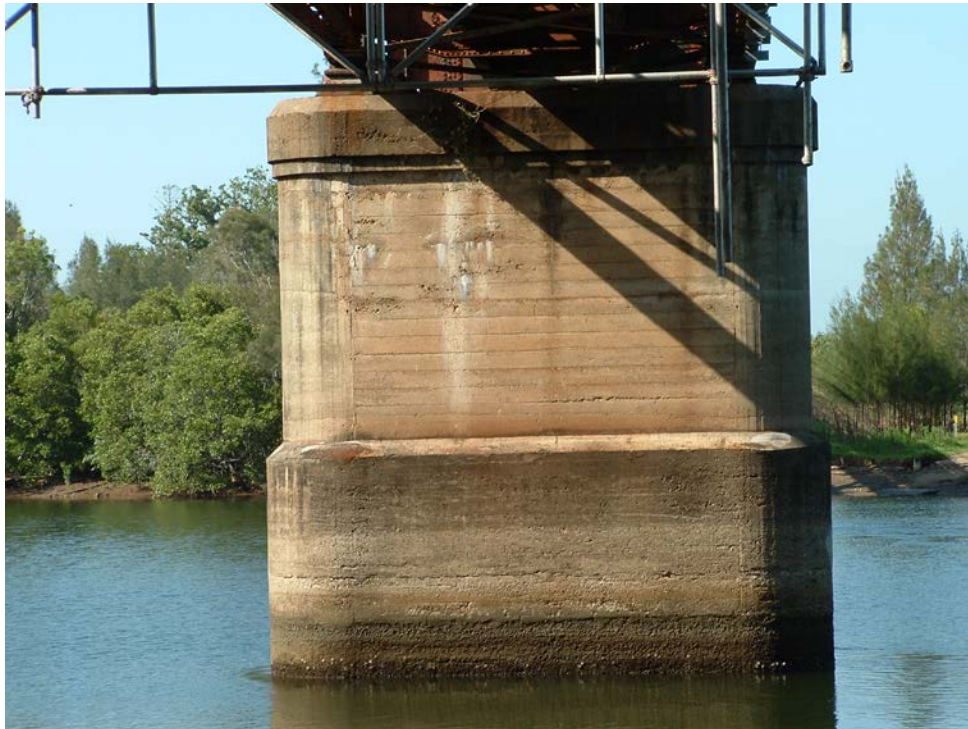
The pier in good condition with minor leaching

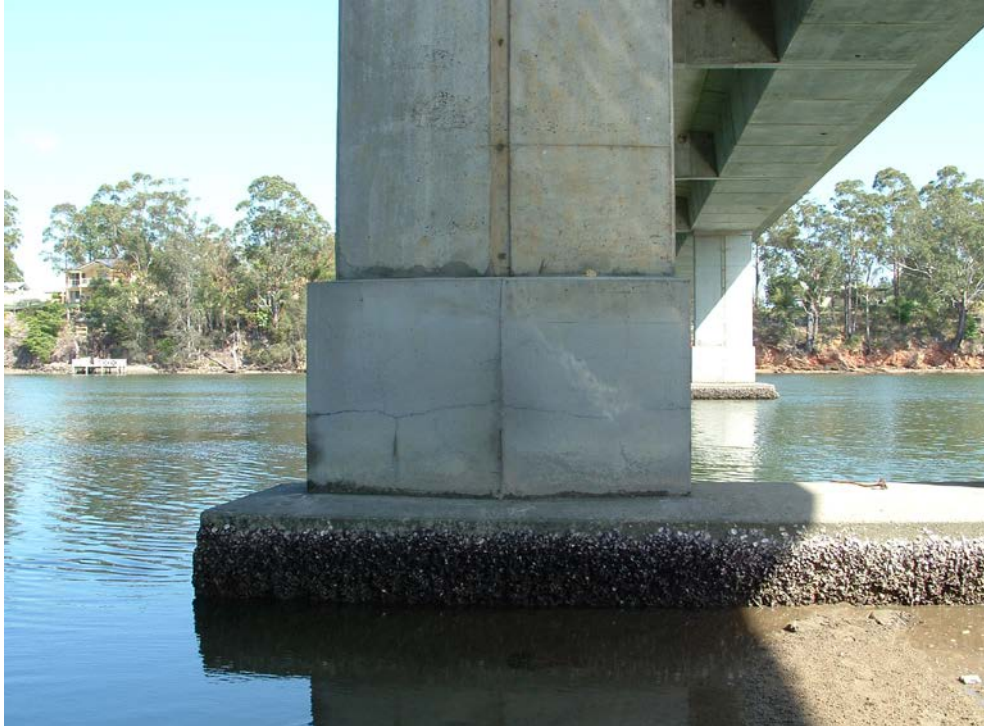
Horizontal crack at the bottom part of Pier. No sign of corrosion or exposed reinforcement.

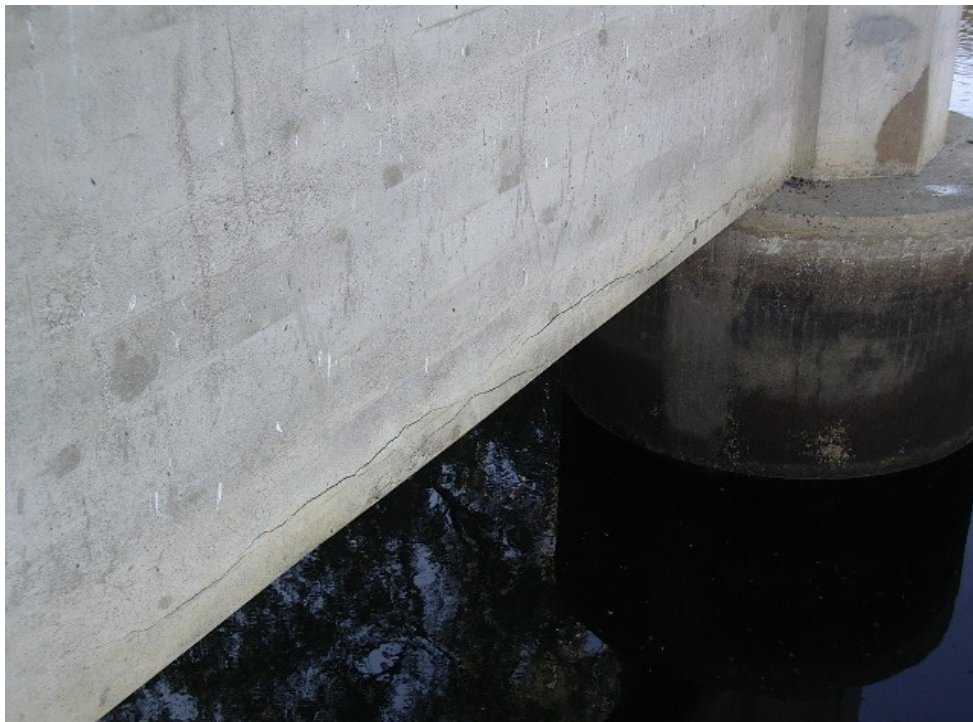
Horizontal crack along the bottom edge. No exposed reinforcement

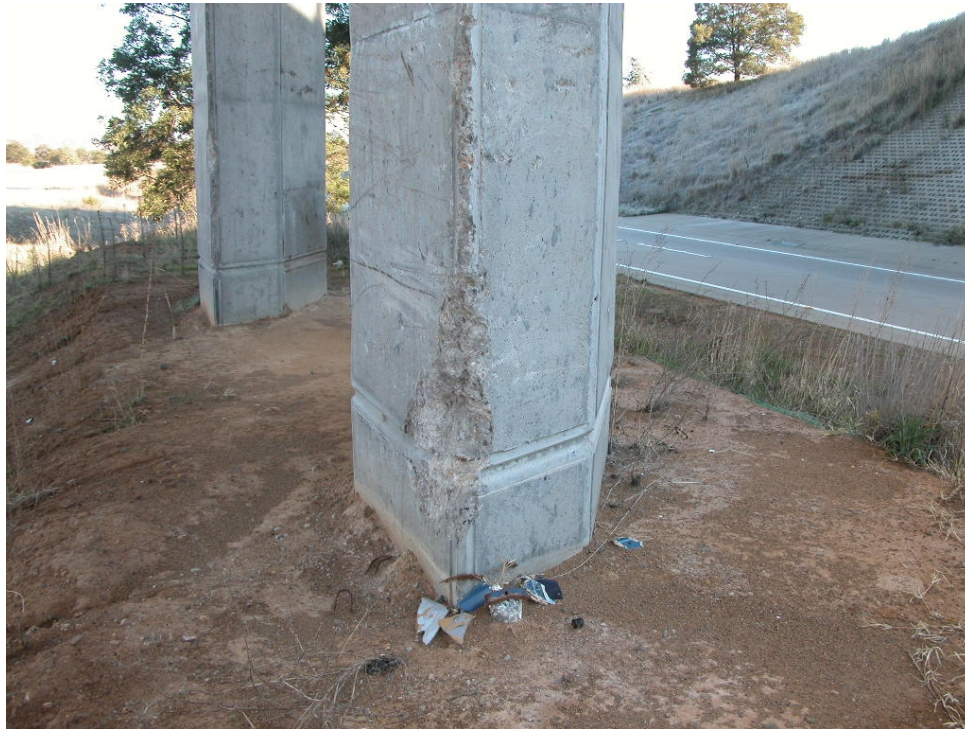
Accident damage - Concrete chipped off the pier column

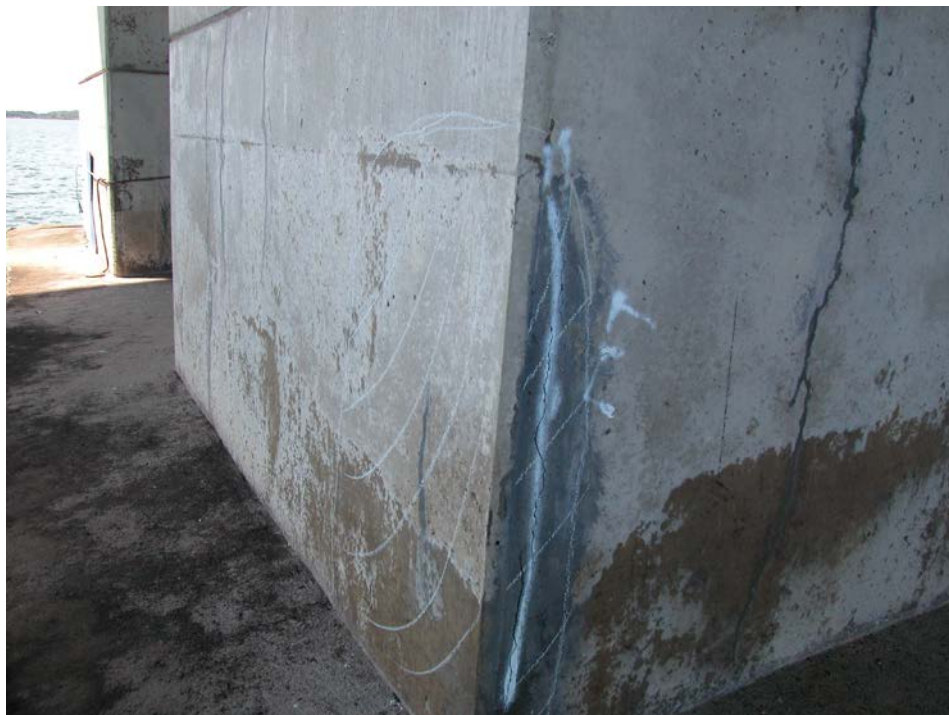
Patched up crack reopening

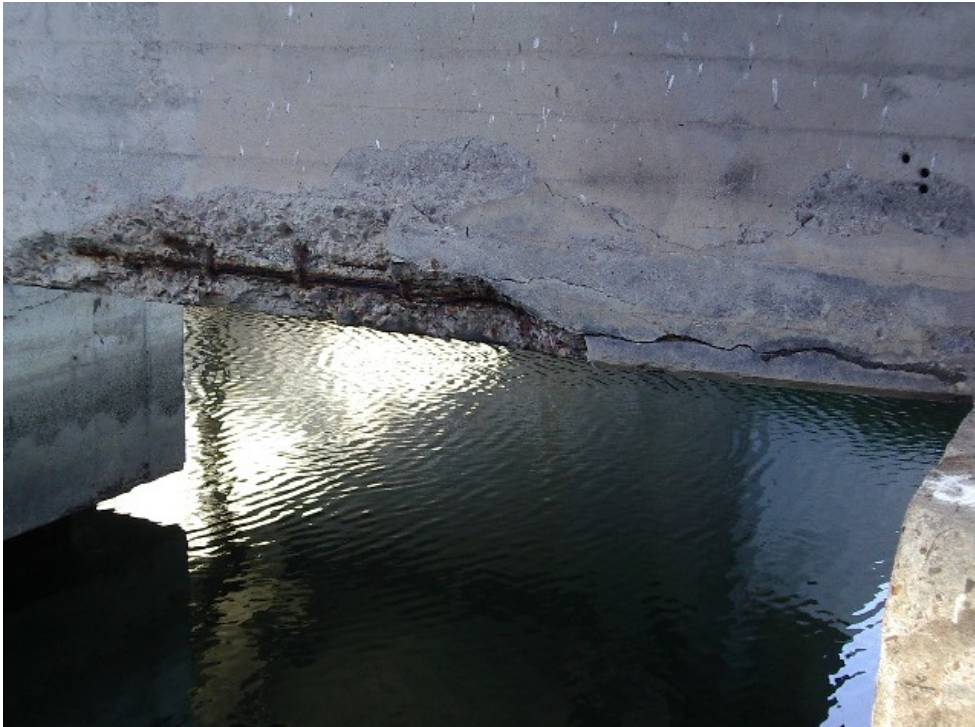
Significant spall with corrosion of exposed reinforcement.

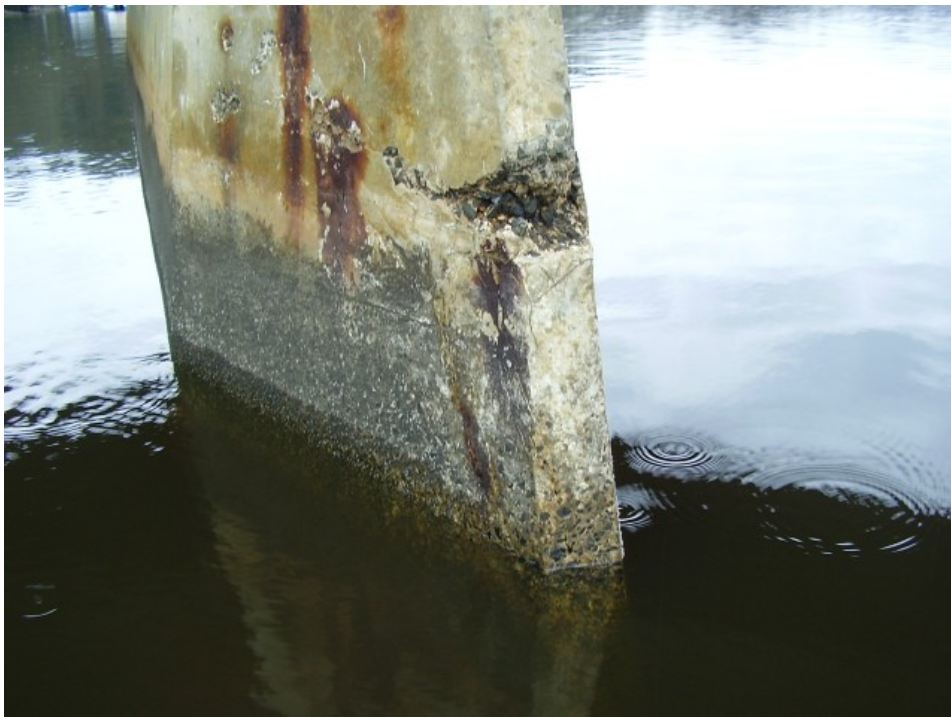
Some spalls and signs of corrosion of reinforcement.

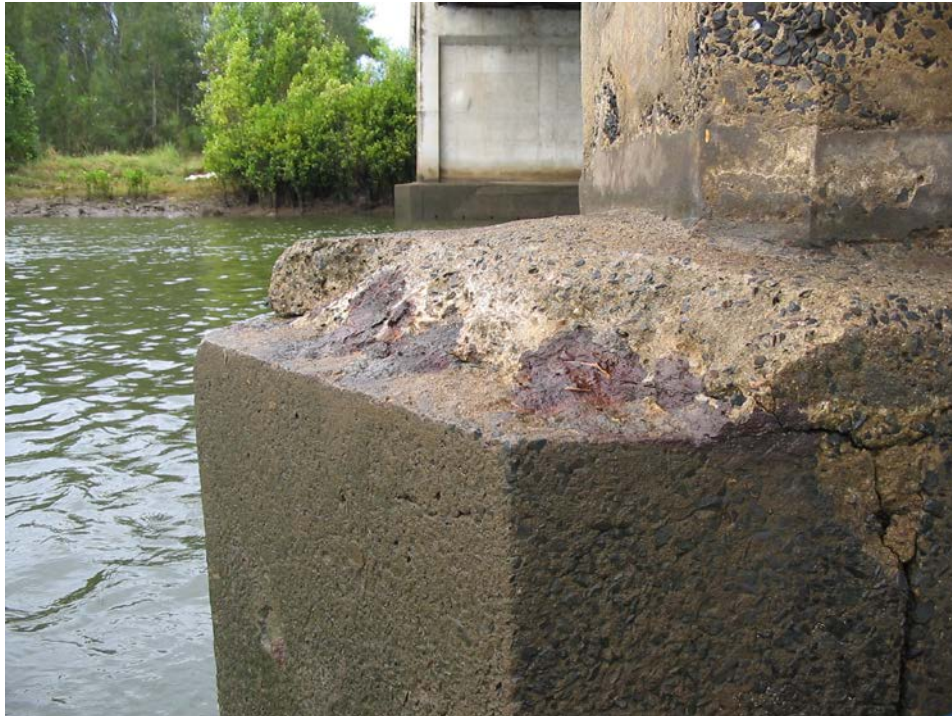
Corroding reinforcement and significant vertical crack on the side.

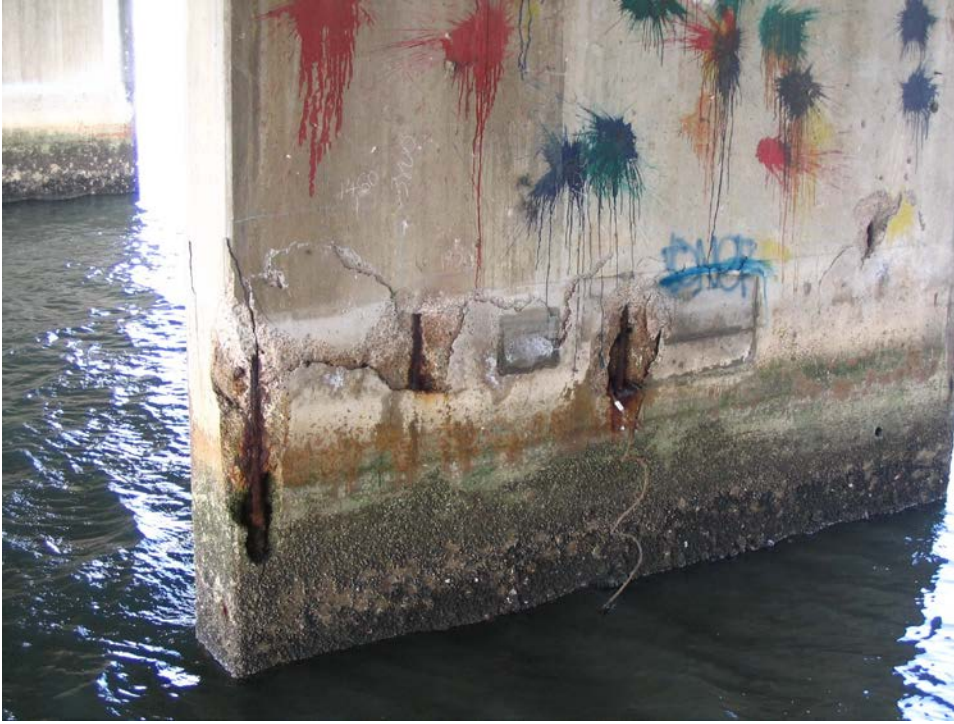
Significant loss of section of reinforcement.

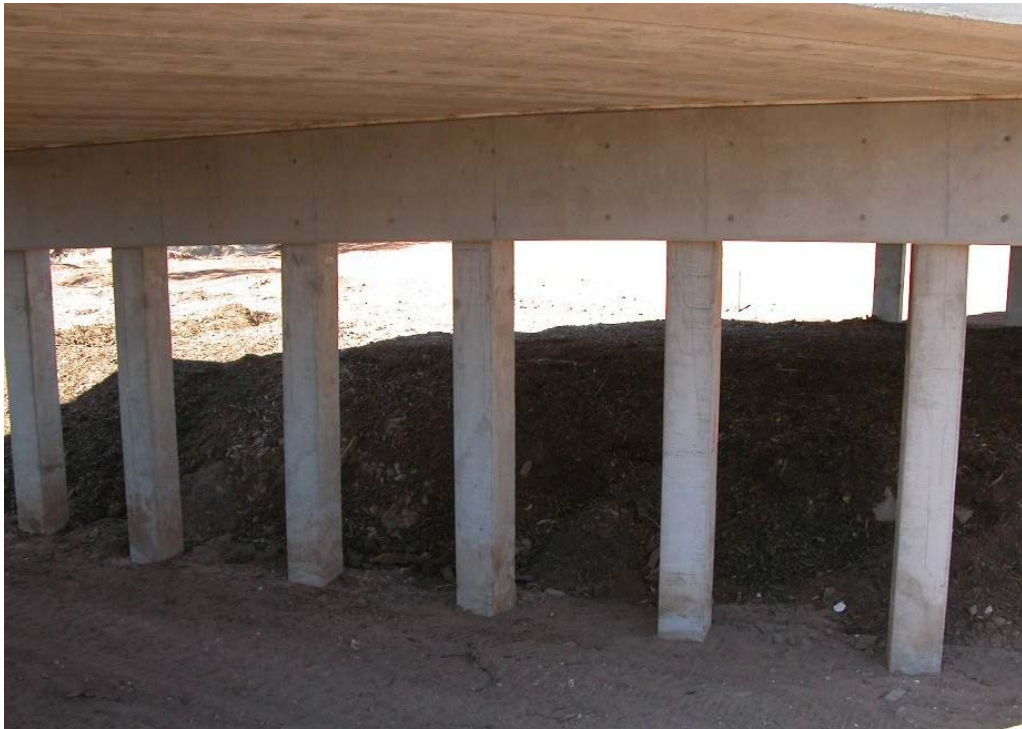
Concrete piles in good condition.

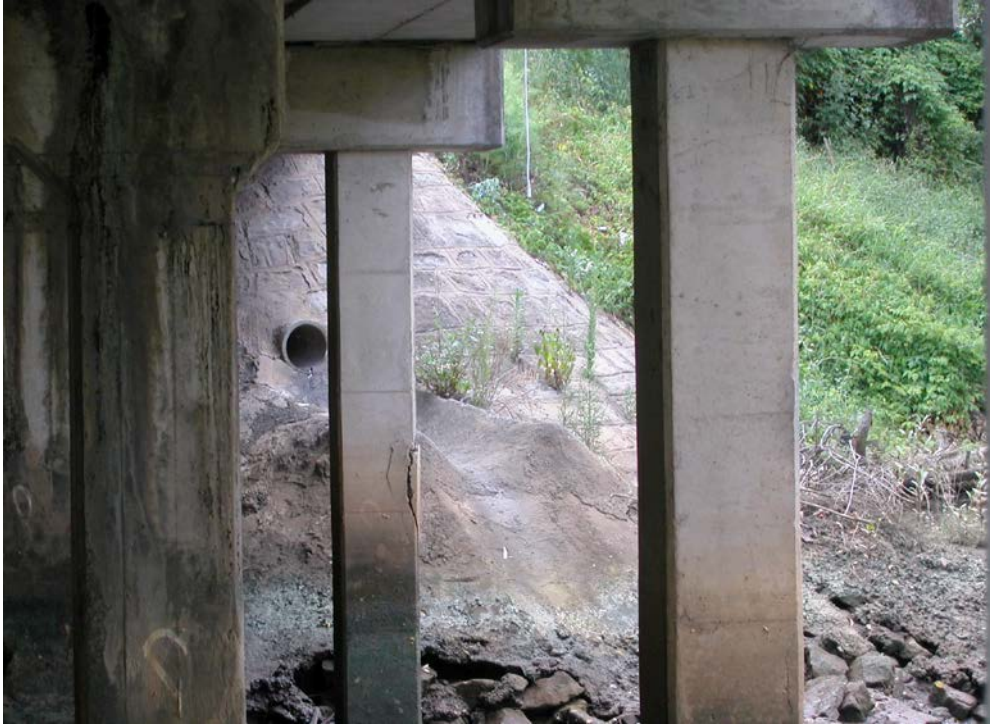
Some delamination of a corner of a pile ready to spall.

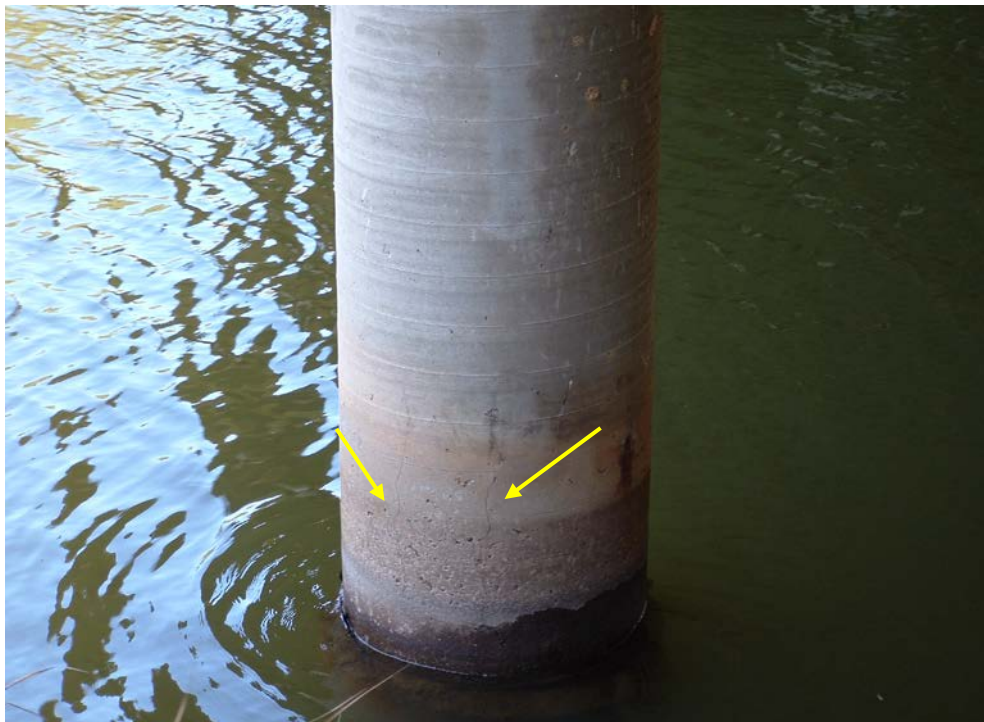
Fine cracks near the water level.

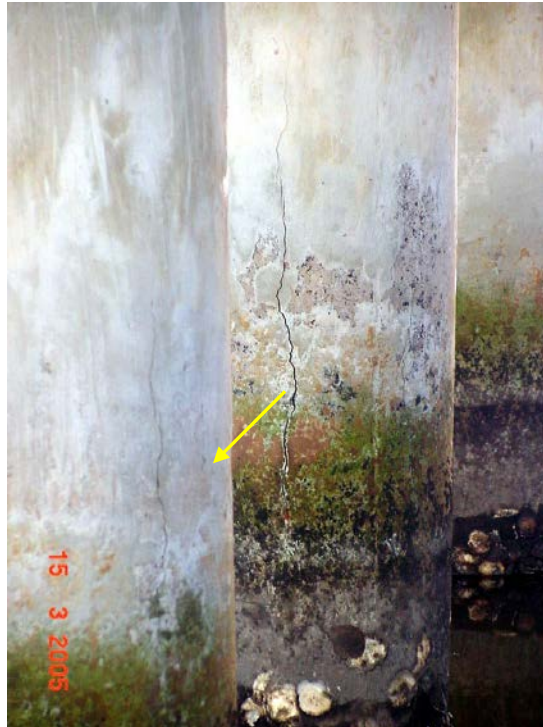
Wide vertical cracks with some signs of corrosion.

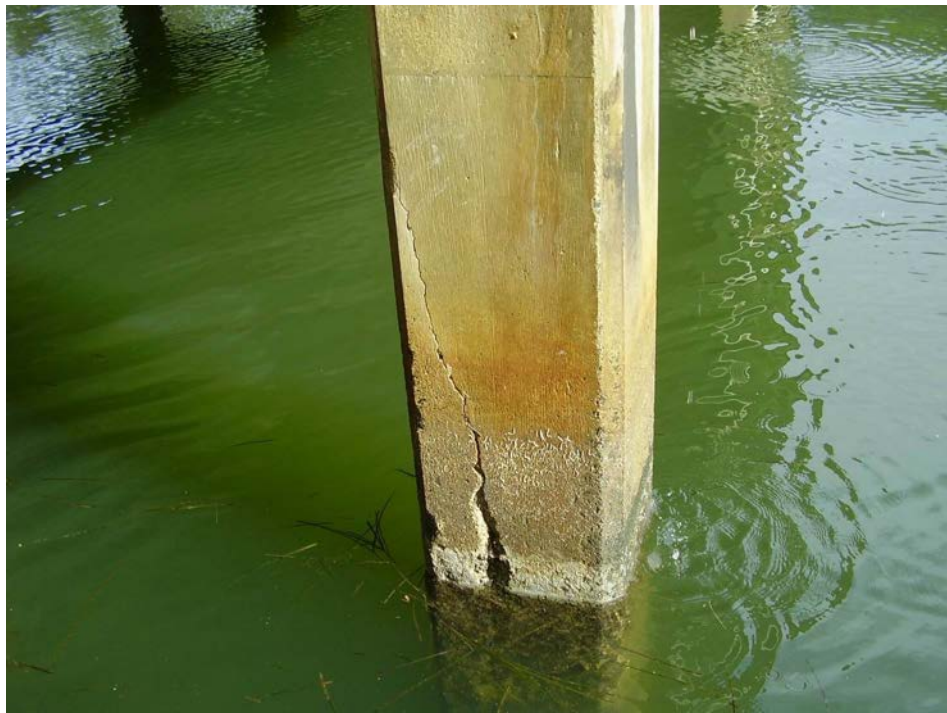
Major cracking of corner of a pile with damaged area extending up to 500mm under water.

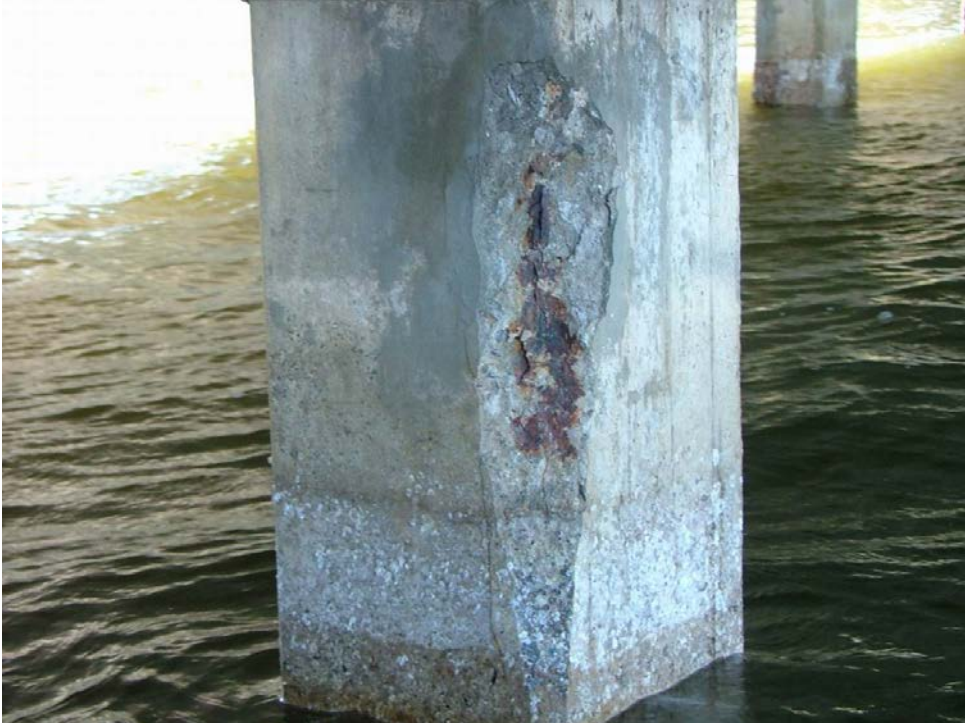
Significant spall with corroding reinforcement.

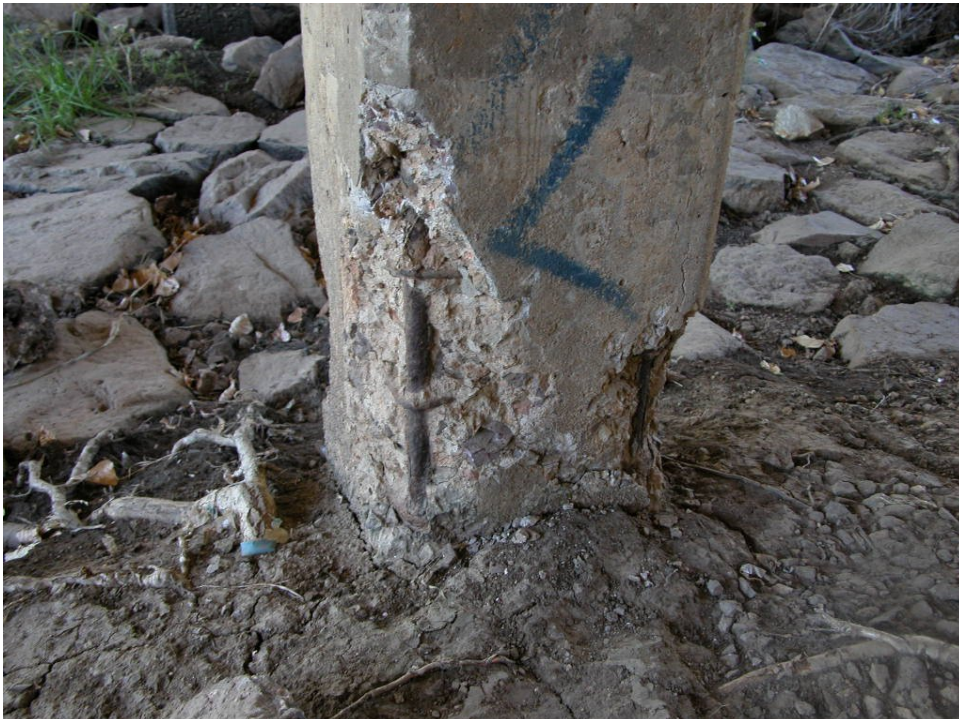
Significant spall with exposed reinforcement.

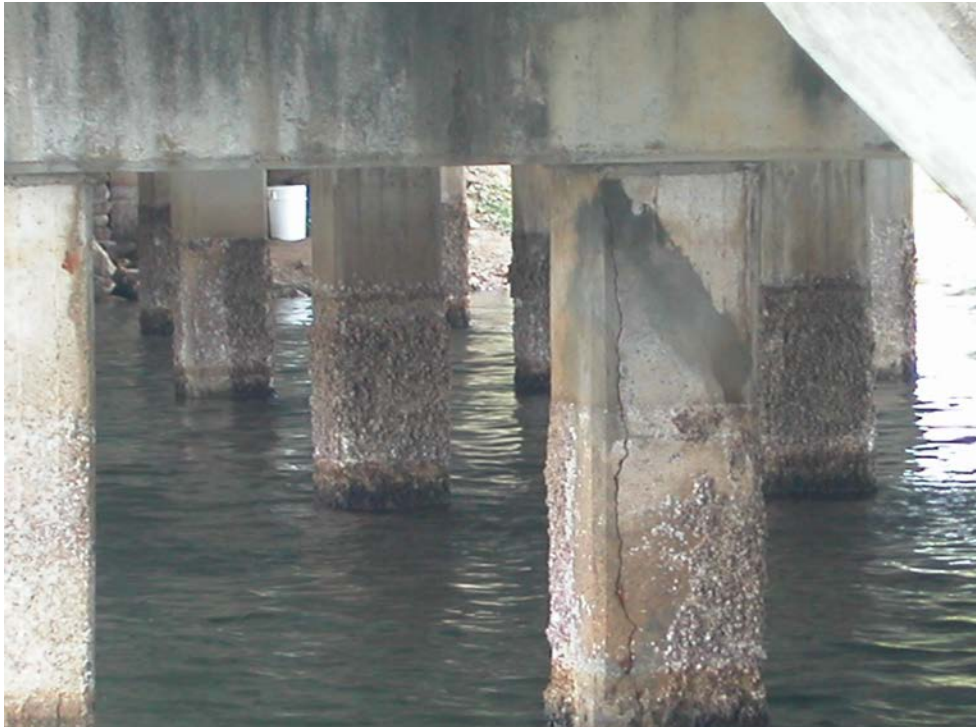
Repaired piles cracking again.

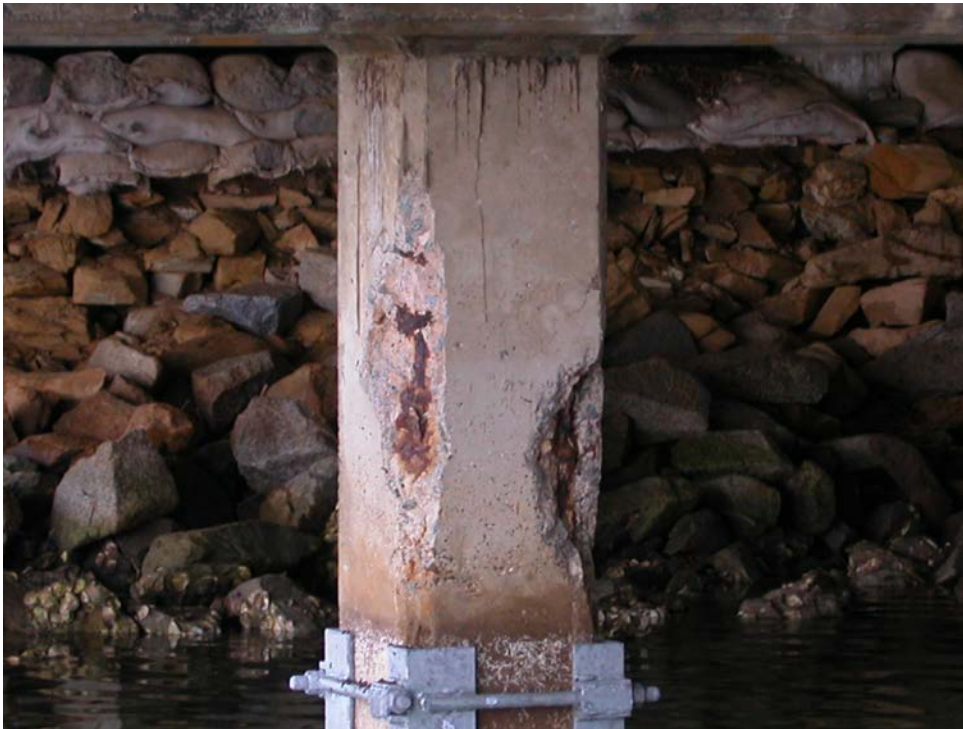
Advanced deterioration. Significant loss of section. Significant vertical cracks on all faces where the pile is braced in the steel frame.

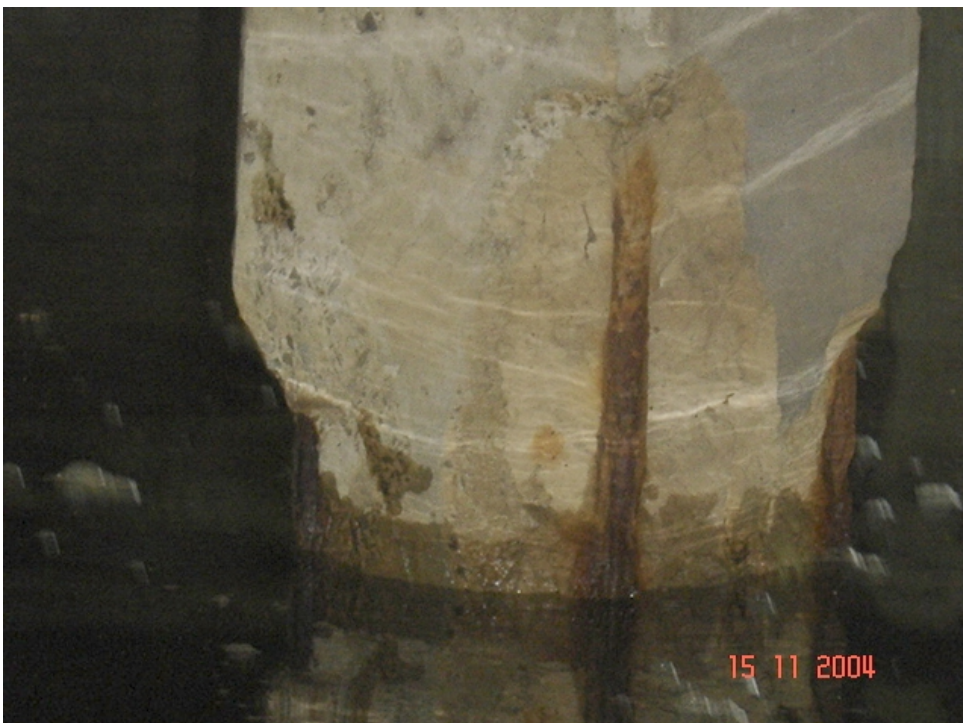
Significant loss of section of the pile and heavy corrosion of reinforcement.

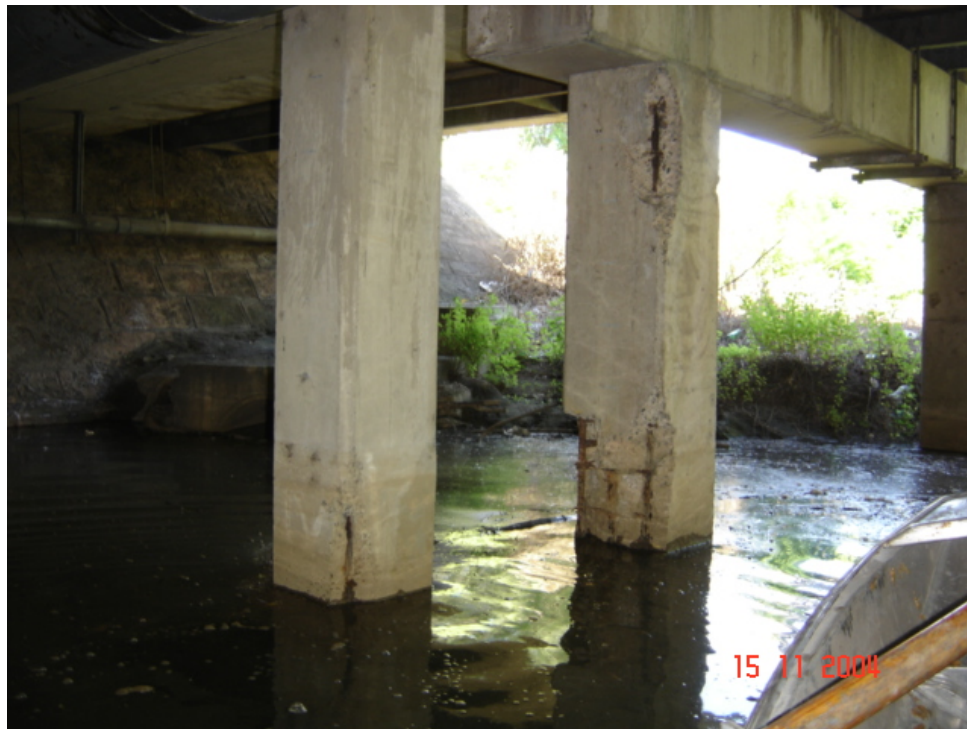
Advanced deterioration and significant loss of section.

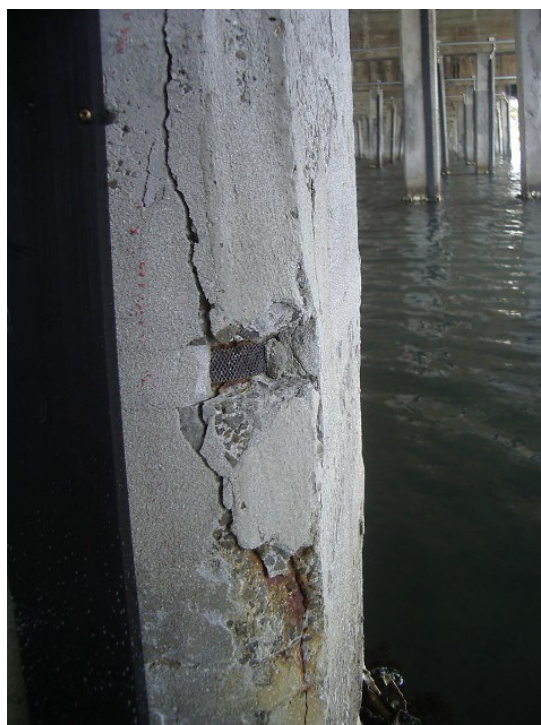
Major vertical cracking and extensive spalling. Cathodic protection mesh exposed. Signs of corrosion.

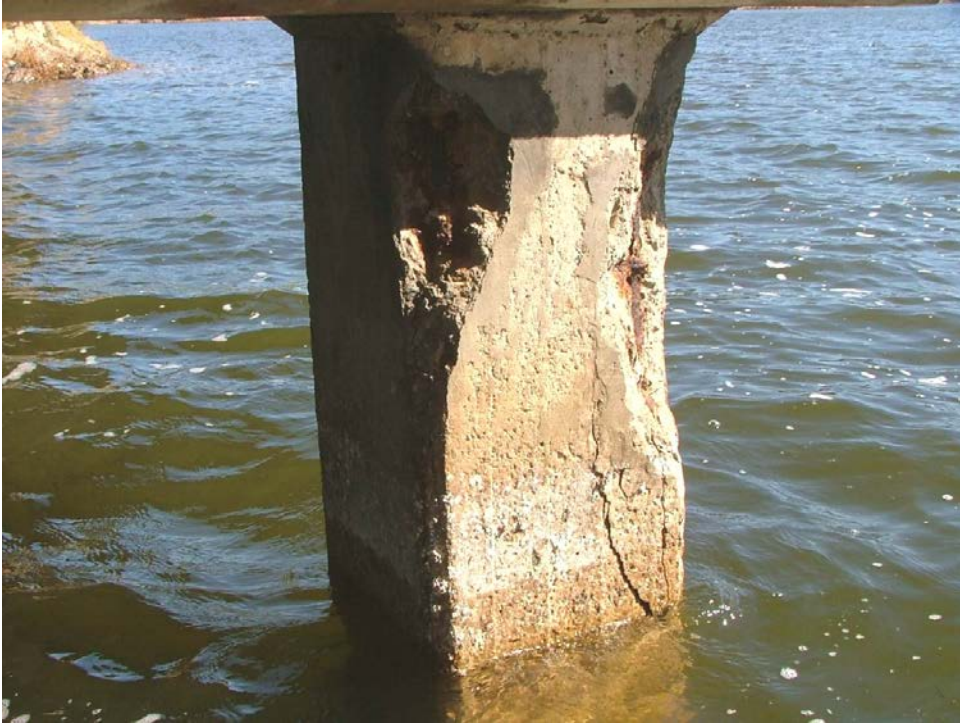
Significant loss of section and corrosion of reinforcement.
