Transport  
**Roads & Maritime  
Services**

# **BRIDGE INSPECTION PROCEDURE MANUAL**

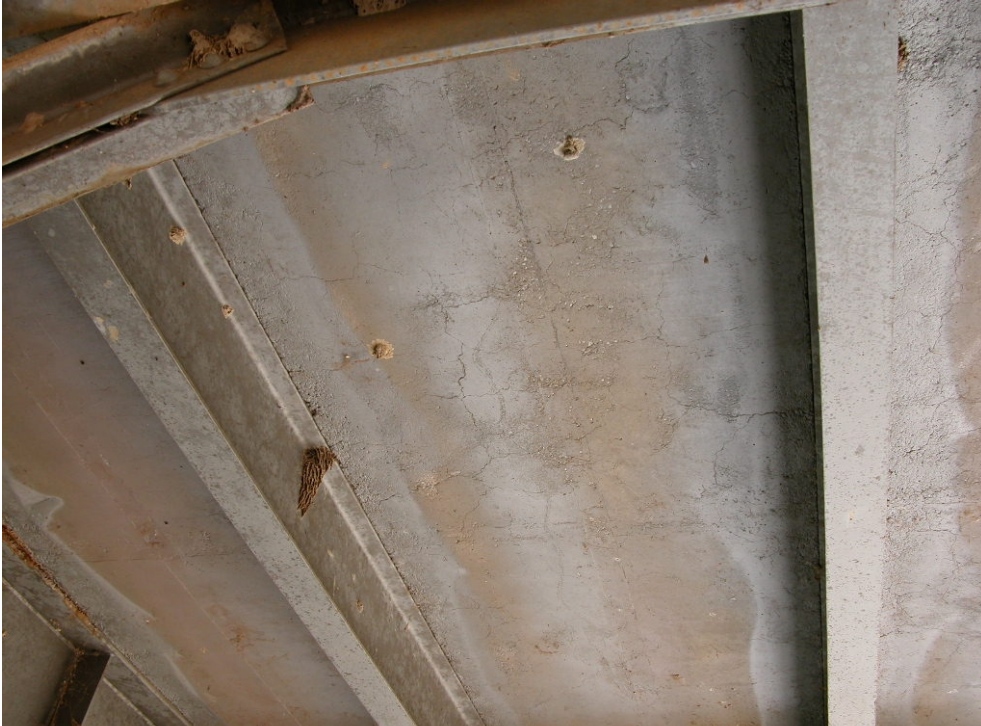
Fine cracks on soffit of deck slab.

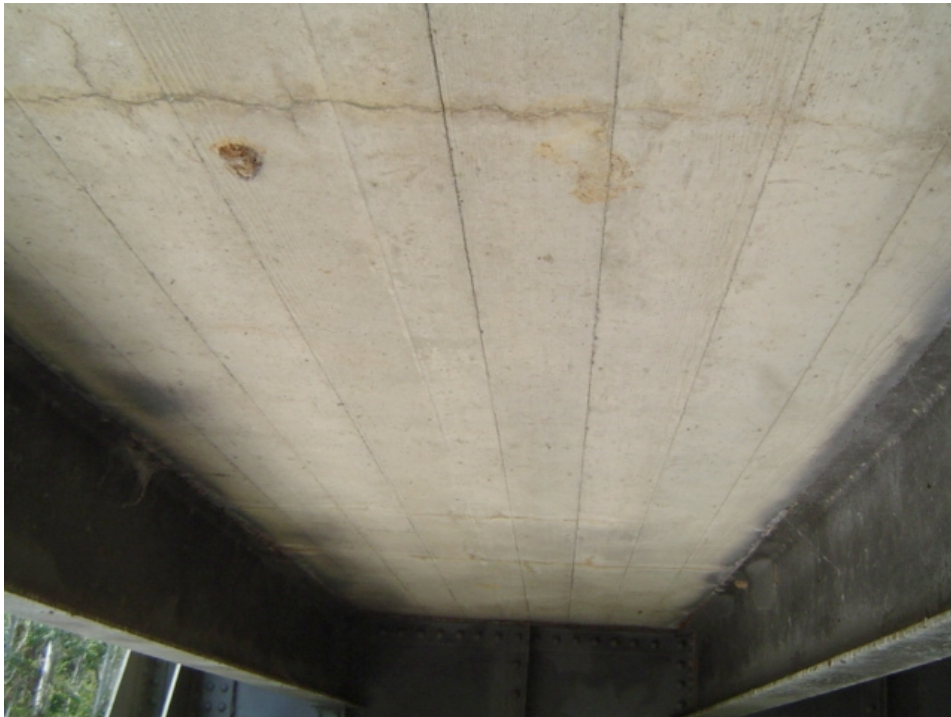
Transverse cracking of deck slab with minor leaching.

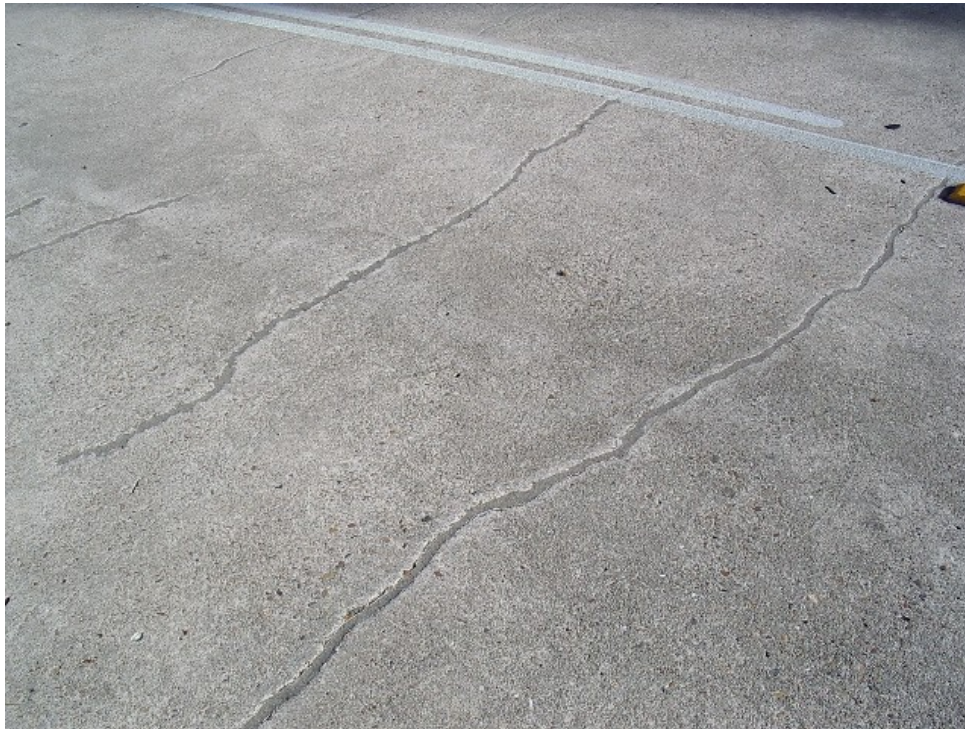
Repaired deck slab functioning well.

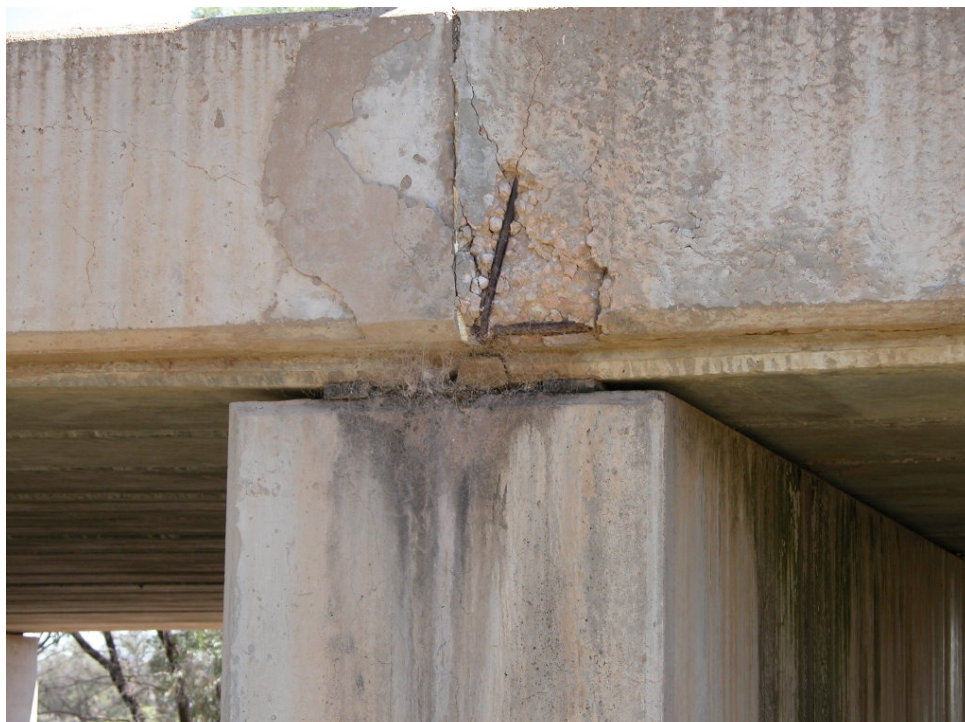
Exposed reinforcement of parapet.

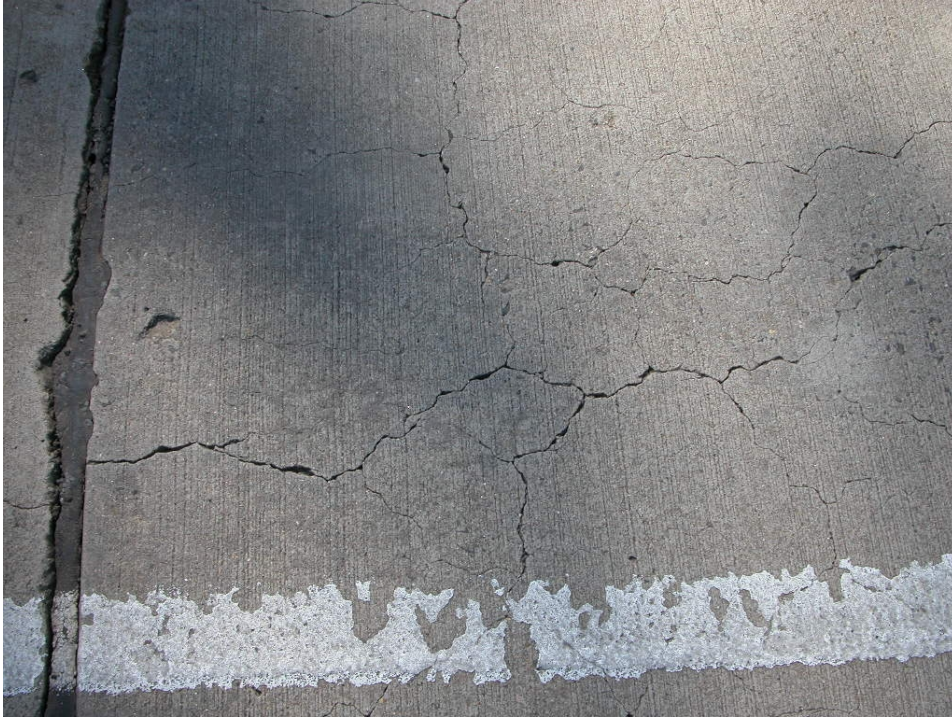
Some delaminations, significant cracks or spalls may be present or some reinforcement may be exposed. Corrosion of reinforcement may be present but loss of section is minor and is not sufficient to warrant analysis to ascertain the impact on the strength and/or serviceability of either the element or the bridge.

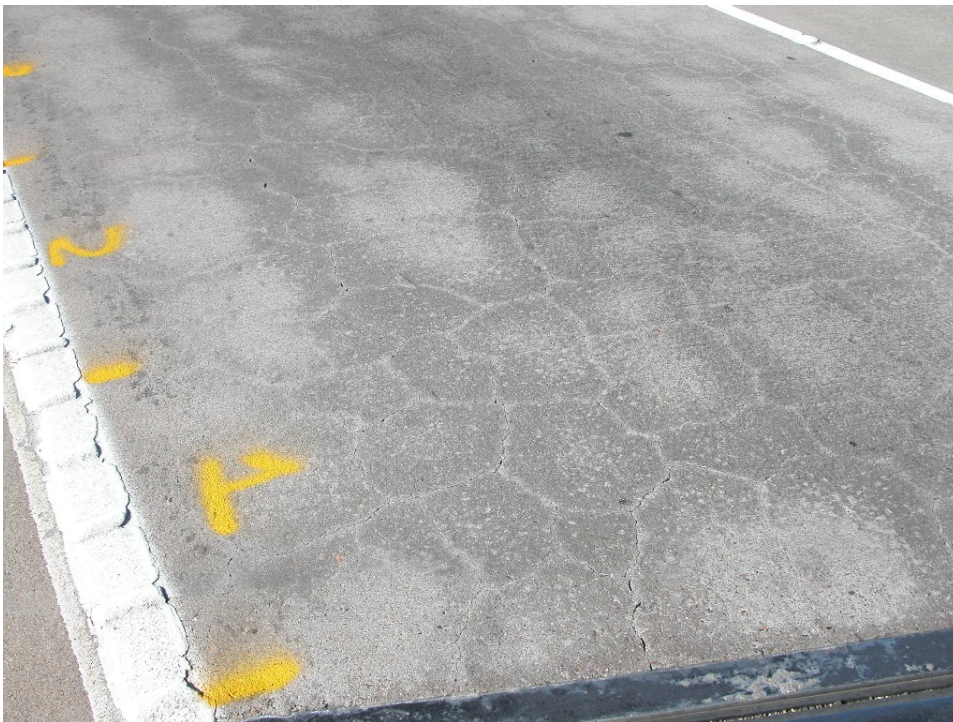
Significant fine cracking of deck slab.

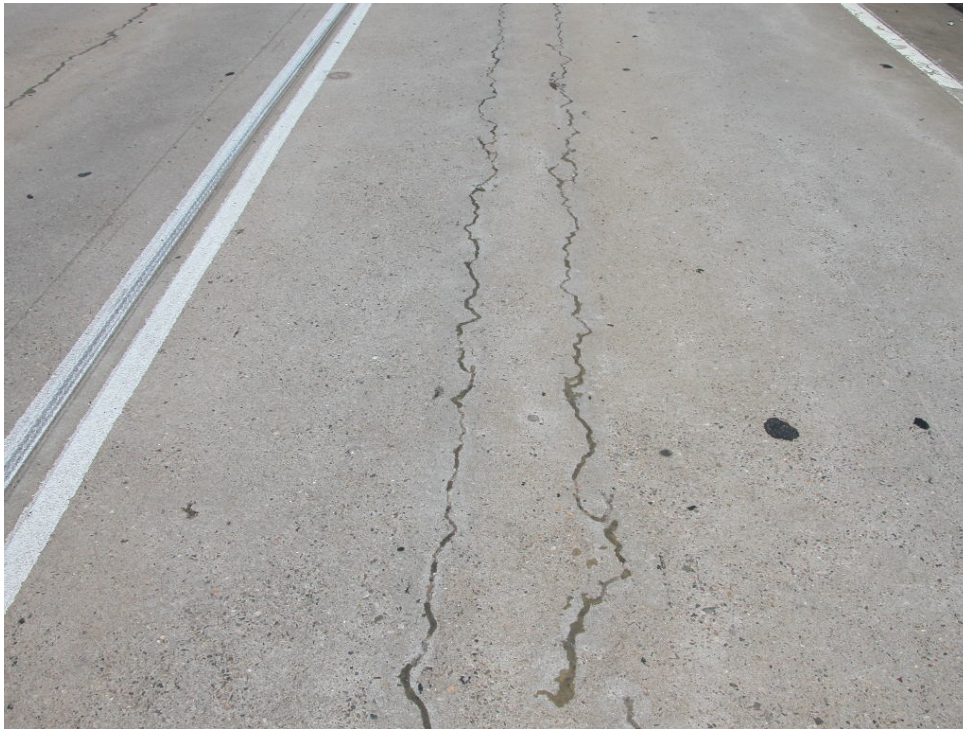
Longitudinal cracks on either side of the road centre line.

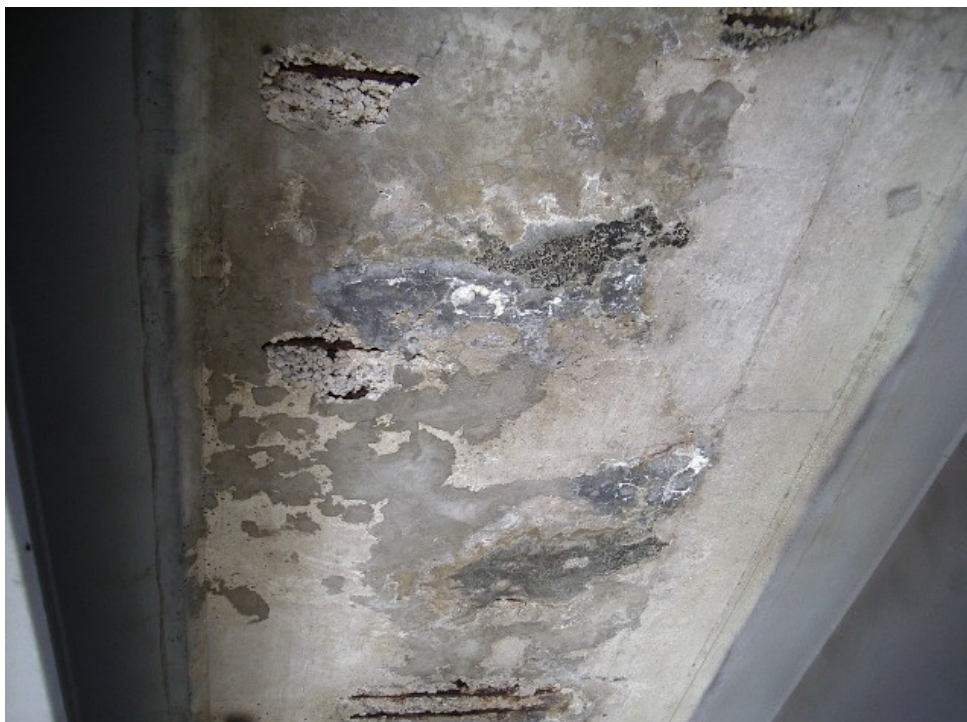
Concrete deck soffit with spalling, leaching and corroding reinforcement.

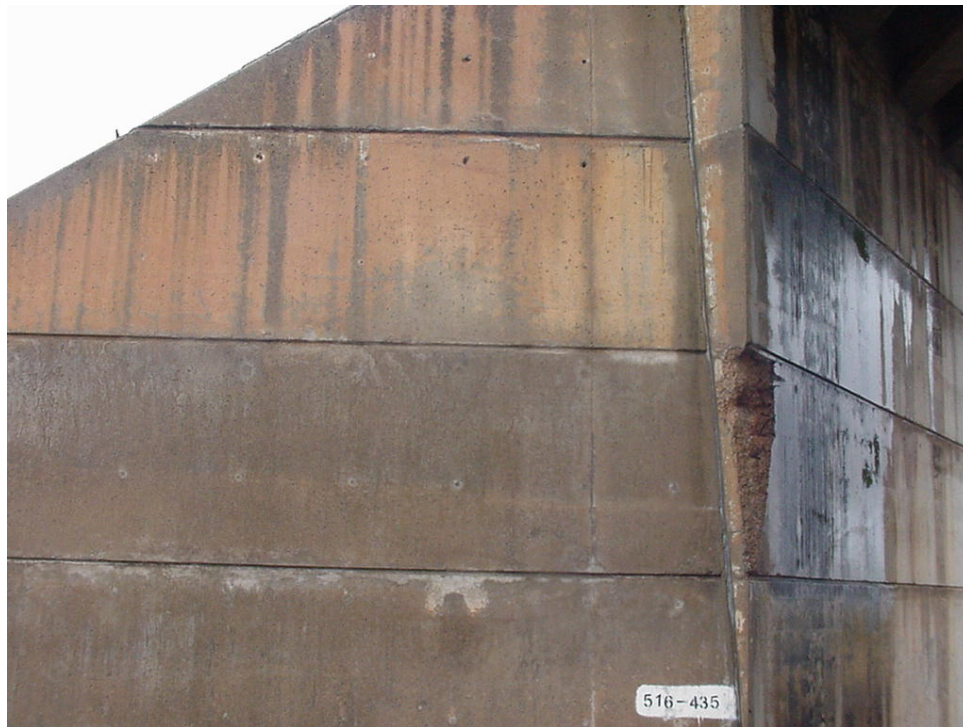
The element shows no deterioration. There may be discolouration, efflorescence, and/or superficial cracking.

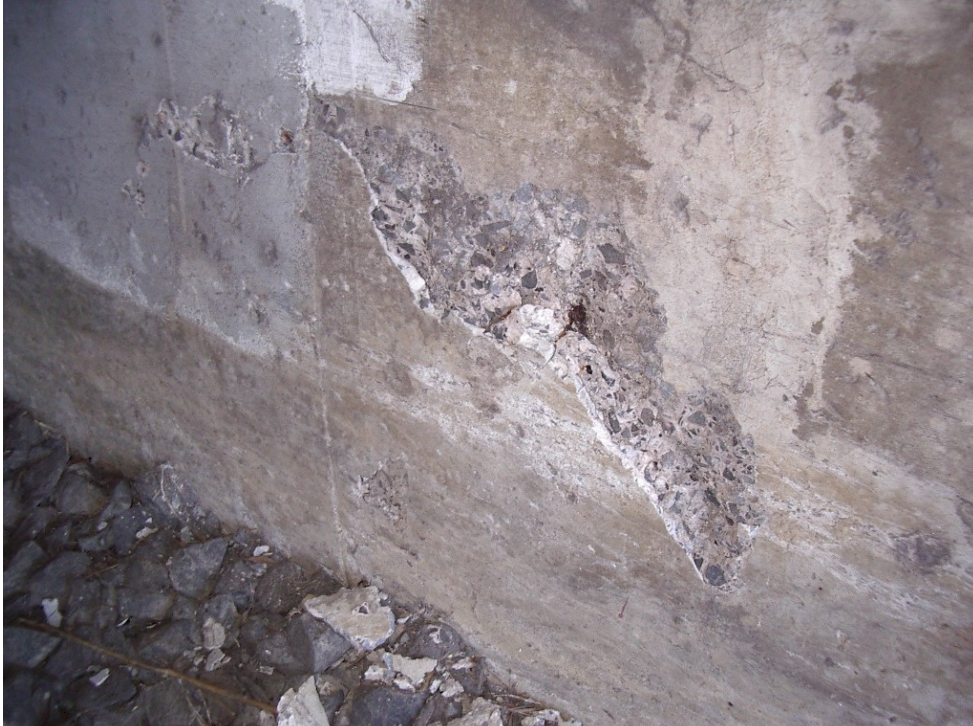
Spalled area at base of abutment.

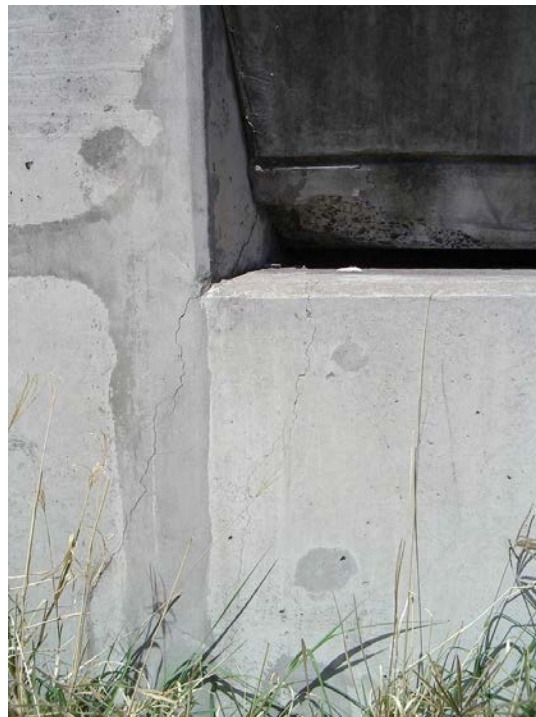
Diagonal crack at wingwall. Voided slab is bearing against the curtain wall with minor spall.

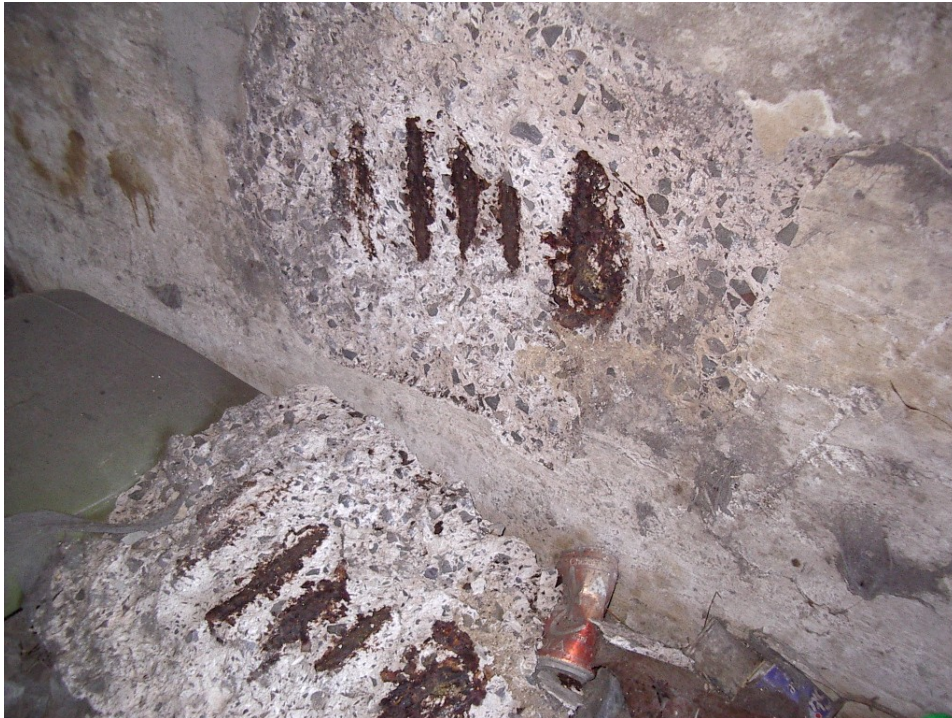
Major delamination - corrosion of reinforcement.

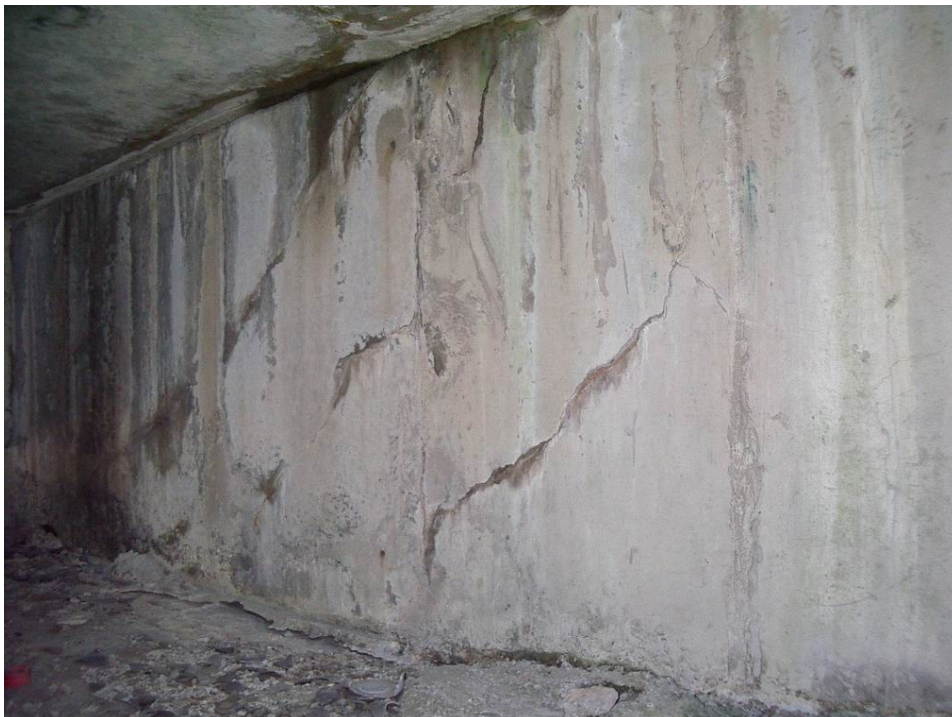
Significant diagonal cracking.

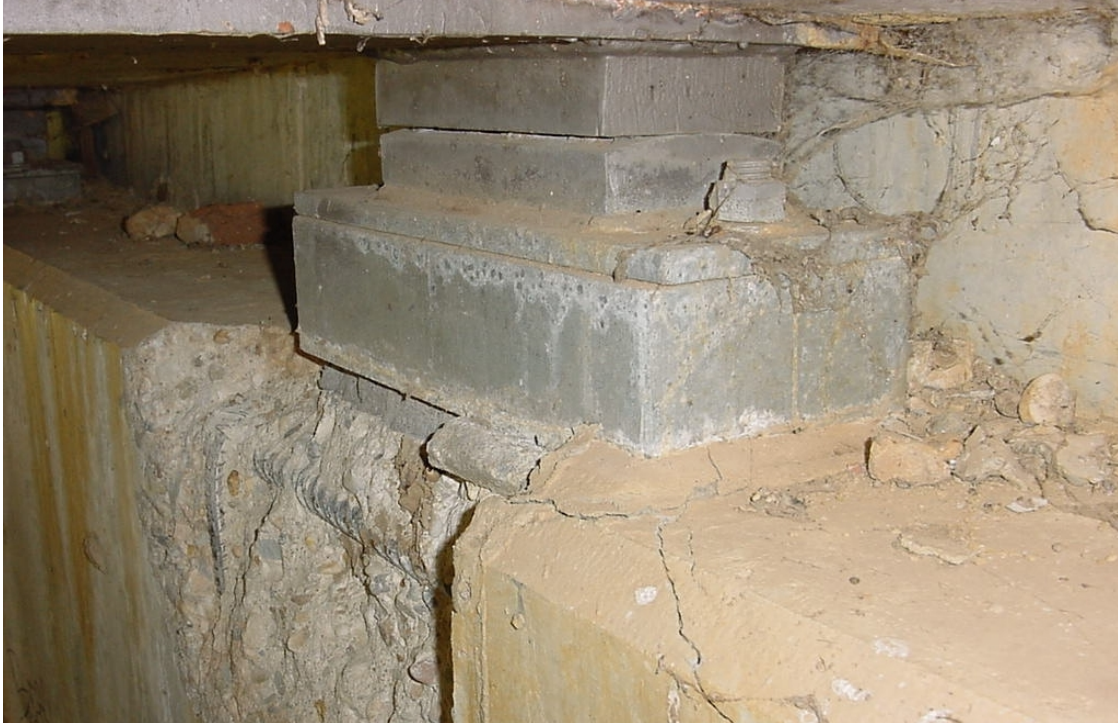
Major spall near the bearing with exposed reinforcement.

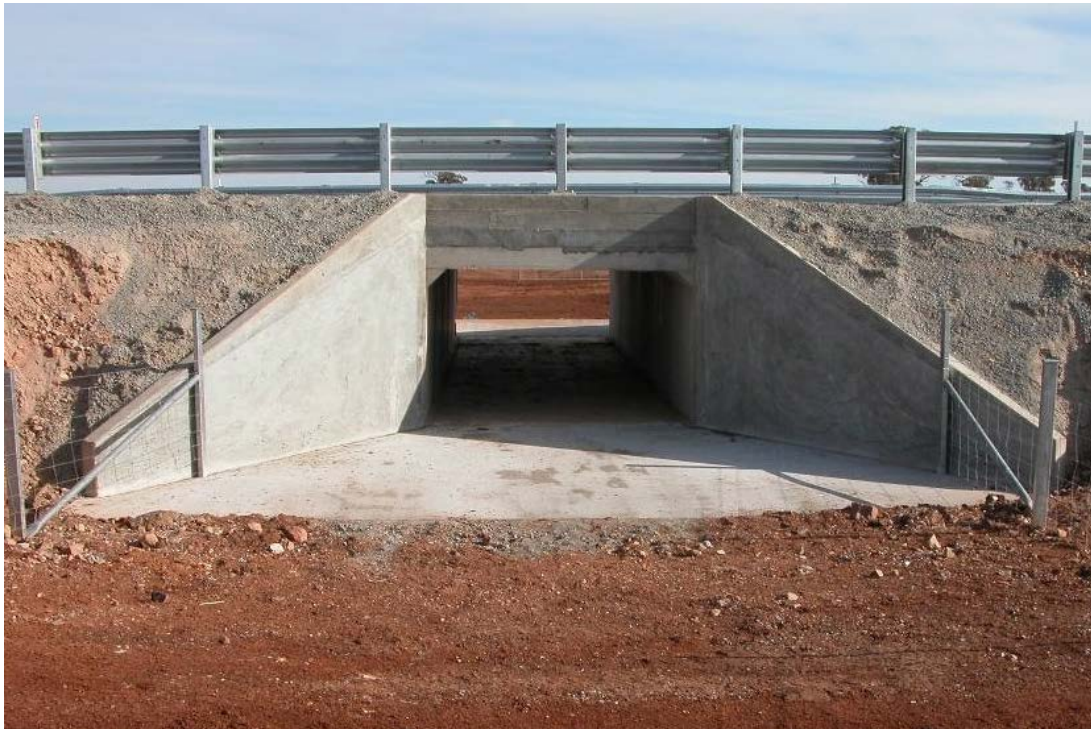
Concrete culvert in good condition.

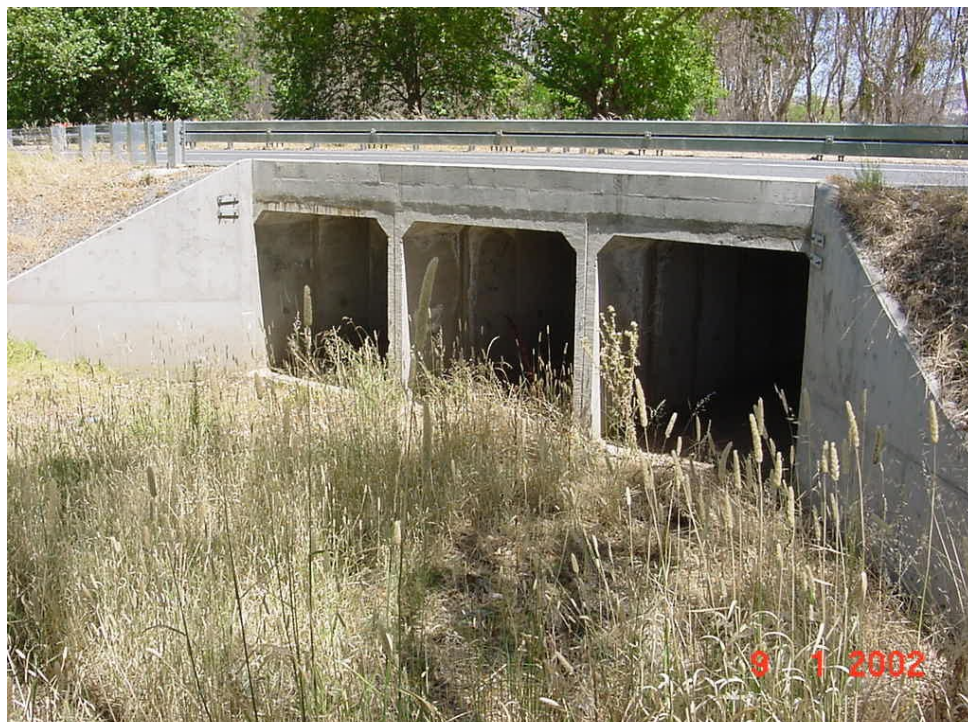
Concrete culvert in good condition.

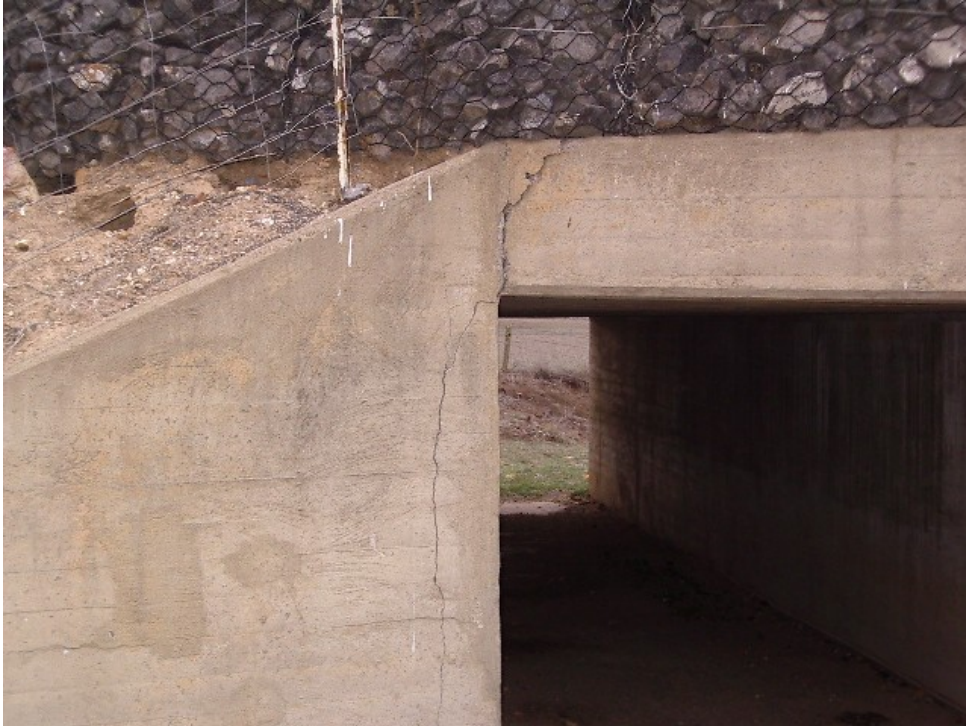
Vertical cracking on the wingwall culvert cell

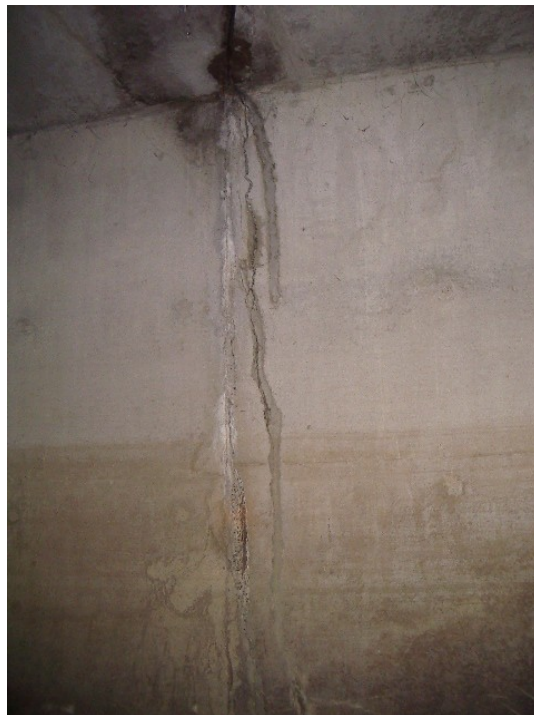
Vertical crack near the construction joint on the wall. noticeable leaching.

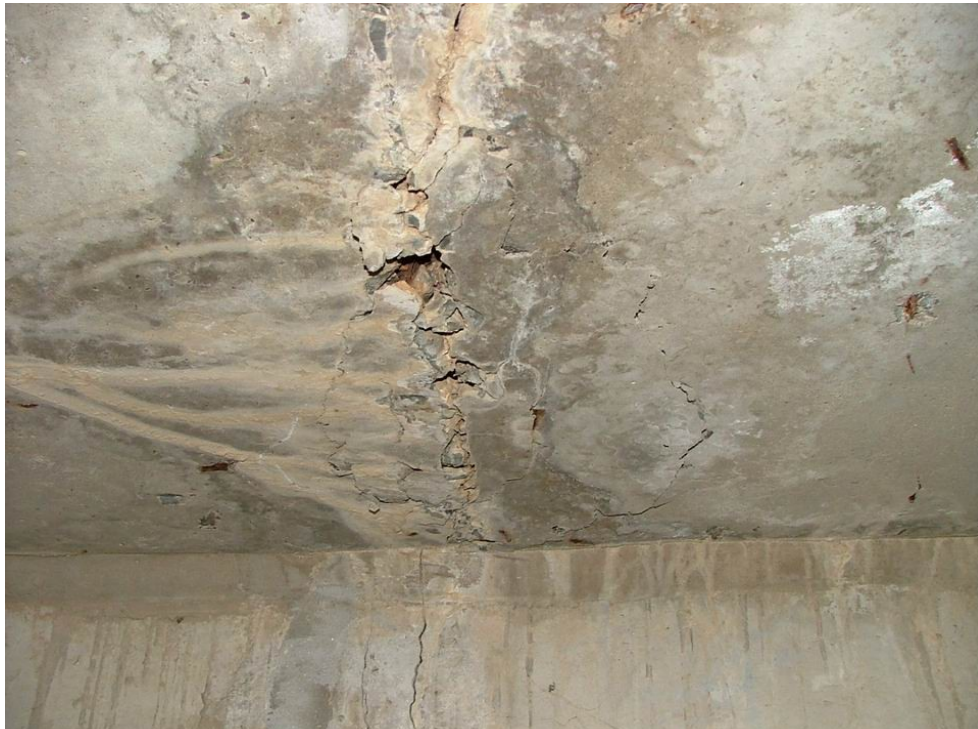
Cracking, leaching and spalling around an area of poor concrete in the roof.

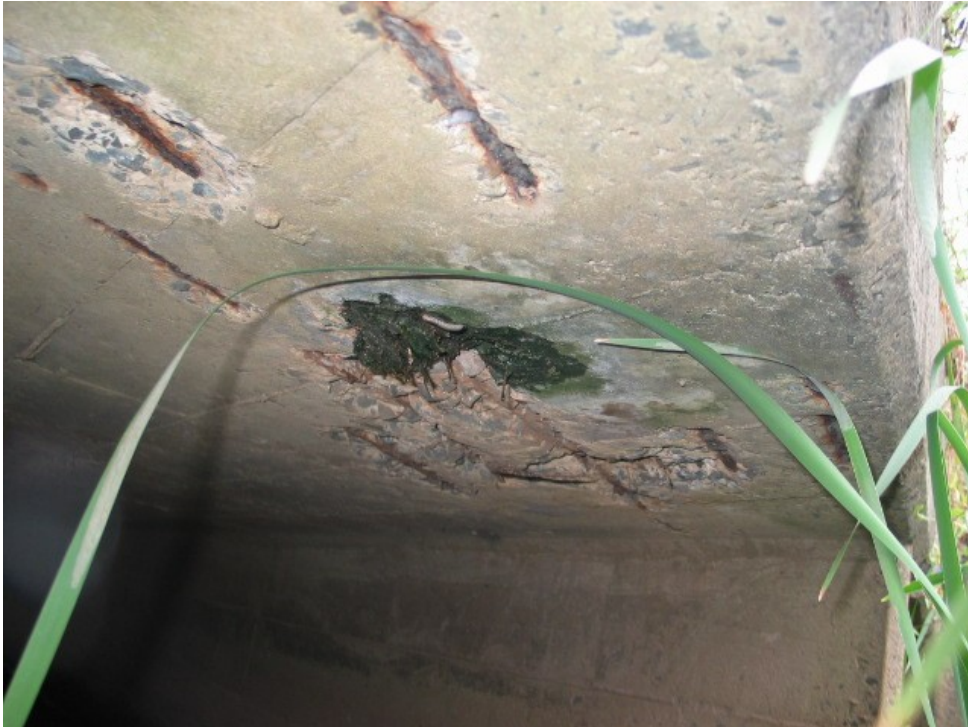
There may be moderate to major deterioration, extensive cracking and/or leaching and large areas of spalls. Scour may be beginning to affect structural integrity. Minor to moderate distortion, settlement, or misalignment may have occurred. There may be considerable deterioration and separation of joints and/or minor roadway settlement.

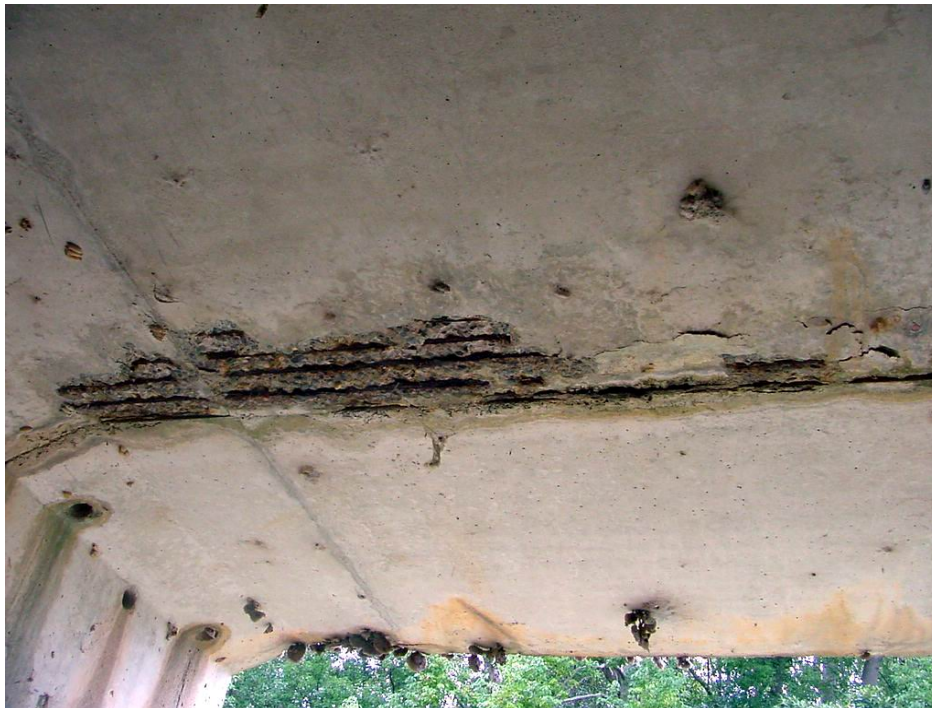
Significant spalling and corrosion of exposed reinforcement in the roof of precast units.

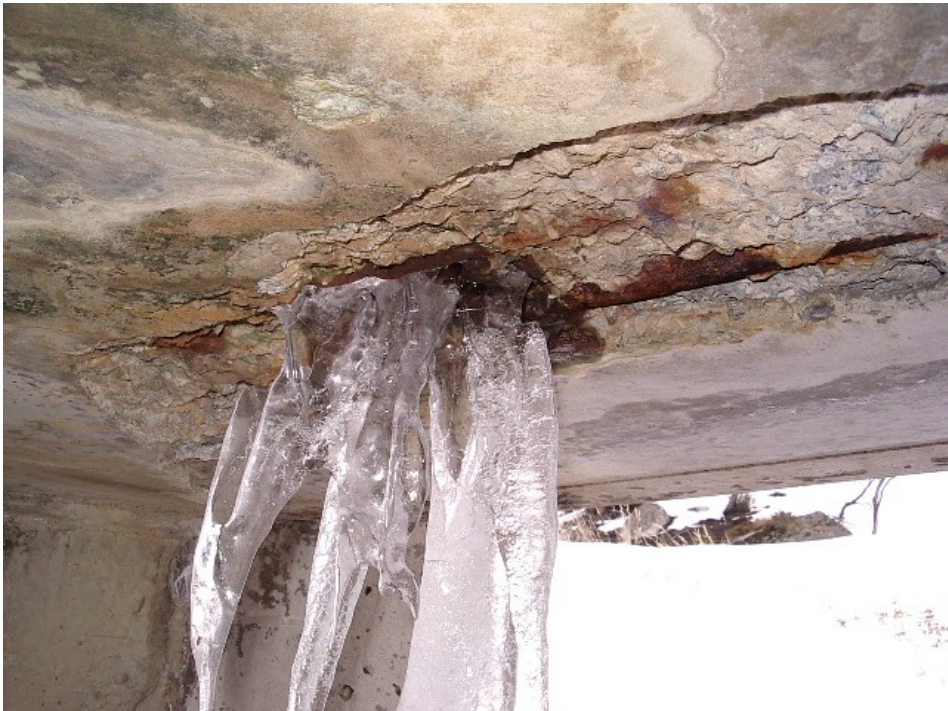
Delamination/spalling around scupper hole in roof. Exposed reinforcement.

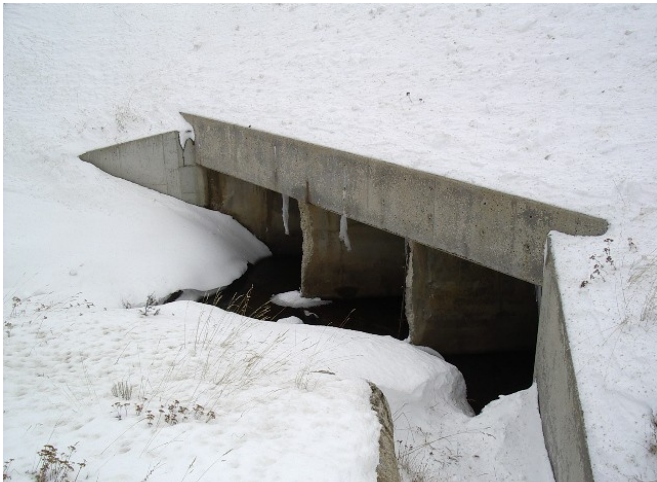
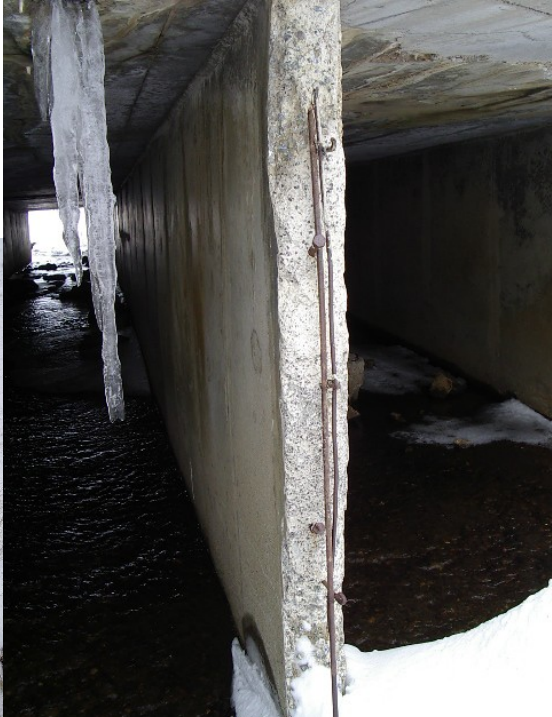
Damage to the blade wall.

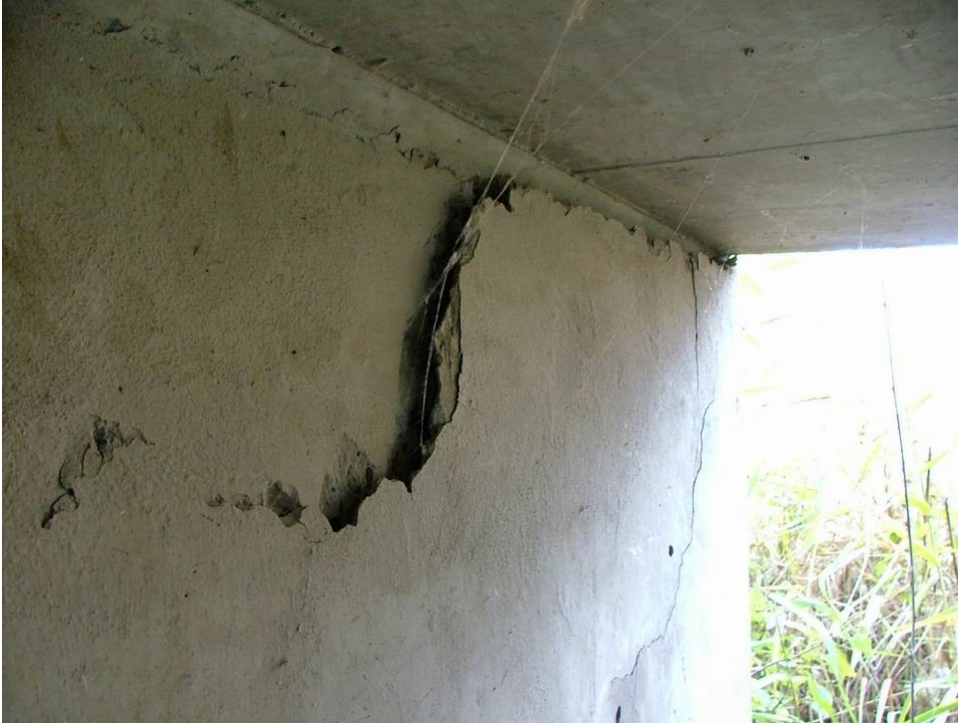
Large delamination of cell wall at inlet end where wingwall is being forced away.

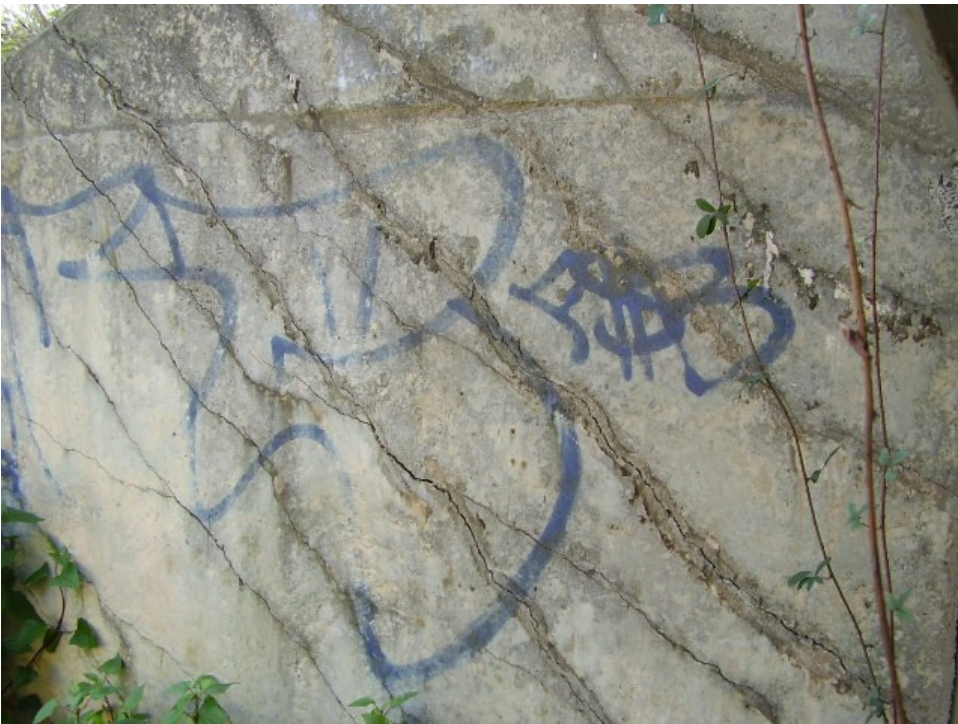
Heavy diagonal cracking of inlet wingwall.

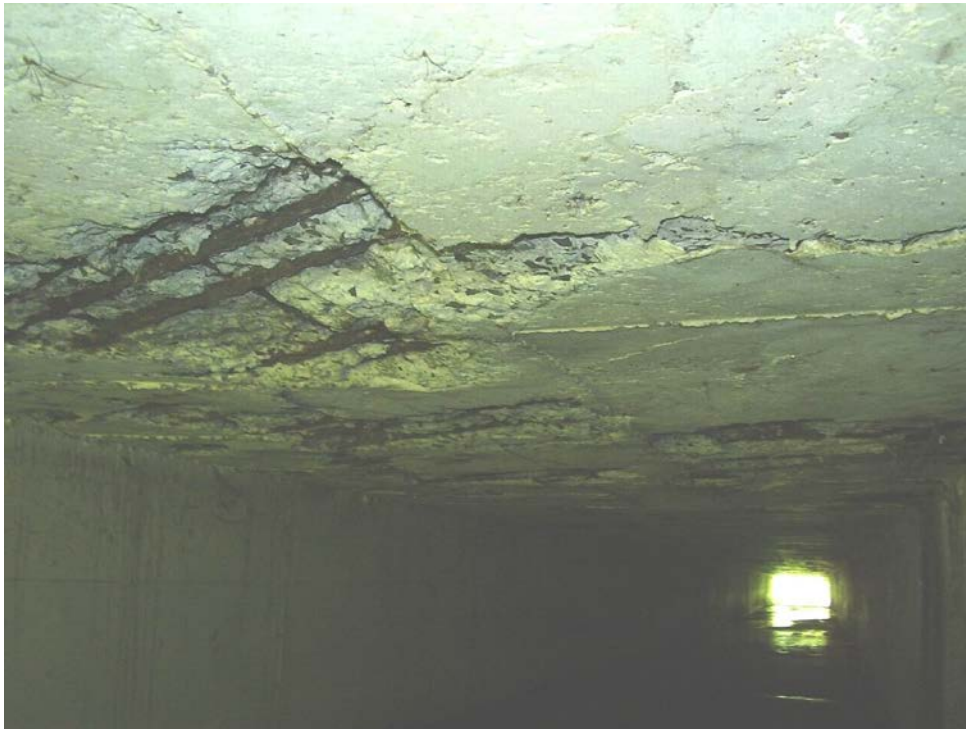
Major deterioration, spalling, cracking, major distortion, deflection settlement, or misalignment of the barrel may be in evidence. Major separation of joints may have occurred. Holes may exist in floors and walls. Settlement of roadway may have occurred. Severe scour, if any, will affect structural capacity.

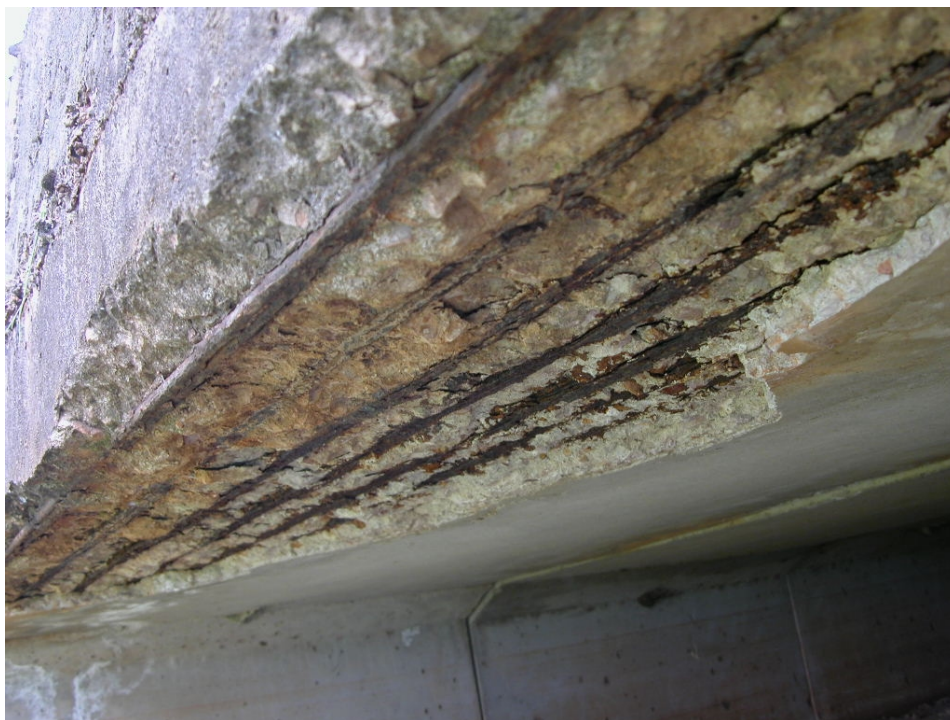
Severe lamination and spalling on all outside precast cell units.

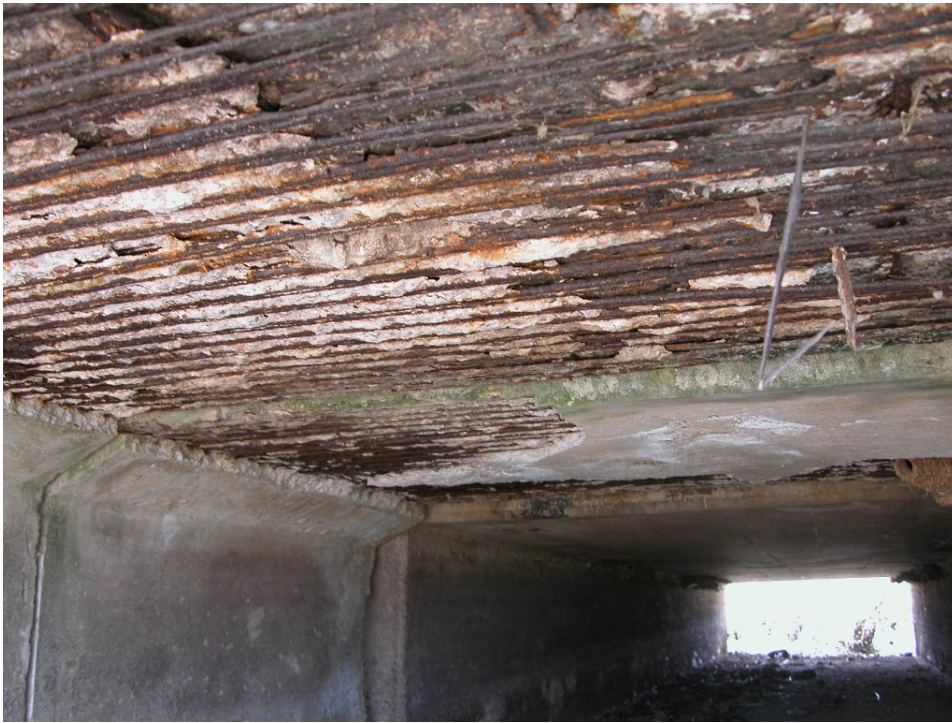
Extreme delamination and corrosion exposed reinforcement of precast units.

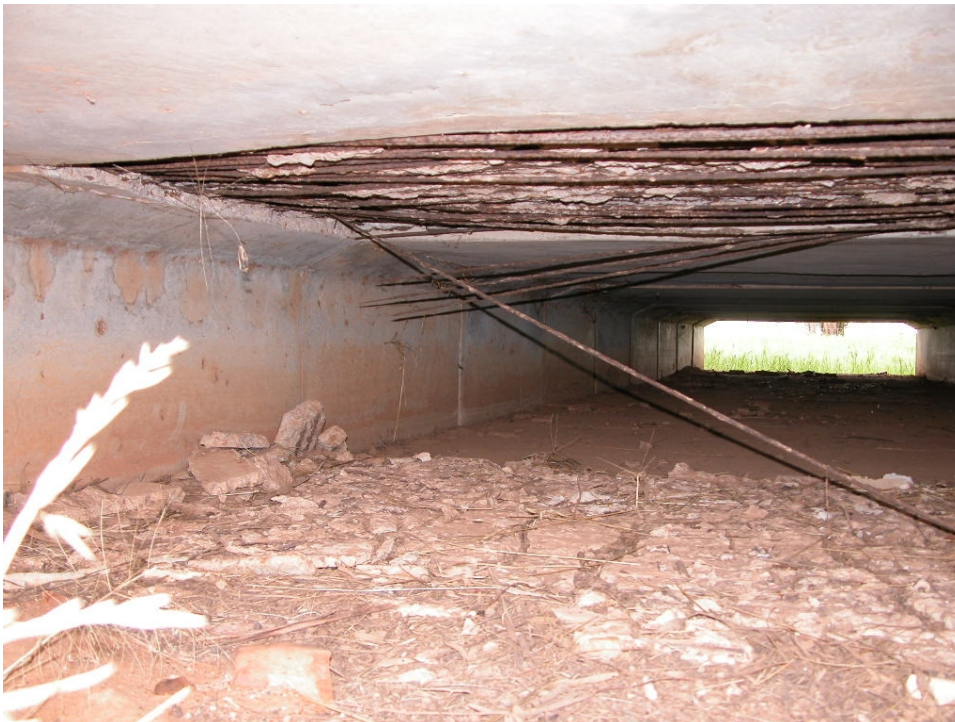
Extreme delamination and with falling off roof reinforcements of precast units.

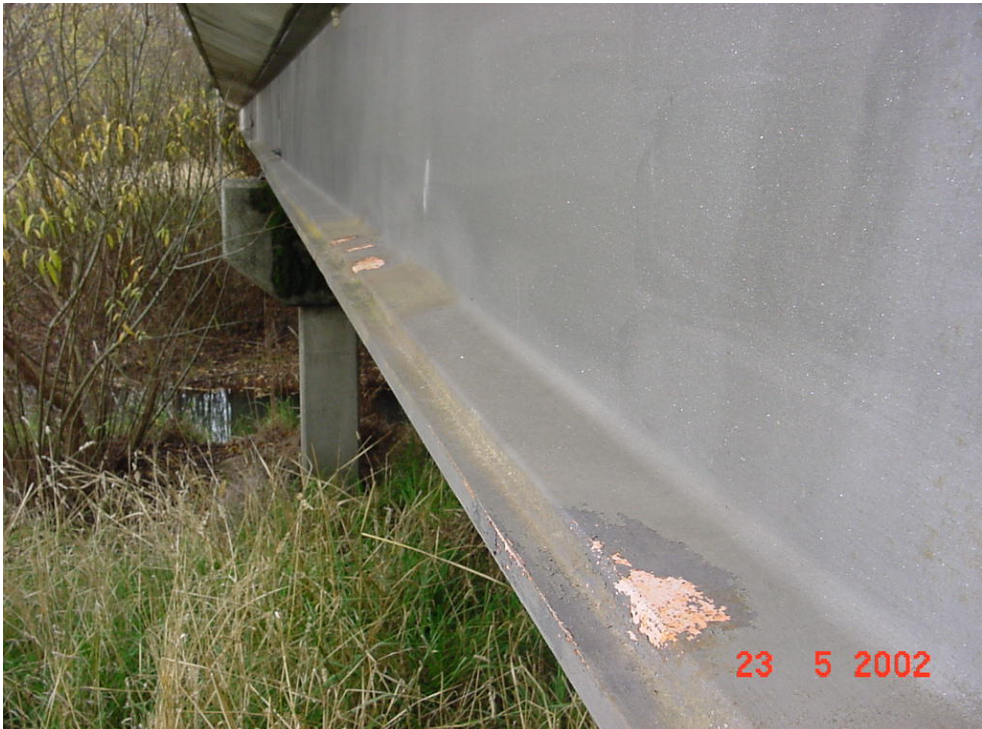
Minor coating deterioration but no steel deterioration.

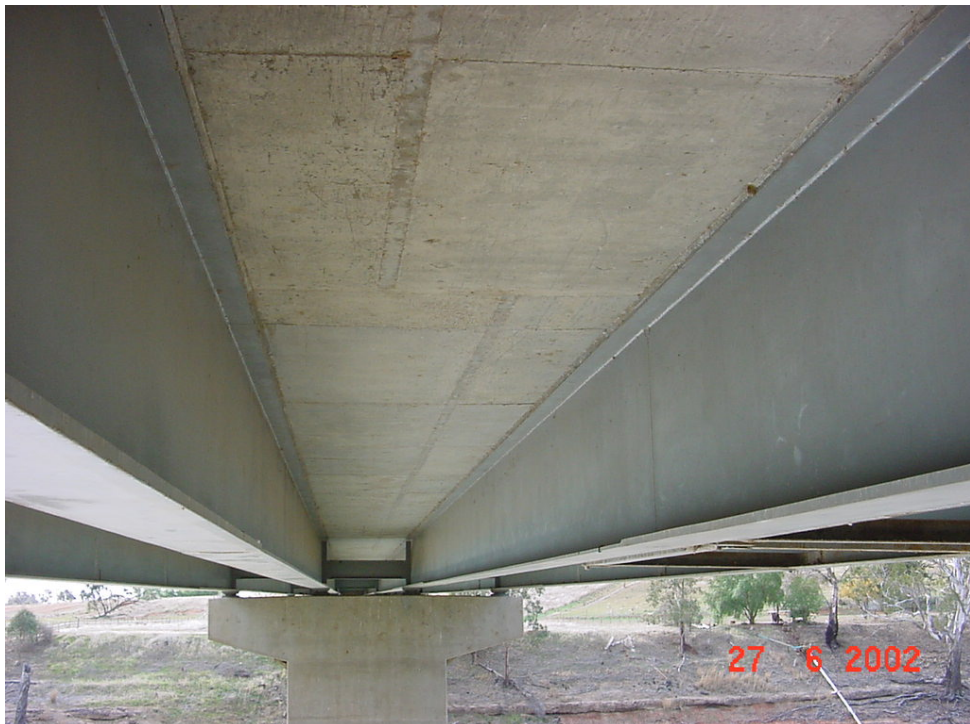
Girders in new or near new condition.

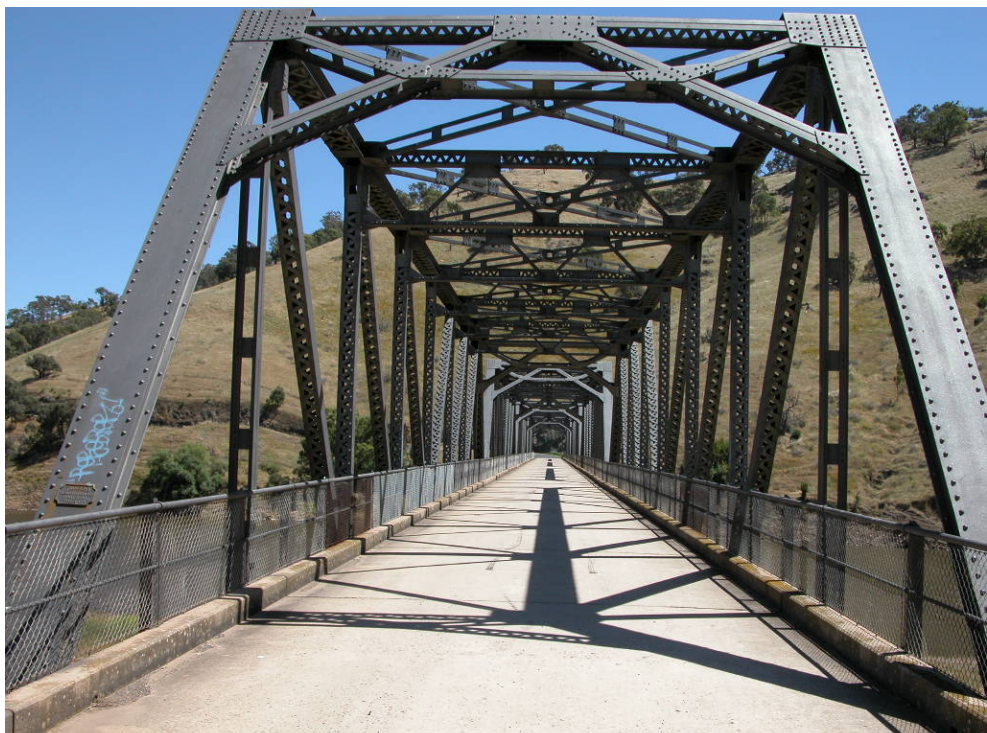
Element in new or near new condition.

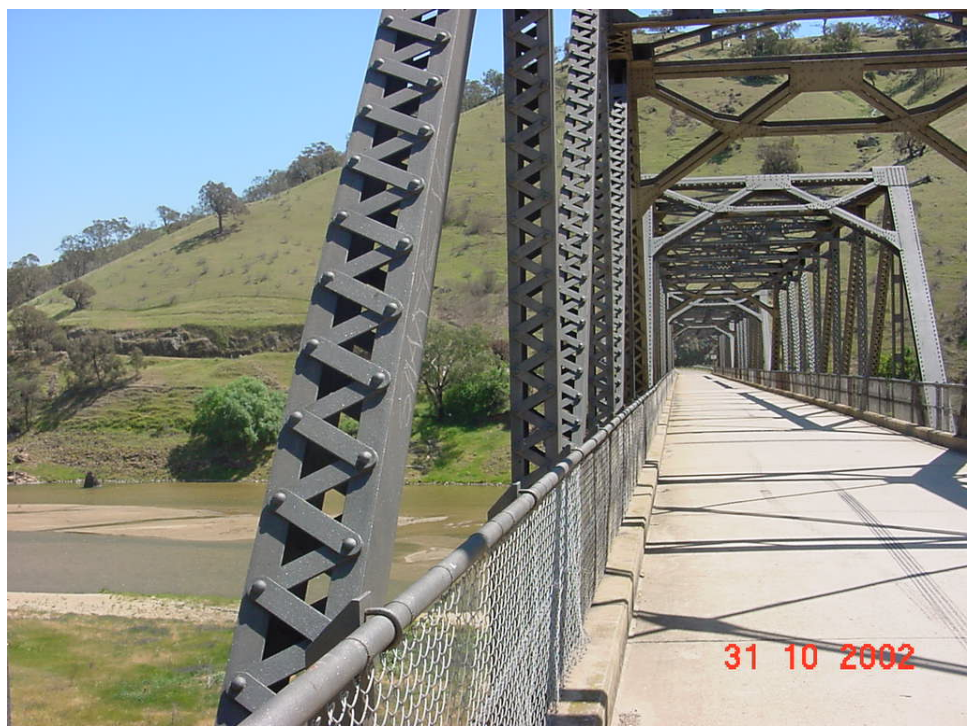
Element in new or near new condition.
