Transport  
**Roads & Maritime  
Services**

# **BRIDGE INSPECTION PROCEDURE MANUAL**

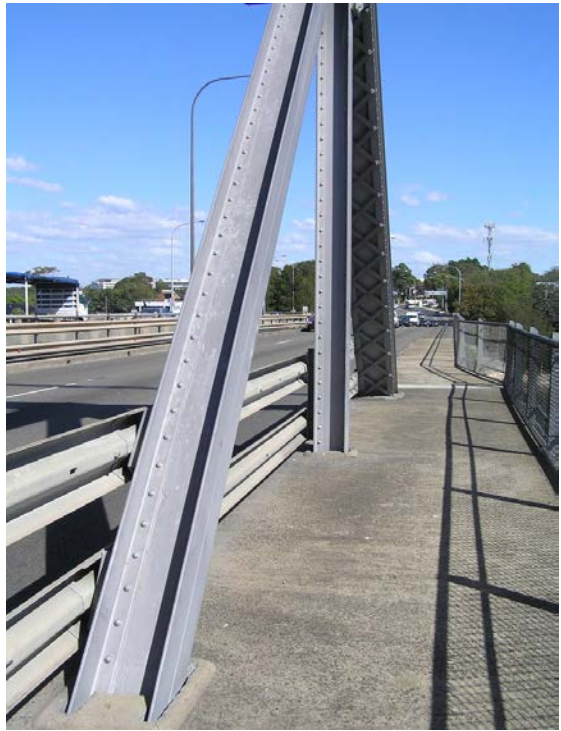
Element in new or near new condition.

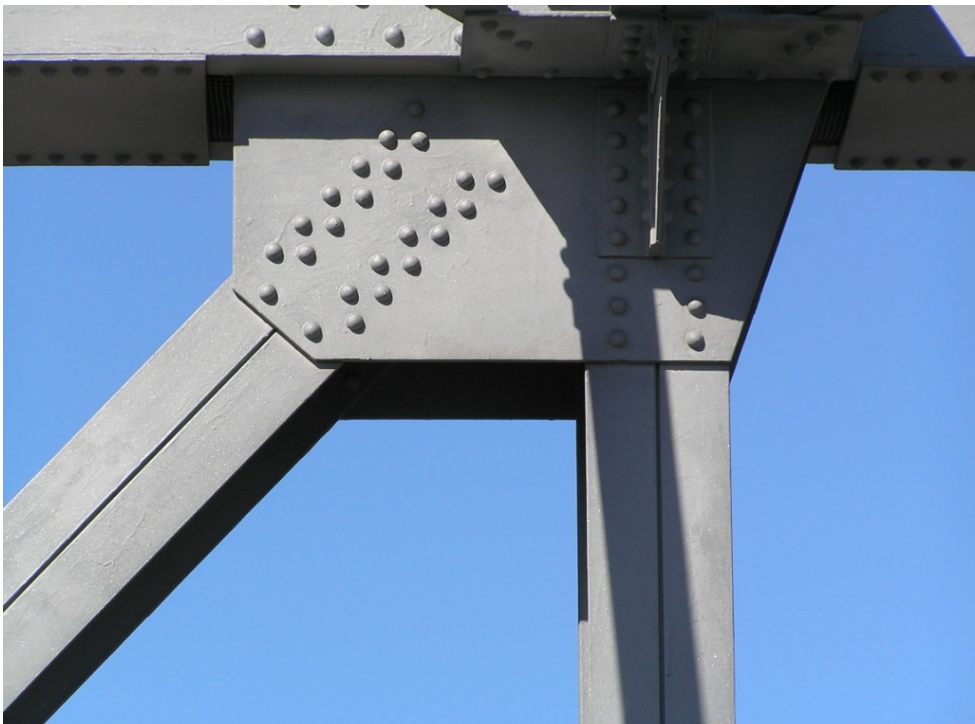
Element in new or near new condition.

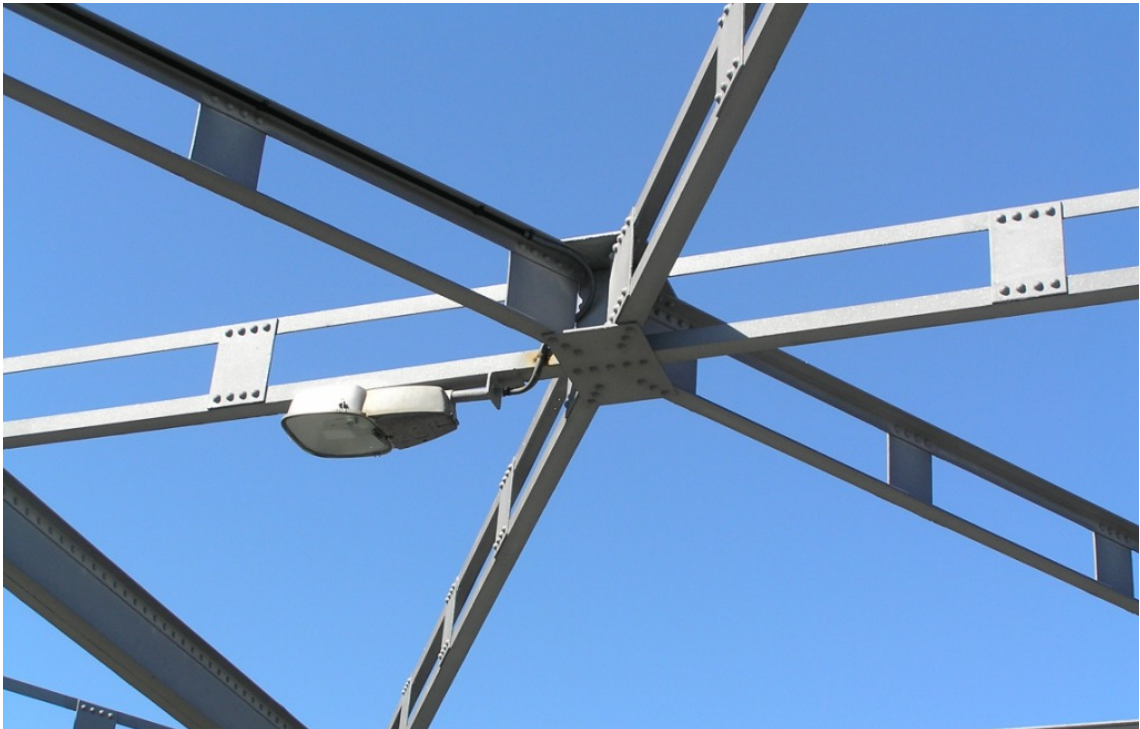
Element in new or near new condition.

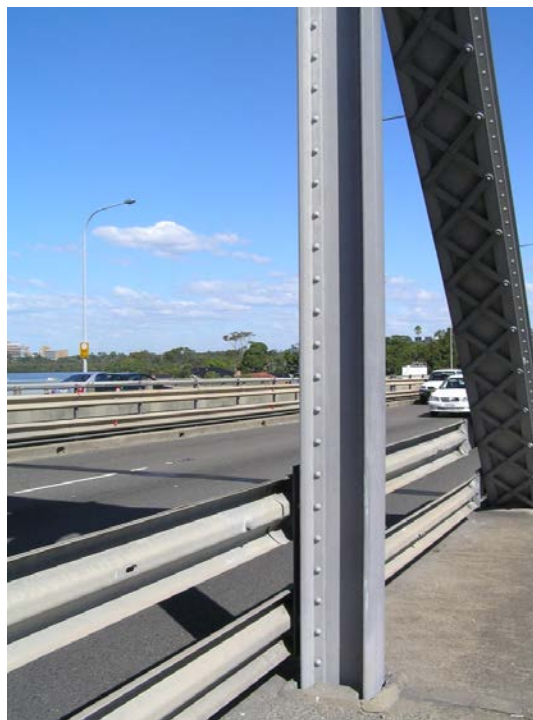
Element in new or near new condition.

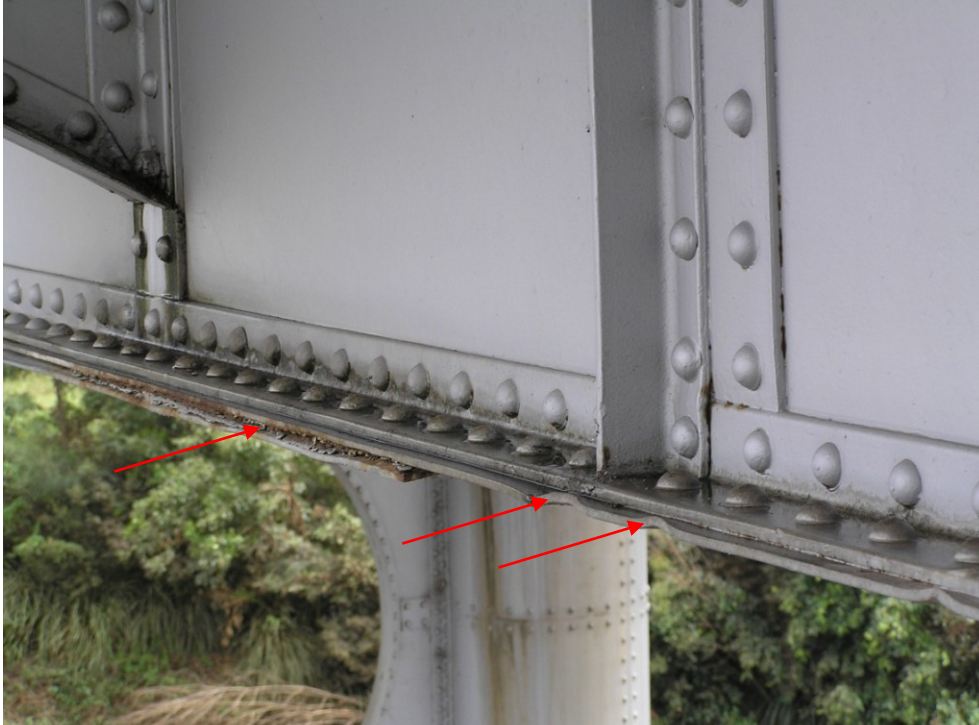
Crevice corrosion at splice plate on underside of girder. Some minor mechanical impact damage also evident.

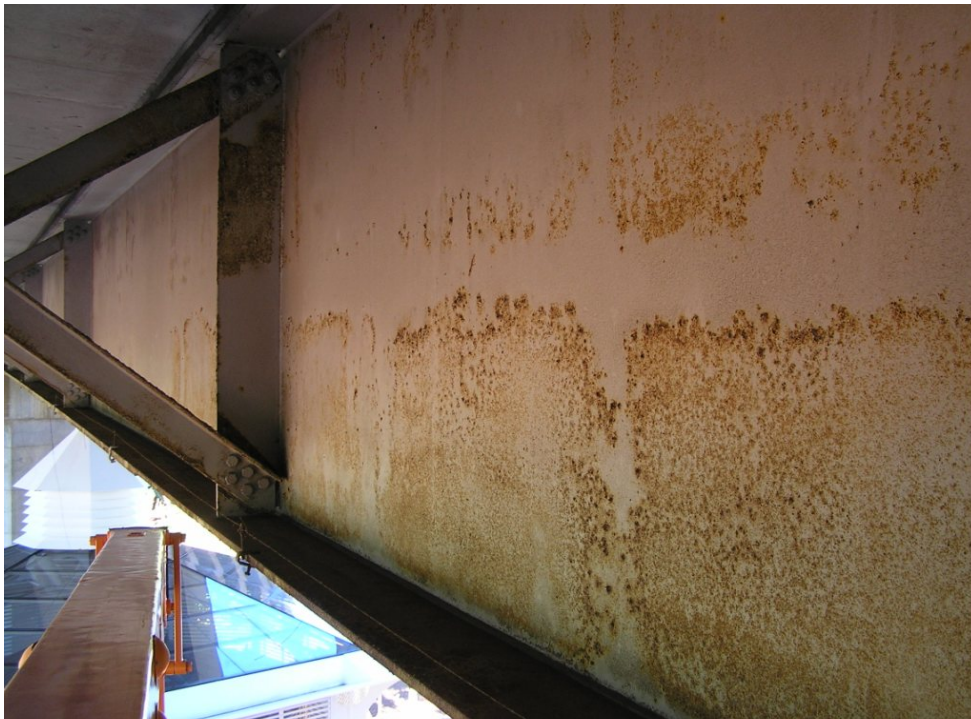
Surface rusting on web of girder.

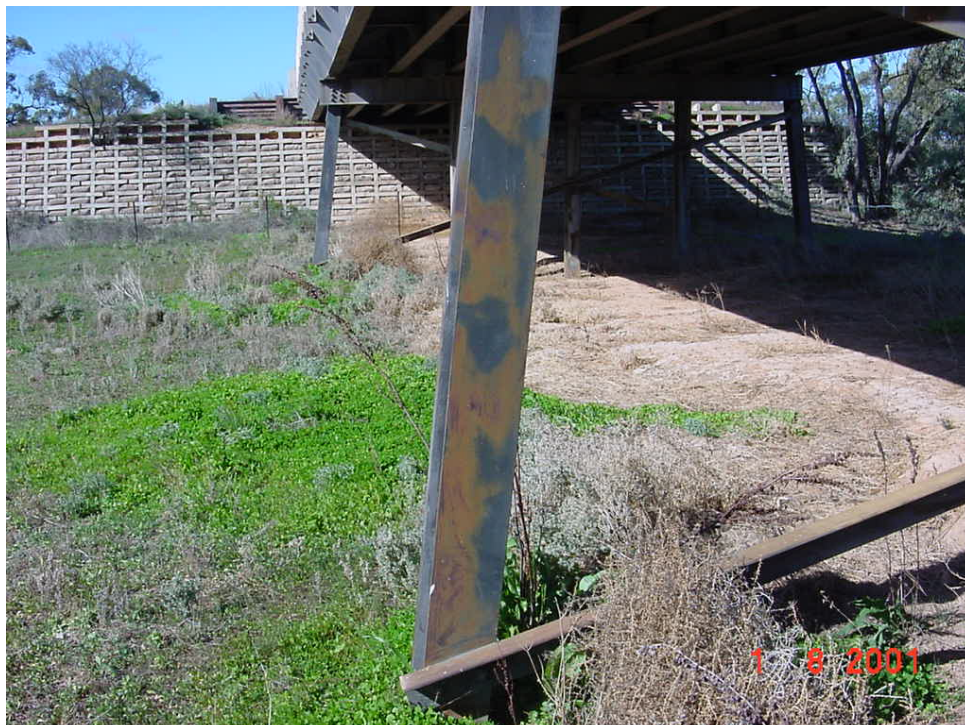
Uniform surface rusting on pile.

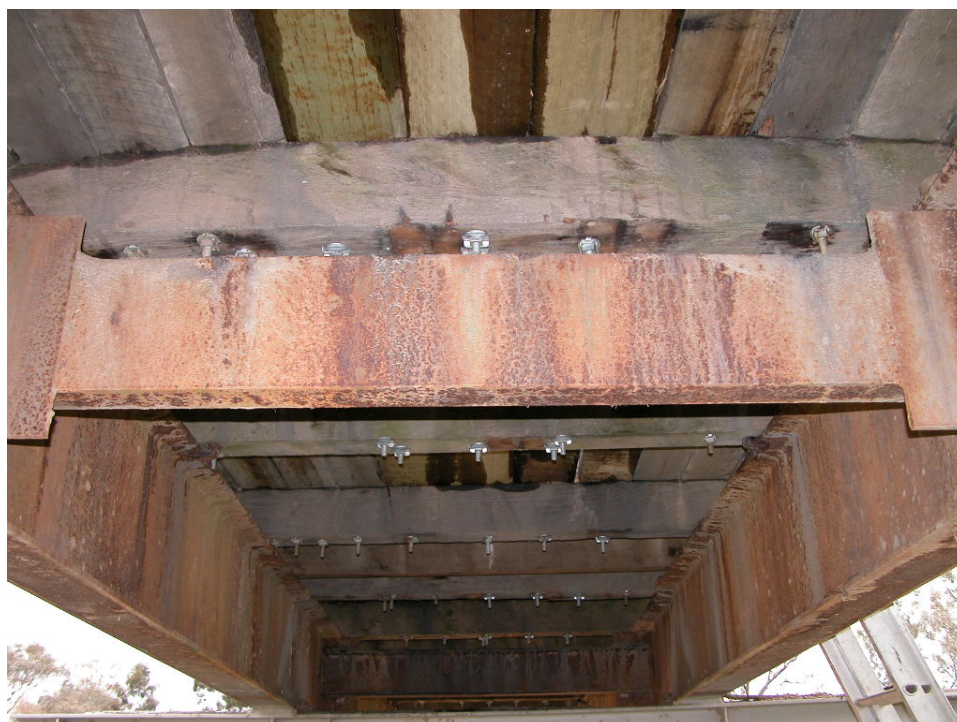
Extensive surface rusting.

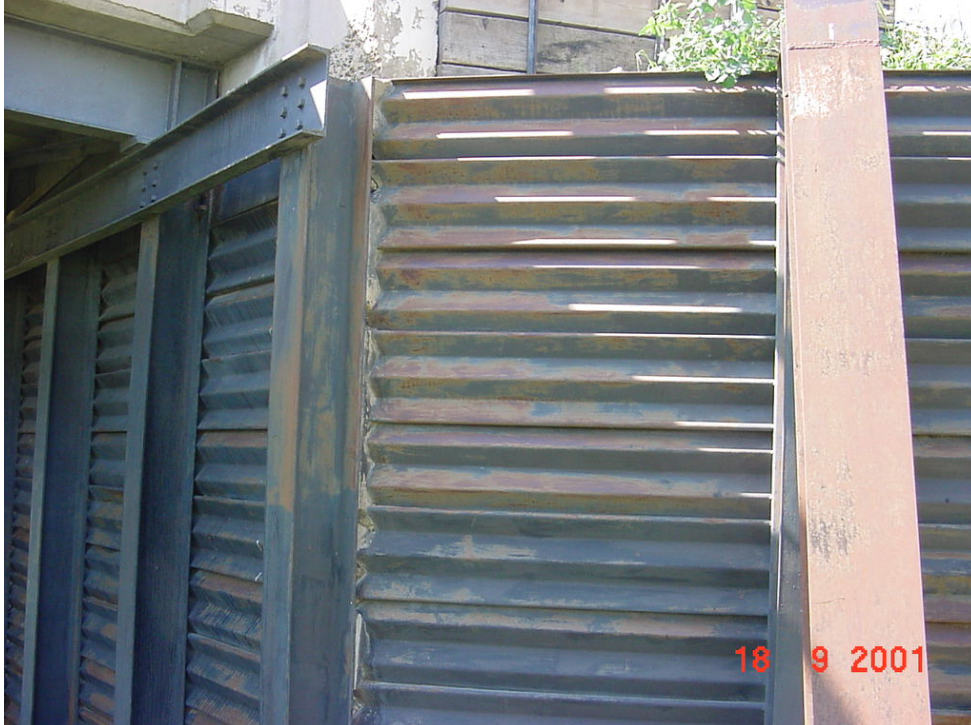
Light surface rusting on sheeting and supports.

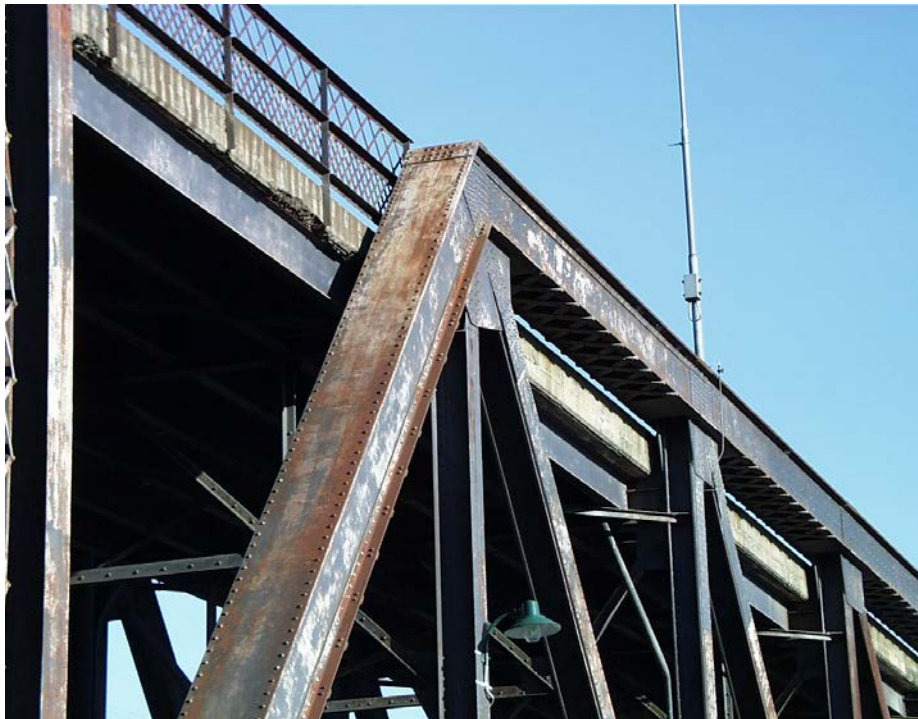
Uniform surface rust on principal. Rusting heavier on the edges and near rivets.

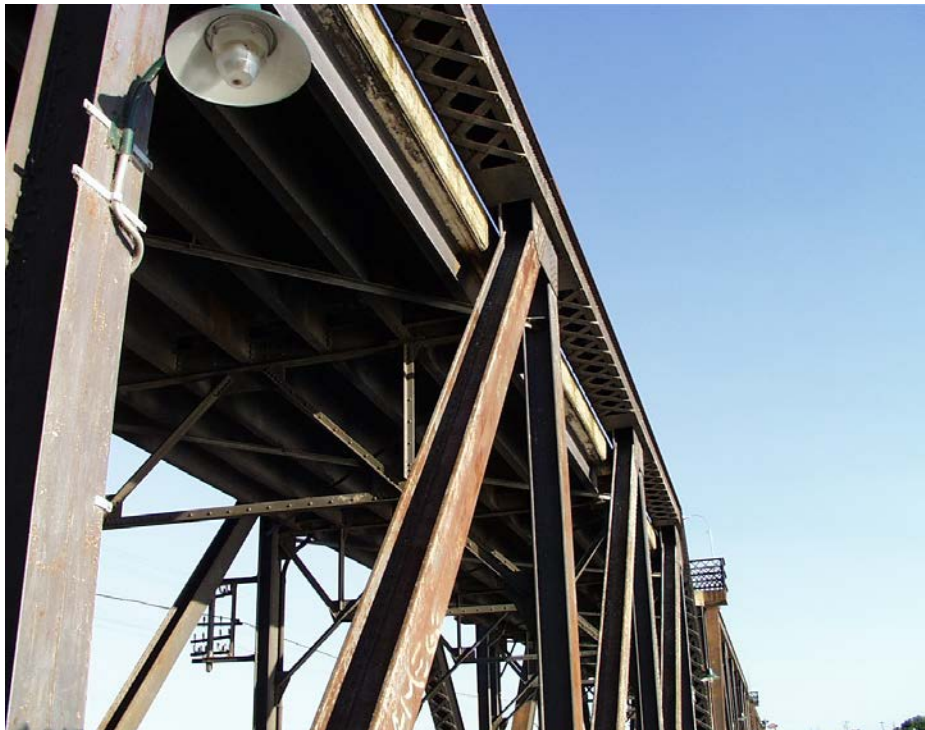
Uniform surface rust on diagonal.

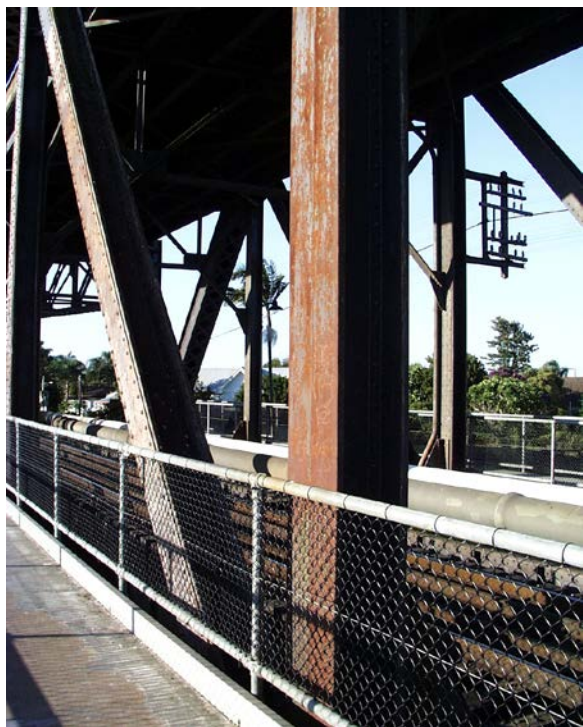
Uniform surface rust on vertical.

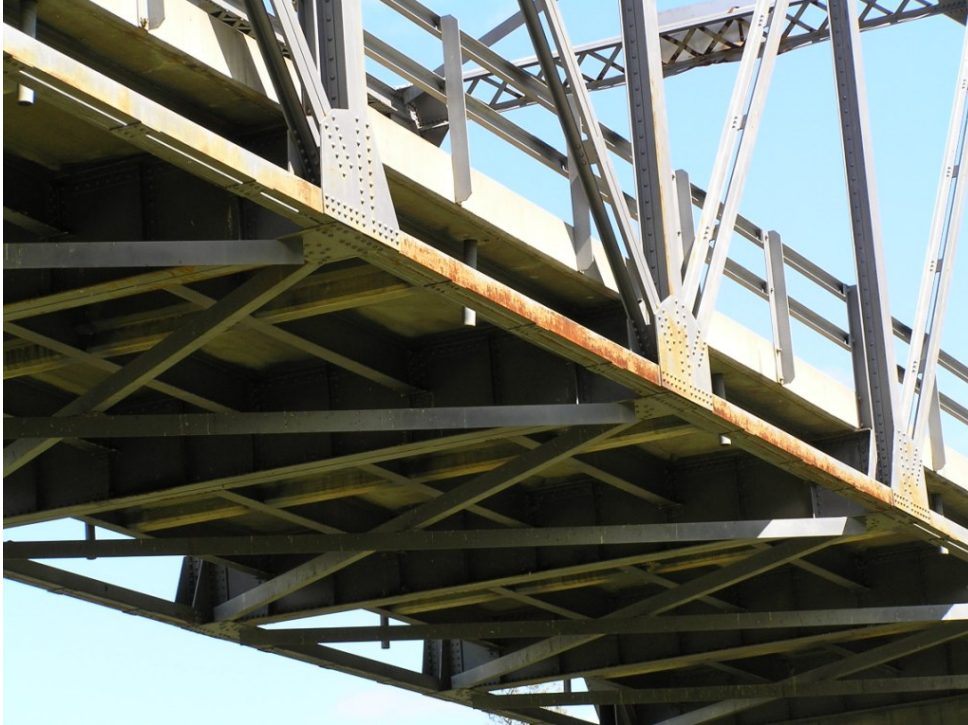
Surface rust on bottom chord.

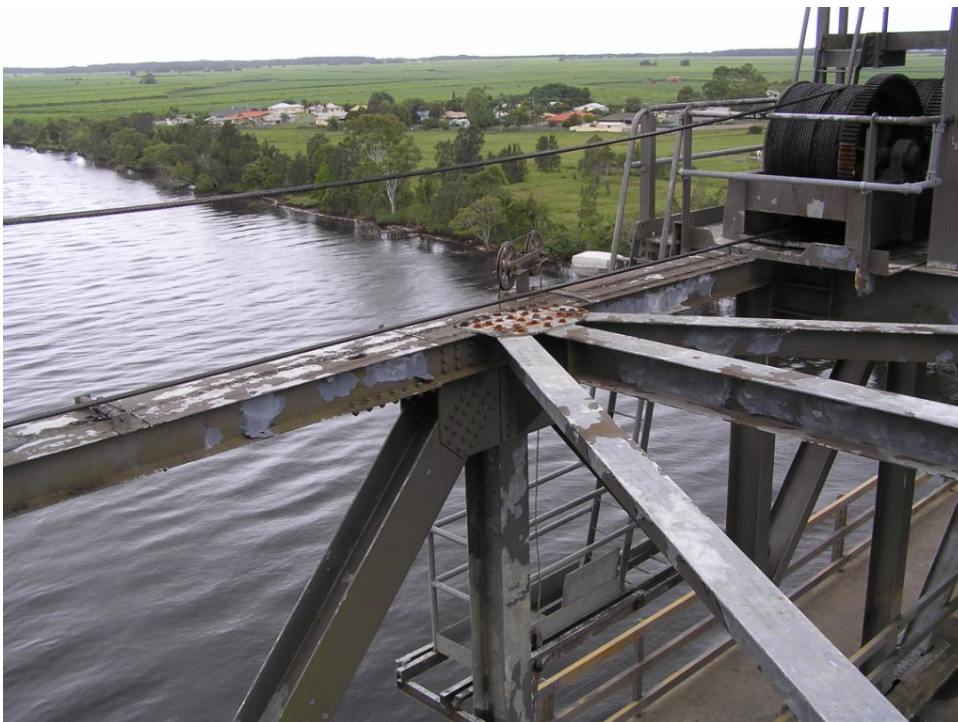
Surface rusting on rivets.

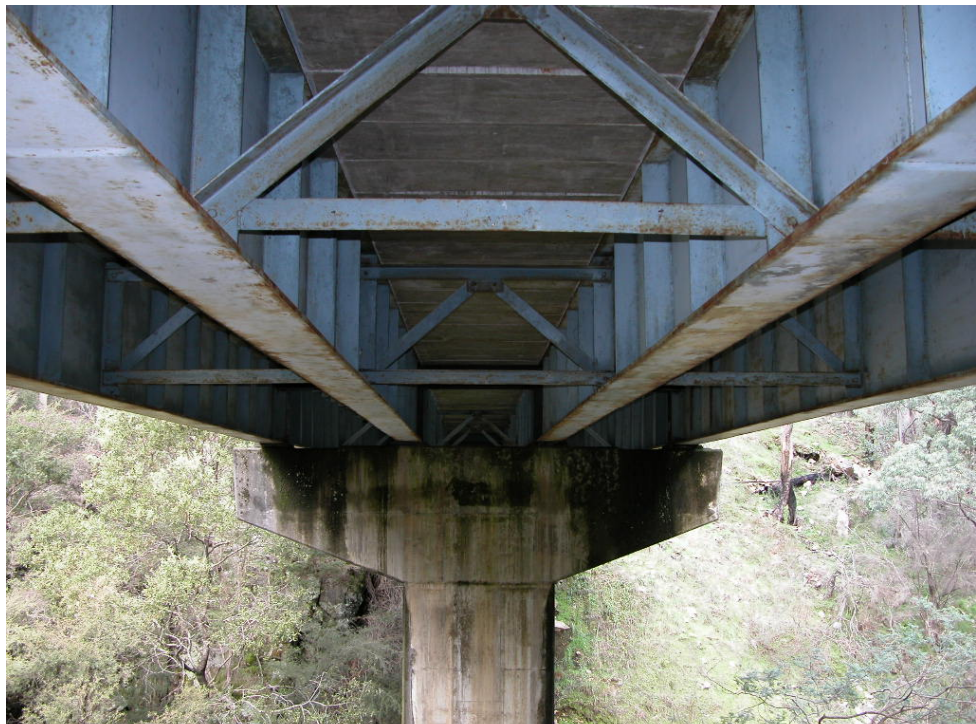
Extensive corrosion at flange edges.

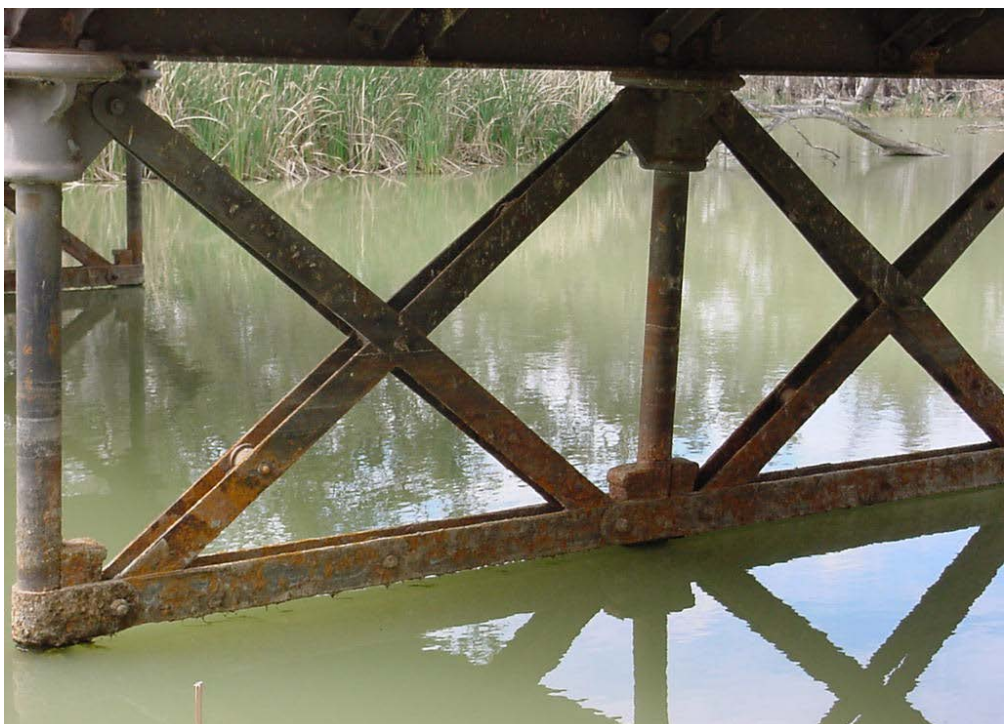
Heavy pitting on steel pier.

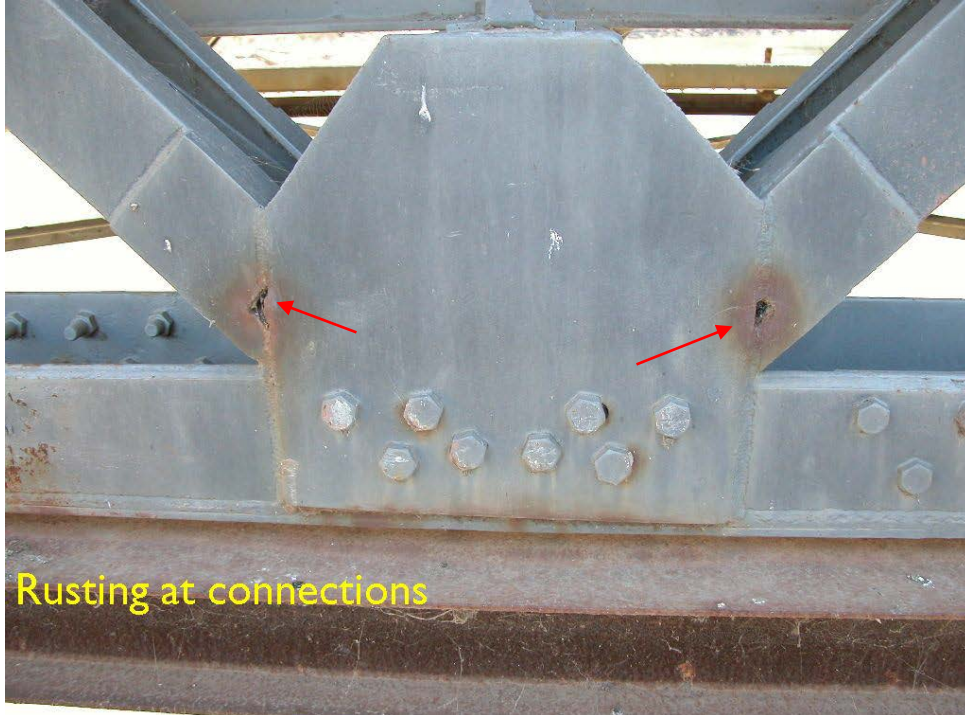
Corrosion and section loss at gusset plate welded connections.

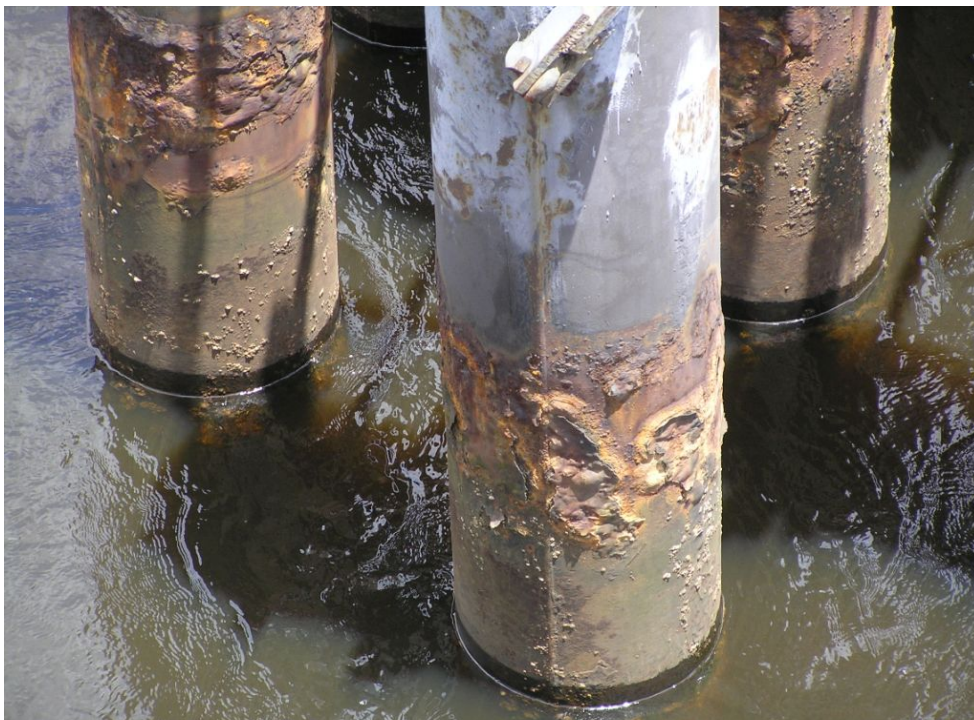
Heavy pitting on piles localised to the splash line.

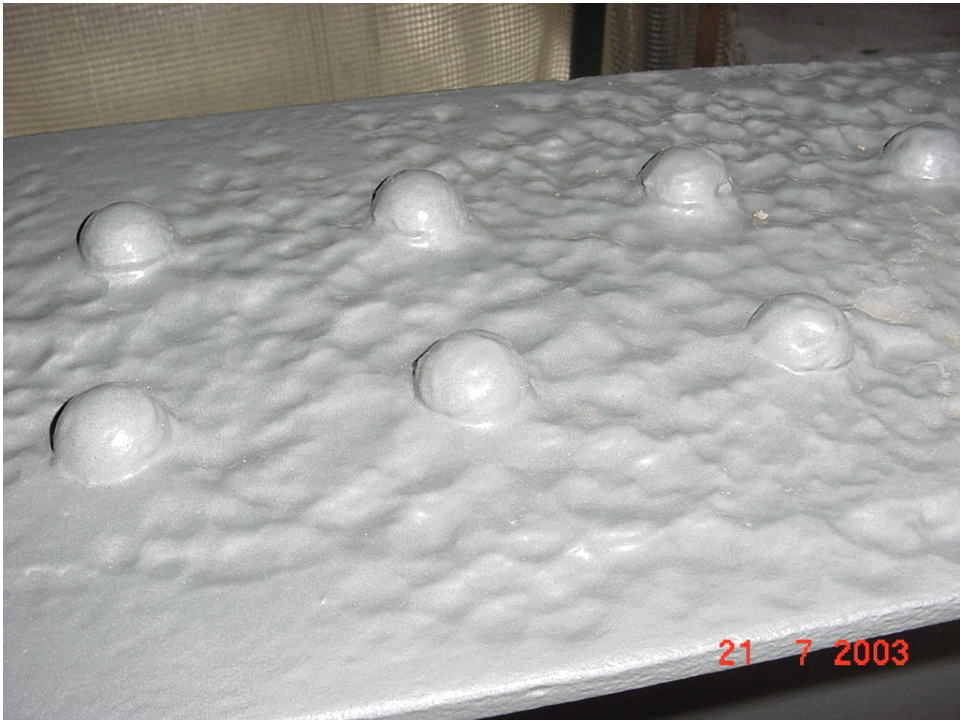
Repaired heavy pitting on cross girder – measurable section loss still evident. *However if a condition assesment of the element from a previous Level 3 inspection is available, that Level 3 inspection rating shall be used as the basis for rating the element with due considertions for any subsequent deterioration.*

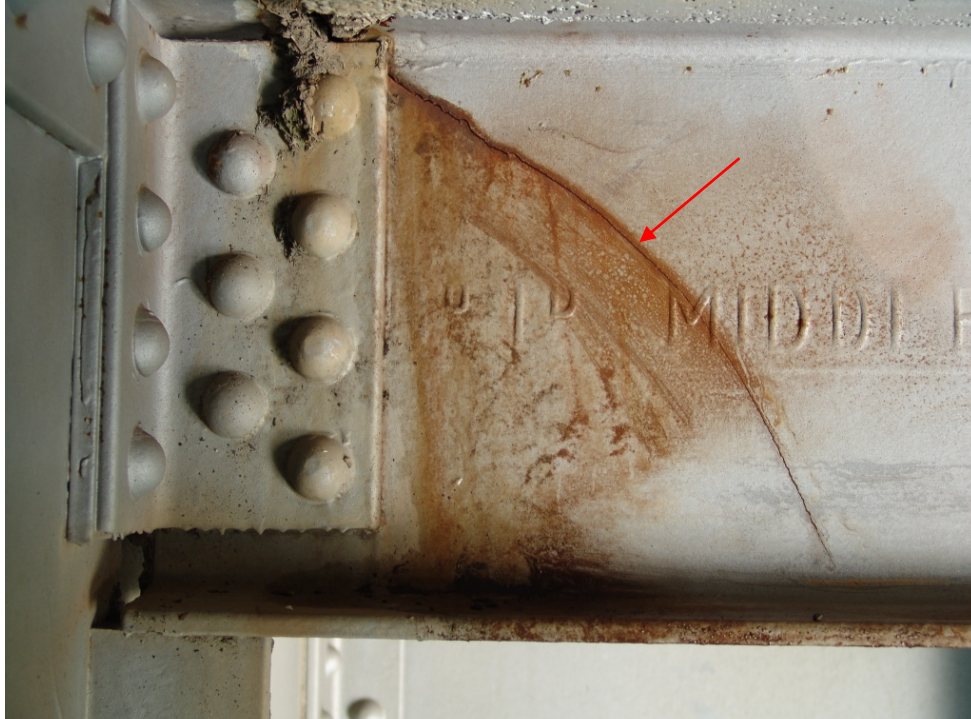
Fatigue crack in stringer.

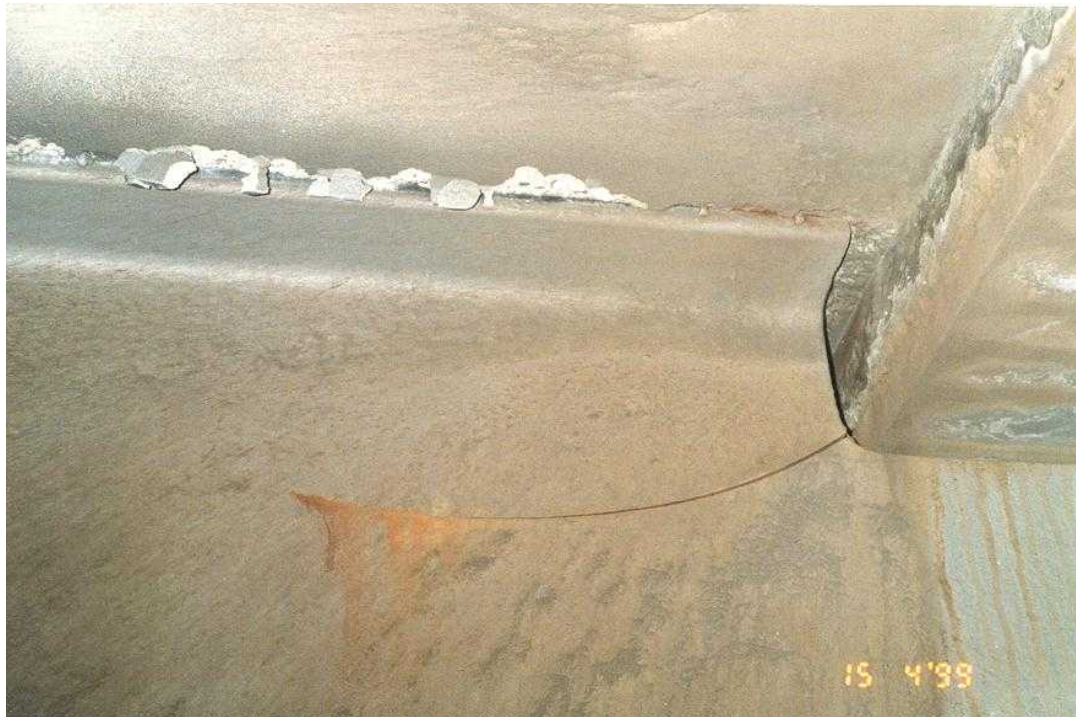
Fatigue crack in stringer.

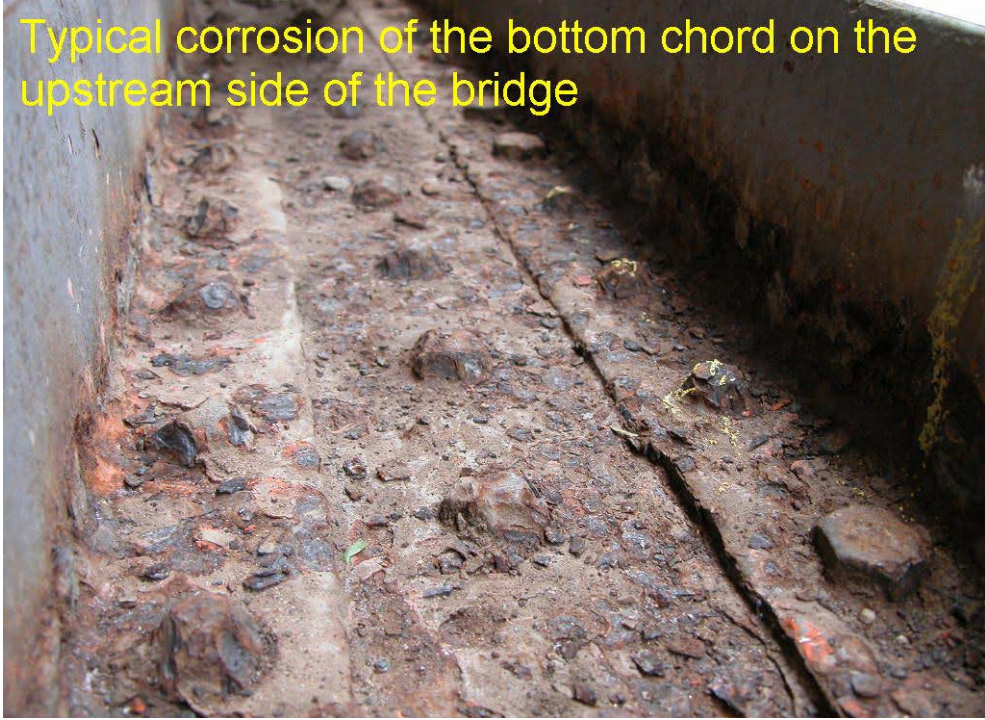
Typical corrosion of the bottom chord on the upstream side of the bridge

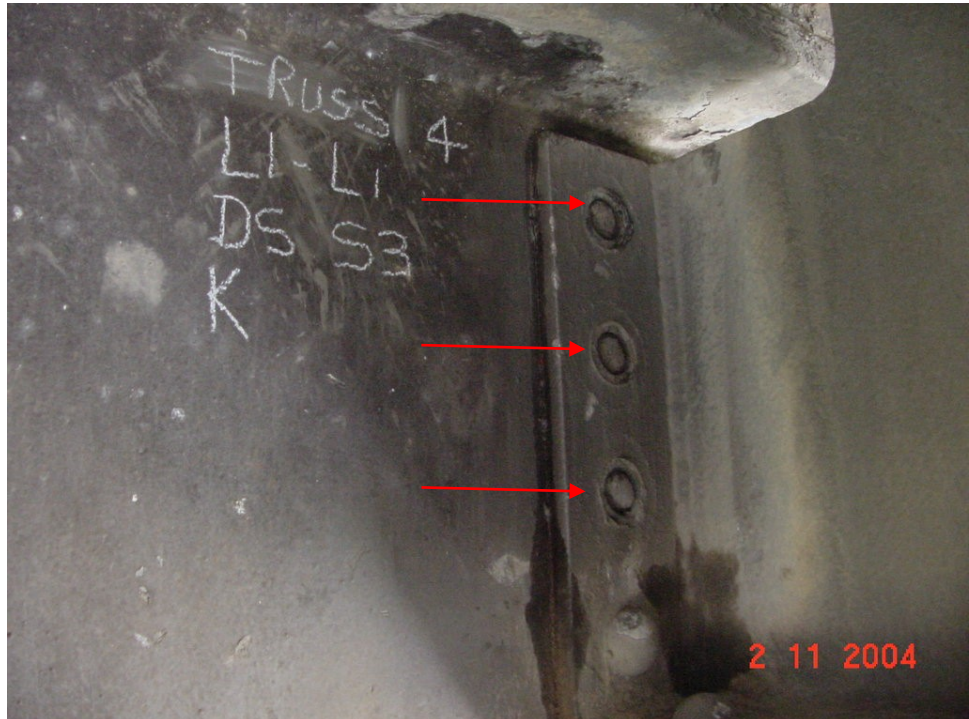
Failed rivets at connection with cross girder.

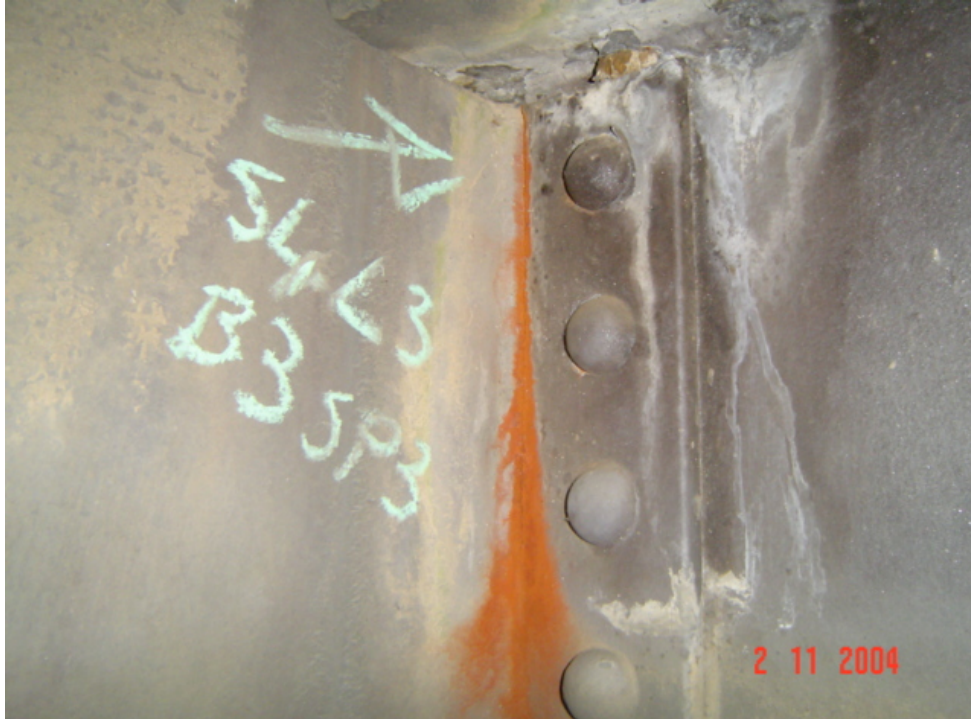
Crack in weld at connection with cross girder.

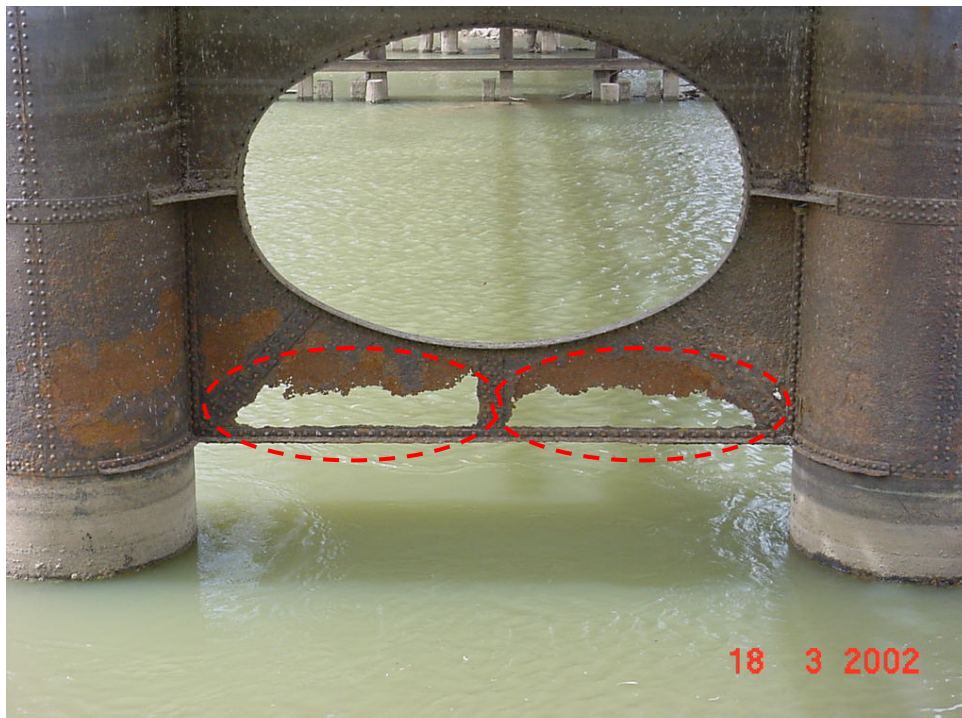
Significant section loss in diaphragm of pier.

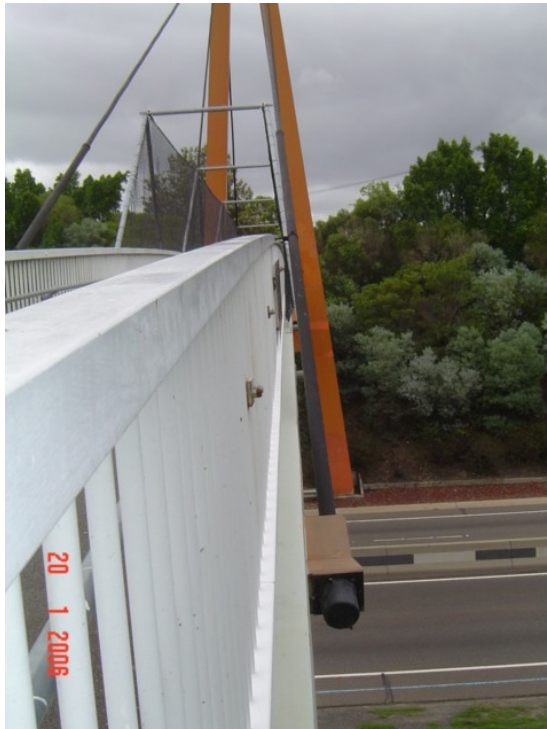
Cables in good condition.

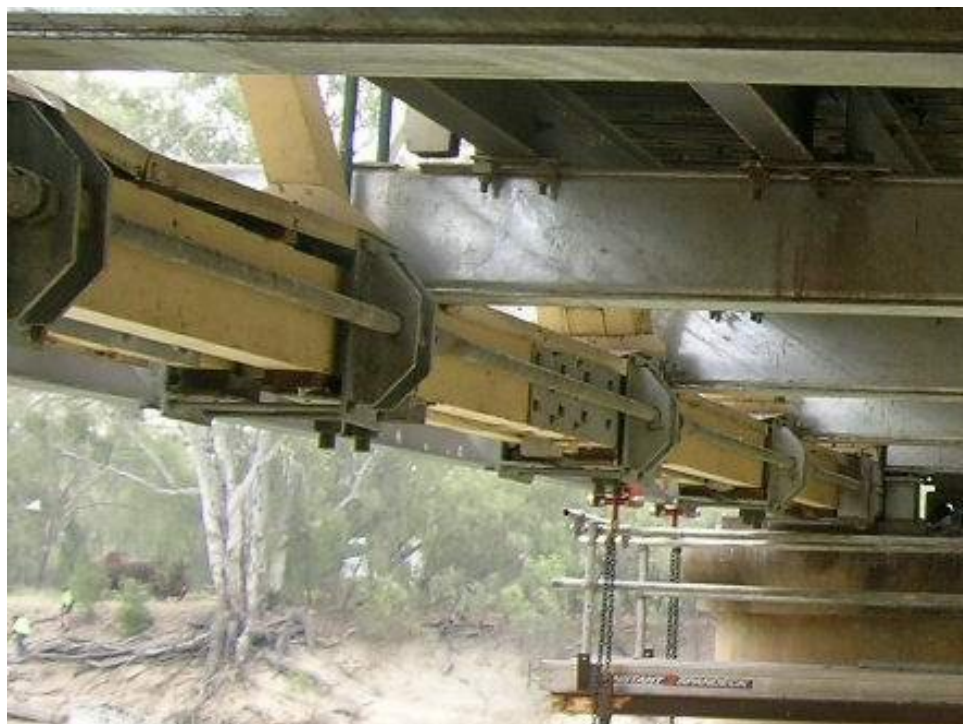
External pre-stressing system at the bottom of a timber truss in good condition.

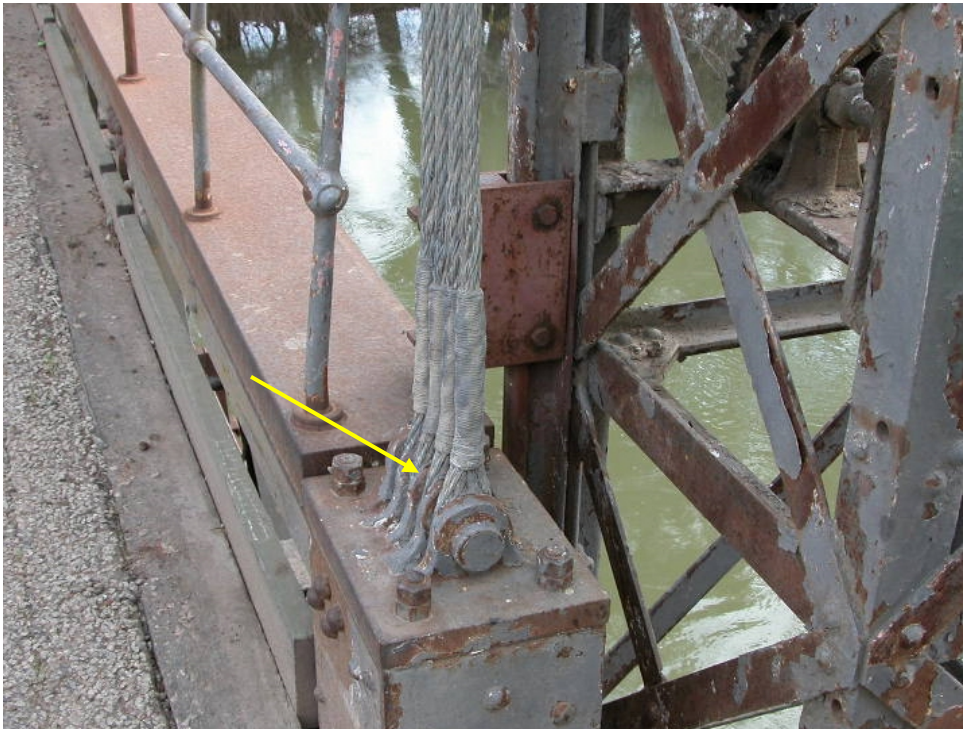
Surface rust on lift span wire cable and connection.

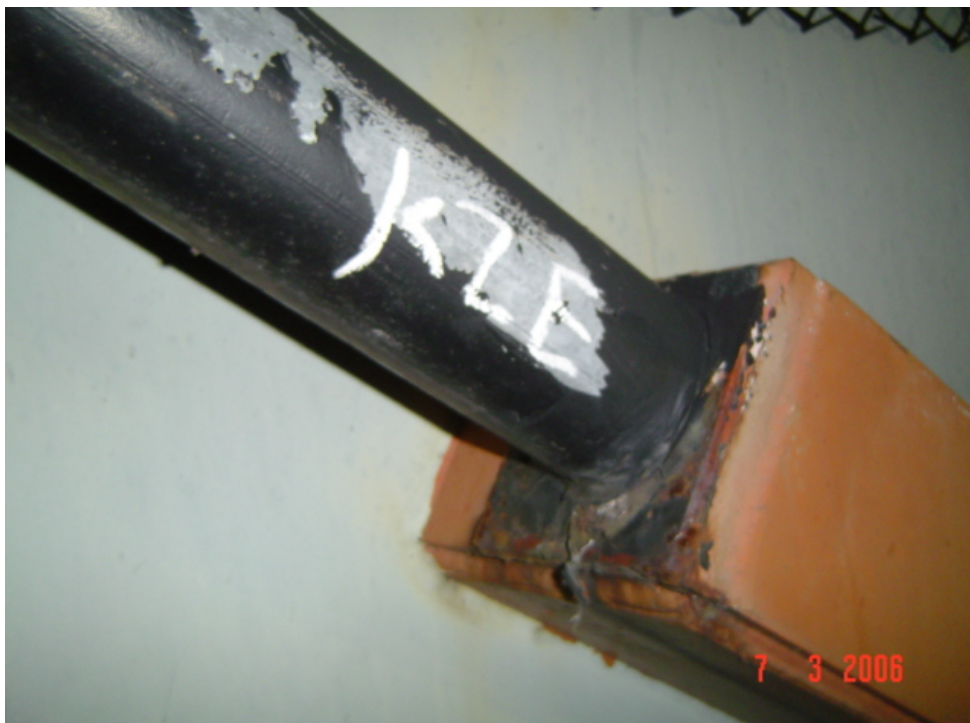
Minor surface corrosion on cable anchorage block in a pedestrian bridge.

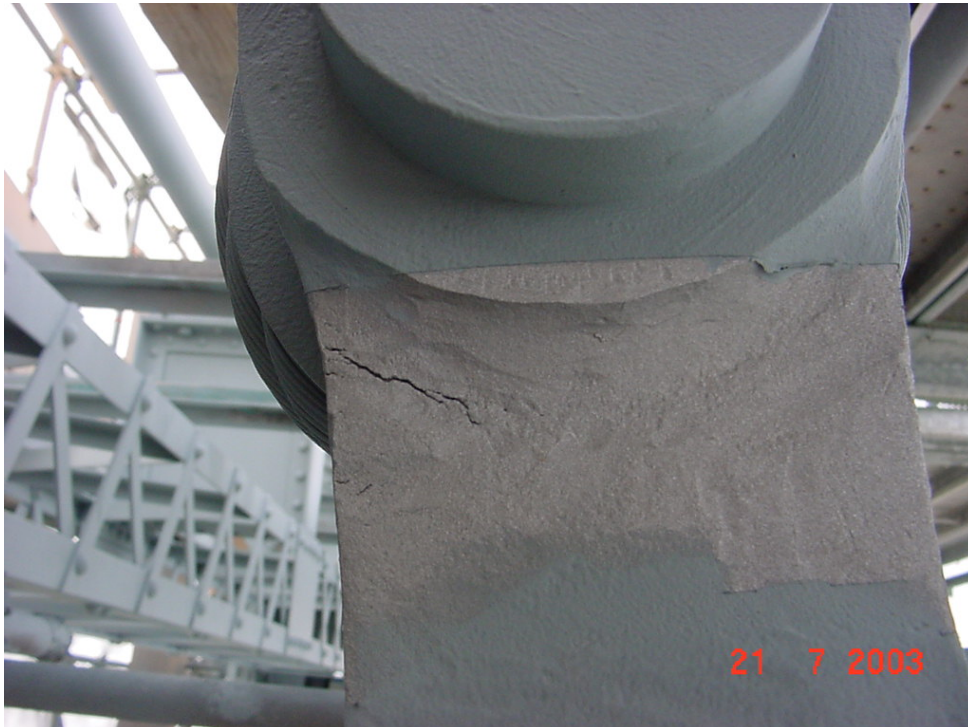
**Condition State 4** - Pitting or general corrosion is advanced. Section loss is sufficient to warrant analysis to ascertain the impact on the ultimate strength and/or serviceability of either the element or the bridge. Cables may be abraded with broken wire(s). Units may have slackened noticeably or differentially and/or are not fully effective. Anchorages may have cracked or have moved or slipped. Sockets may have loosened or saddles are badly damaged.

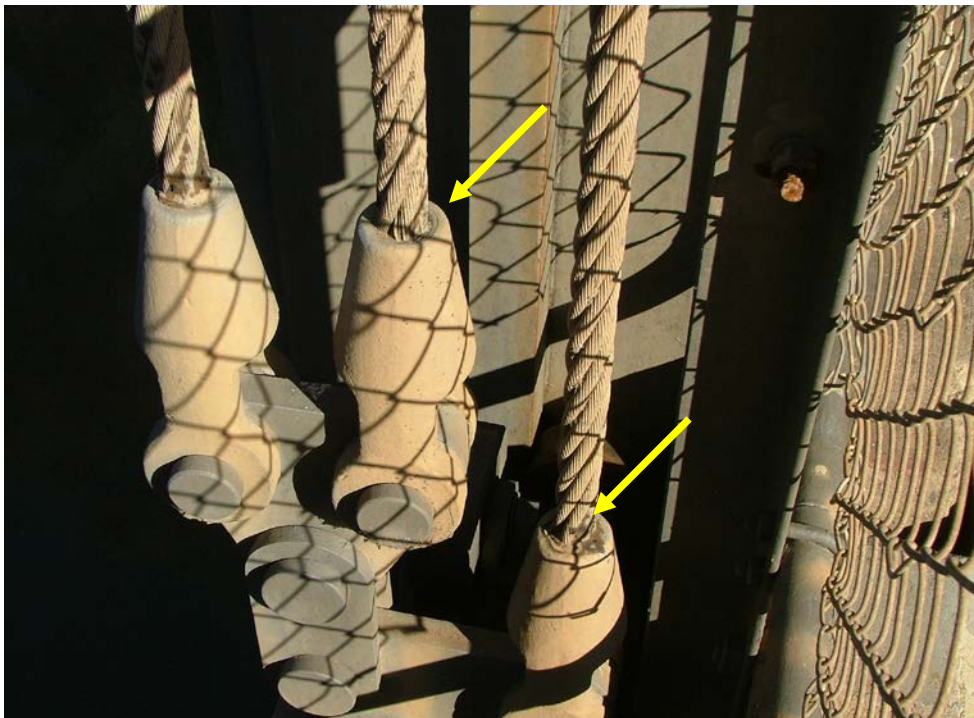
Lift span wire rope cables with broken wires near the anchor sockets.

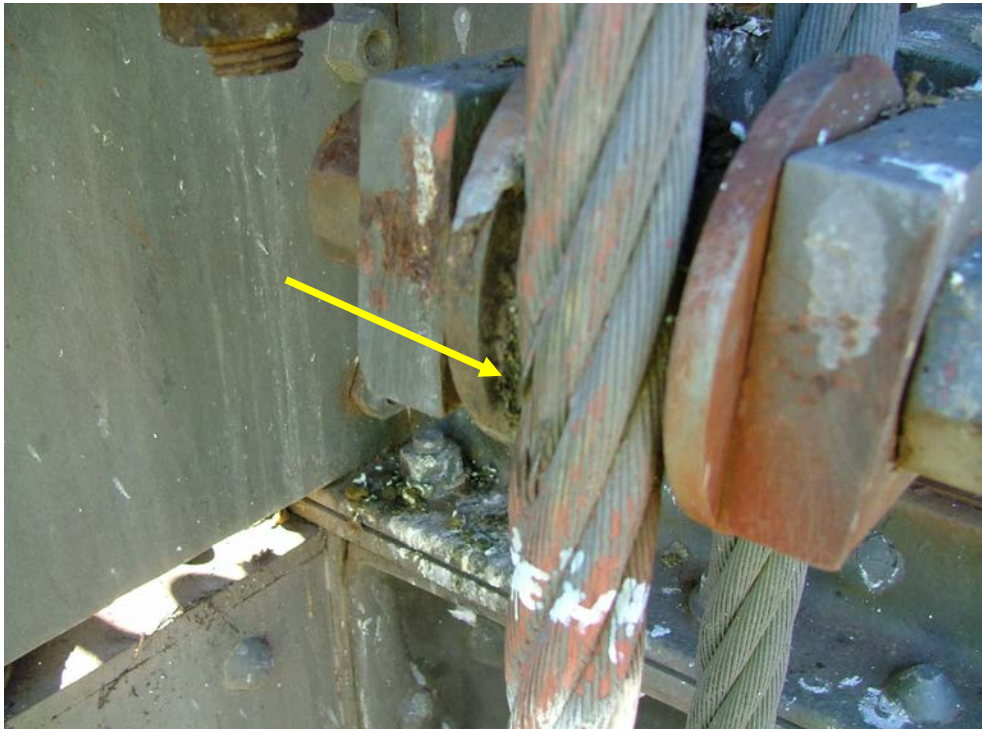
Lift span cable with broken wires.

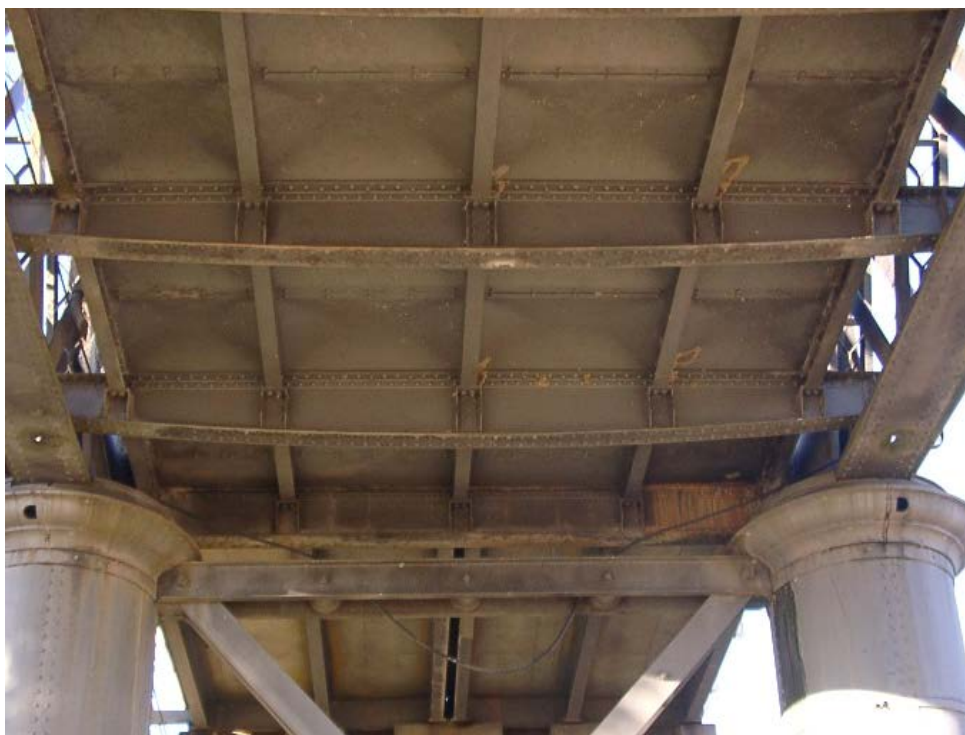
Buckle plate deck in good condition.
