Transport  
**Roads & Maritime  
Services**

# **BRIDGE INSPECTION PROCEDURE MANUAL**

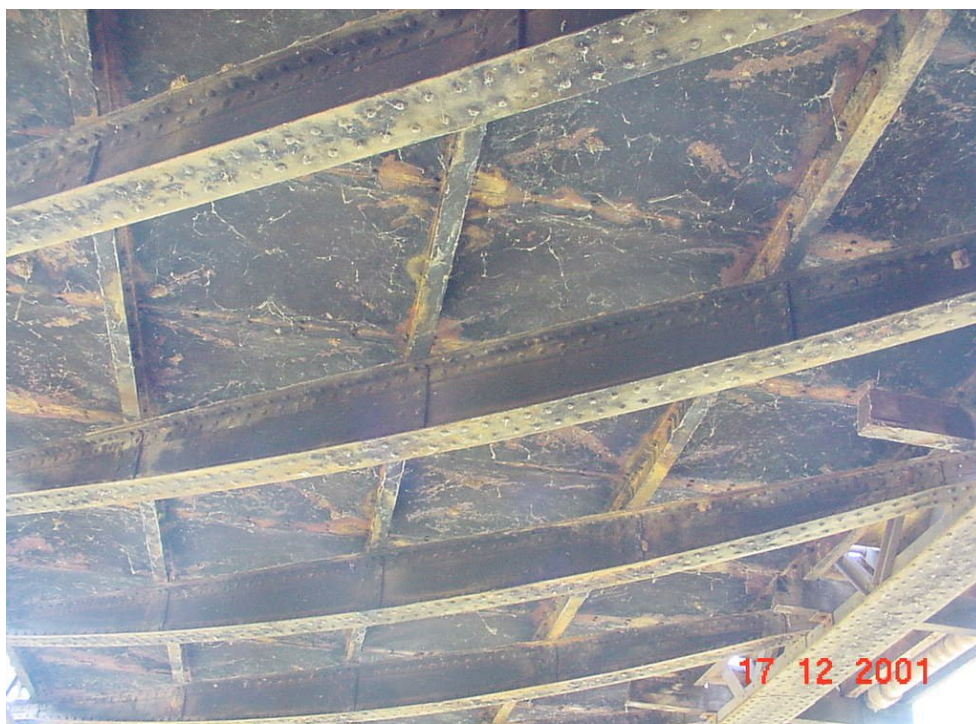
Buckle plates are still in good condition although the paint has failed.

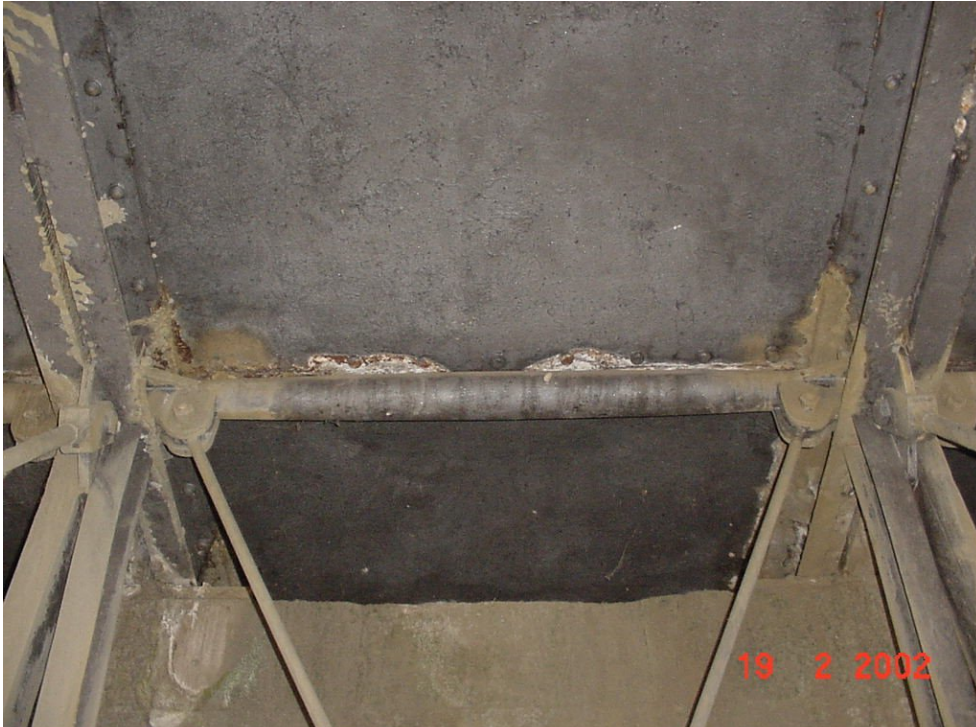
Buckle plate deck with minor leakage and corrosion at the edges.

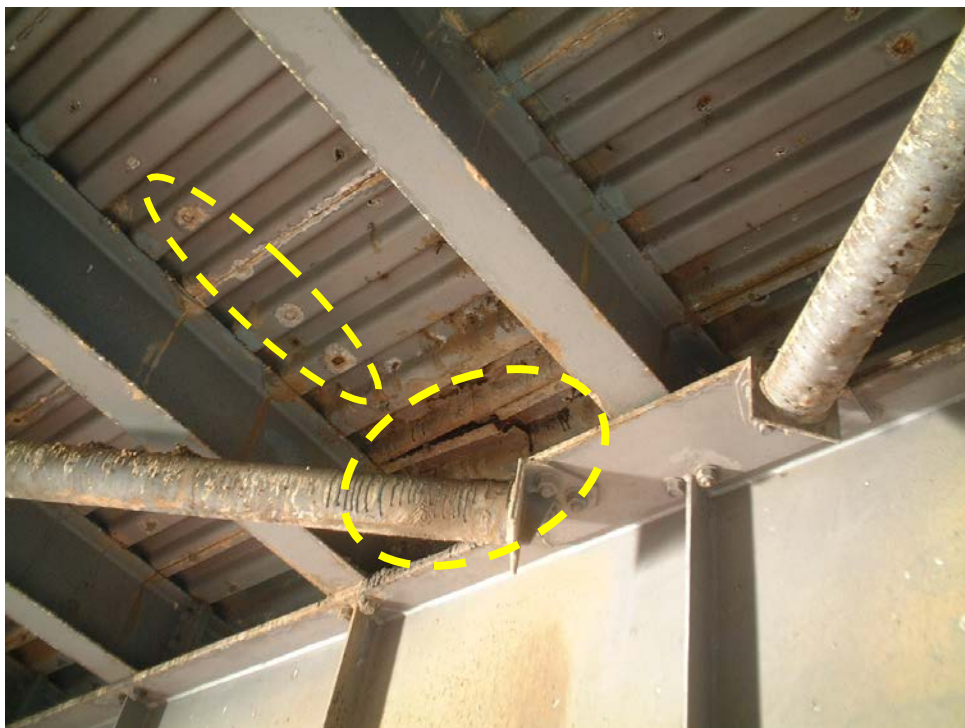
Failed connectors and localised failure of decking.

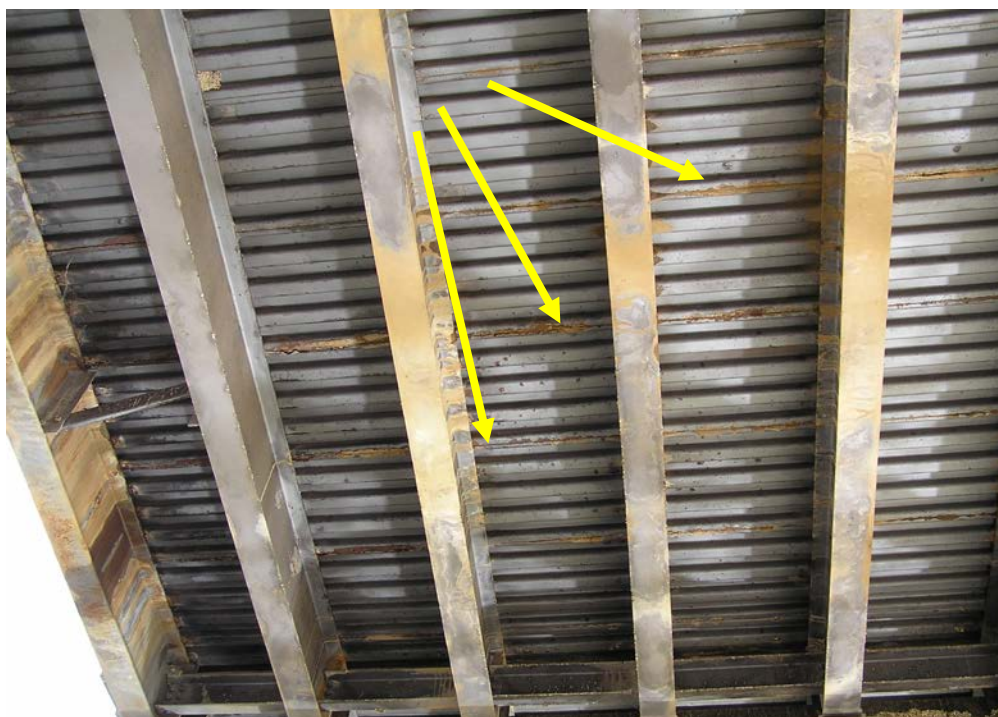
Moderate corrosion at all deck connections.

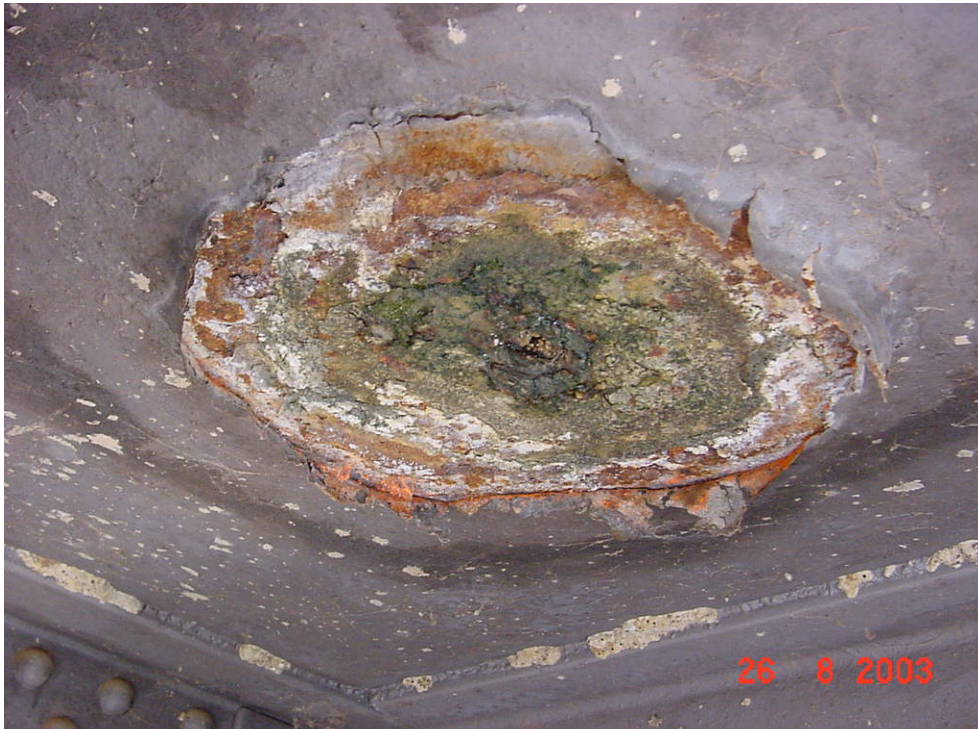
Severe corrosion of buckle plate with complete section loss over large areas.

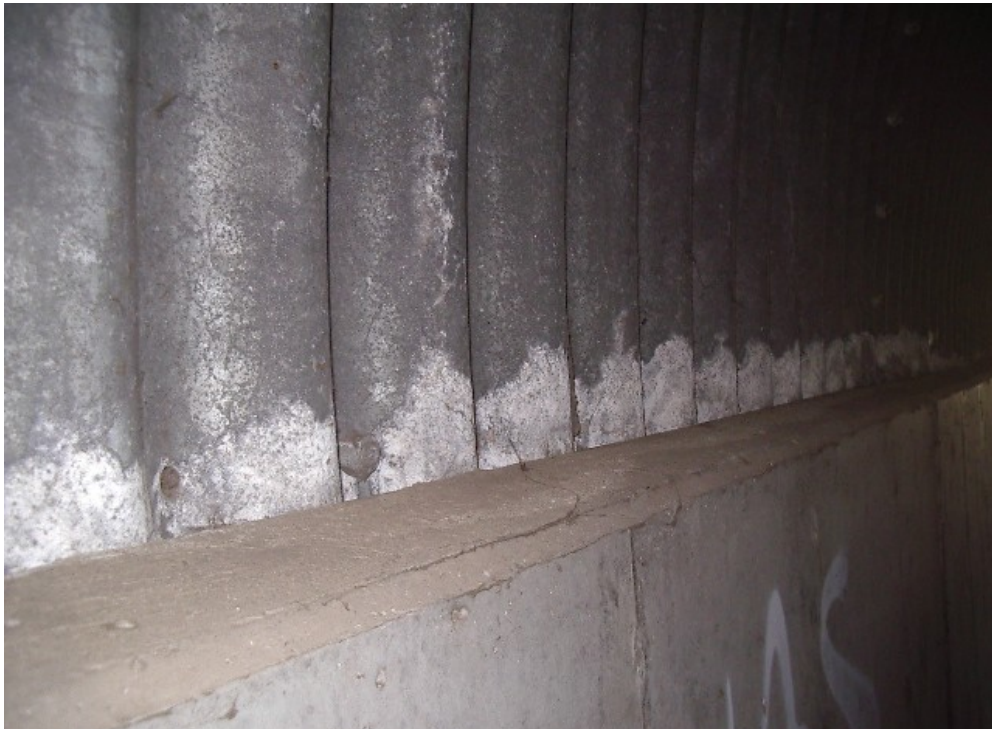
Surface discolouration near the base but culvert is still in good condition.

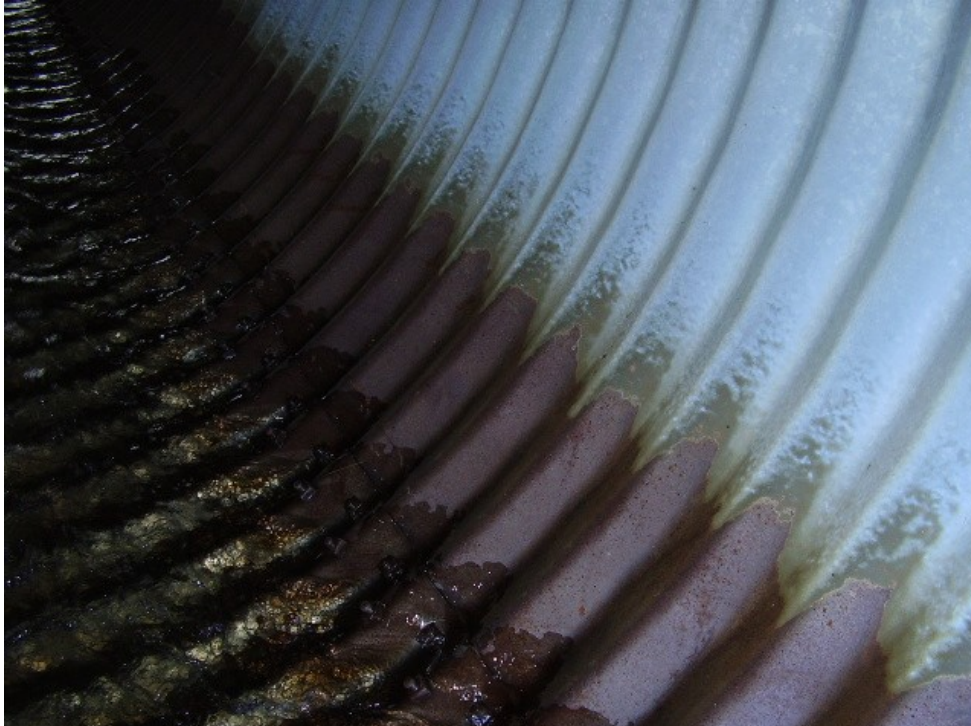
Loss of galvanised protective coating but there is no significant corrosion.

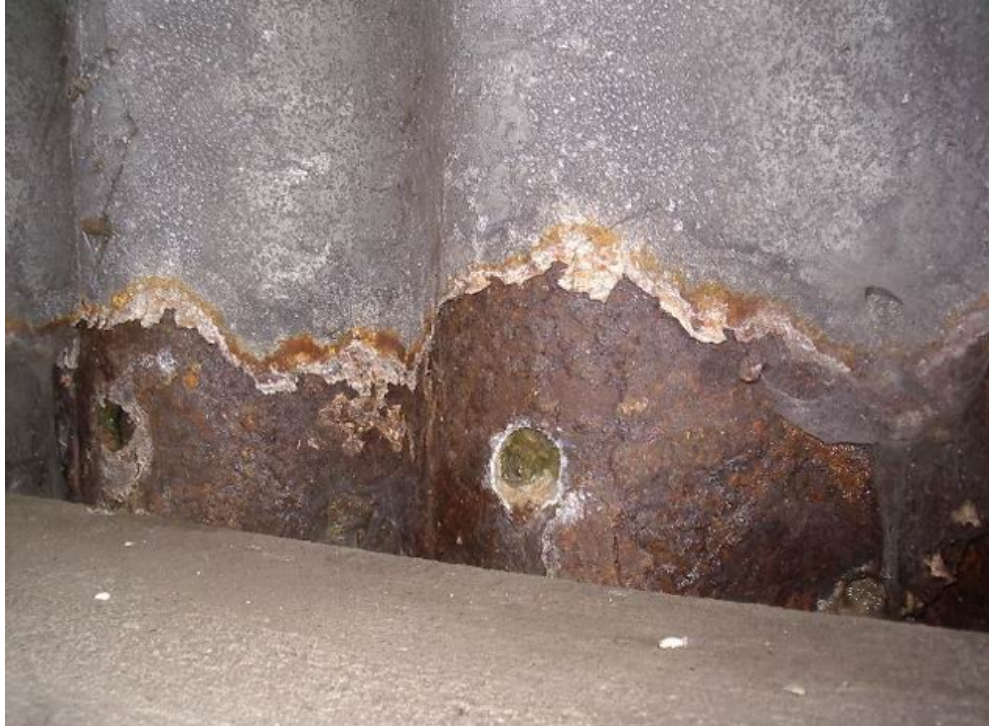
Significant corrosion with missing bolts.

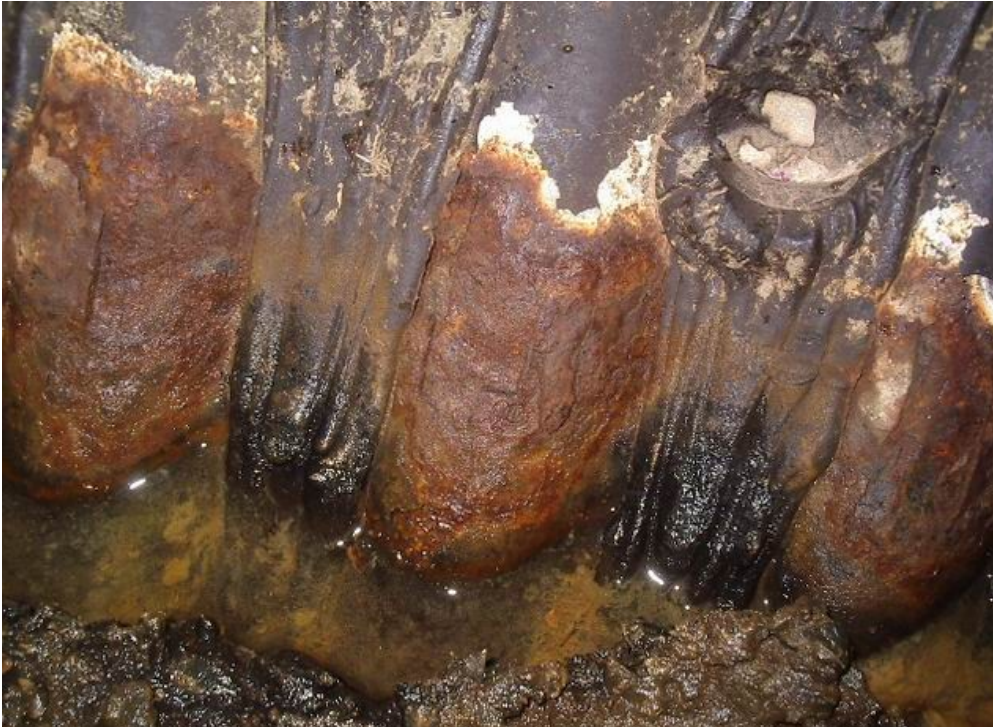
Major corrosion with some distortion.

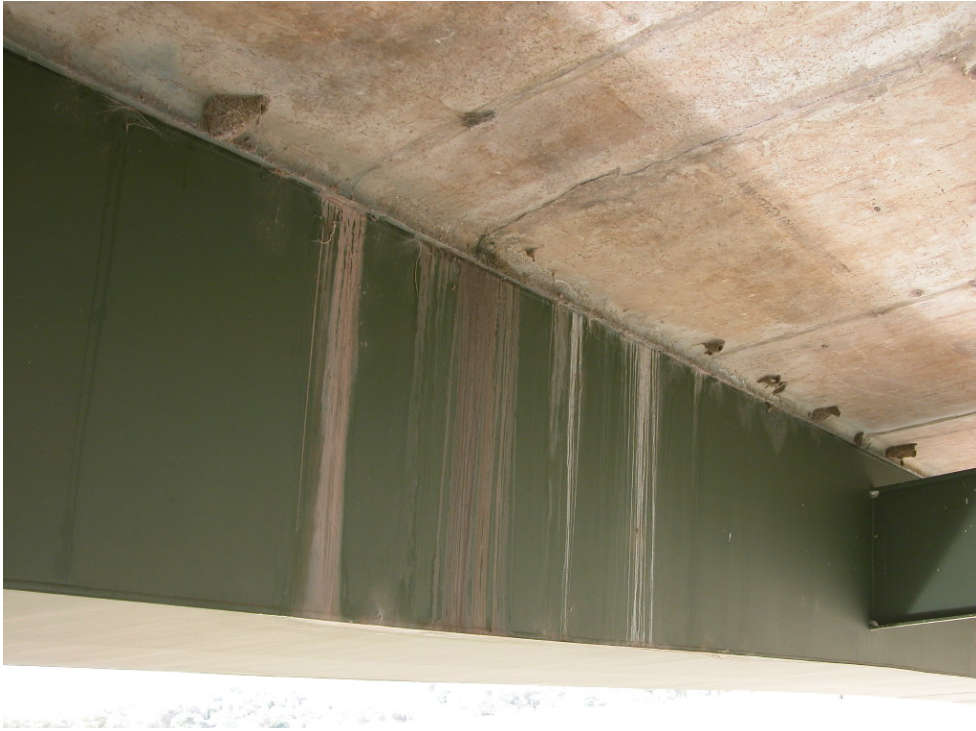
Water staining evident but coating in good condition.

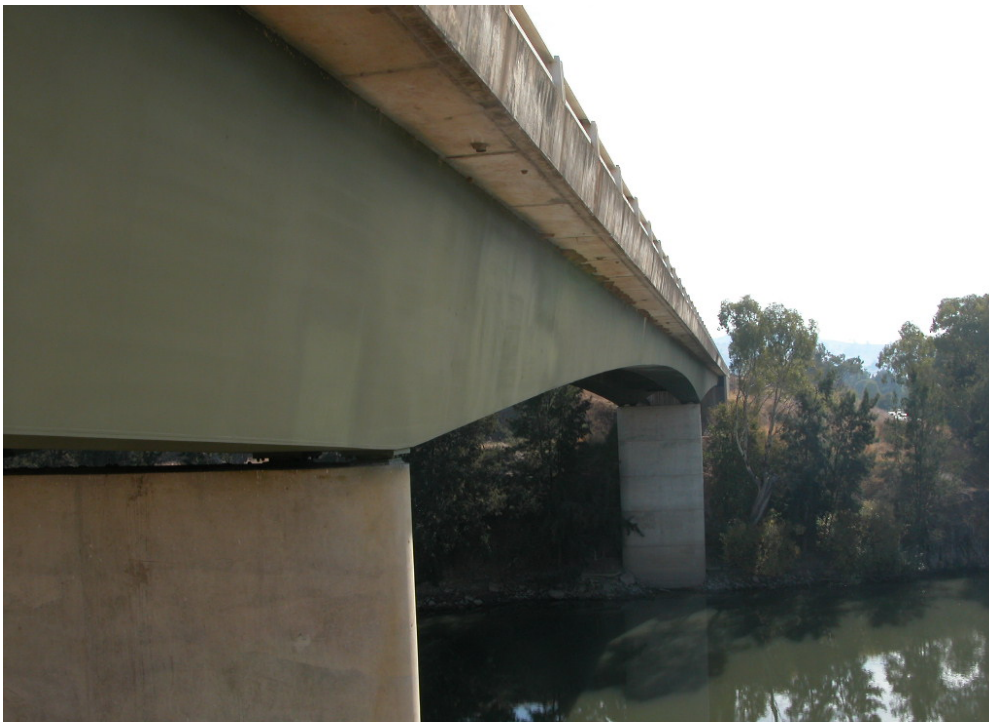
Coating in near new condition.

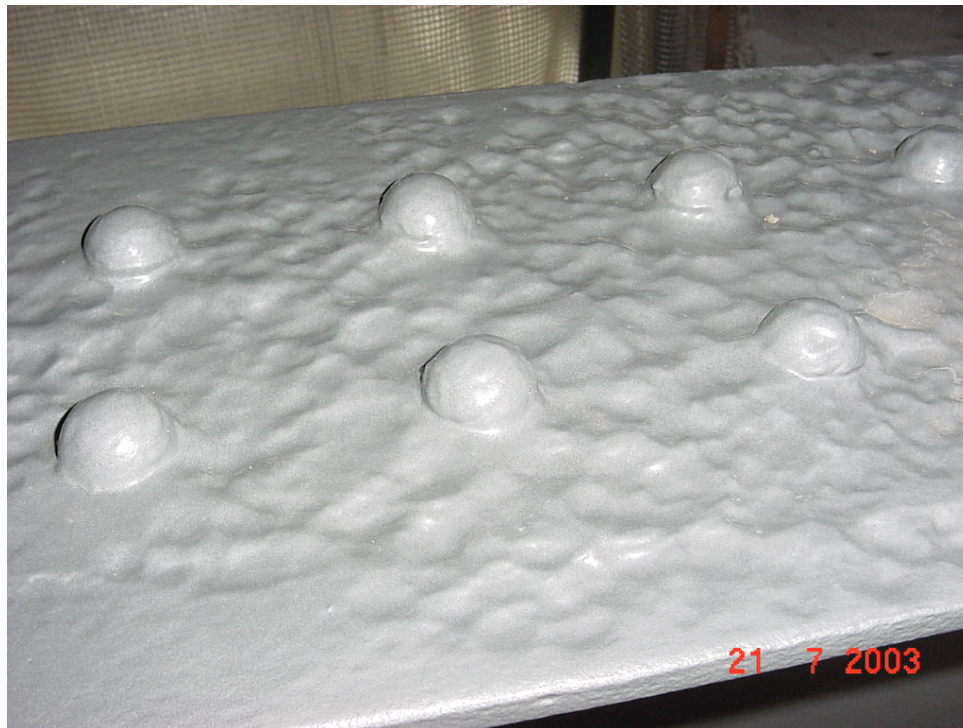
Coating in near new condition.

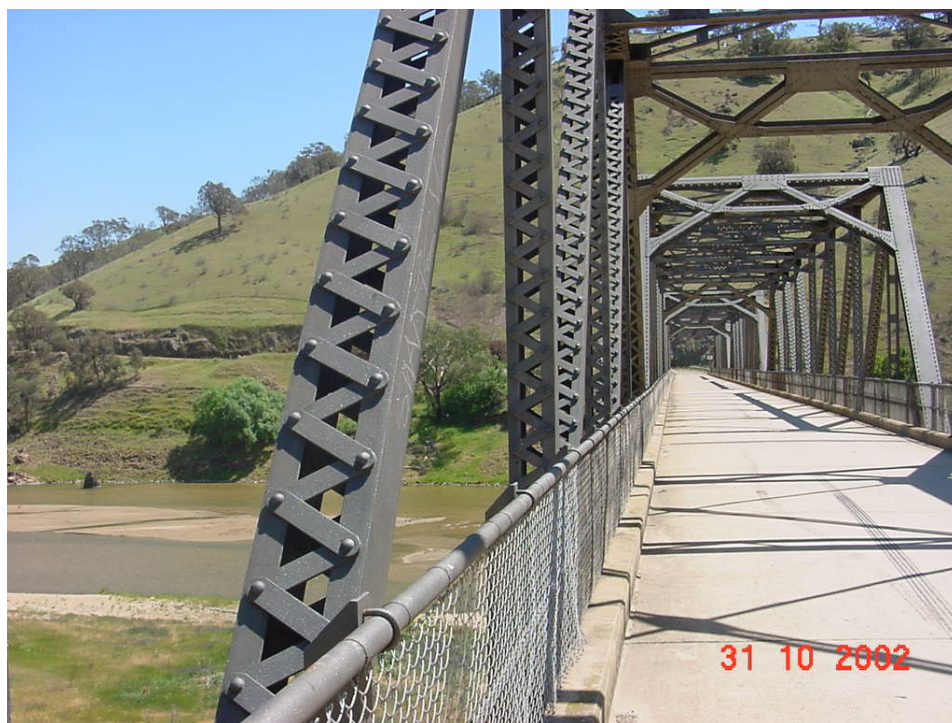
Coating in near new condition.

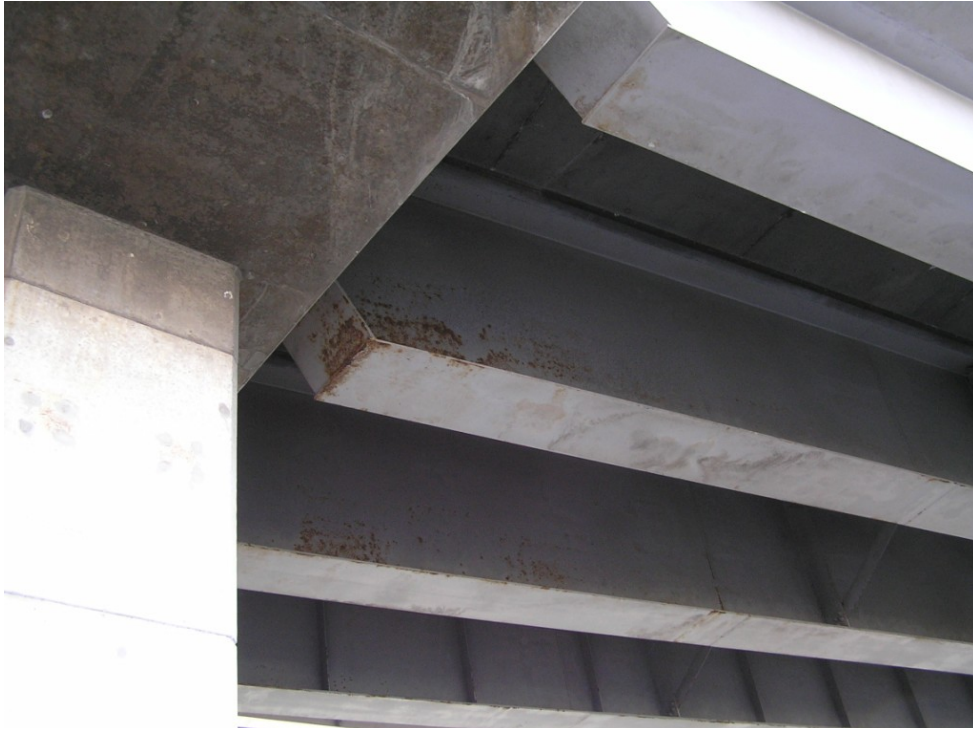
Localised breakdown at end of girder.

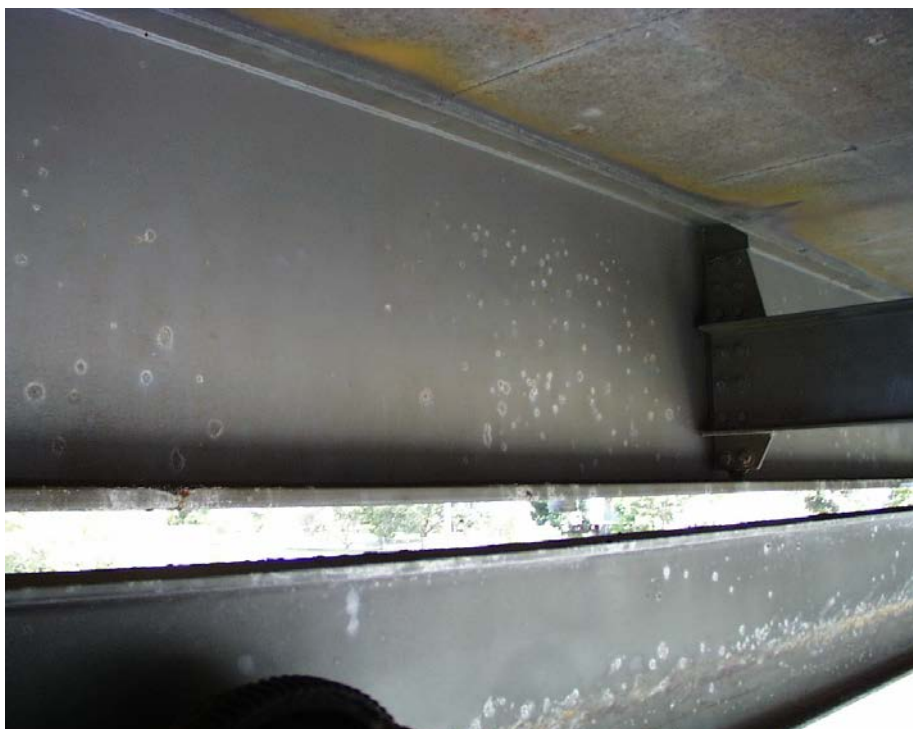
Localised failure of zinc primer with white salts evident.

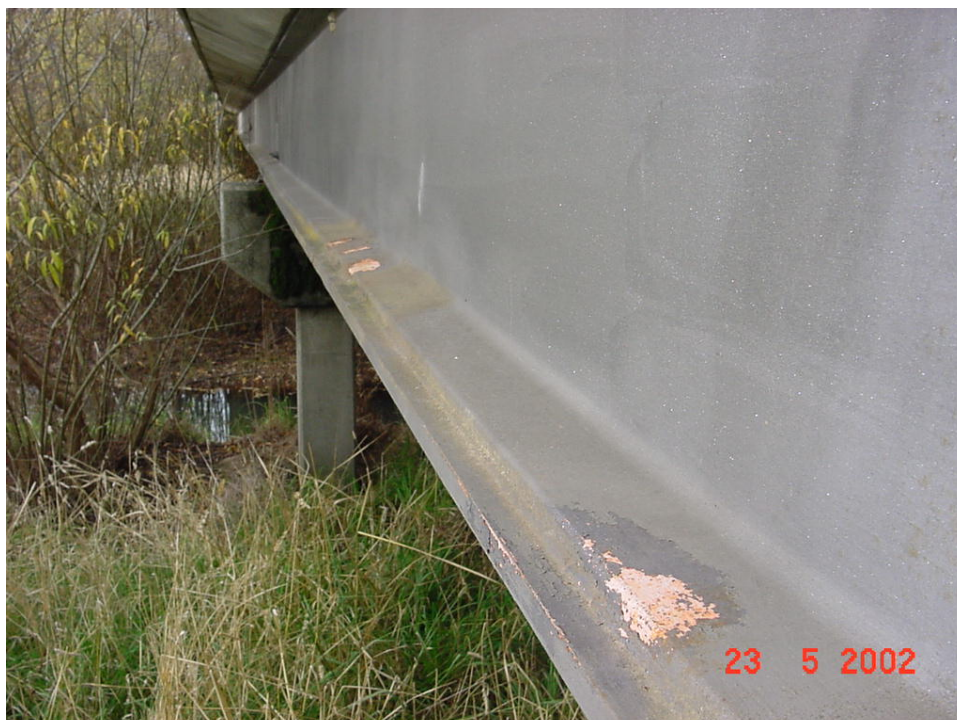
Localised patches of topcoat breakdown.

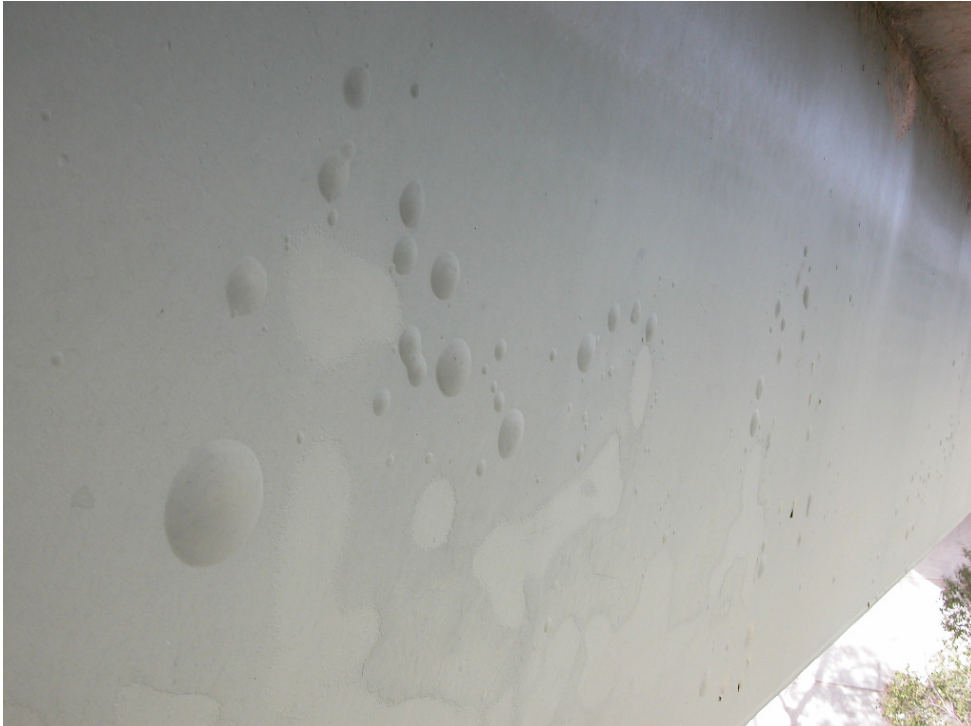
Blistering of topcoat.

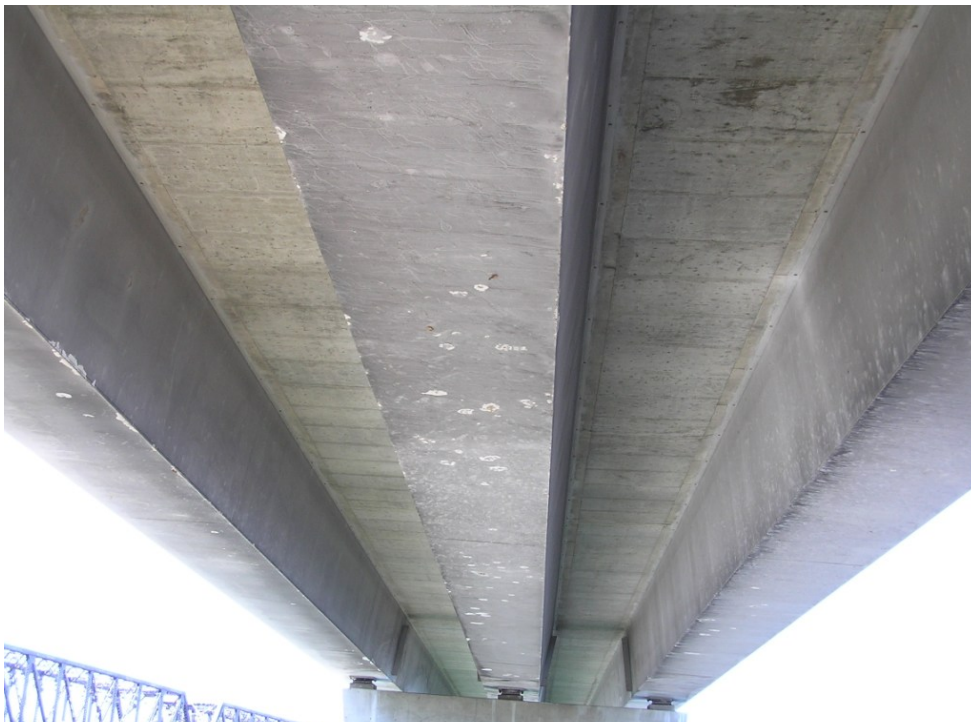
Localised failure of zinc primer.

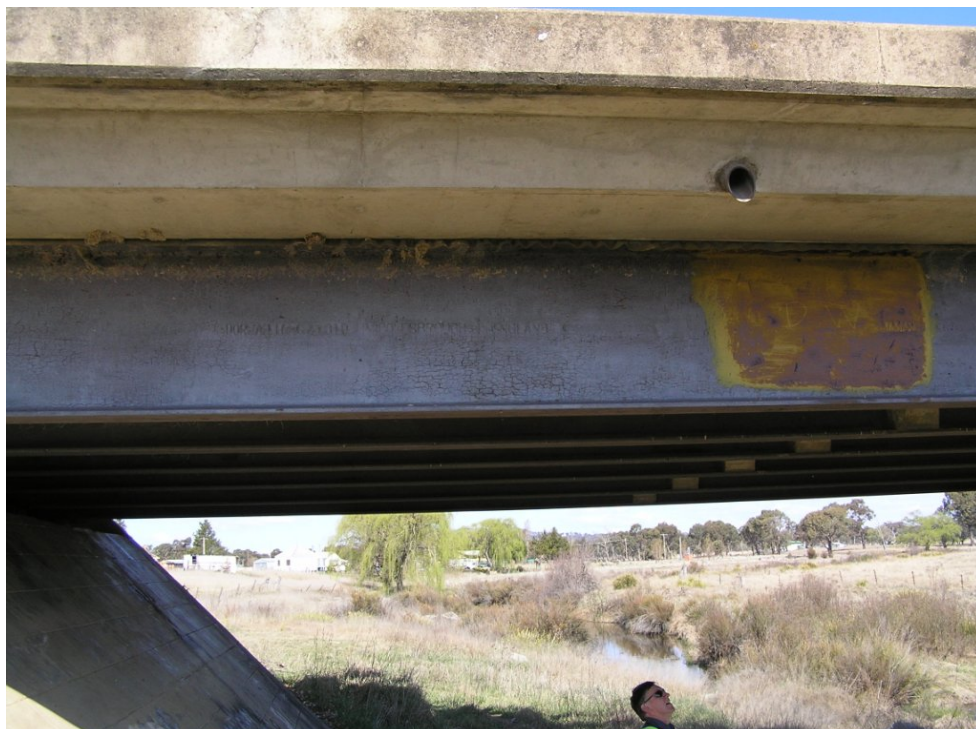
Failed patch of top coat.

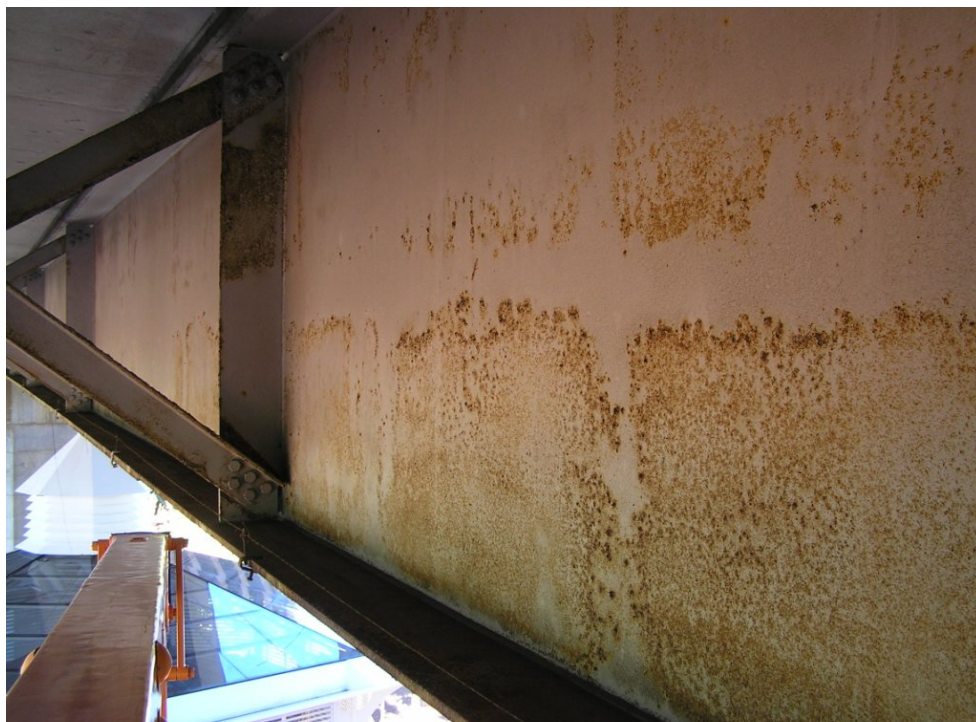
Primer and top coat breakdown over large areas.

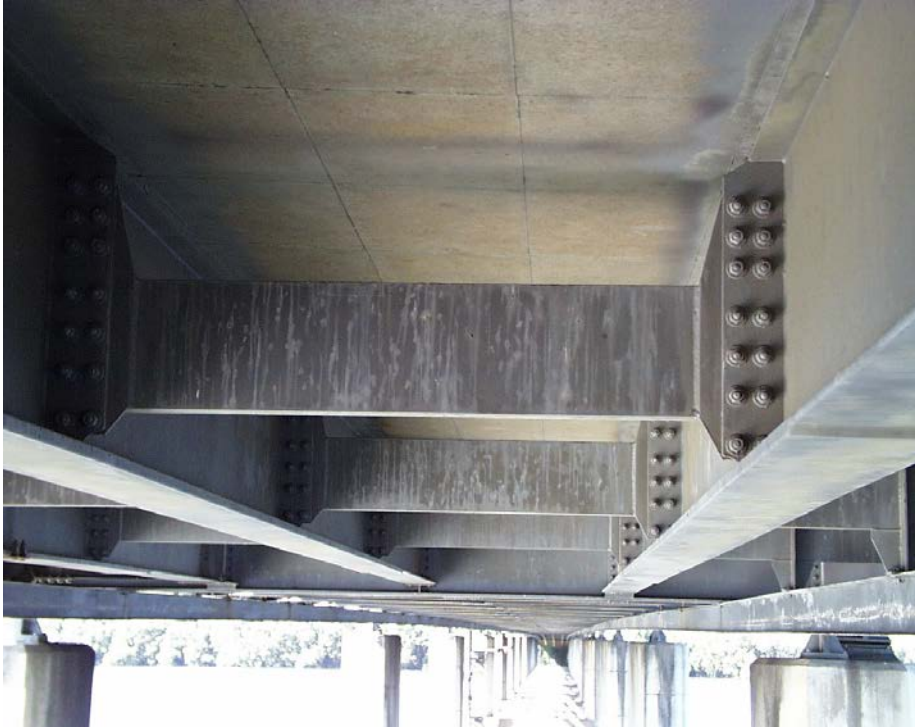
Zinc primer failure on all cross members.

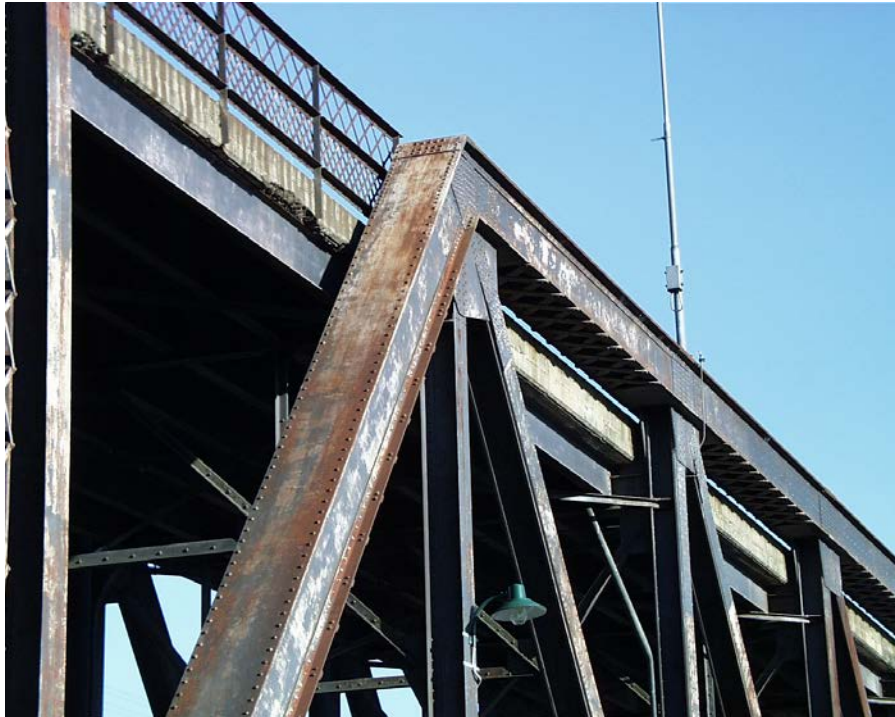
Breakdown of top coat with primer exposed over large areas.

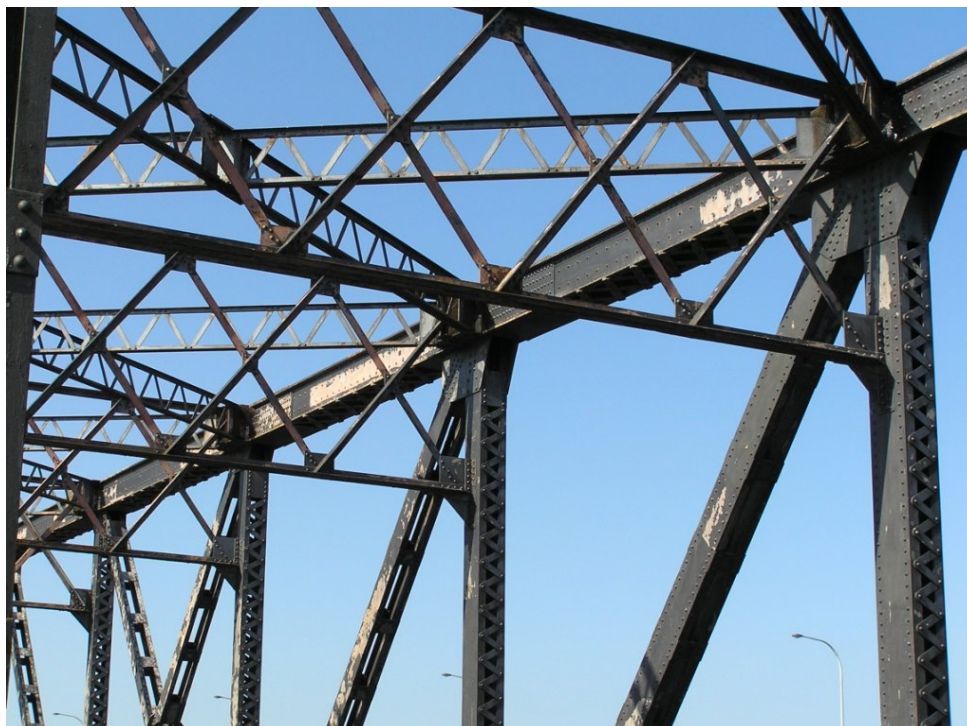
Breakdown of top coat with primer exposed over large areas.

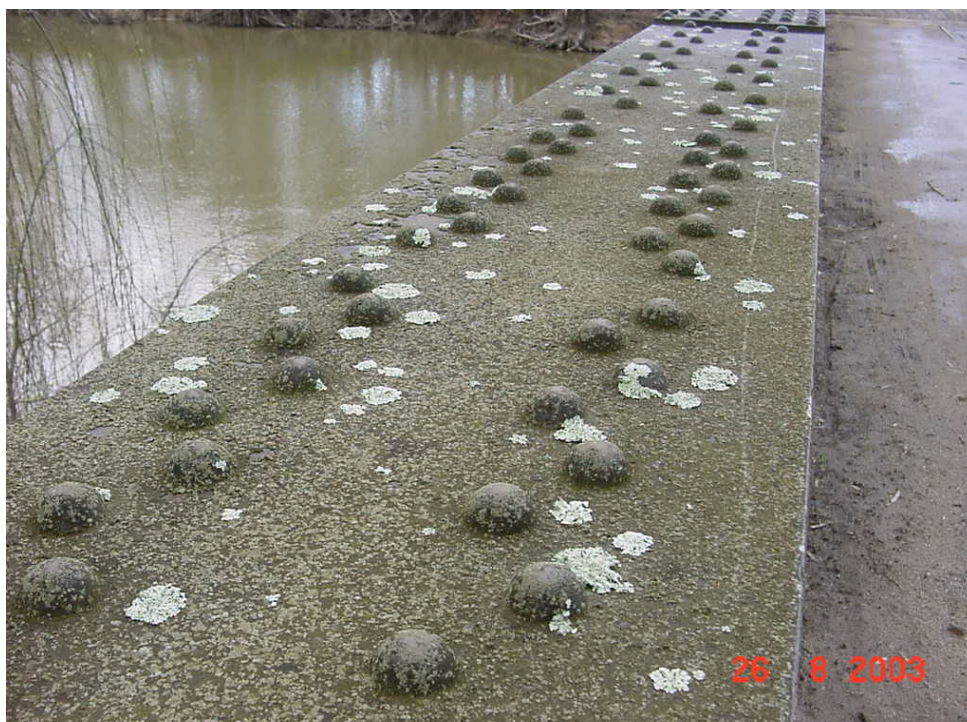
Deterioration of entire topcoat.

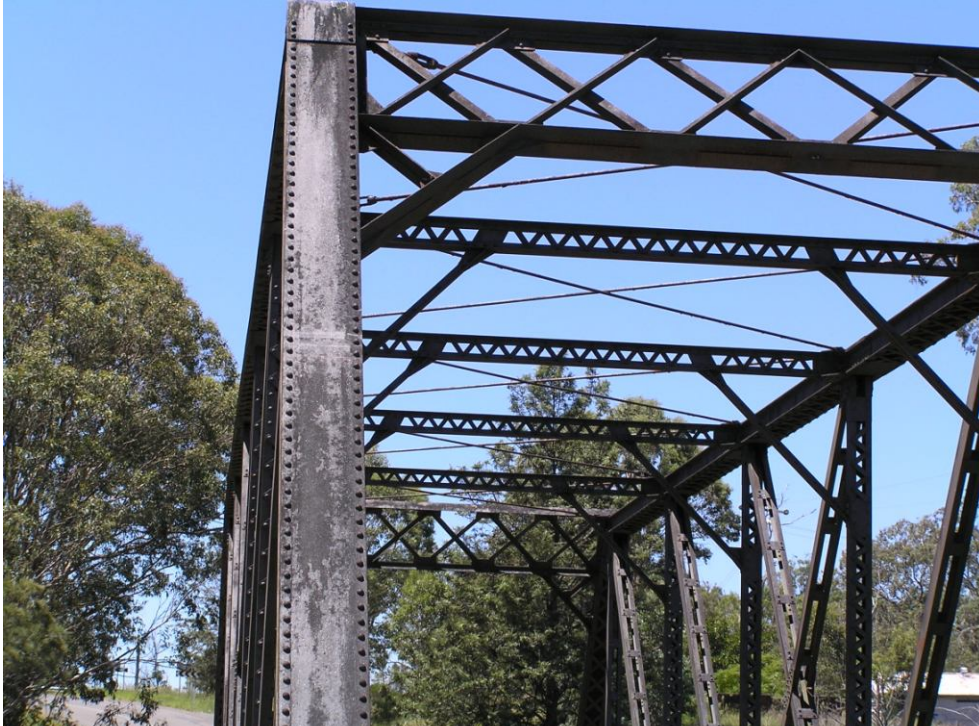
Large areas of topcoat deterioration with primer exposed.

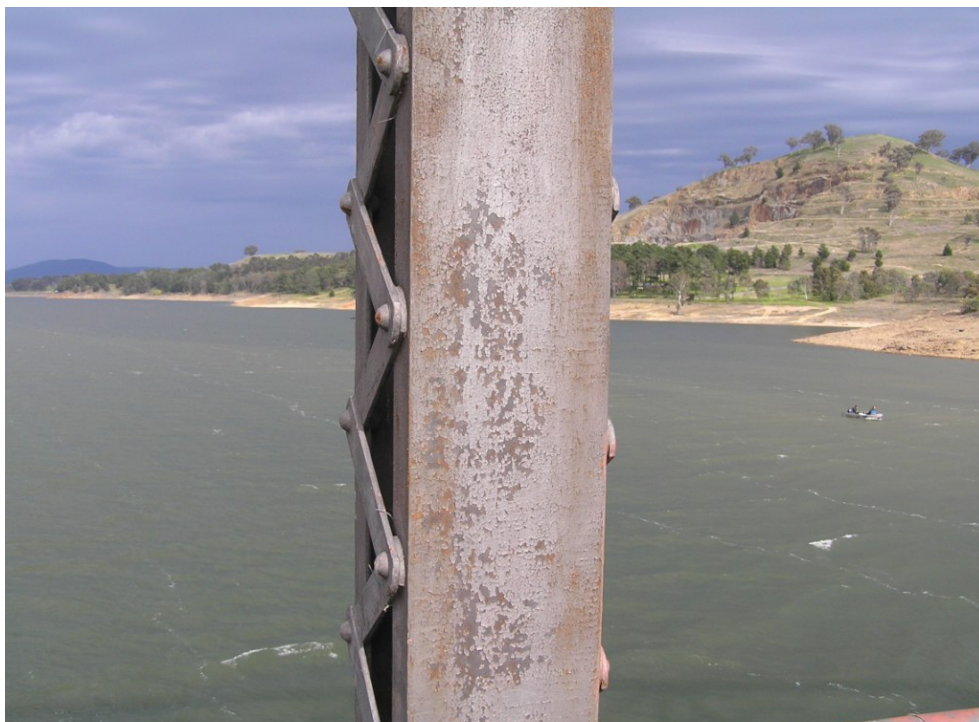
Large areas of topcoat deterioration with primer exposed.

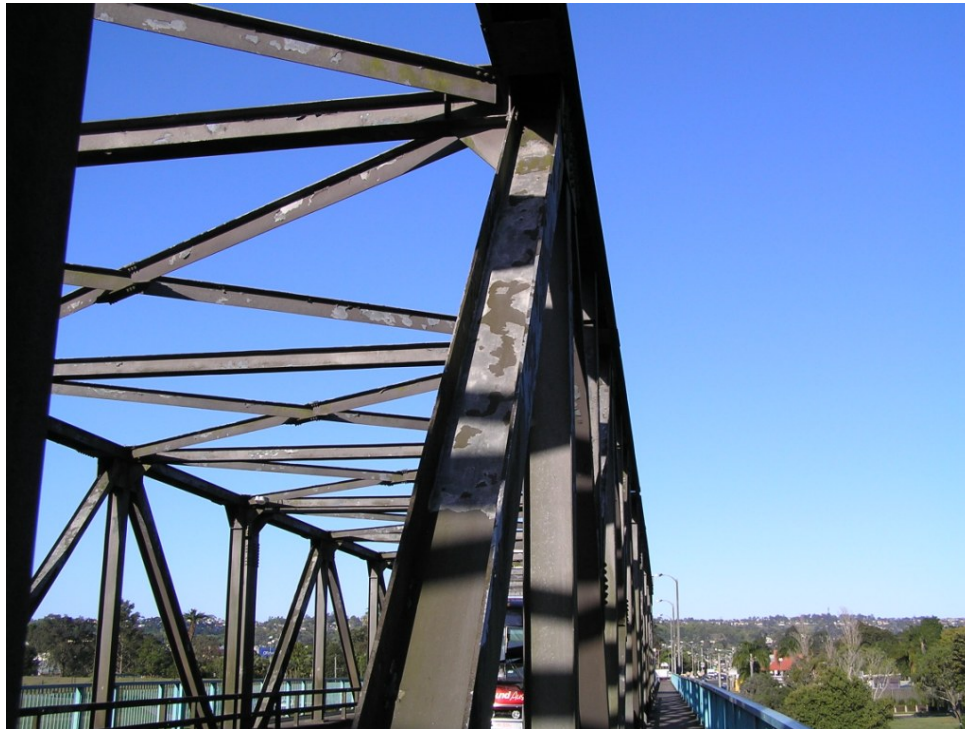
Large areas of topcoat deterioration with primer exposed.

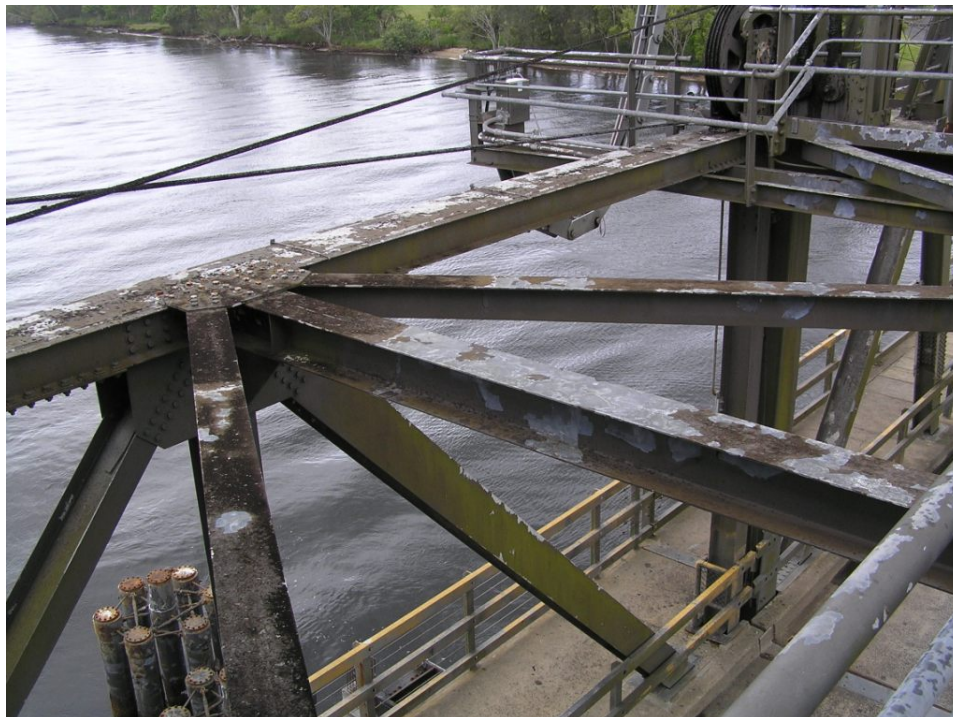
Large areas of topcoat deterioration with primer exposed.

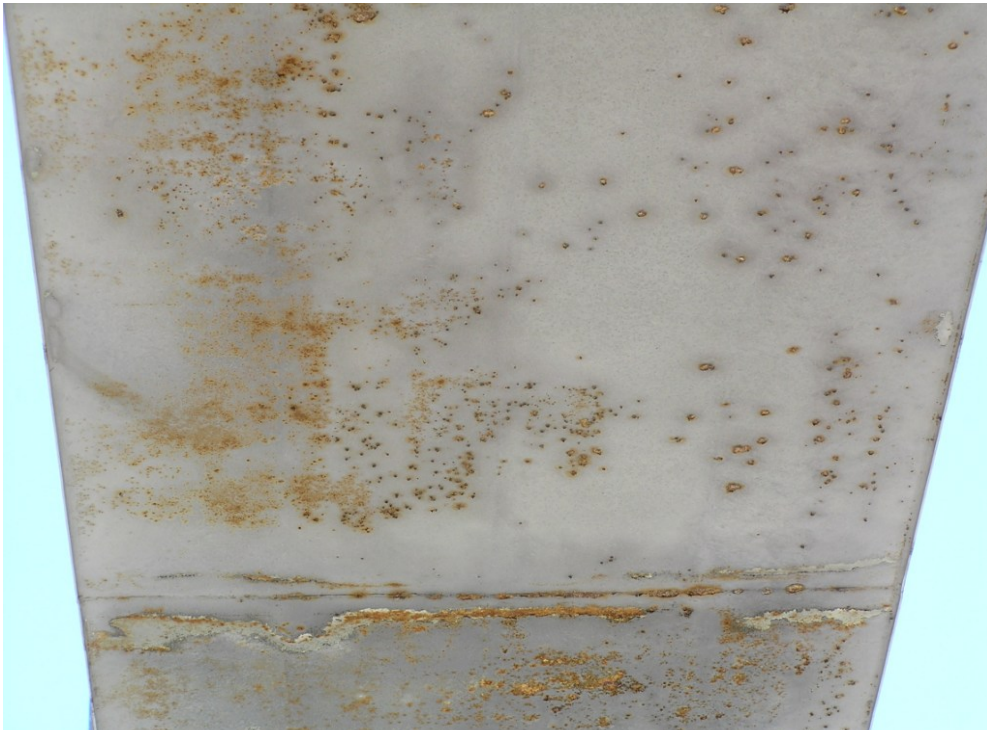
Extensive speckled red rust, coating no longer protecting steel.

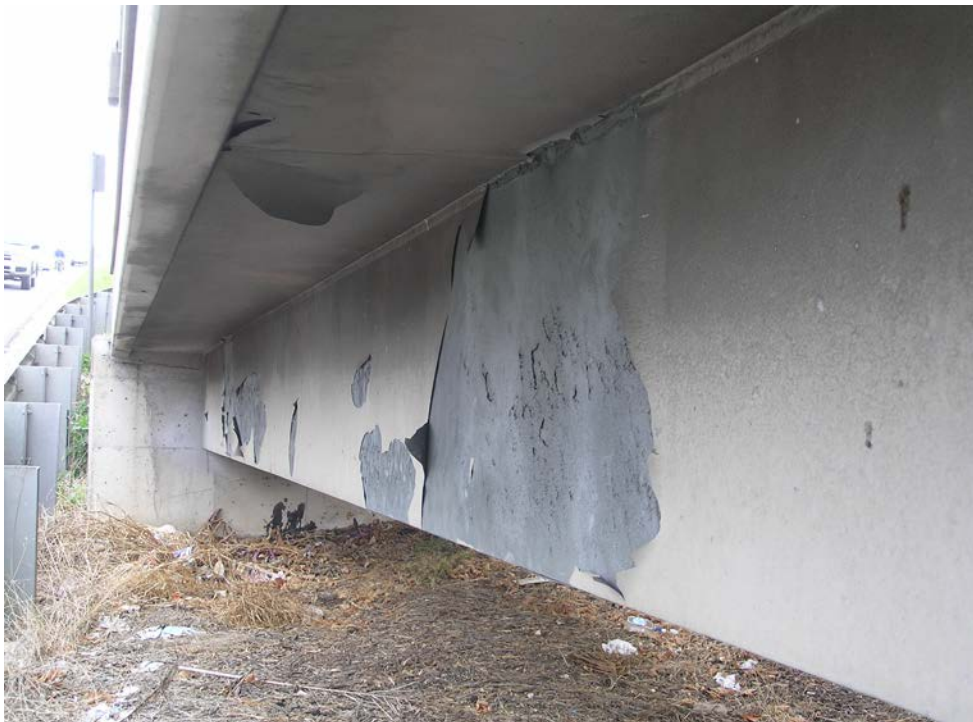
Large areas of delaminated coating. No longer providing effective protection.

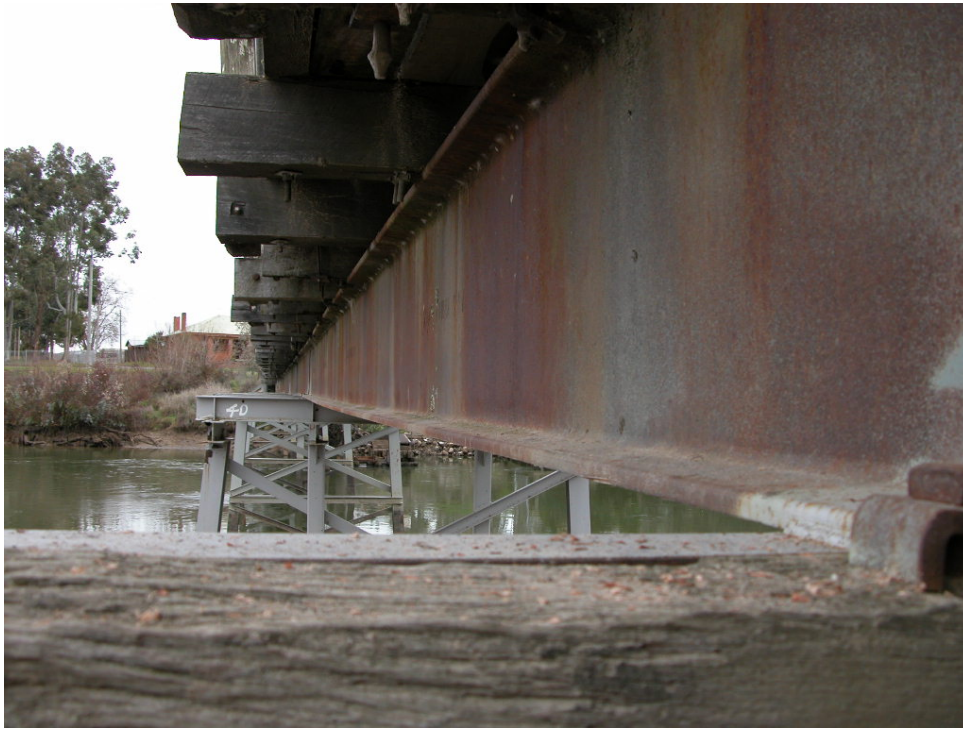
Coating no longer present.

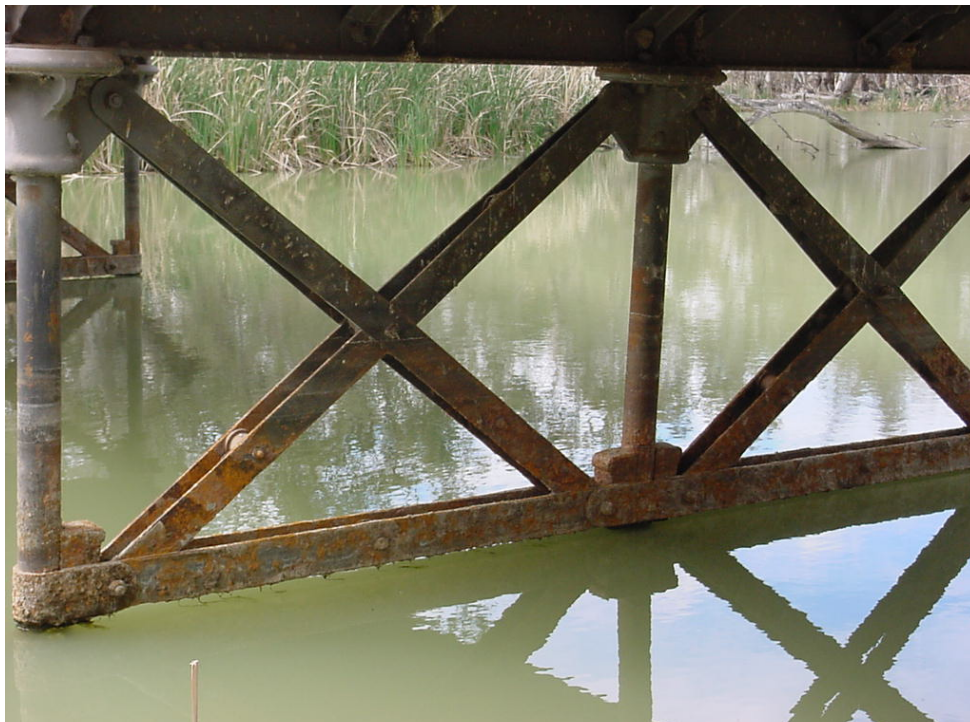
Failed coating and significant corrosion of pier bracing.
