Transport  
**Roads & Maritime  
Services**

# **BRIDGE INSPECTION PROCEDURE MANUAL**

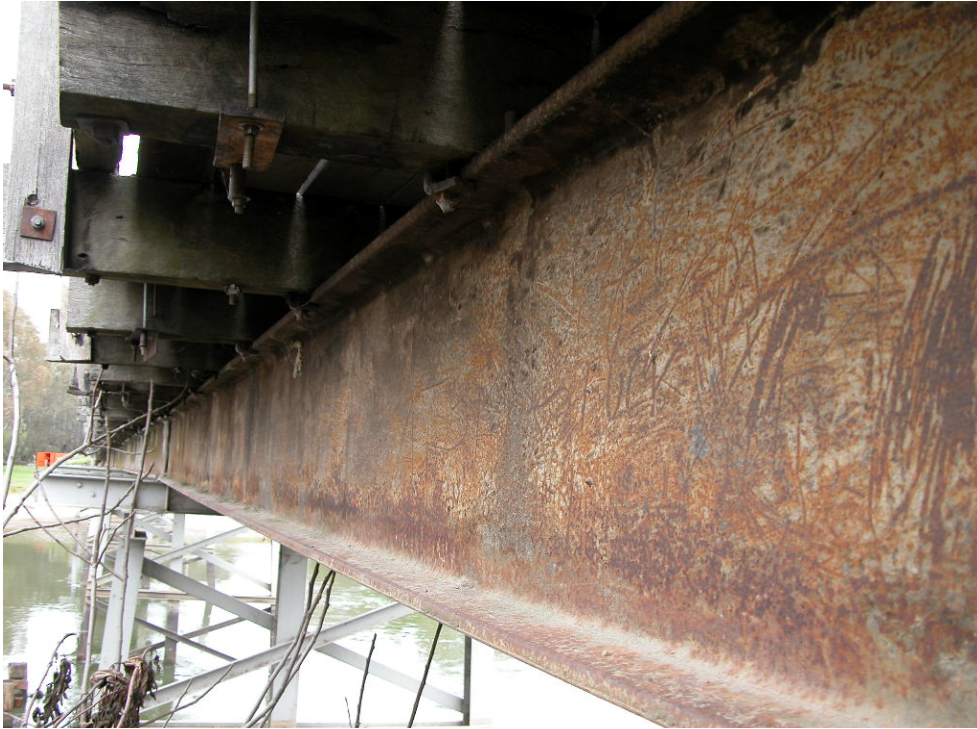
Coating no longer present.

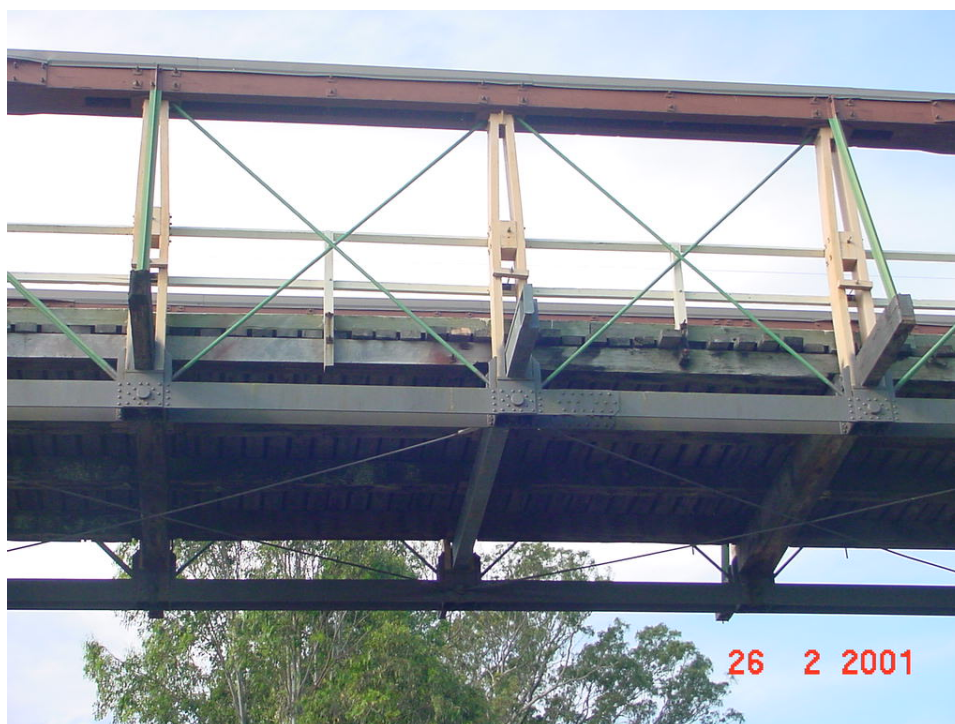
Timber truss in good condition.

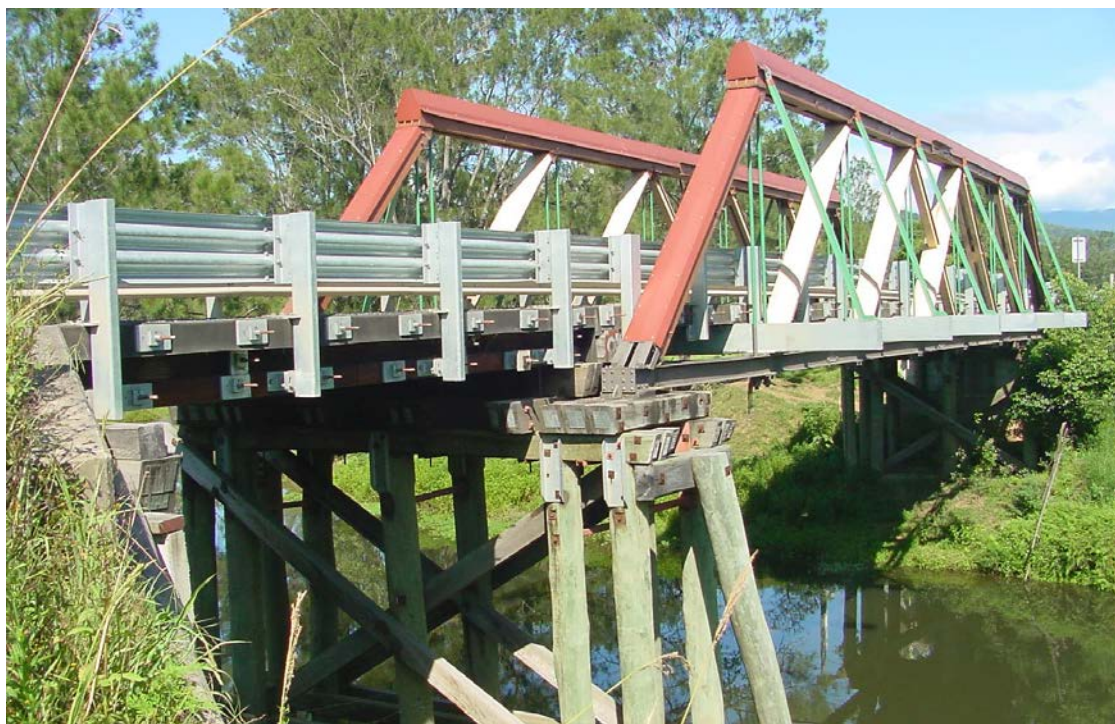
Timber truss in good condition.

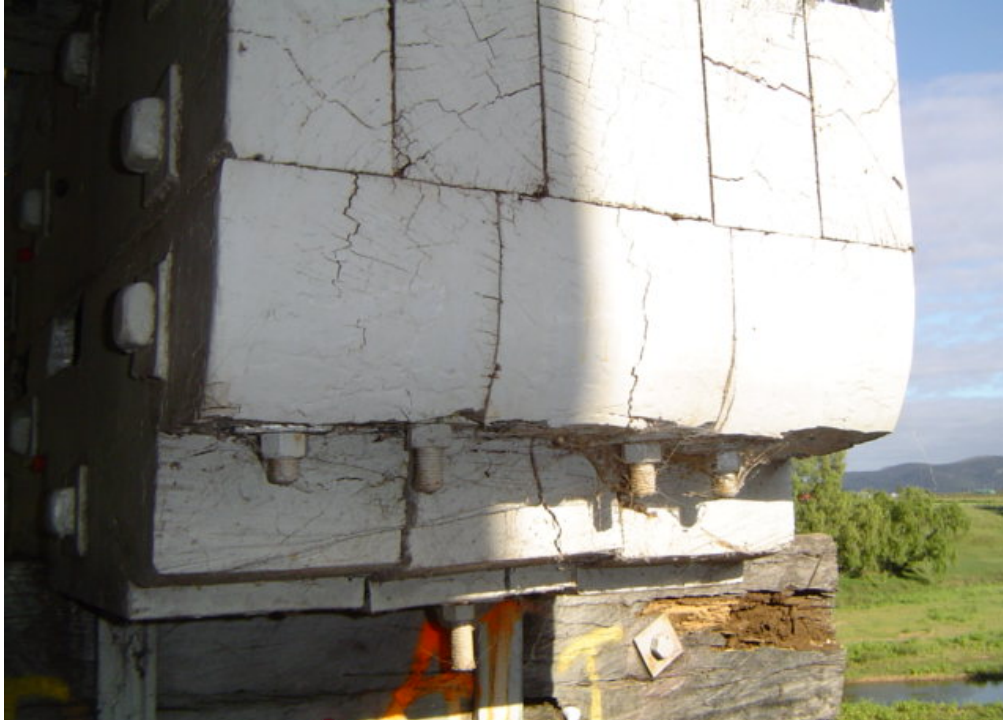
Minor splits on the members of the butting block.

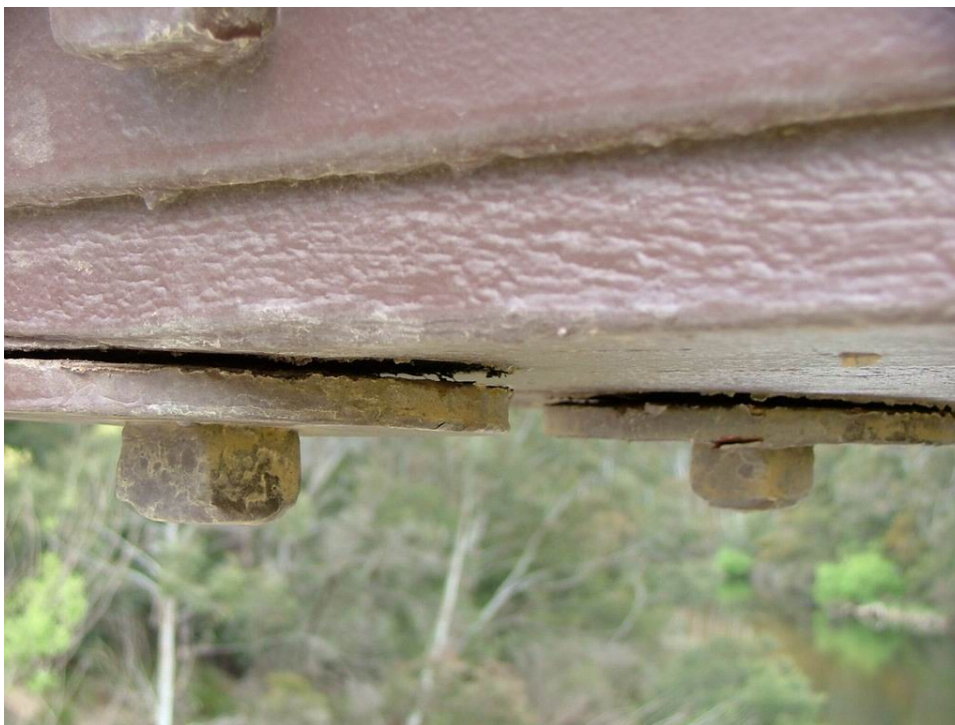
Slightly loose vertical splice bolts at top chord.

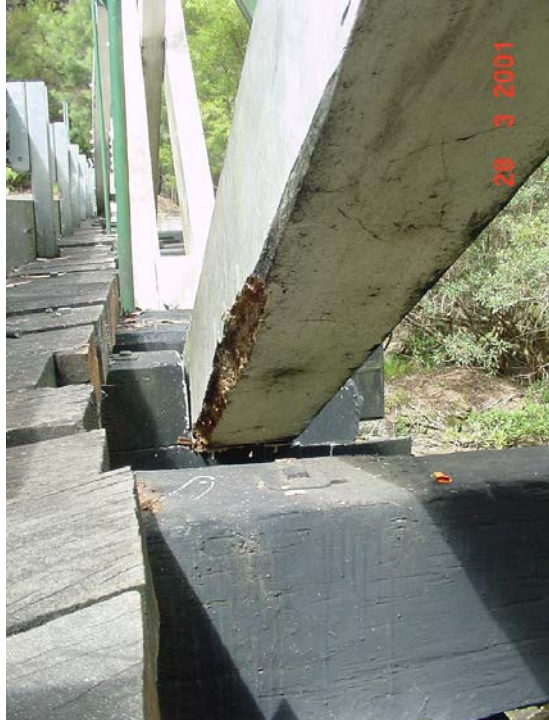
Minor decay on a strut.

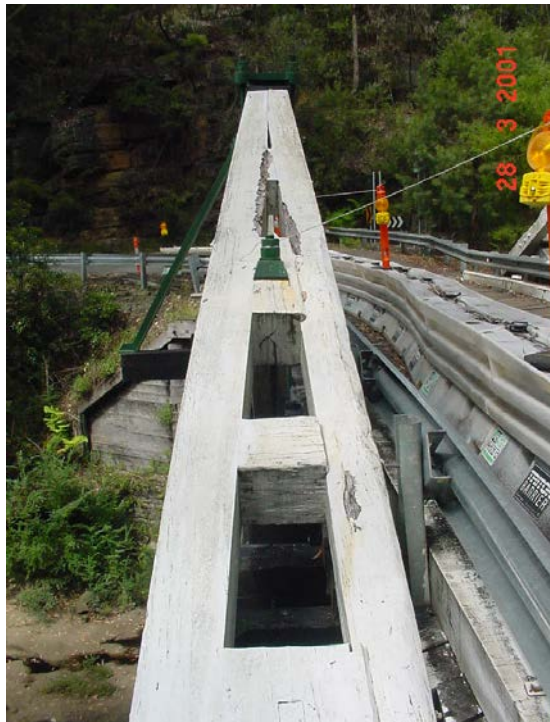
Minor rot on a principal.

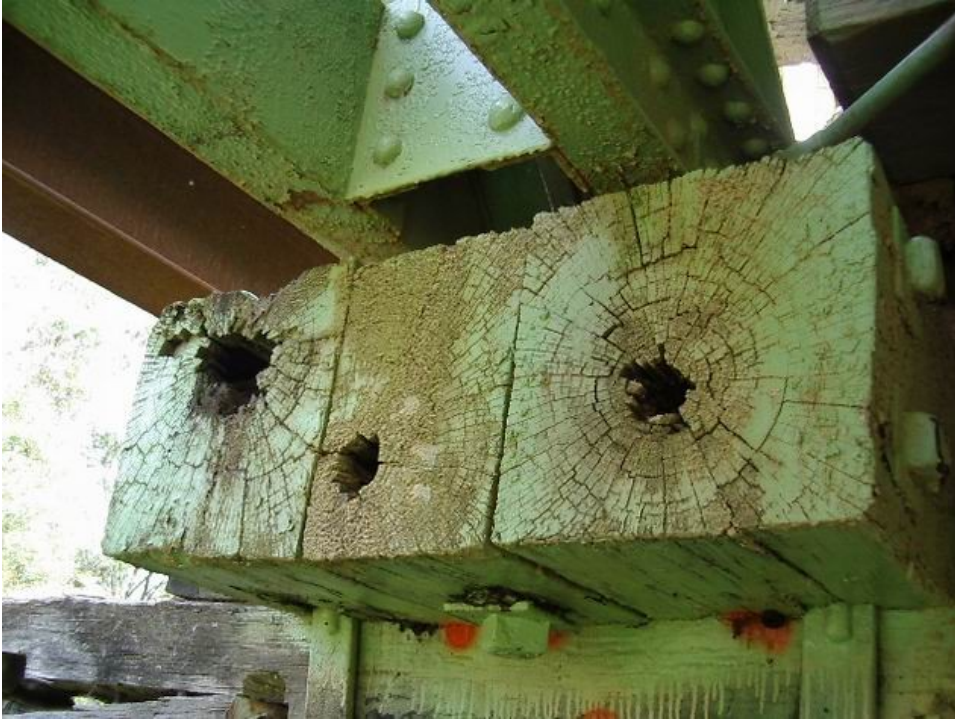
Significant piping in one of the members of the butting block.

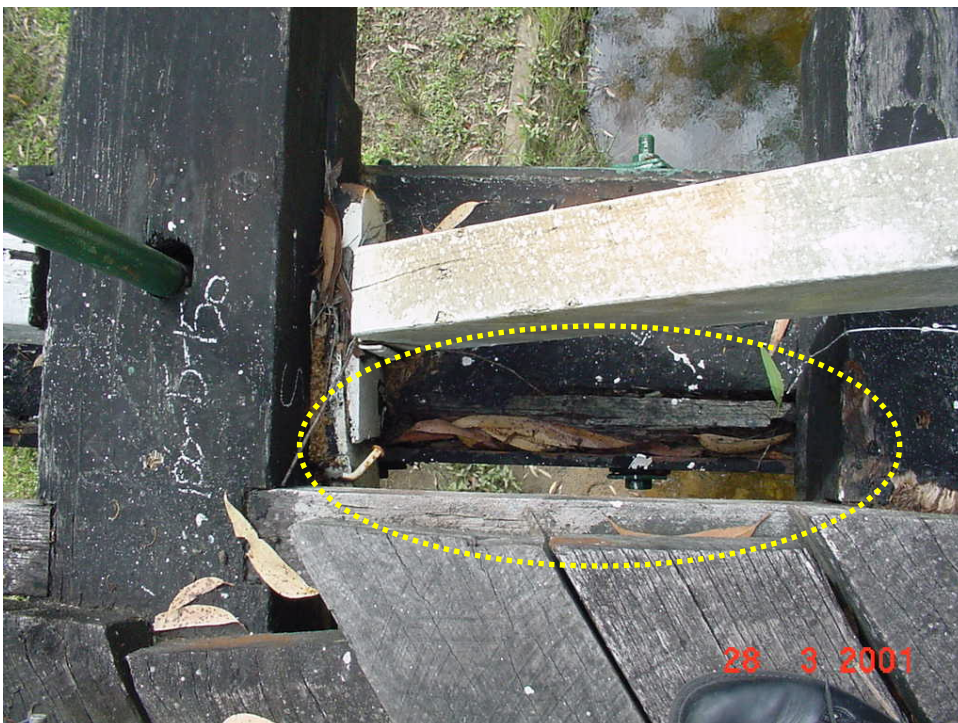
Medium decay of the bottom chord.

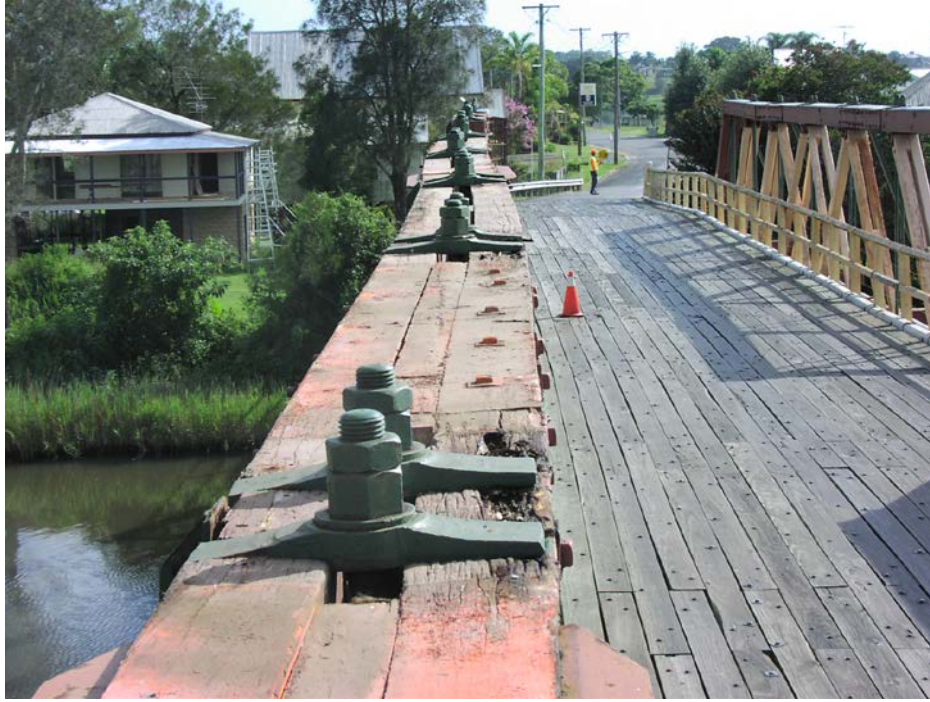
Significant out of alignment of the top chord with major decay.

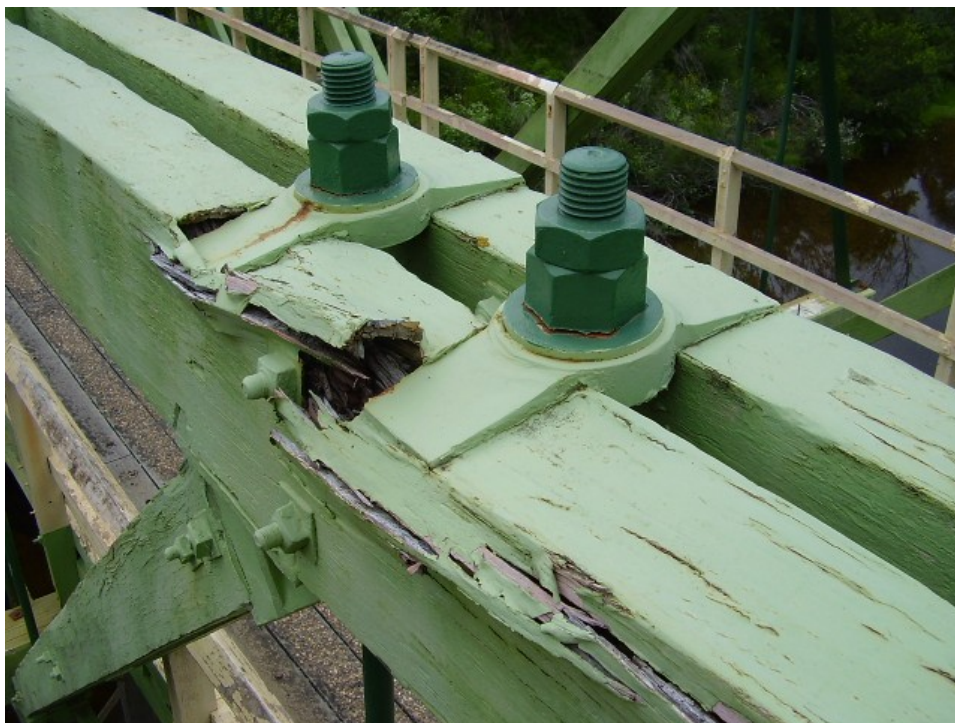
Badly rotten top chord crushing near the support of steel verticals.

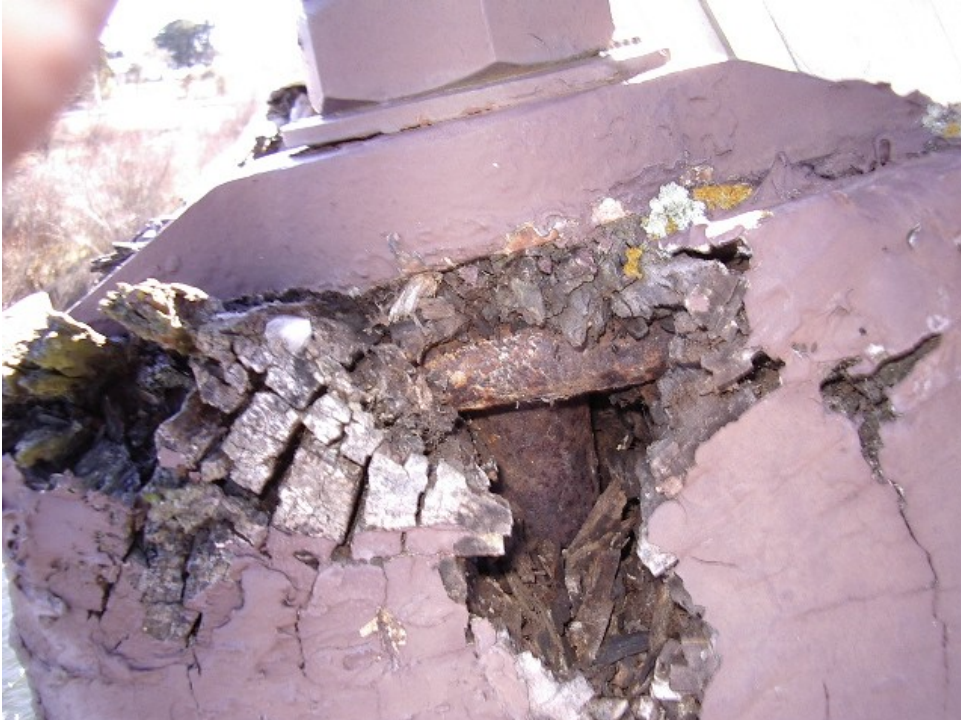
Major rot on end of top chord with crushing of timber and tilting of tension rod bearings.

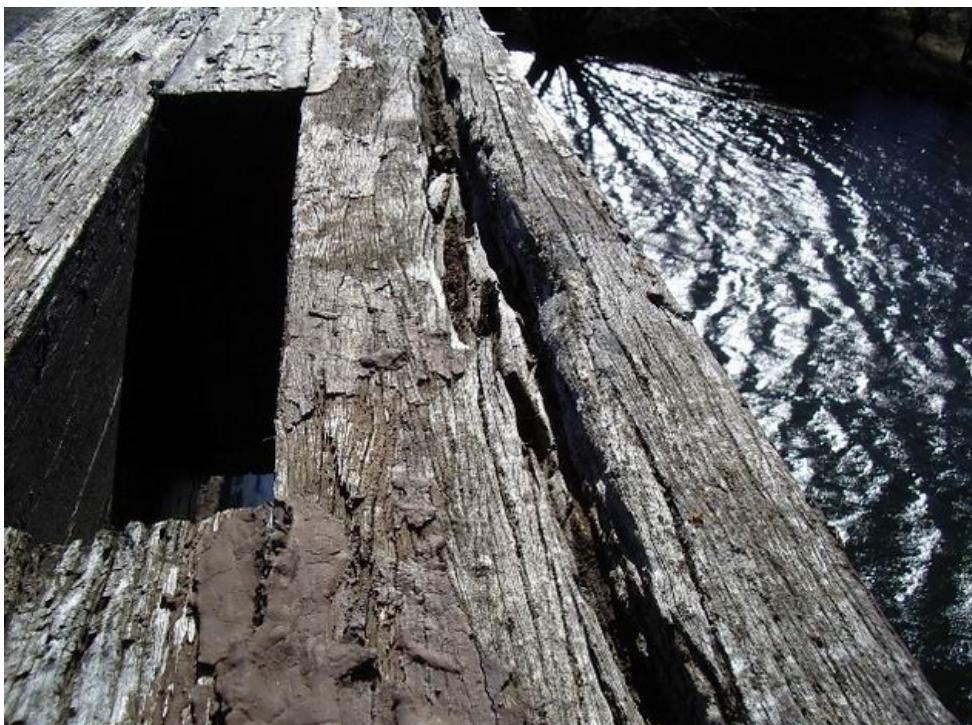
Badly split and rotting top chord.

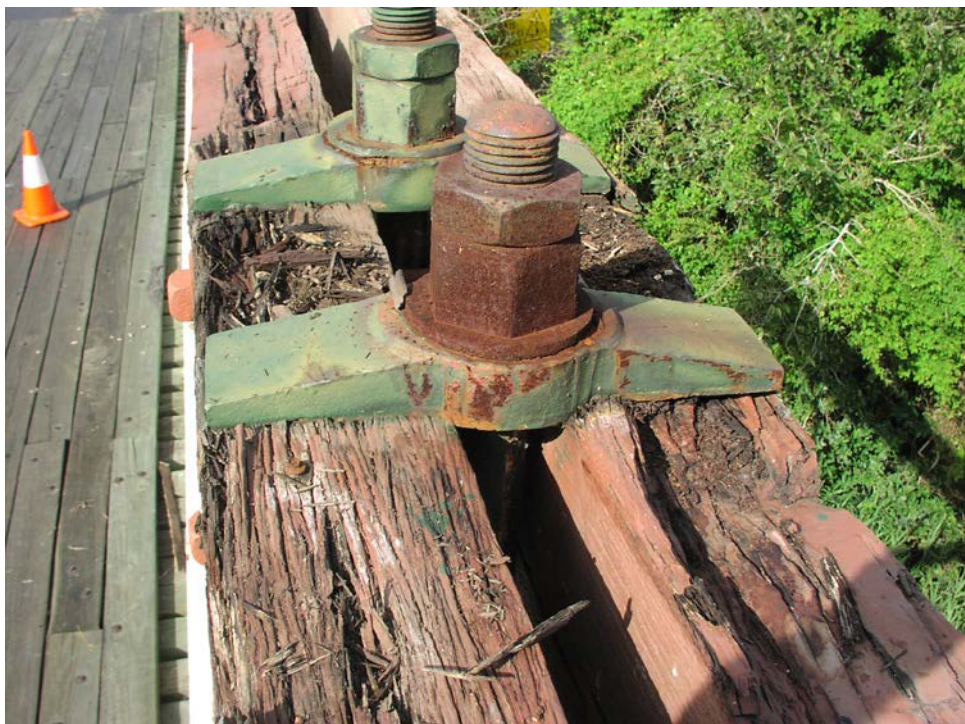
Heavy decay of the top chord.

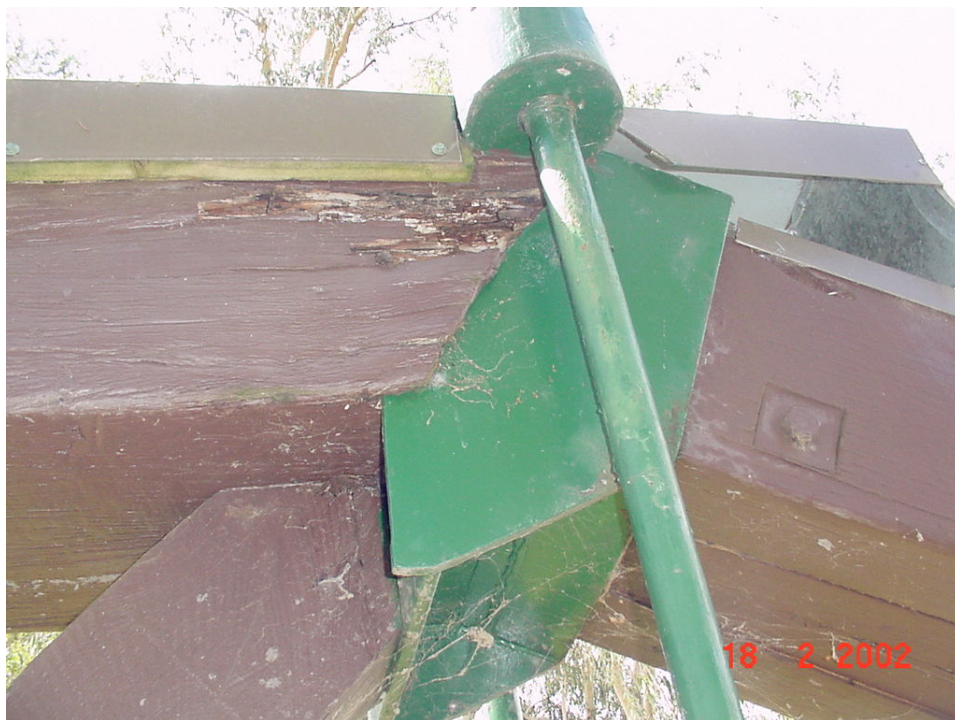
Significant crushing of the top chord.

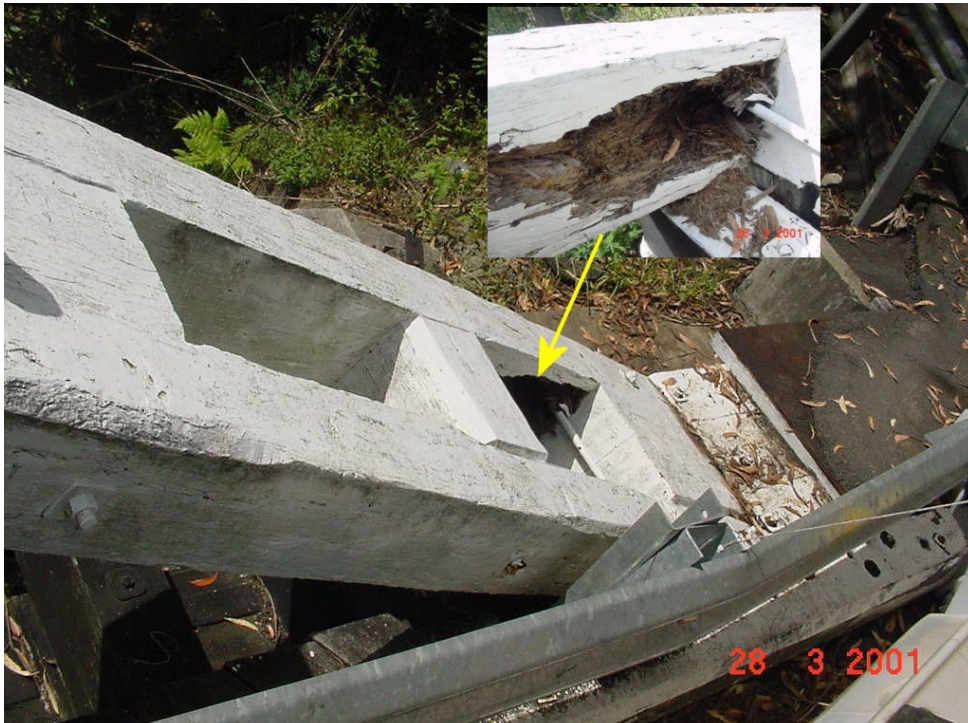
Major rot near the bottom of the principal.

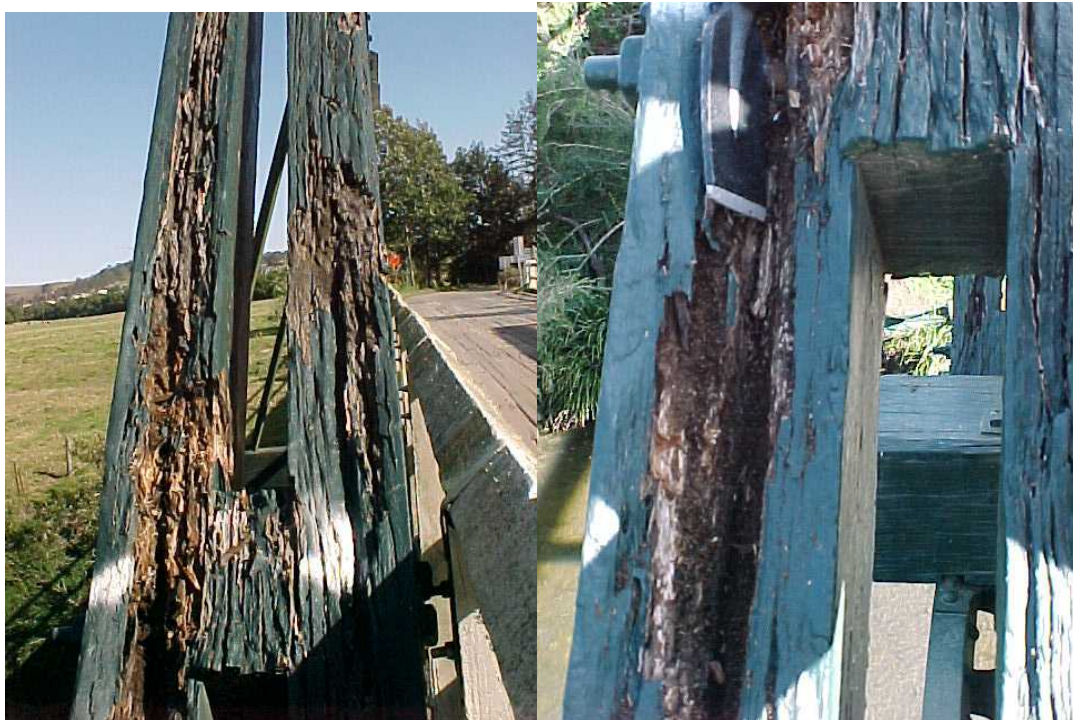
Advanced decay of principals

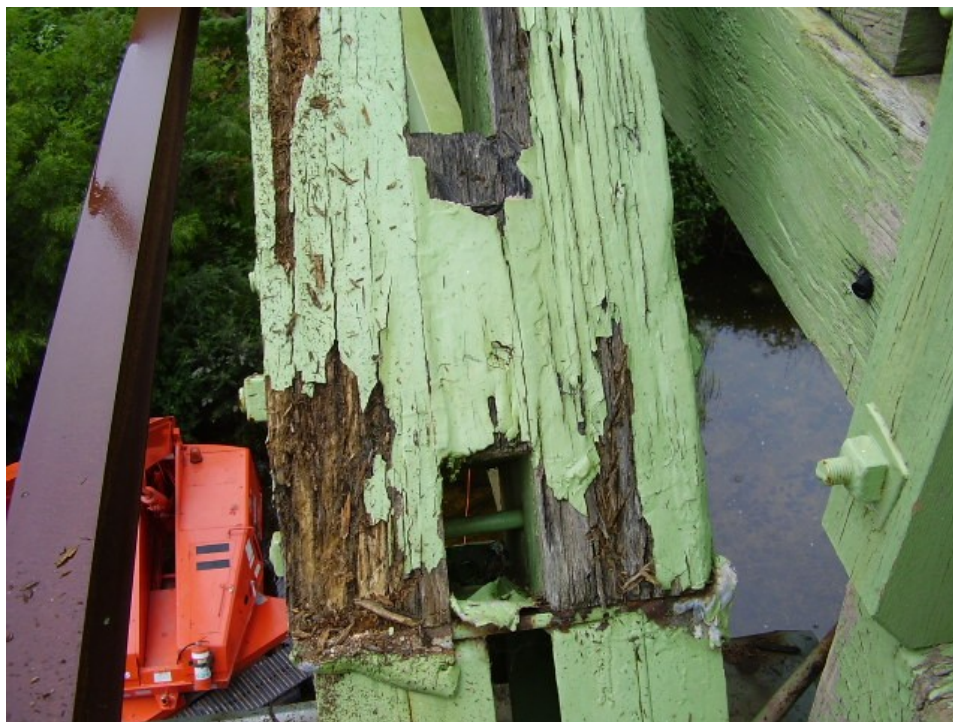
Rot on the principal

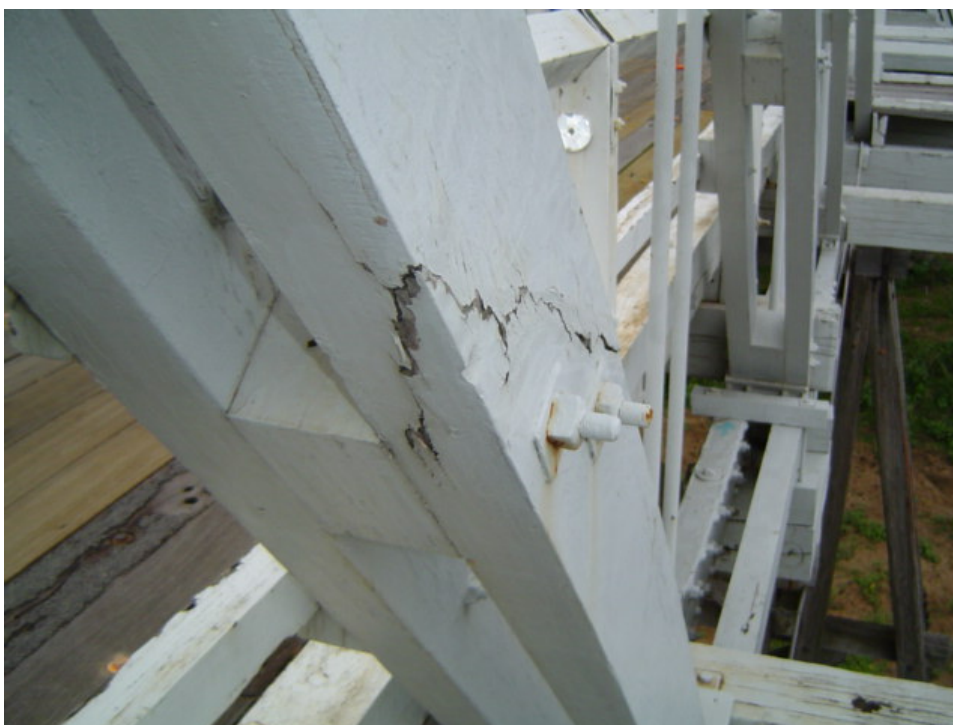
Failed diagonal strut flitch.

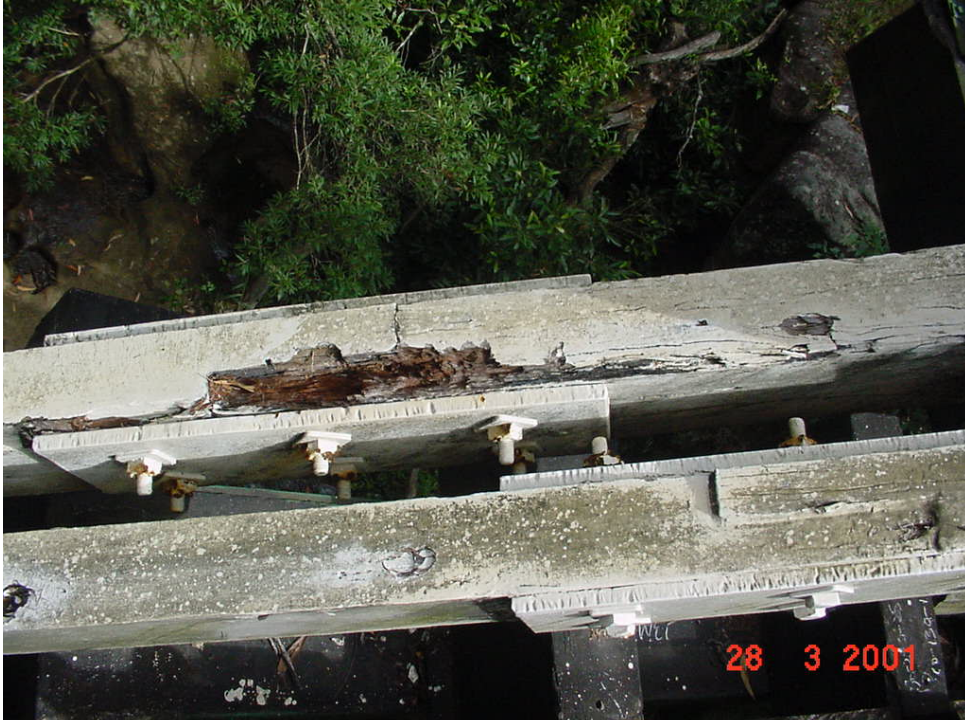
Rotting at the bottom chord flitch at the splice.

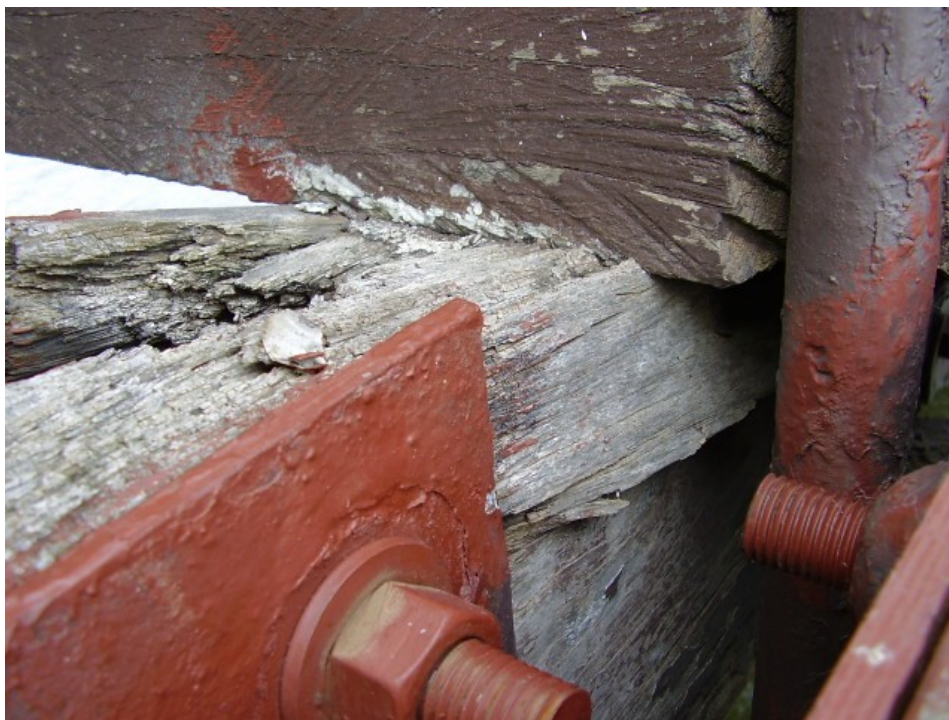
Bottom chord crushing and splitting.

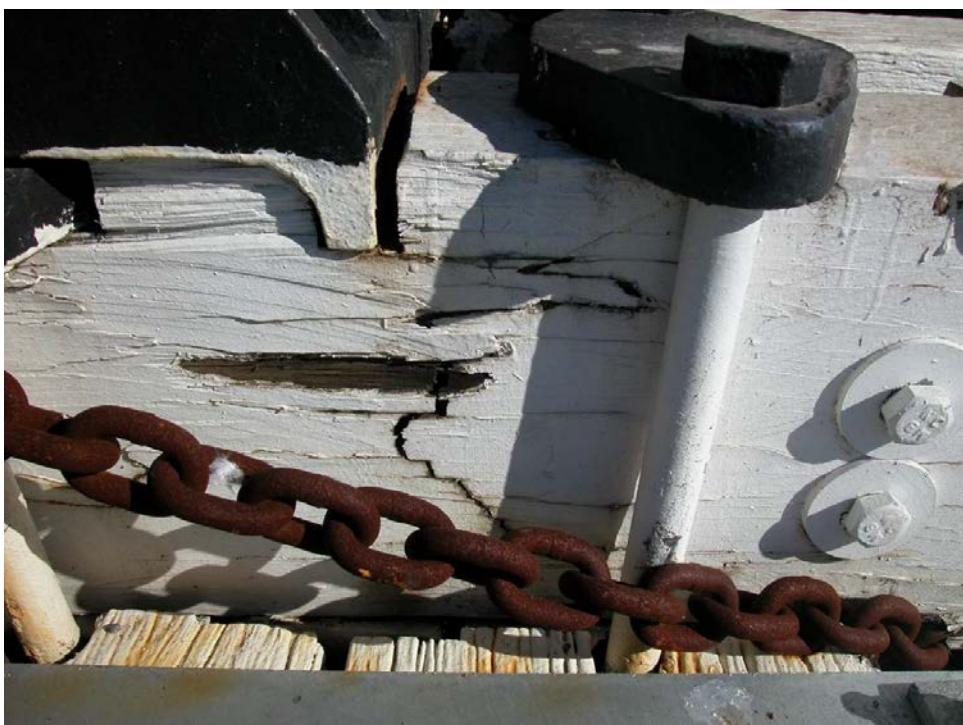
Failure of a timber bottom chord in tension.

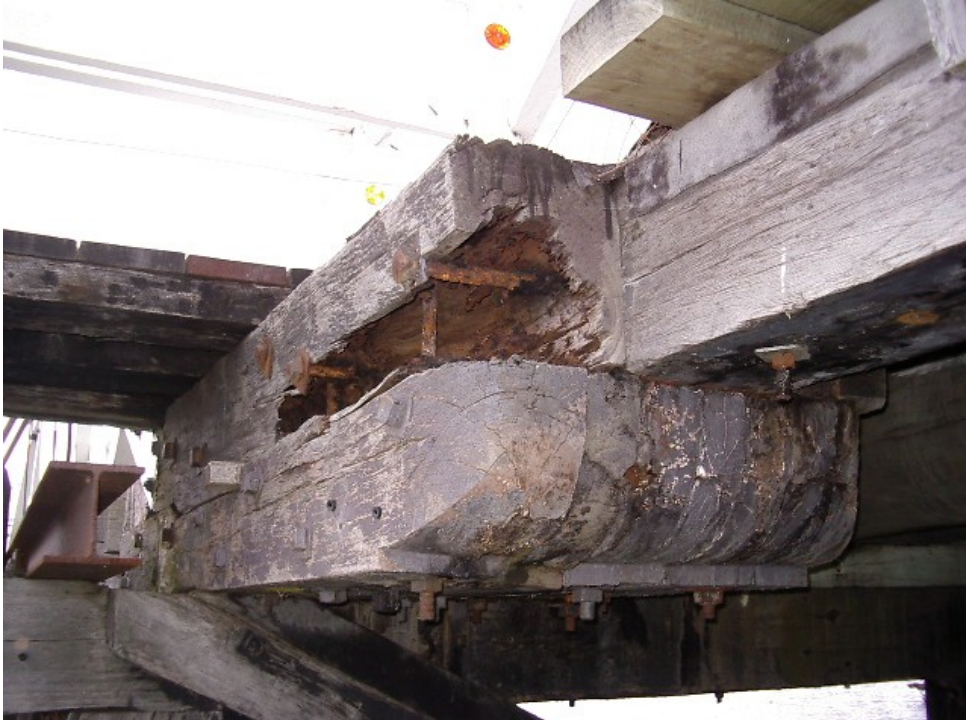
Badly rotten butting block.

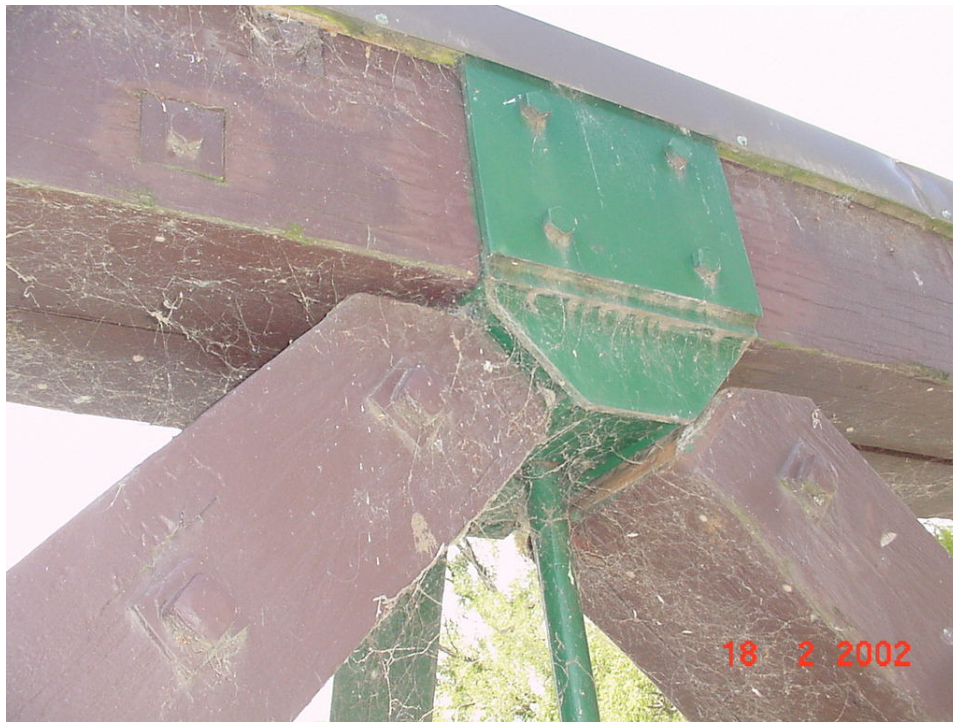
Timber strut in good condition has partially slipped off the joint. The movement is significant to affect the serviceability of truss.

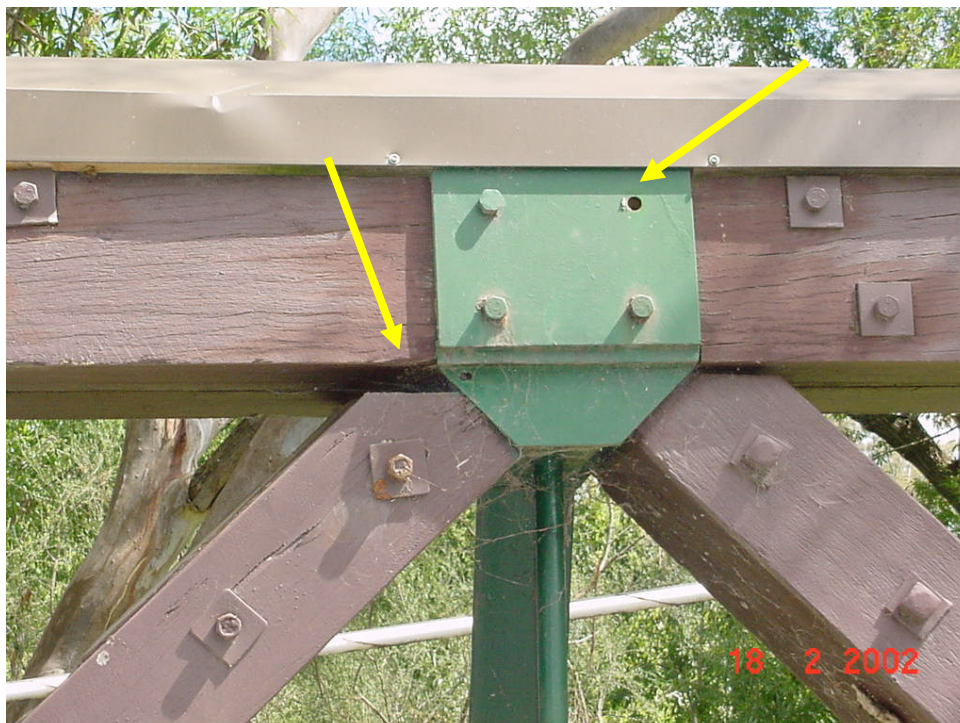
Unsound connection with slipping strut member and missing bolt.

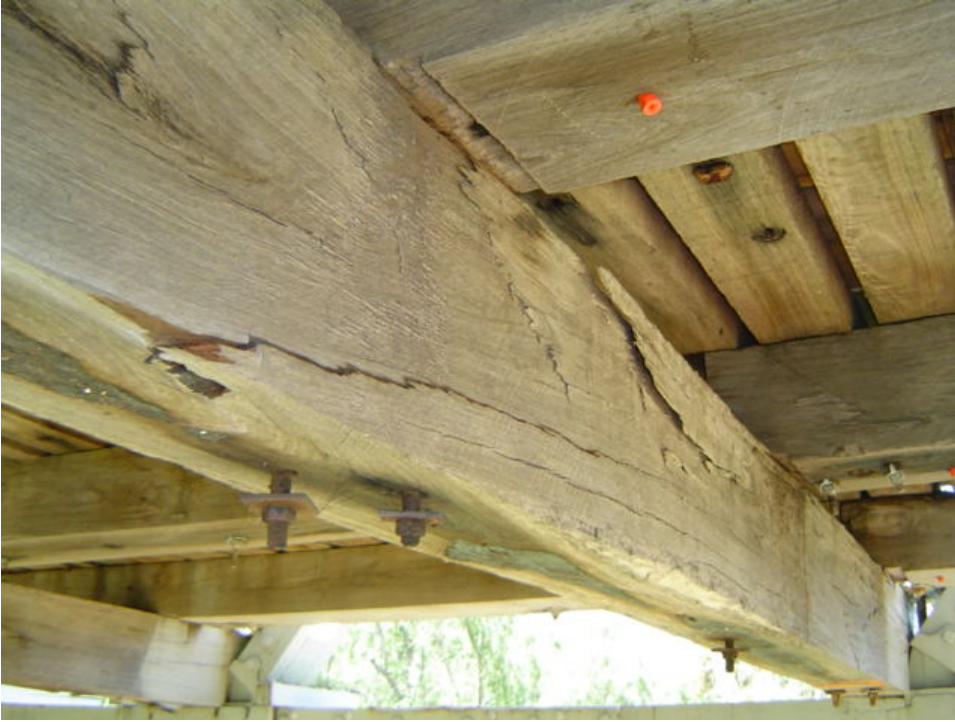
Badly split and cracked cross girder.

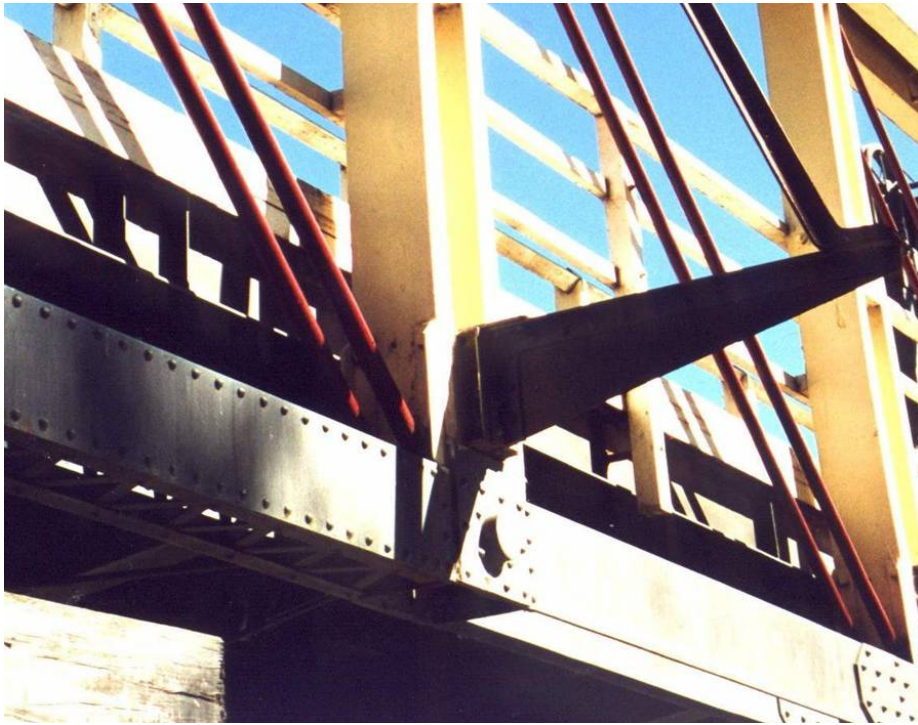
Bottom chord in good condition.

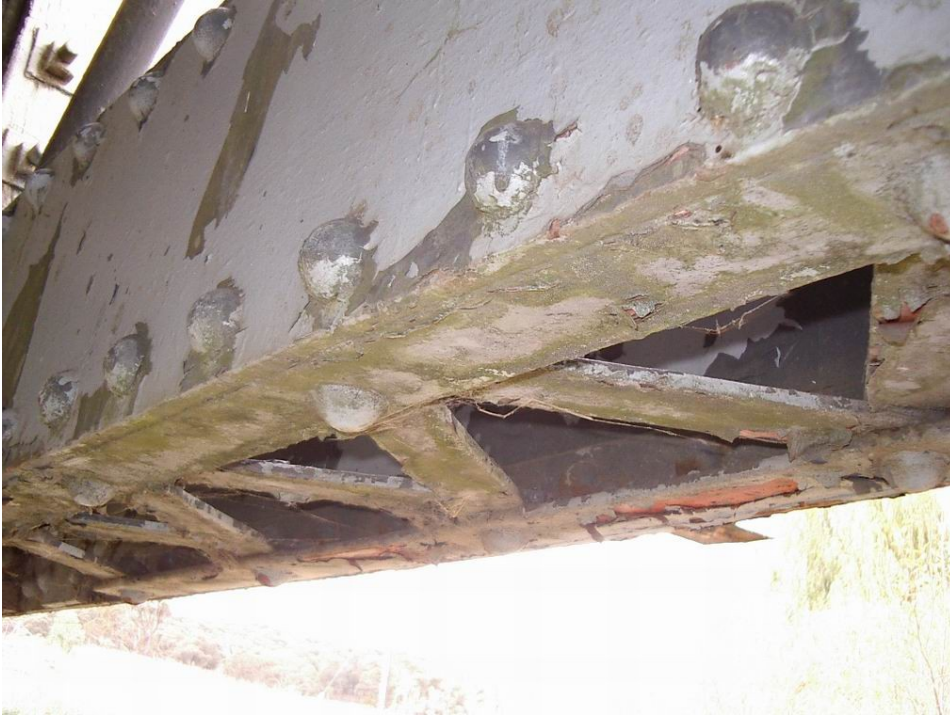
Surface rust and minor pitting at the bottom.

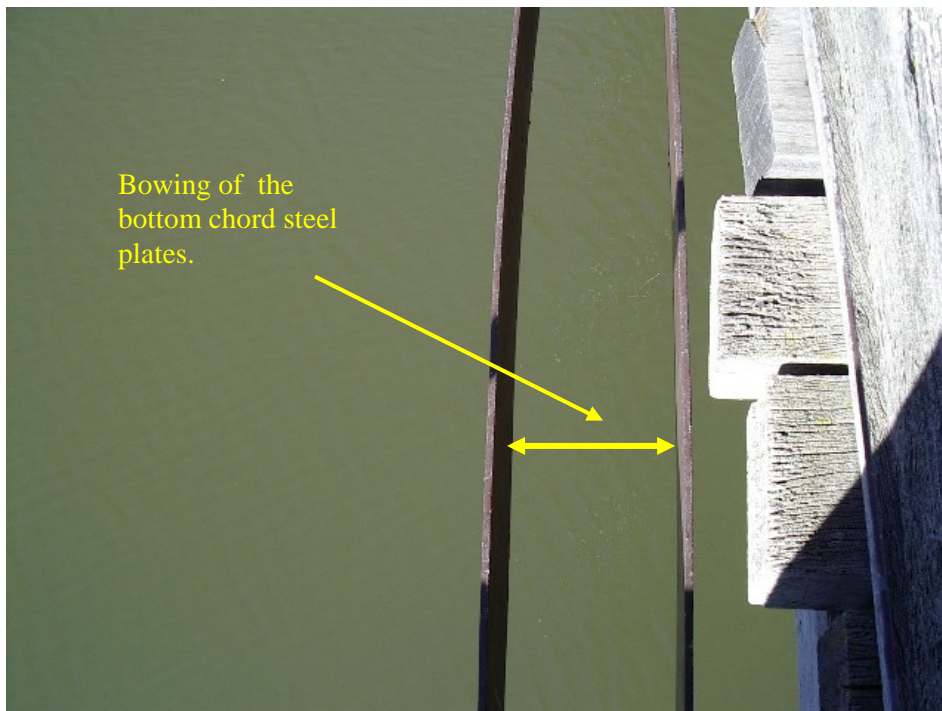
Bowing of the steel bottom chord in tension.

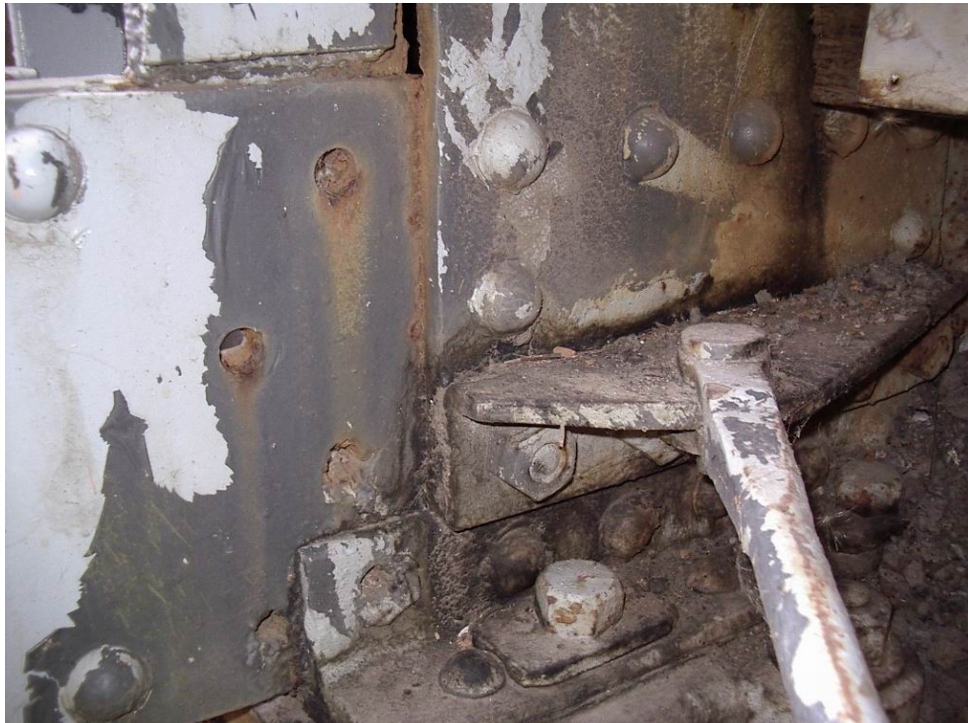
Number of rivet heads missing

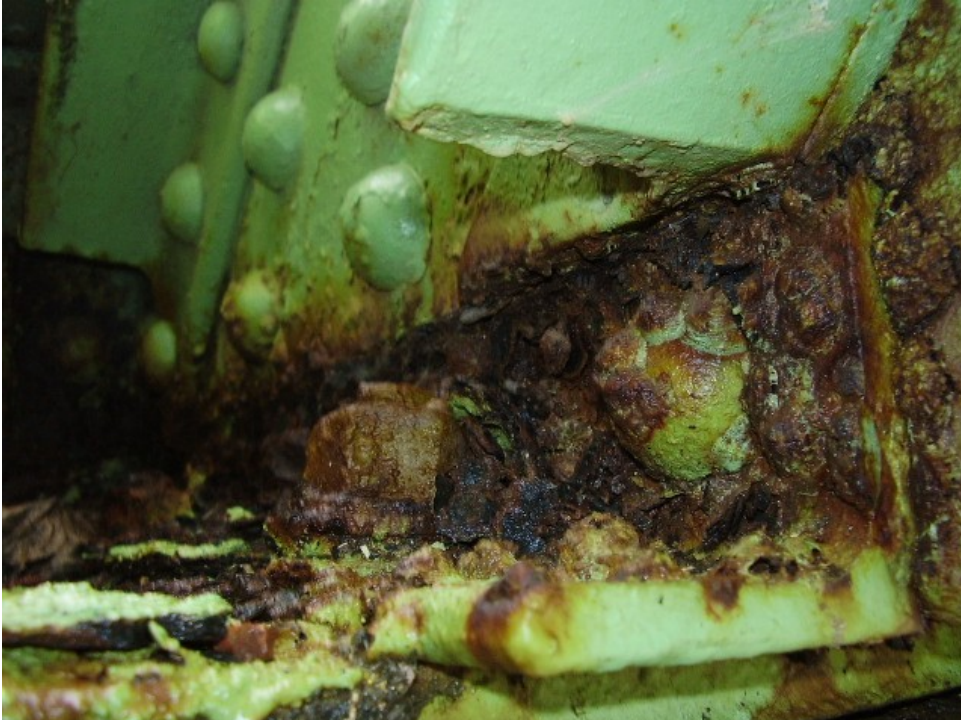
Significant section loss may be present. There may be cracks and/or deformations in the steel or welds. There may be numerous failed connectors.

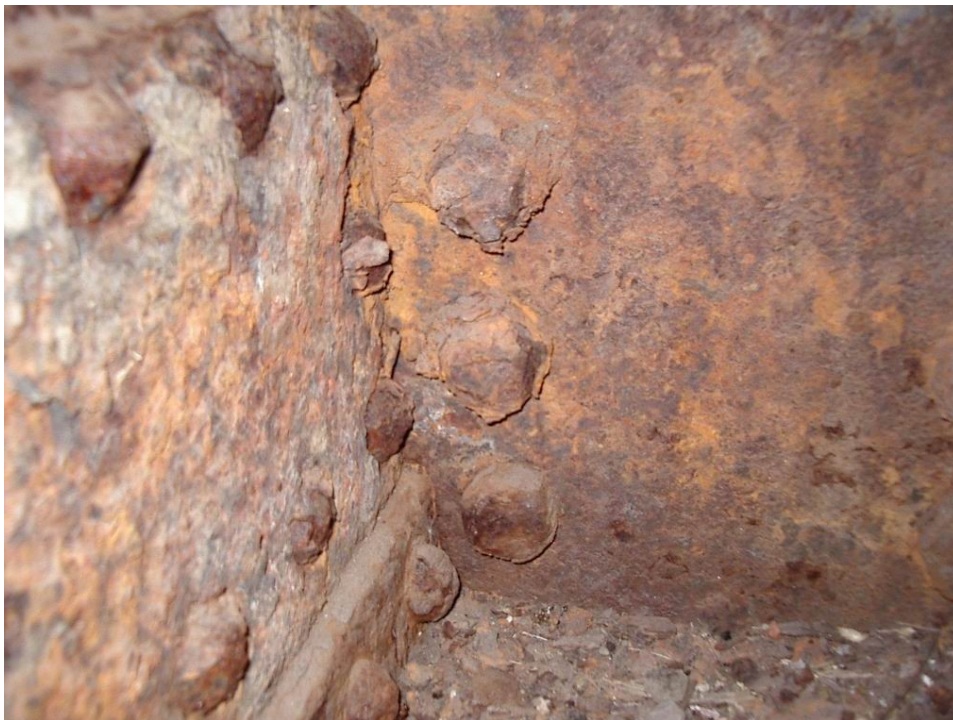
Heavy pitting and the bolt heads corroding away.

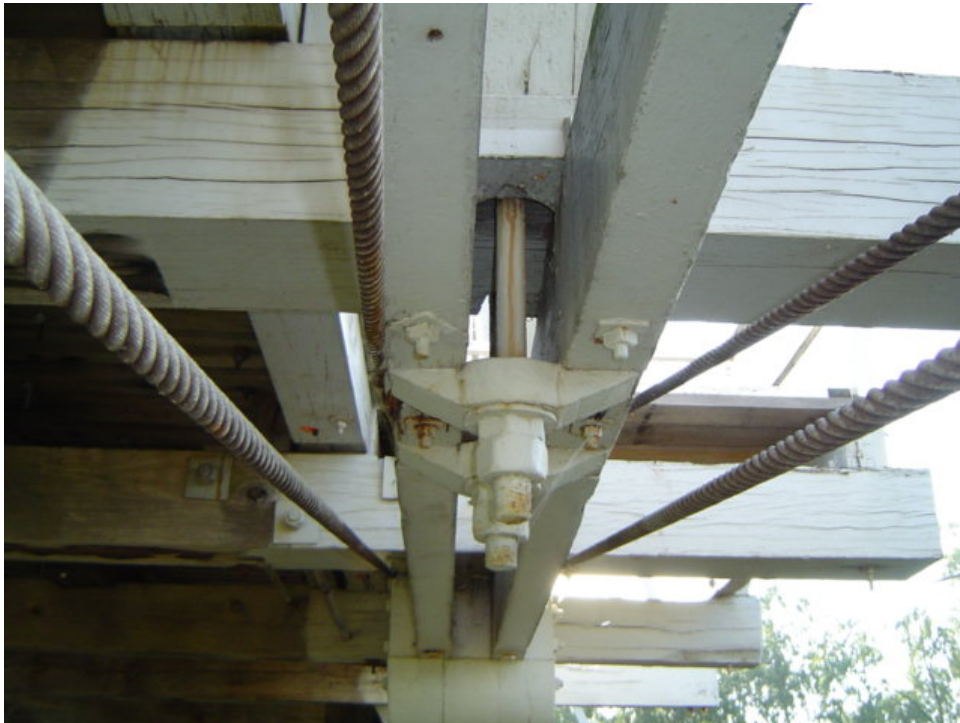
Tie rods in good condition.
