Transport  
**Roads & Maritime  
Services**

# **BRIDGE INSPECTION PROCEDURE MANUAL**

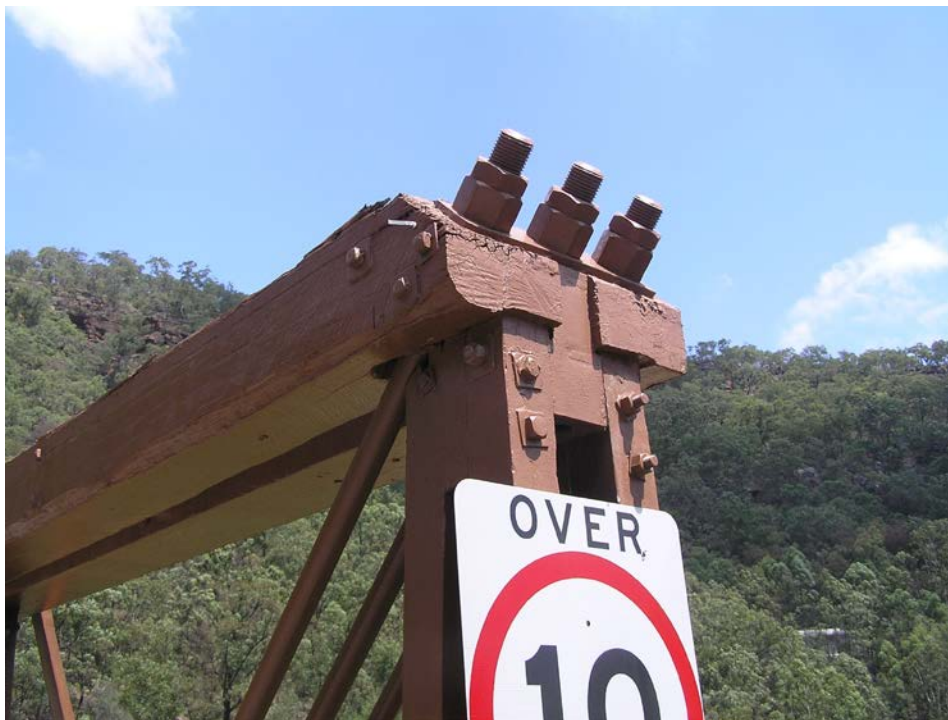
Tie rods in good condition.

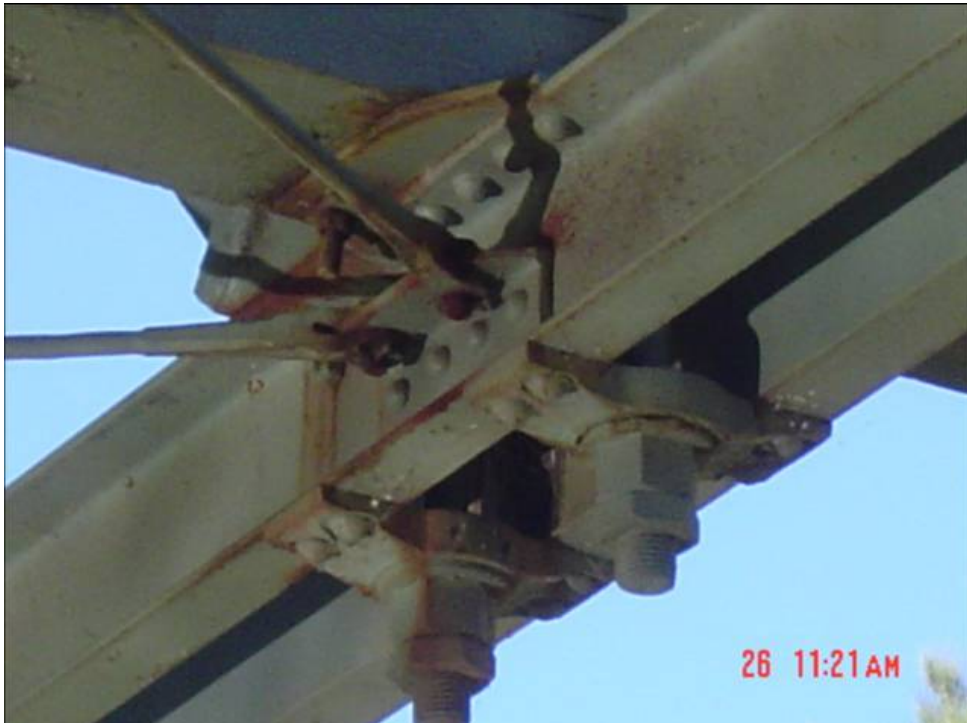
Surface rust is forming.

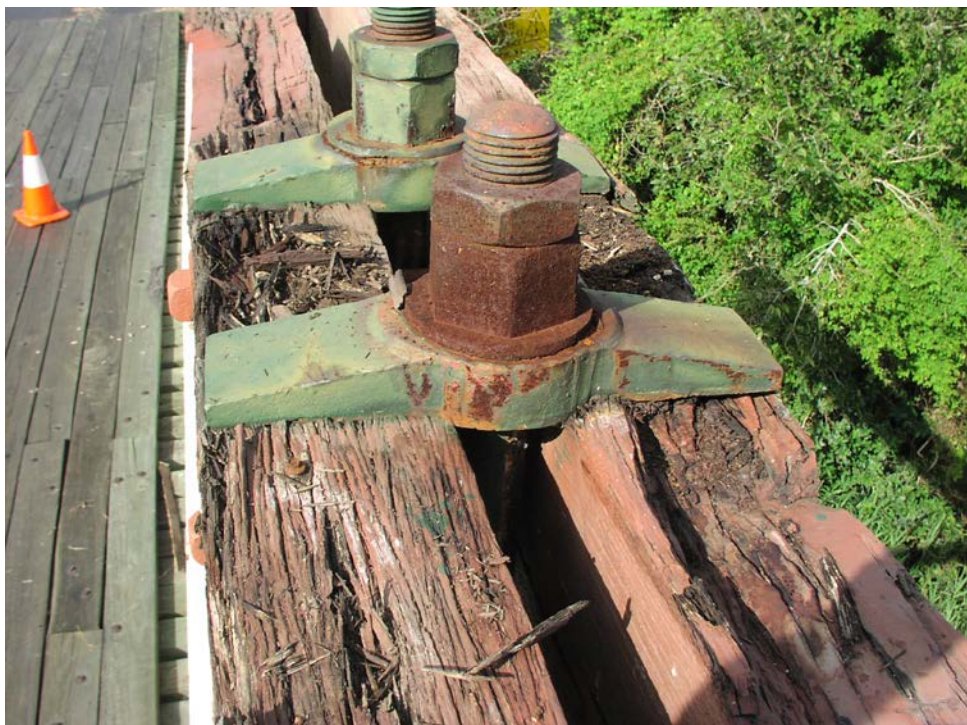
Corrosion of nuts and surface rust on tie bearings

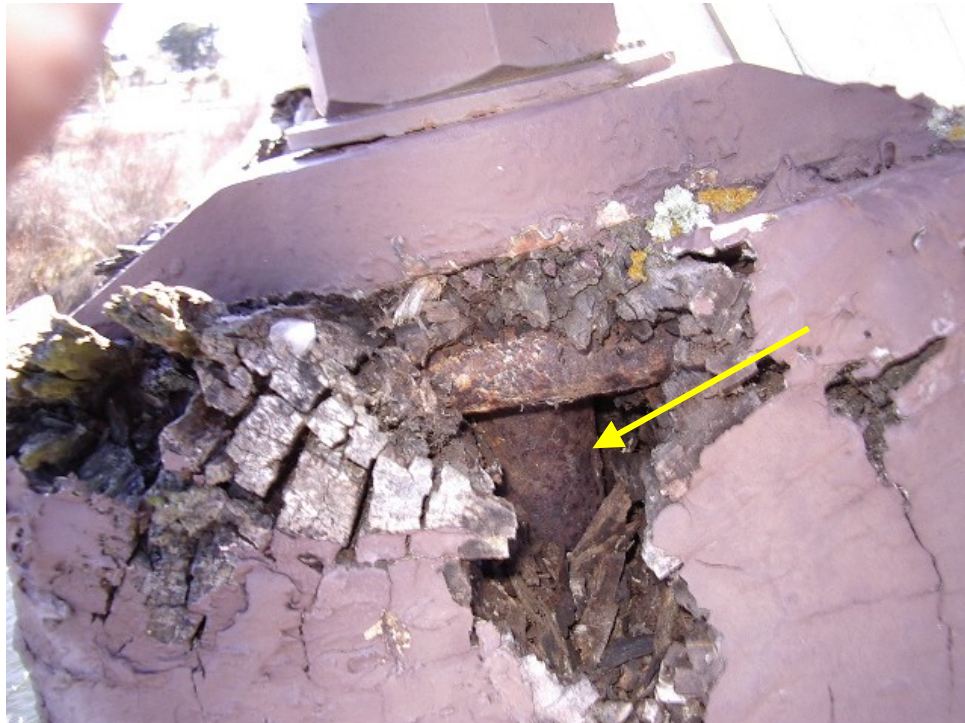
Minor to moderate corrosion.

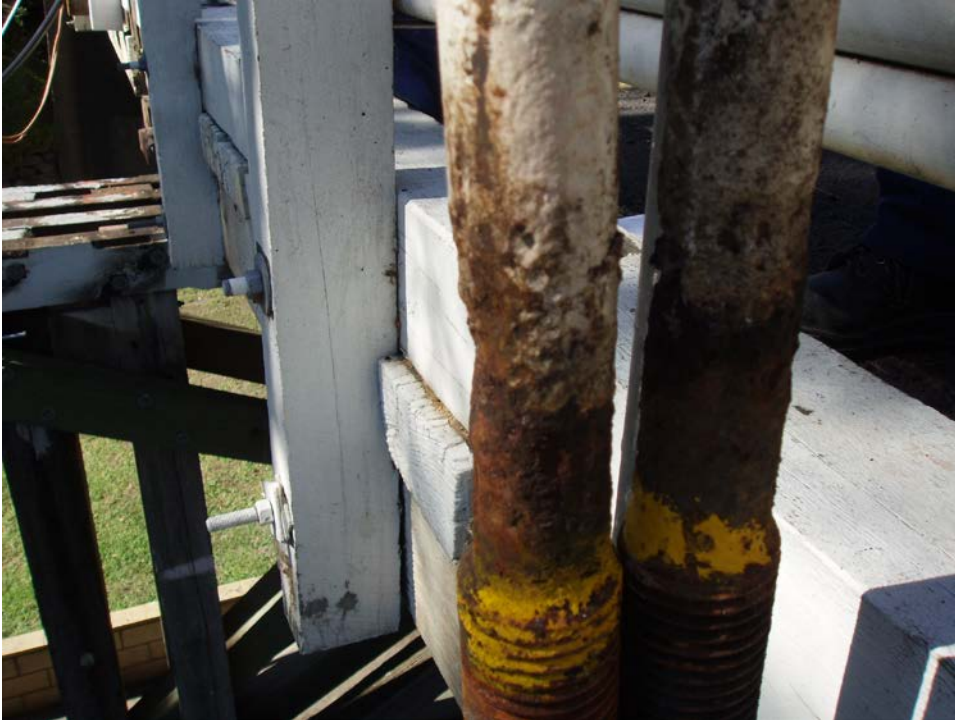
Advanced corrosion with significant loss of section.

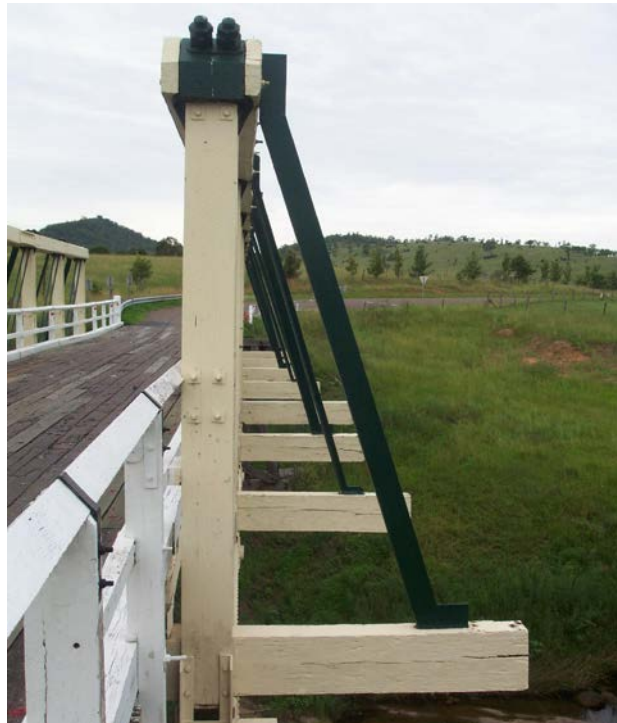
Bracing in good condition.

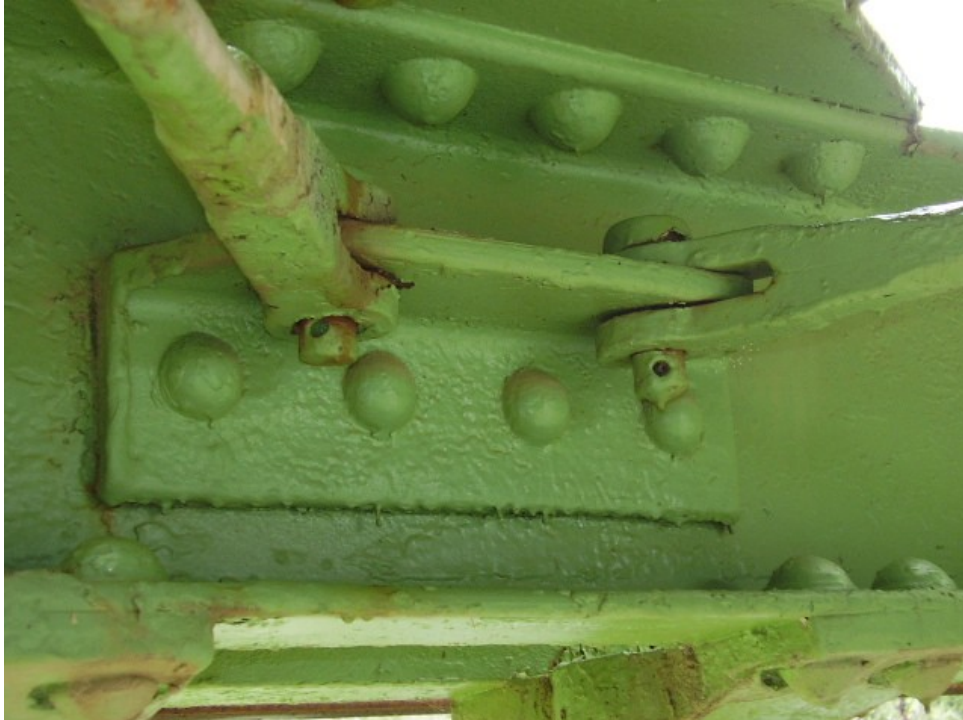
Brace tie rods with missing clips on pins.

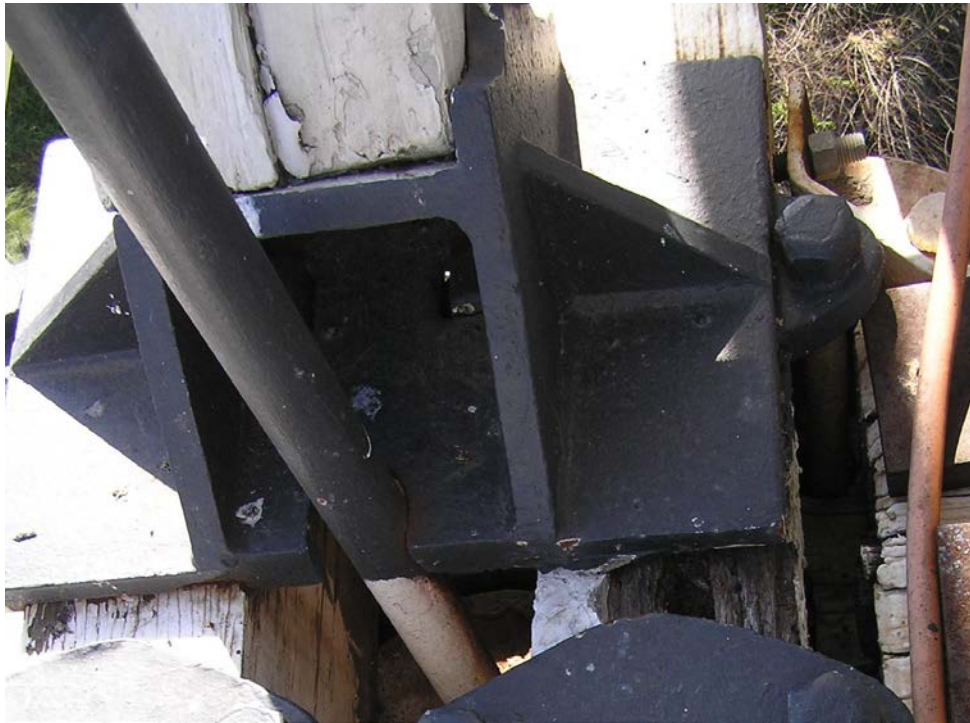
Metal shoe in good condition.

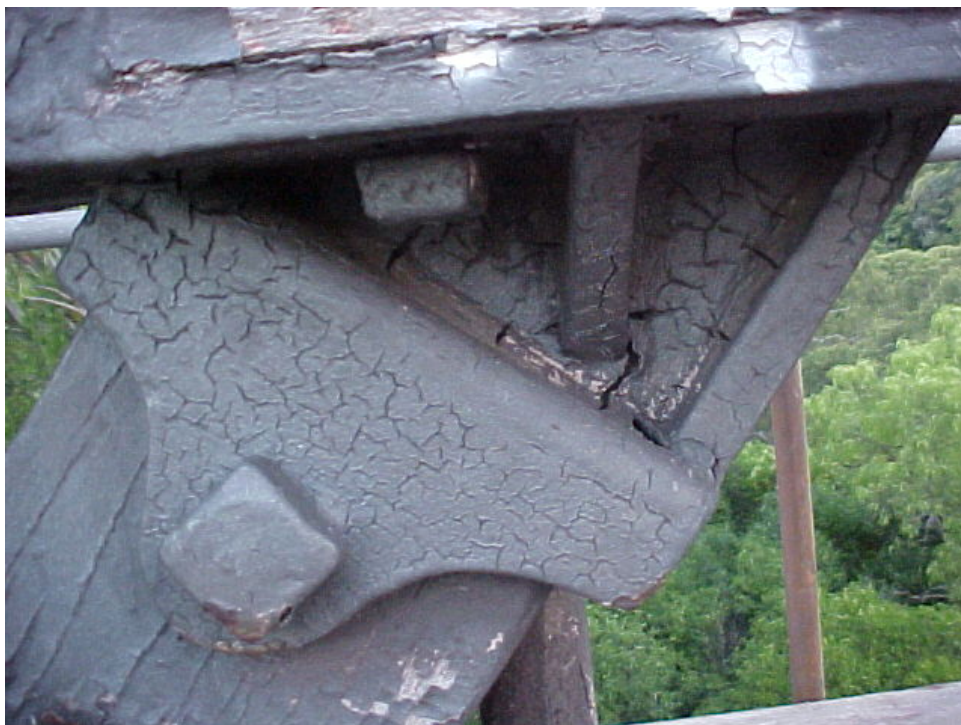
No evidence of corrosion.

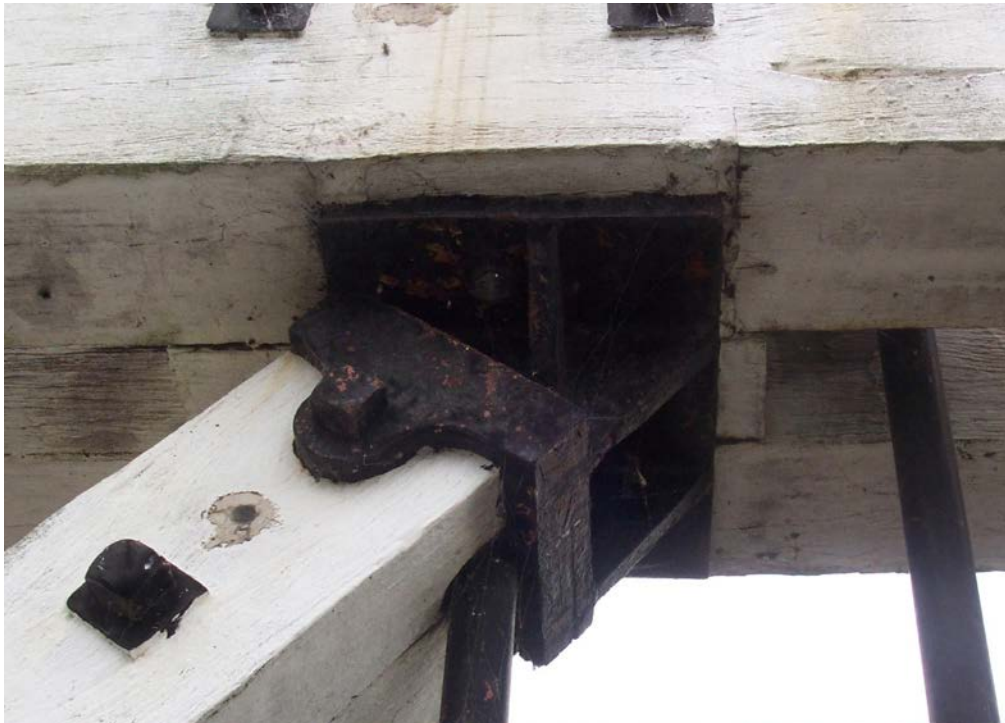
Shoe showing surface rust and minor pitting.

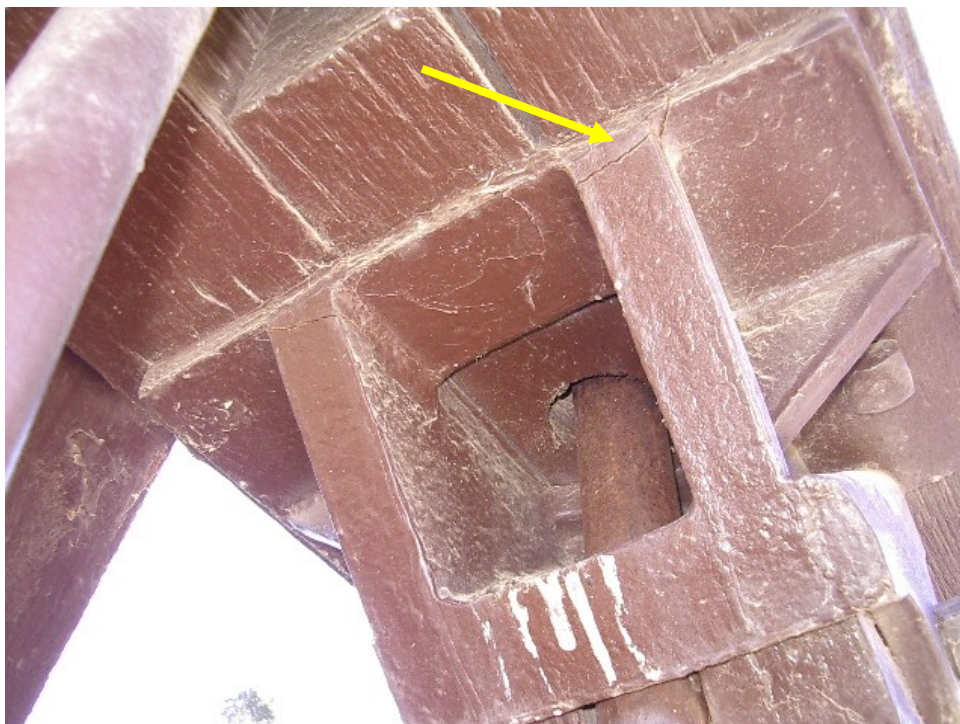
Heavy pitting may be present. Some measurable section loss is present locally. There may be minor cracks and/or deformations in the steel or welds. All connectors are in sound condition.

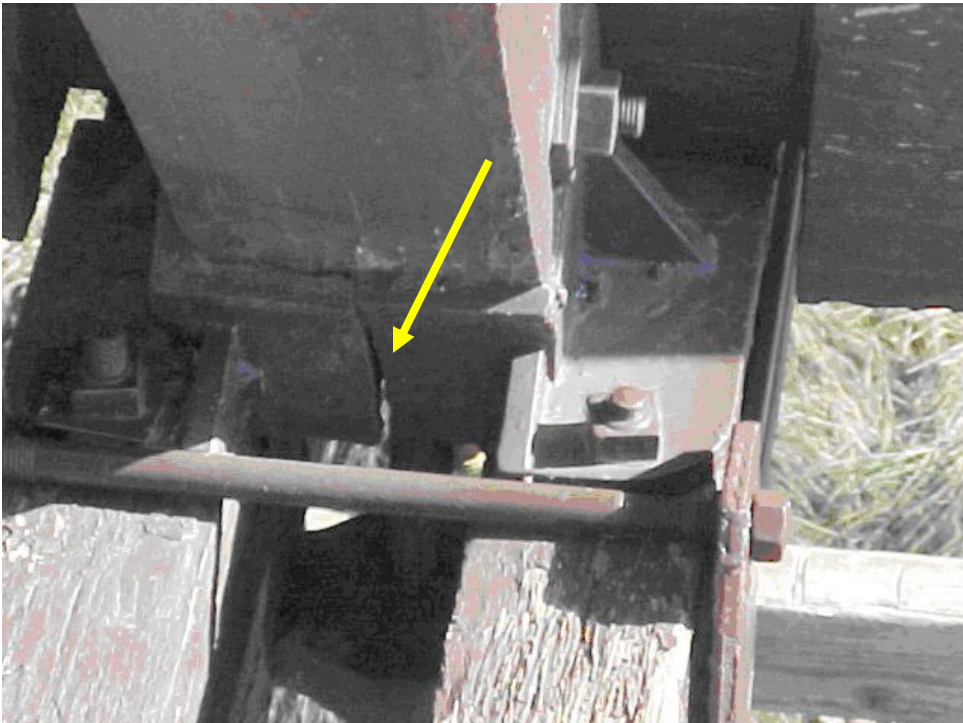
Significant section loss may be present. There may be cracks and/or deformations in the steel or welds. There may be numerous failed connectors.

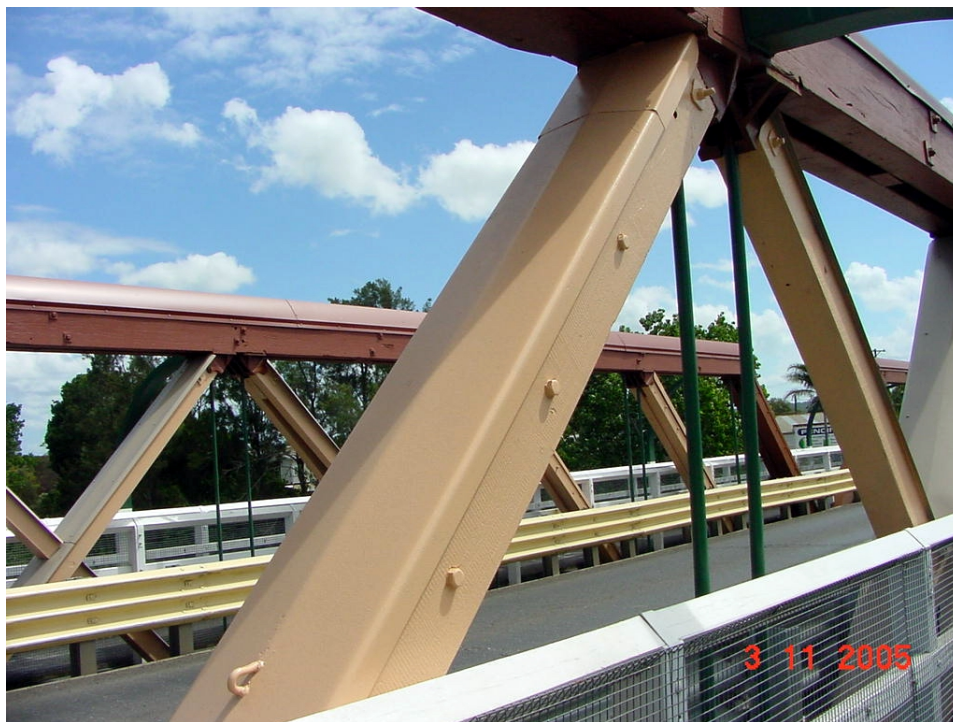
Truss paint in good condition.

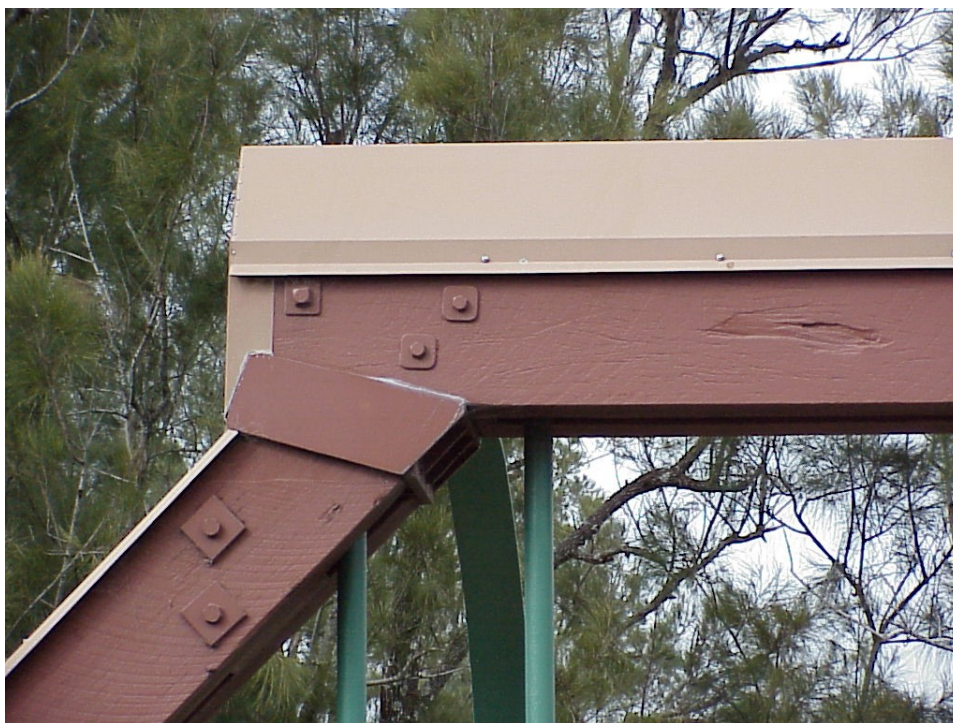
Truss paint and flashing in good condition.

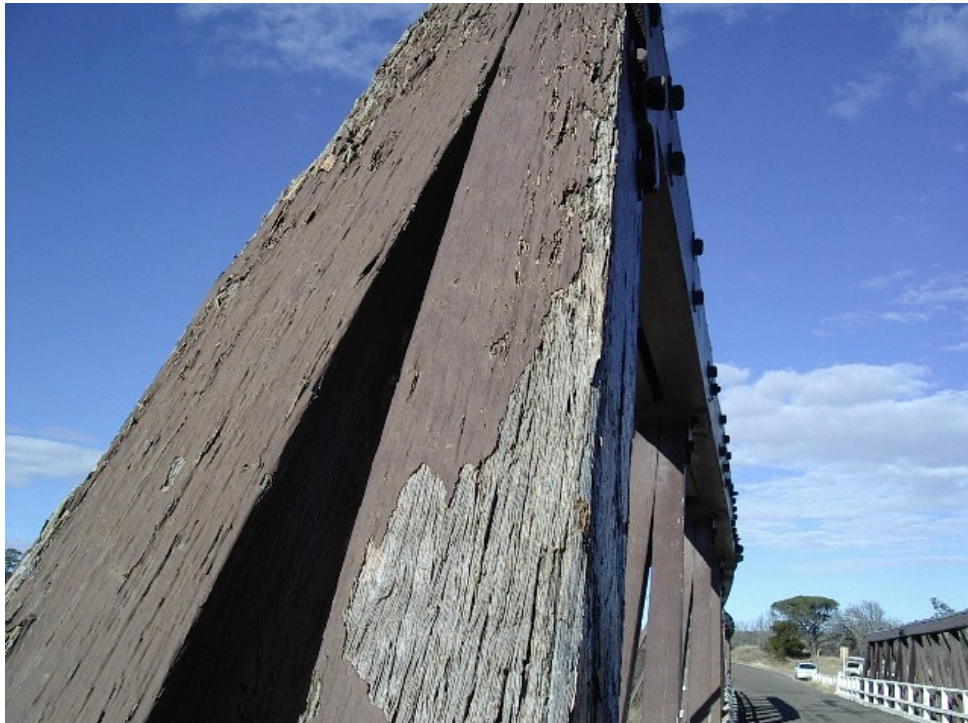
Coating has failed in significant areas.

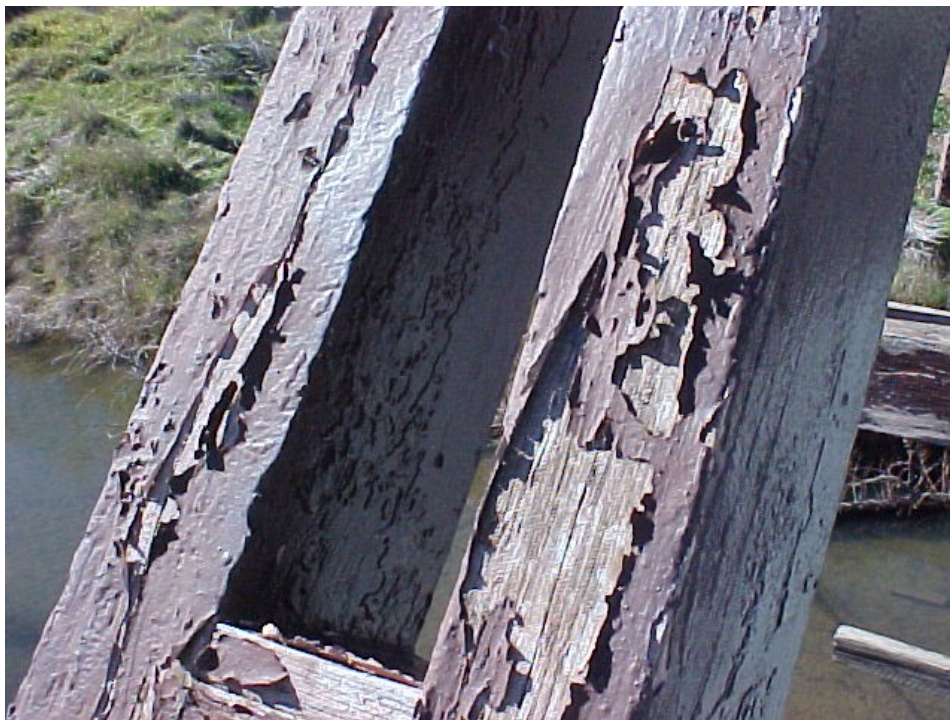
Coating has failed in significant areas.

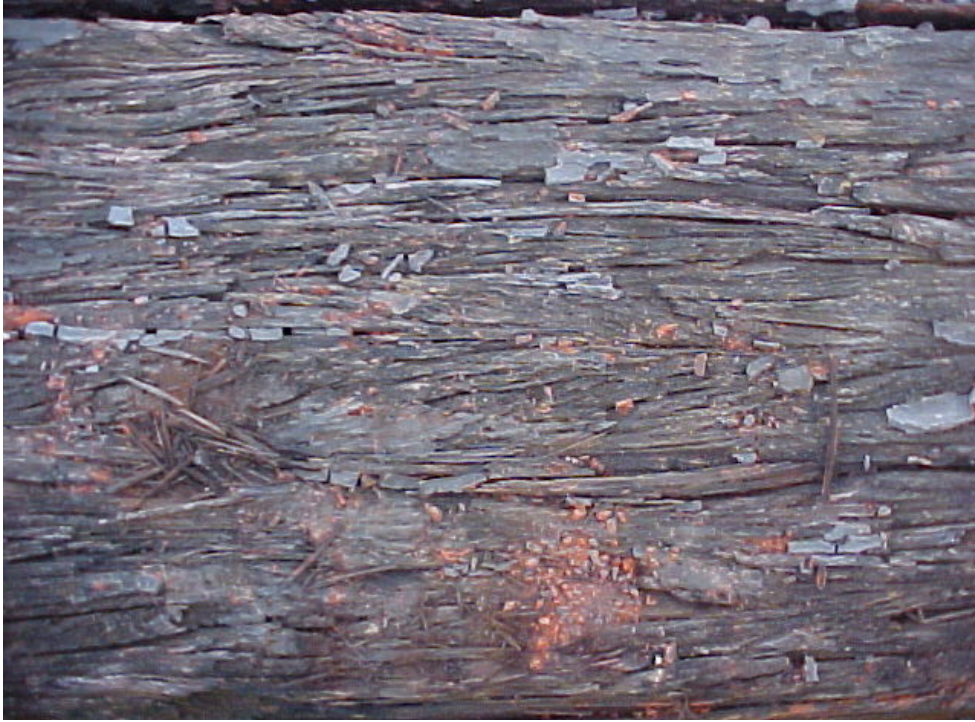
Paint has failed and timber is deteriorating.

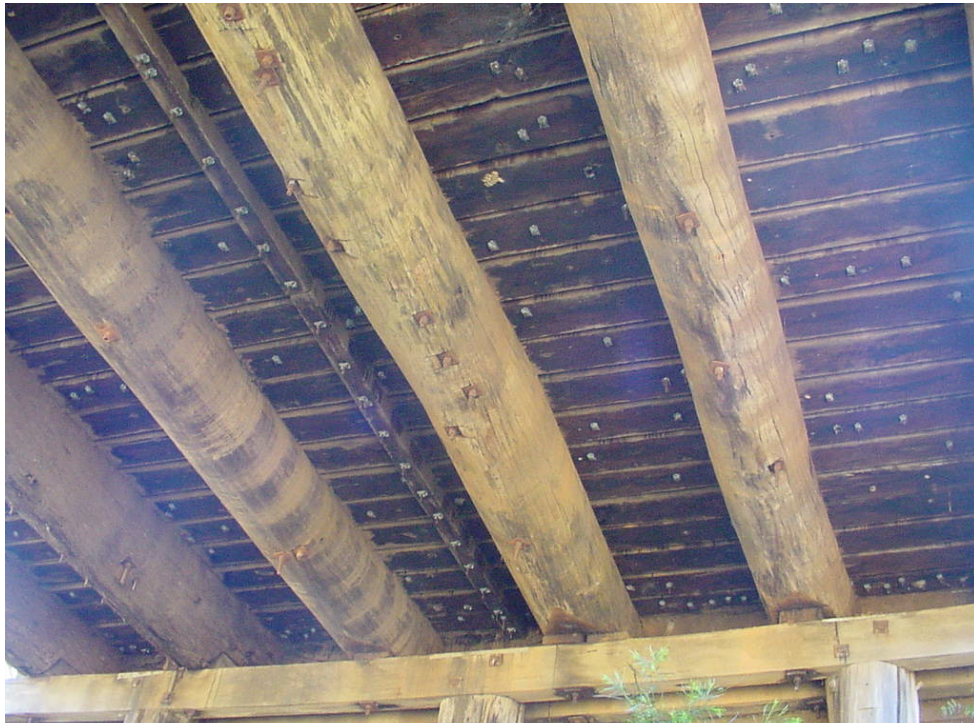
Timber girders in good condition.

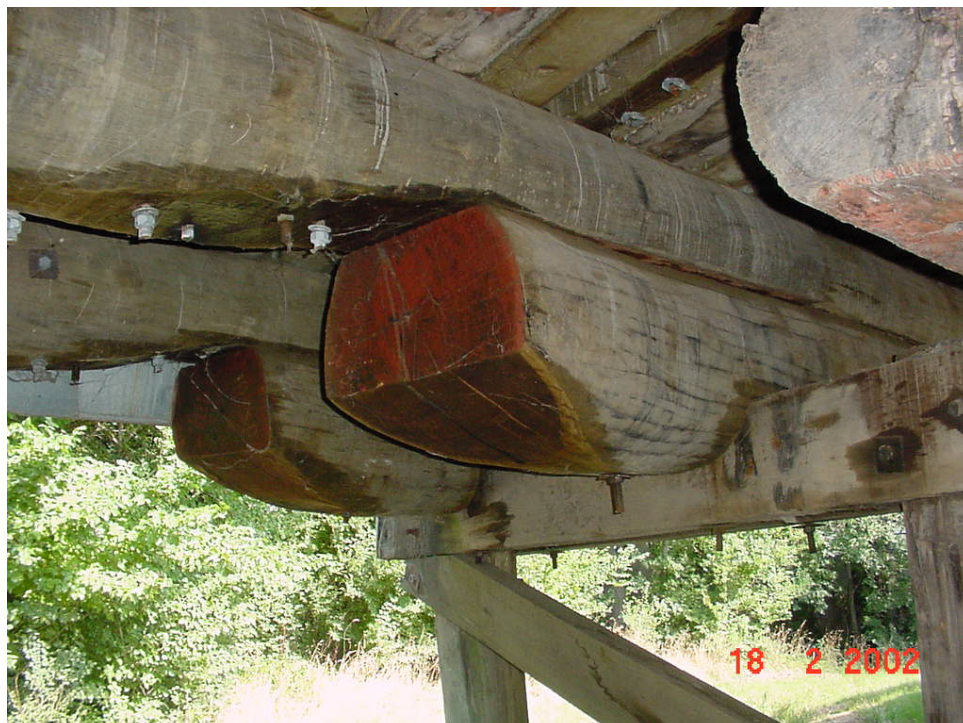
Girders and corbels in good condition.

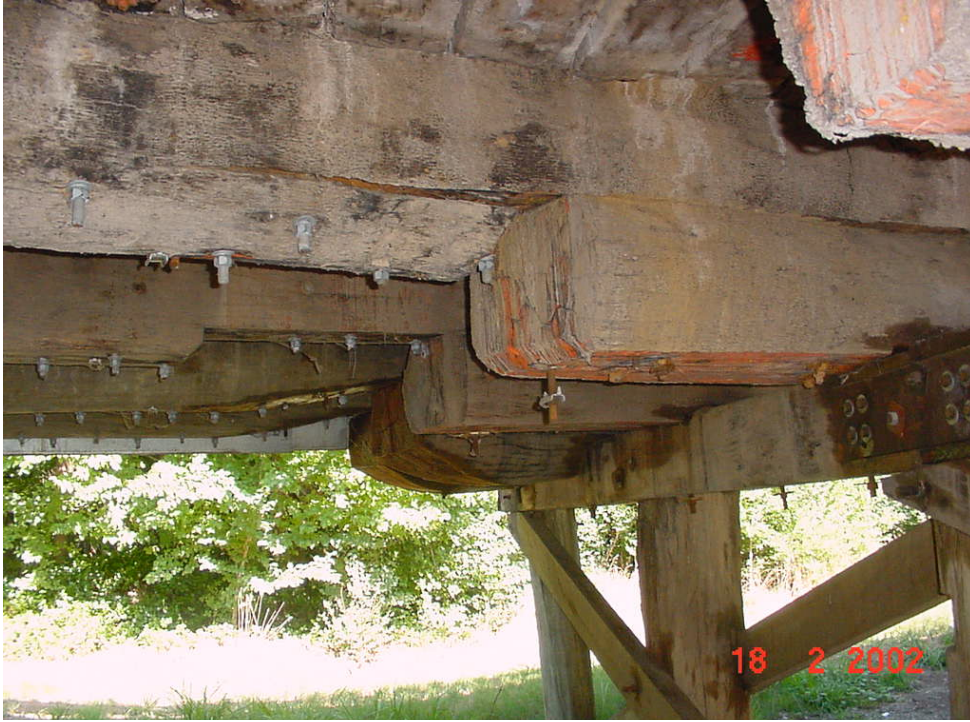
Minor split on the girder.

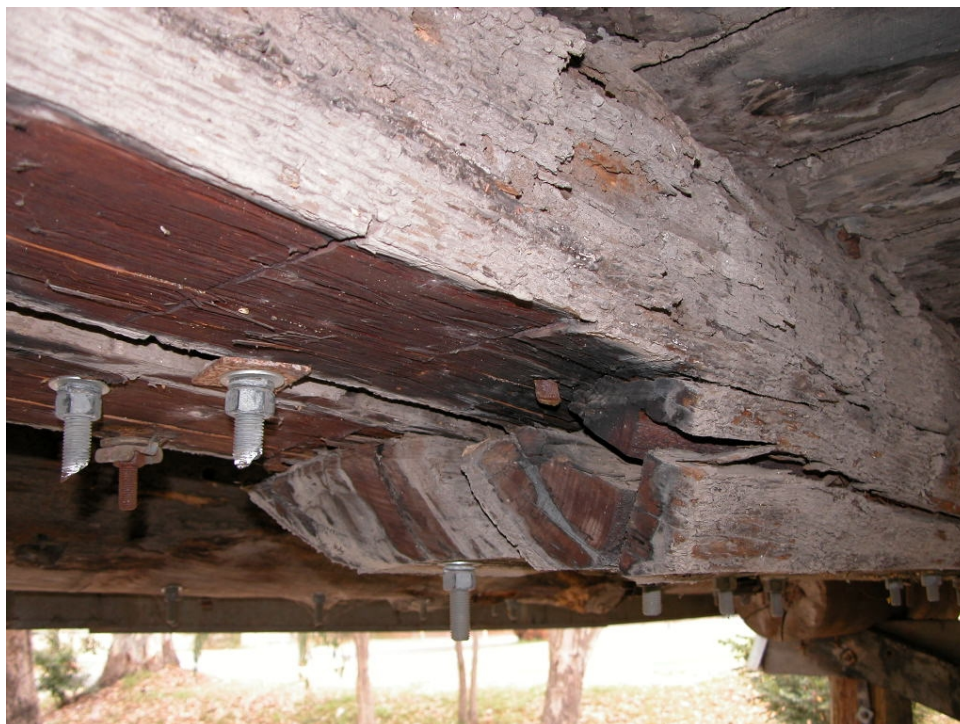
Vertically split girder with other horizontal splits at the snipe.

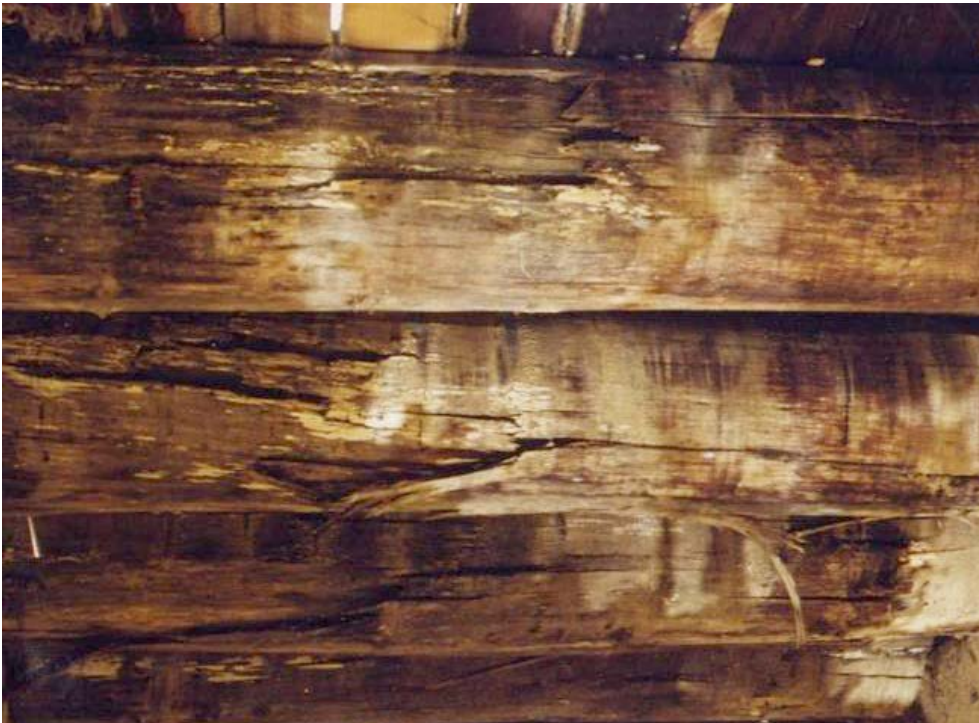
Girders in poor condition with heavy splits and checks.

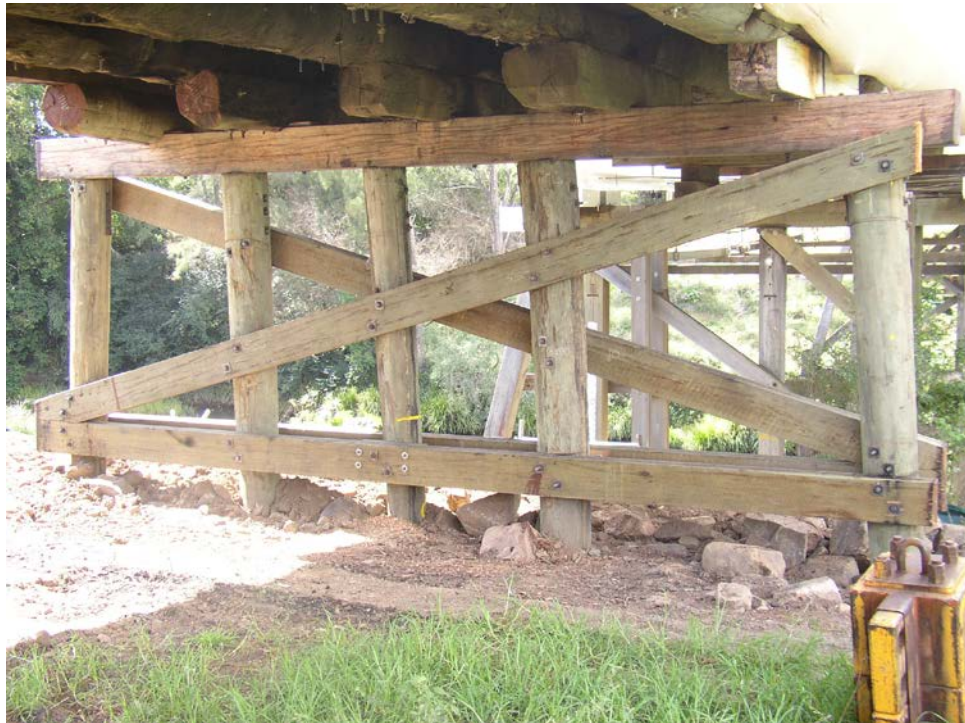
## Timber-Capwale/Headstock/Sill

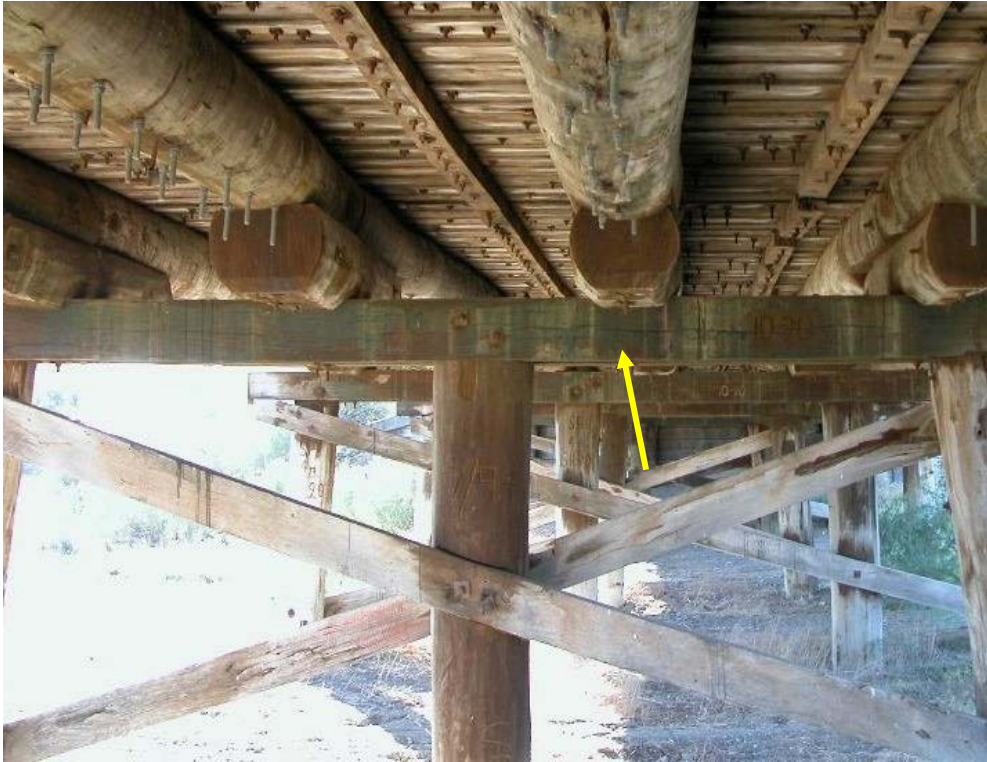
Headstock with minor check.

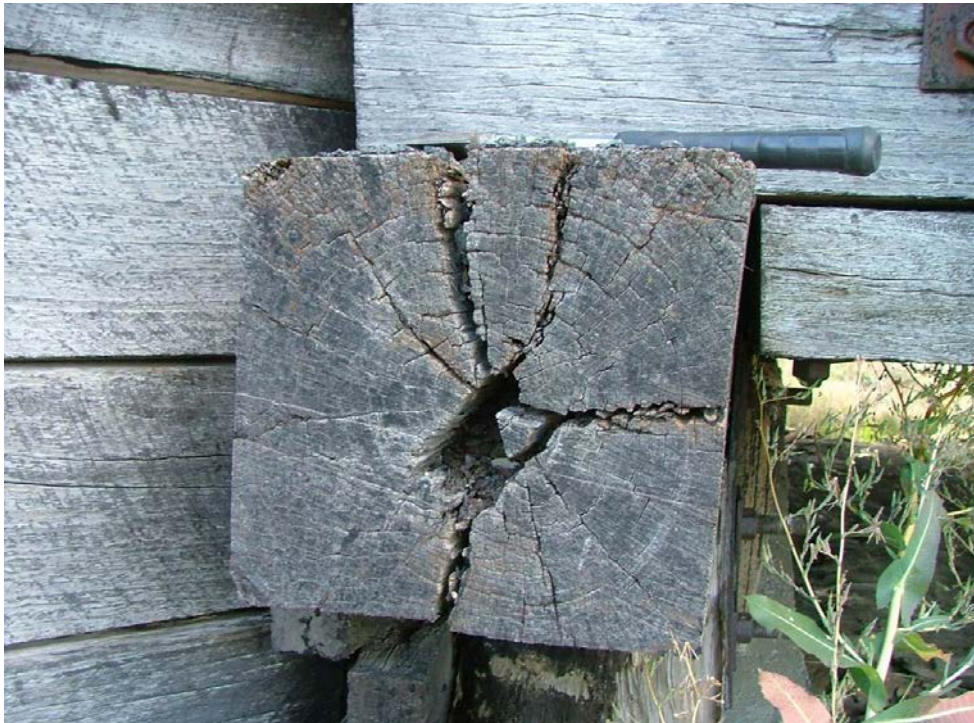
Medium rot and splitting of the headstock.

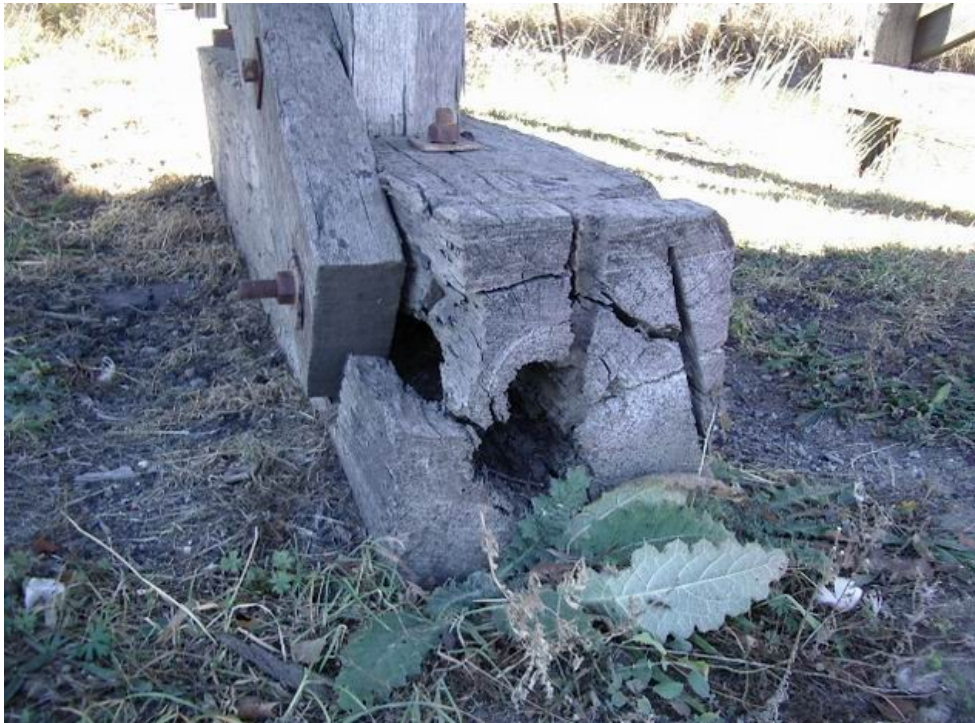
Badly rotten sill beam.

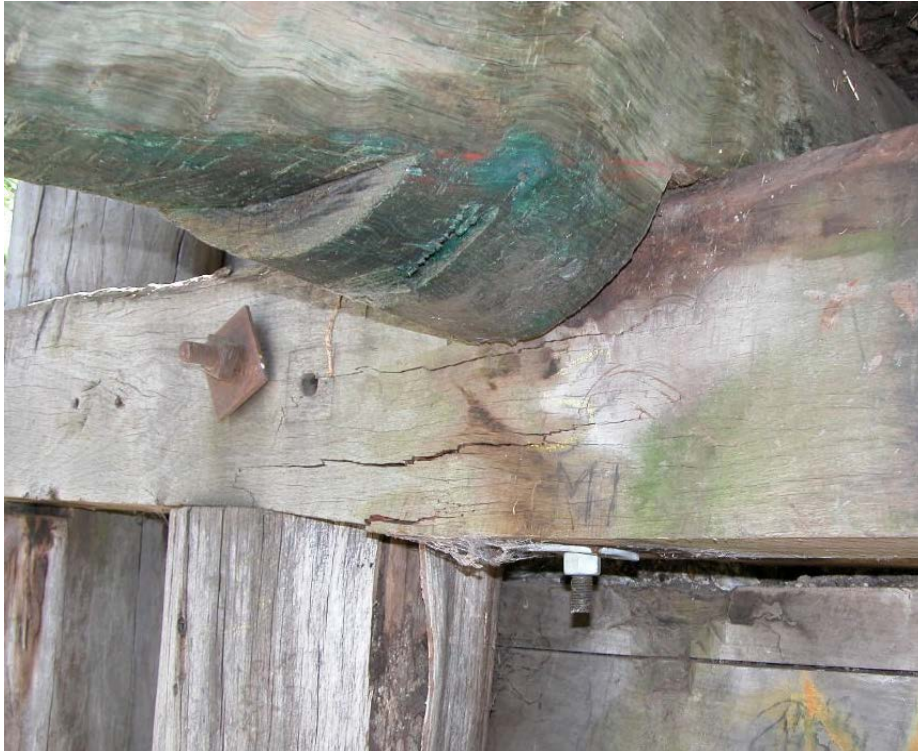
Timber headstock with significant crack under the girder.

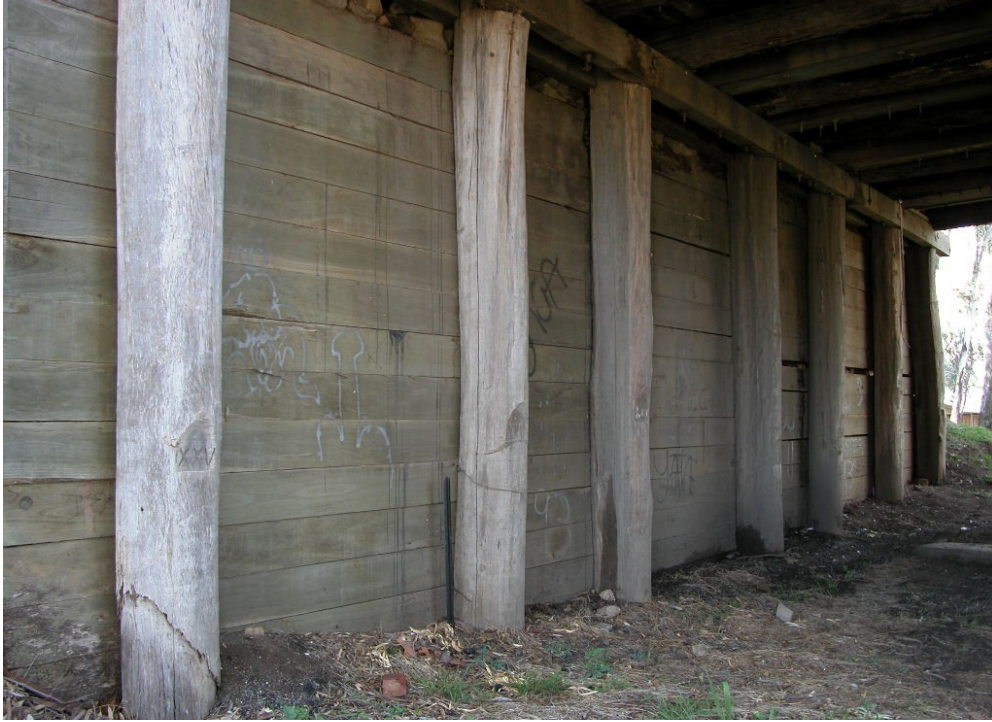
Timber piles in good condition.

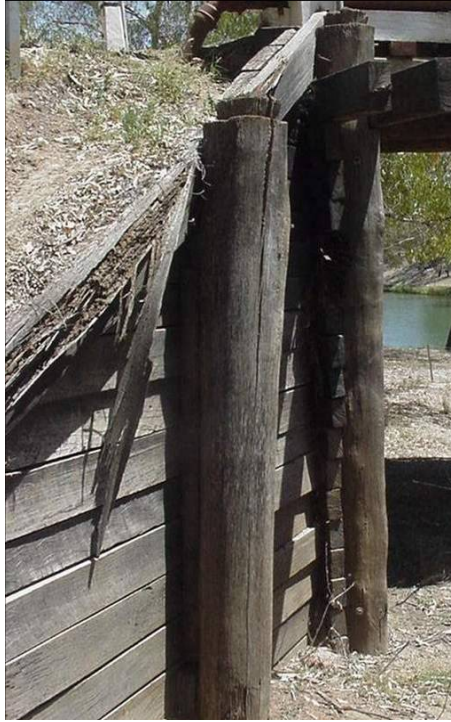
Minor split in the pile.

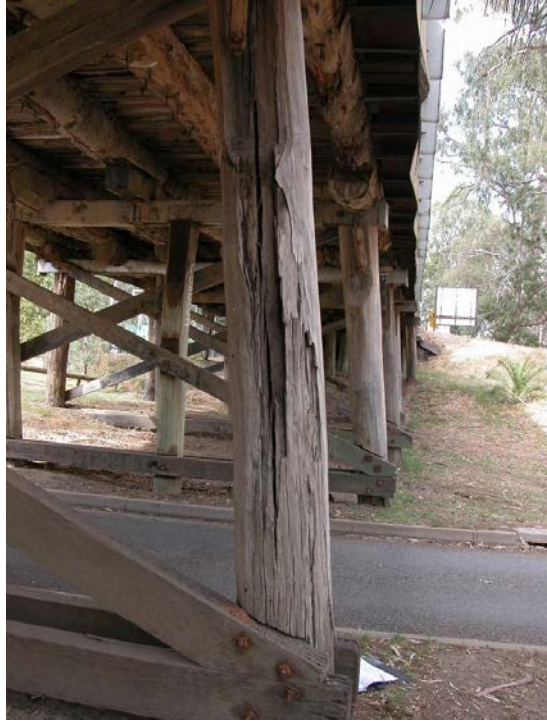
Timber pile split and with indications of damage below ground.

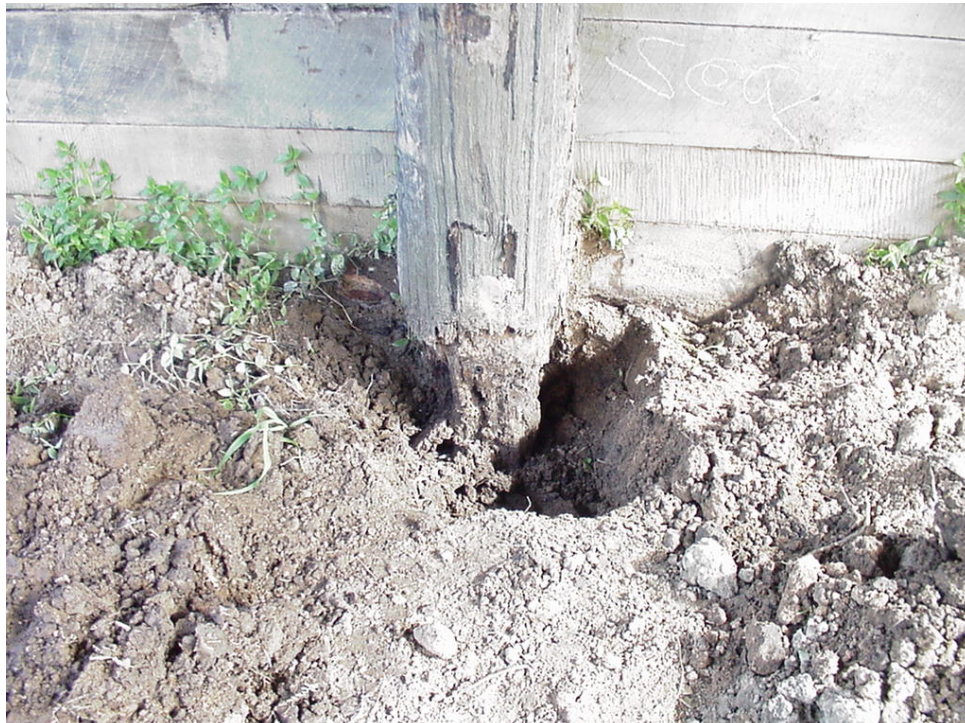
Significant rot and major loss of section just below the ground surface.

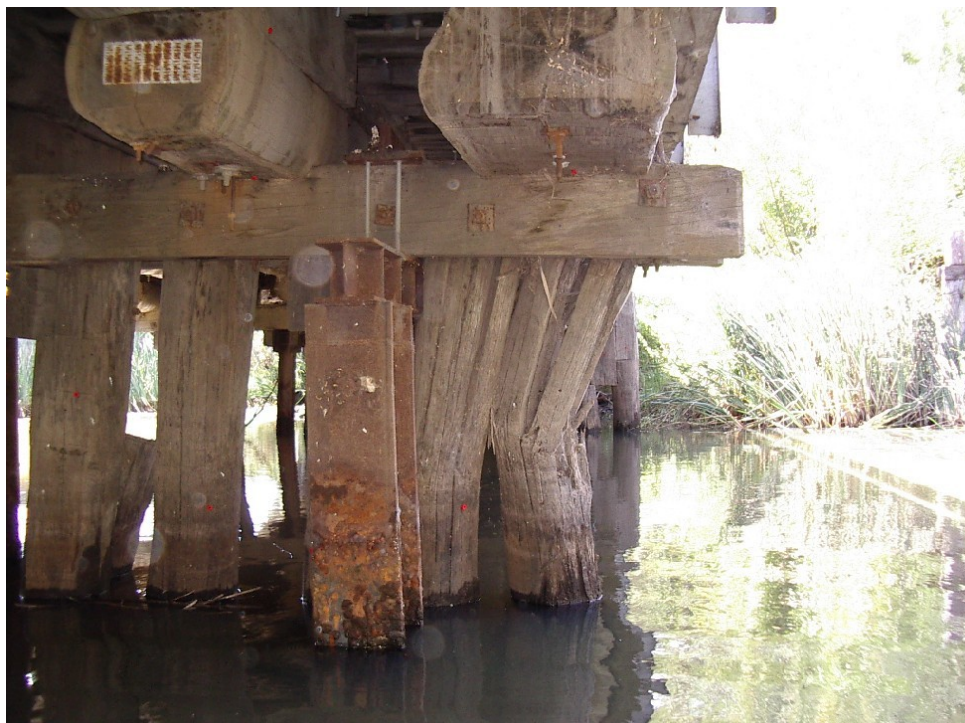
Failed timber piles.

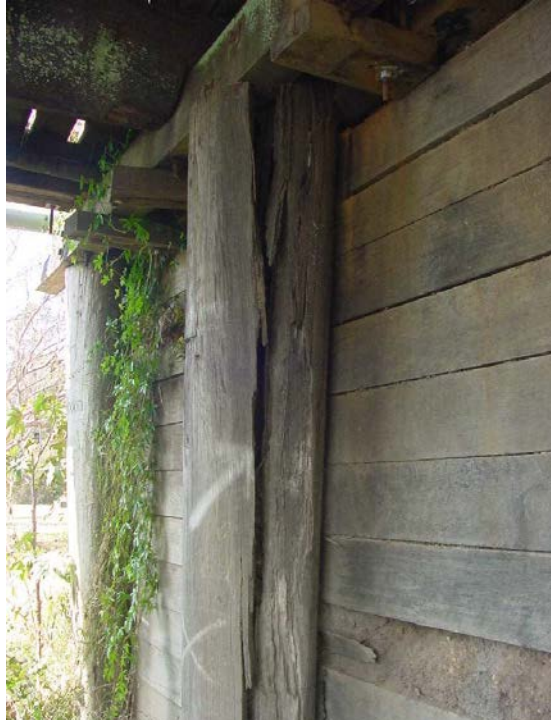
Major split on the pile.

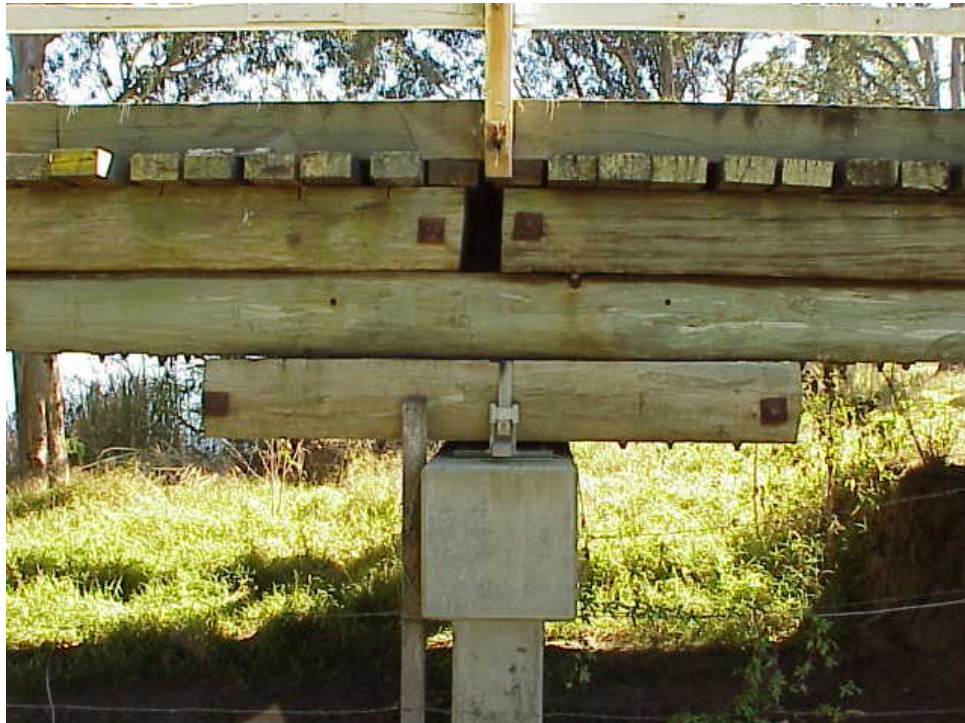
Timber corbels in good condition.
