Transport  
**Roads & Maritime  
Services**

# **BRIDGE INSPECTION PROCEDURE MANUAL**

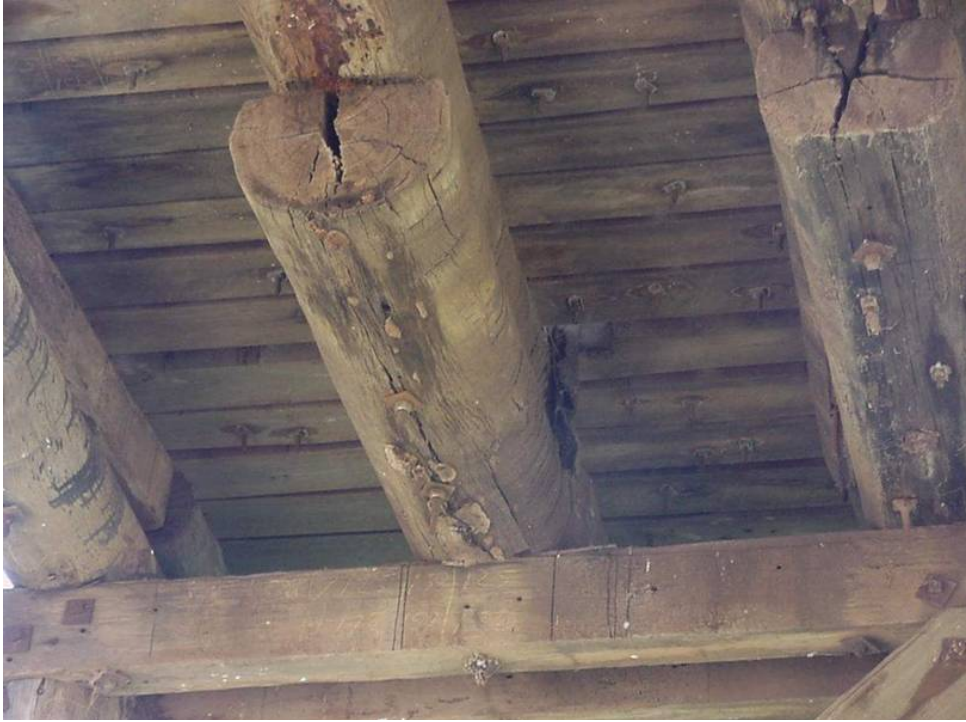
Minor end splits, mainly vertical.

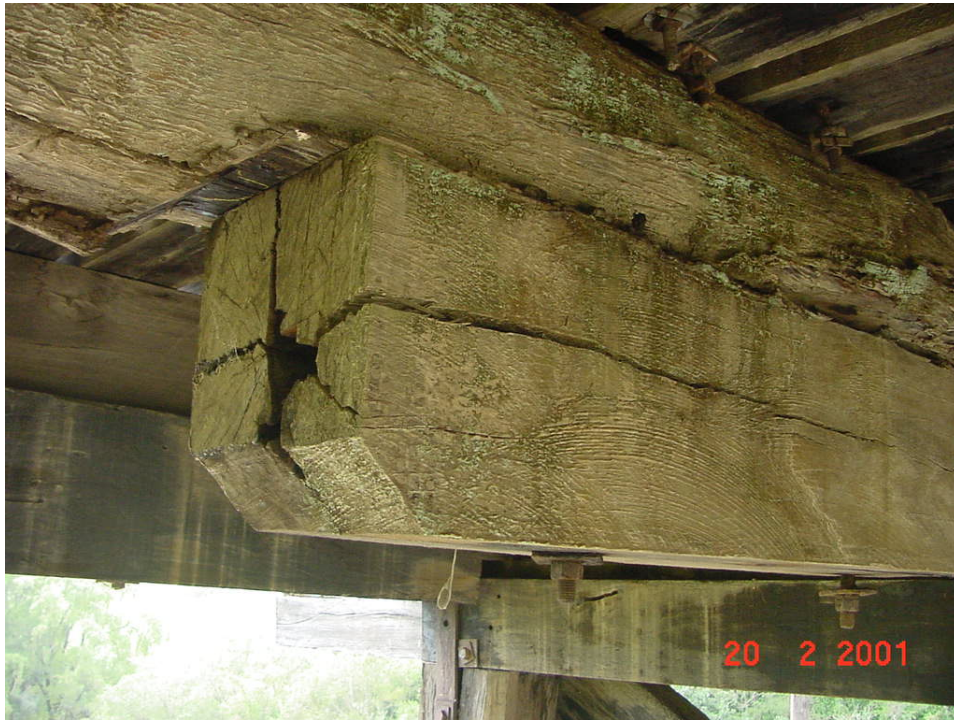
Piping with moderate horizontal split.

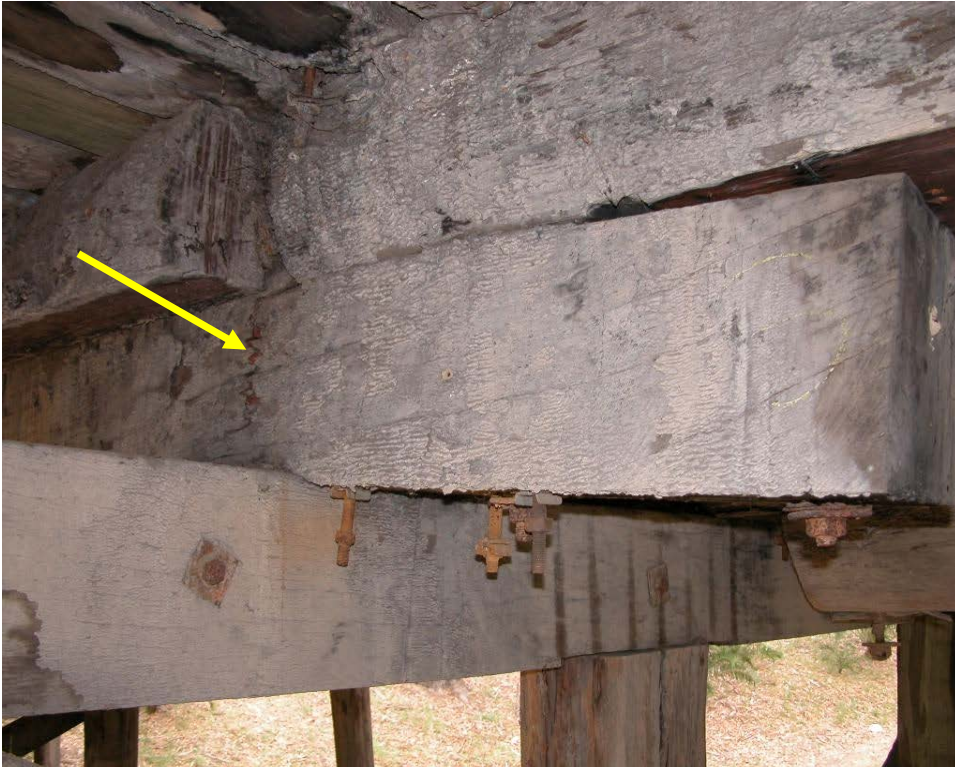
Advanced deterioration. Heavy decay, insect infestation, splits, cracks or crushing has produced loss of strength that affects the serviceability of the bridge.

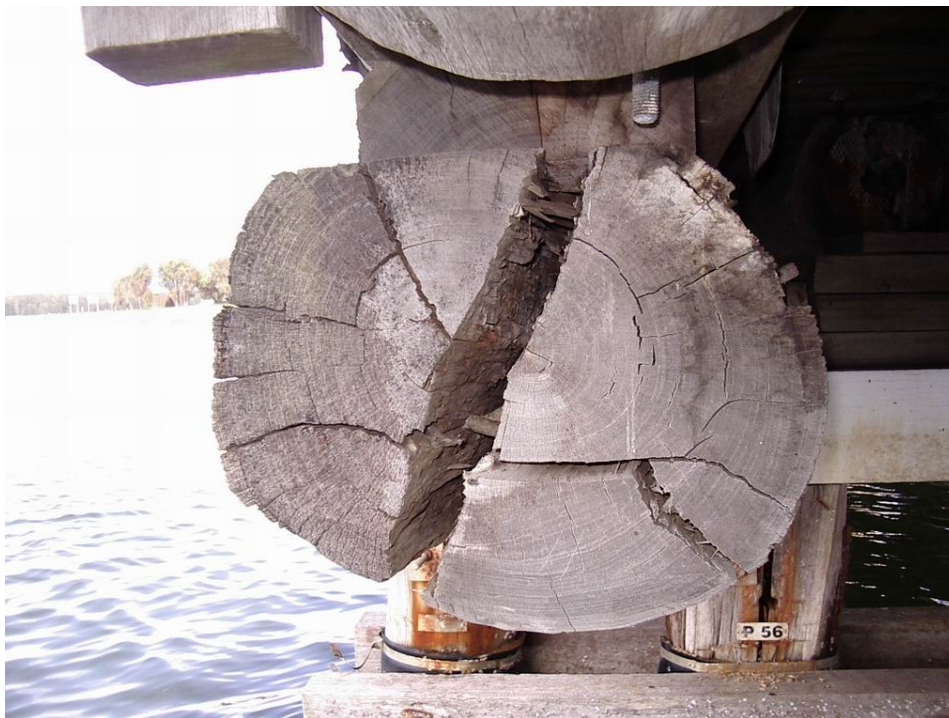
Severely split and splintering corbel

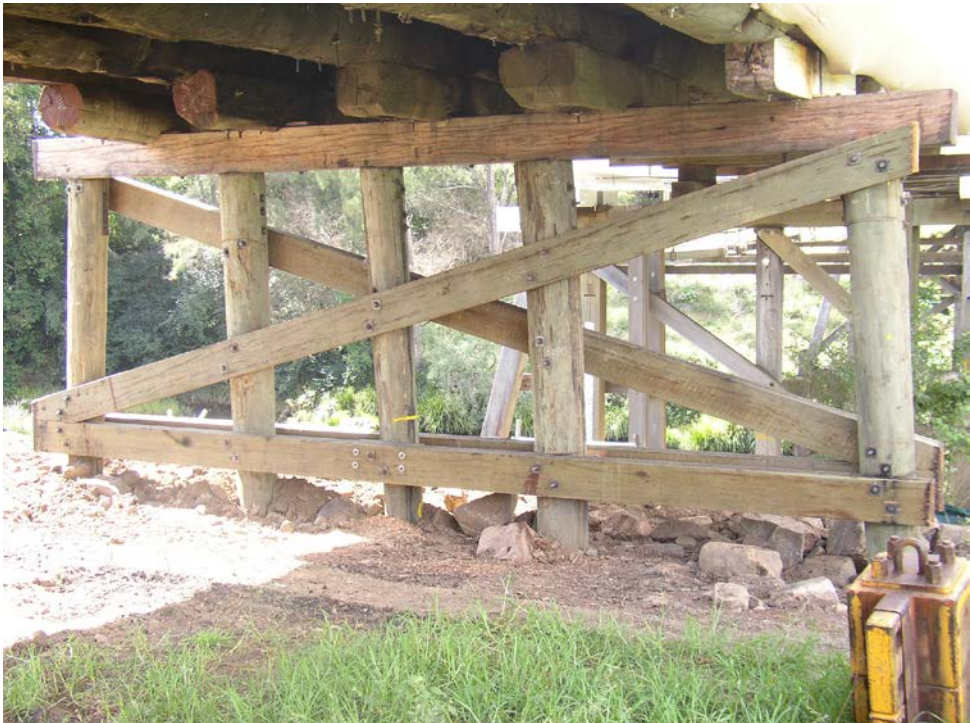
Timber elements in good condition.

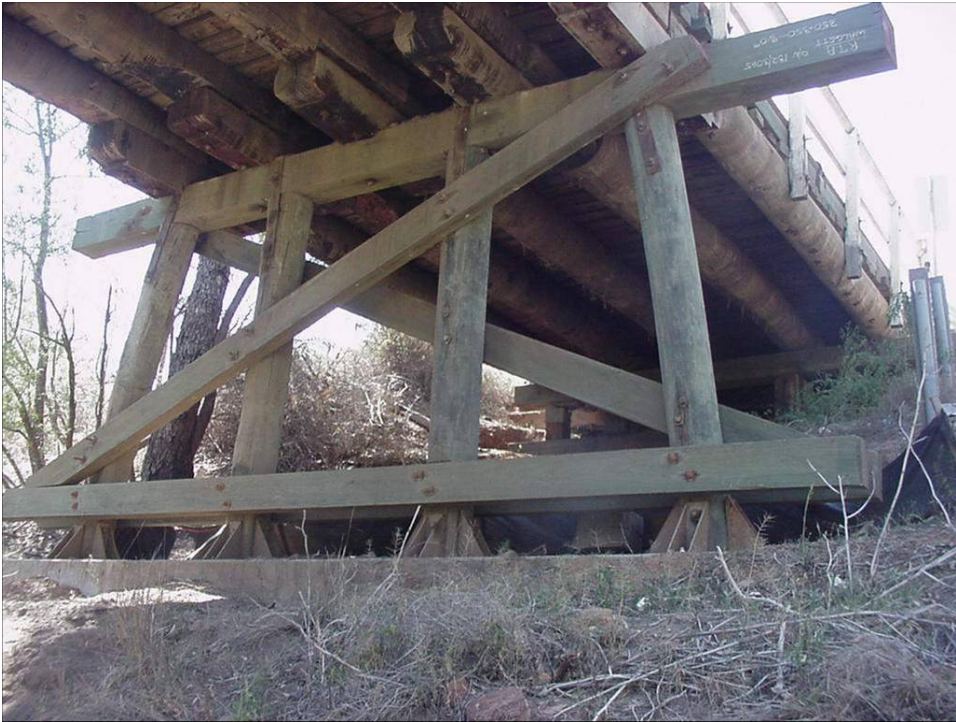
## Timber- Wale/Brace

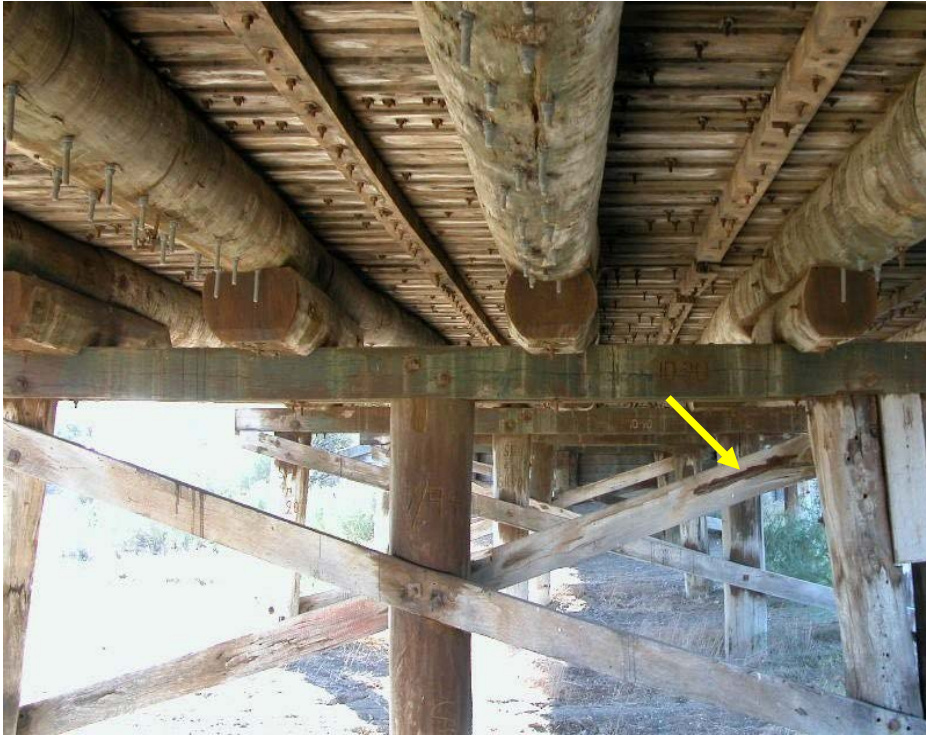
Minor decay of the wale.

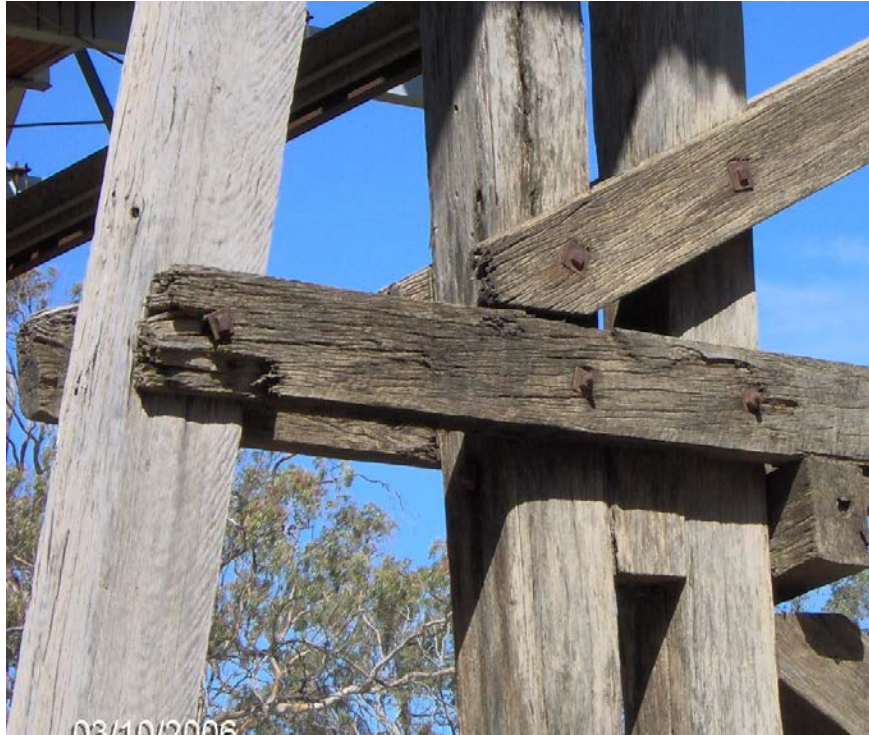
Wale showing end rot.

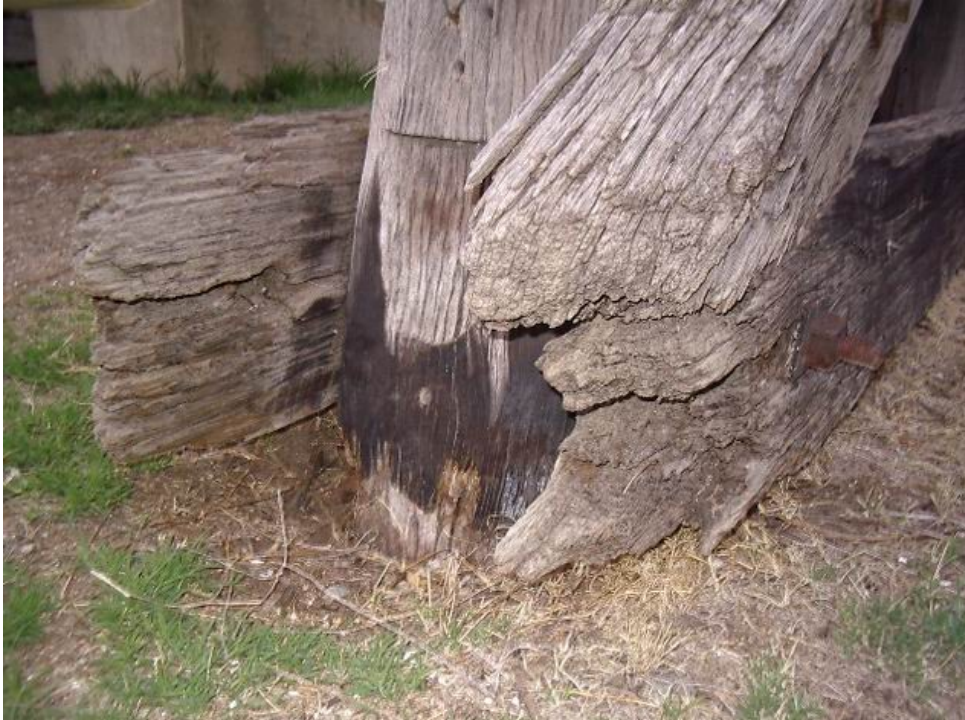
Rotten ends of wale.

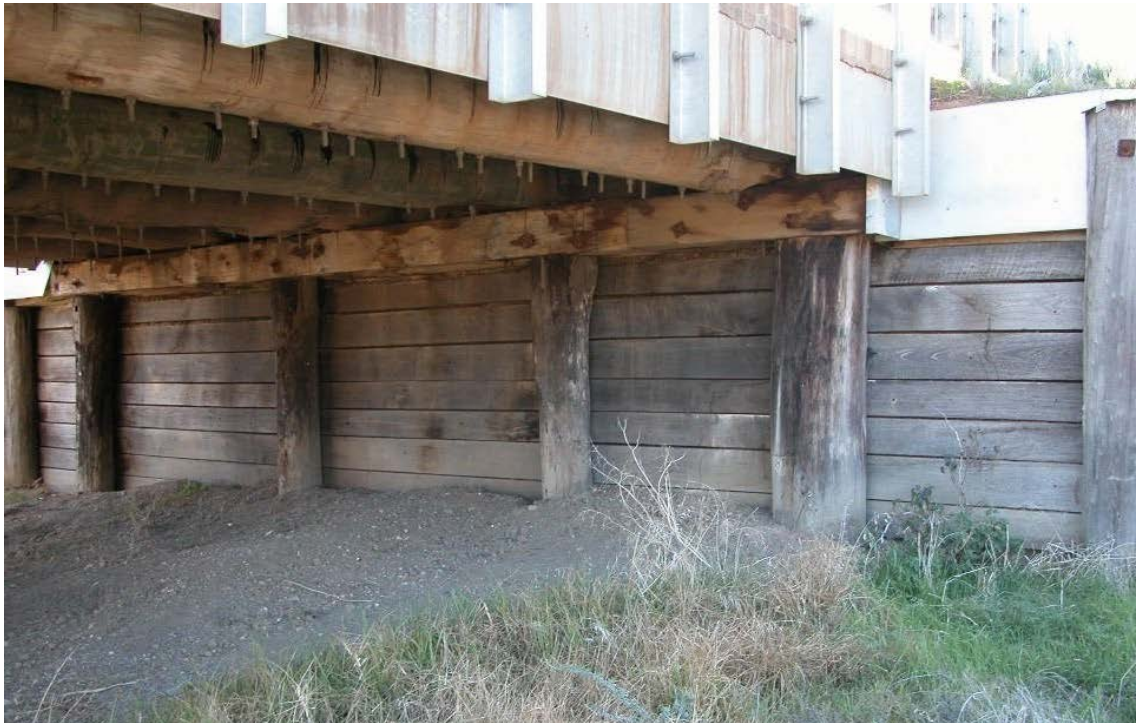
Abutment sheeting in good condition.

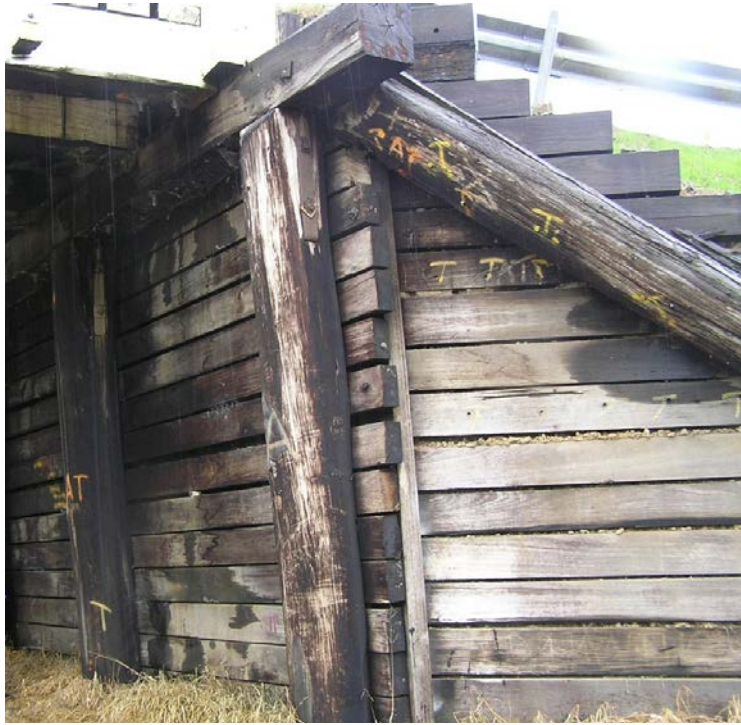
Abutment sheeting with some termite infestation.

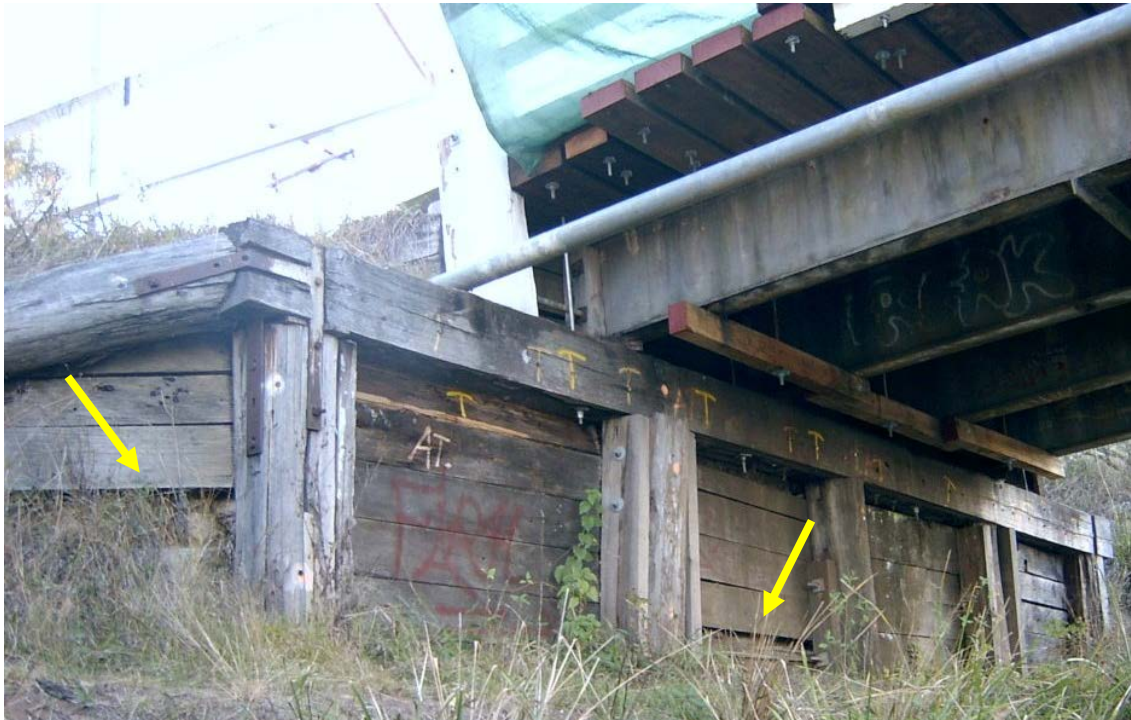
Abutment sheeting with termite infestation and some rotten boards.

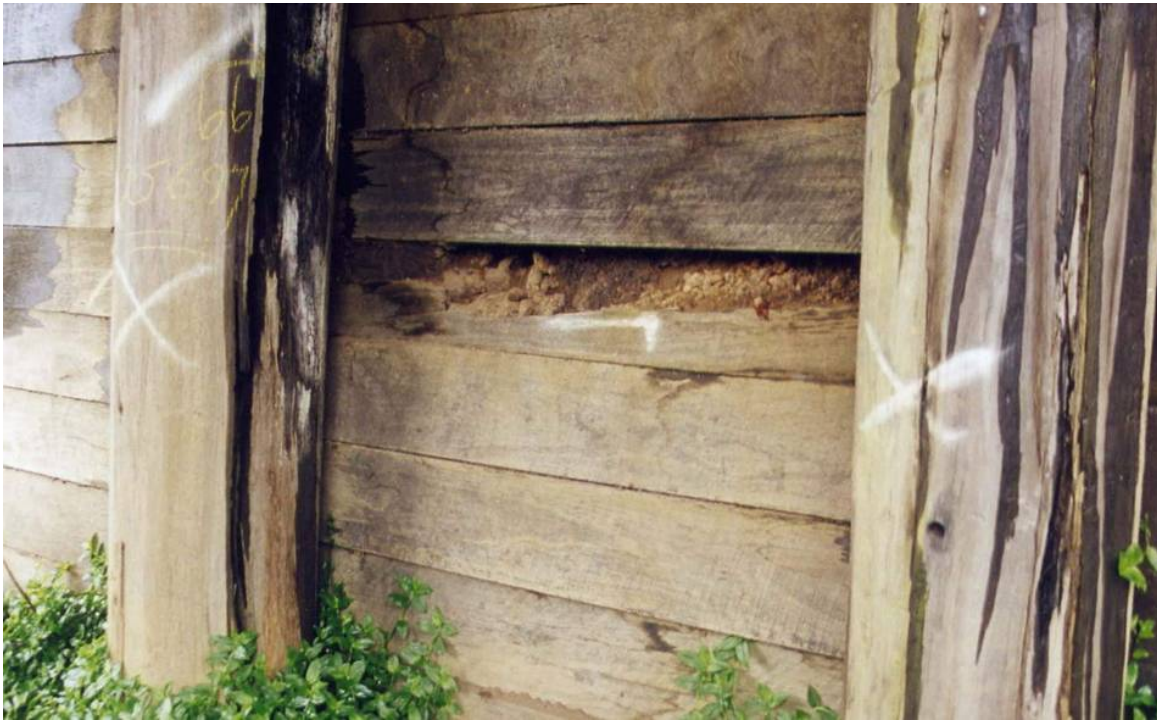
Broken abutment sheeting.

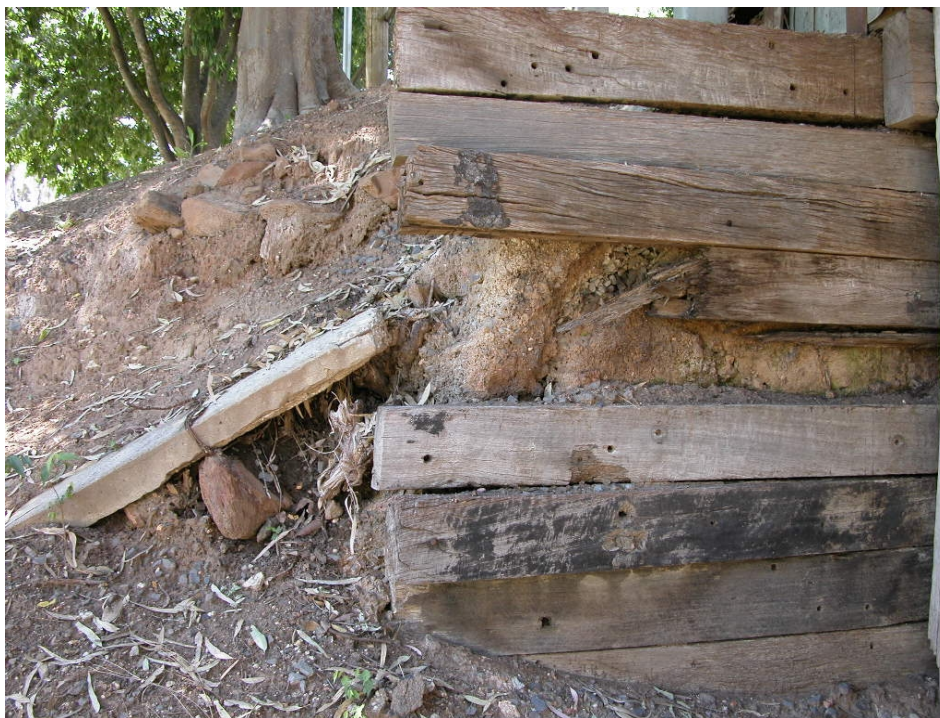
Missing sheeting with erosion problems.

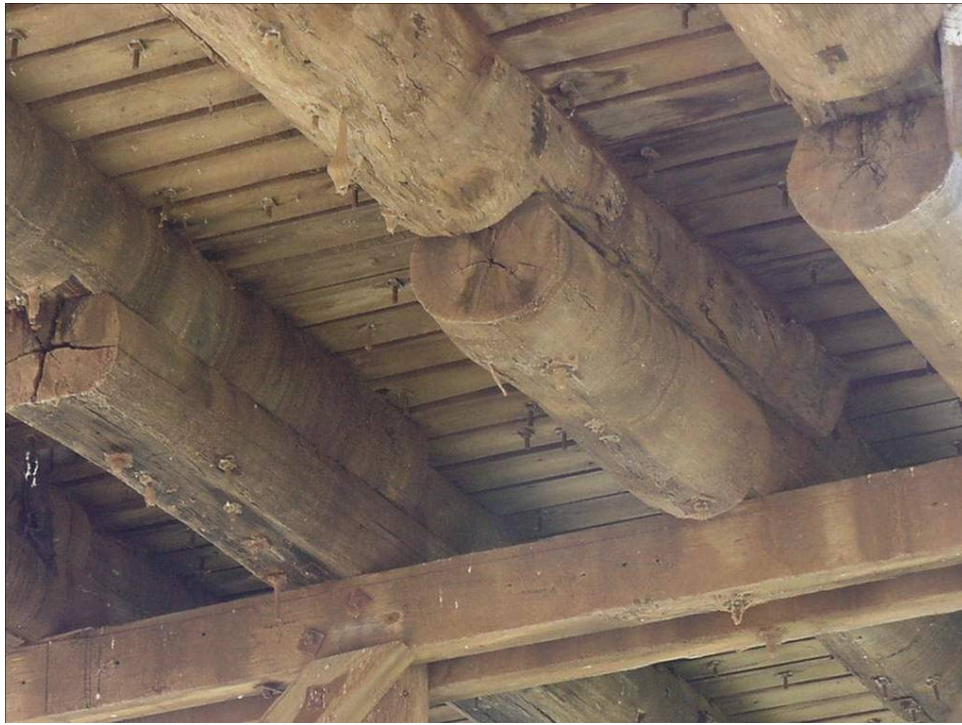
Transverse Deck planks in good condition.

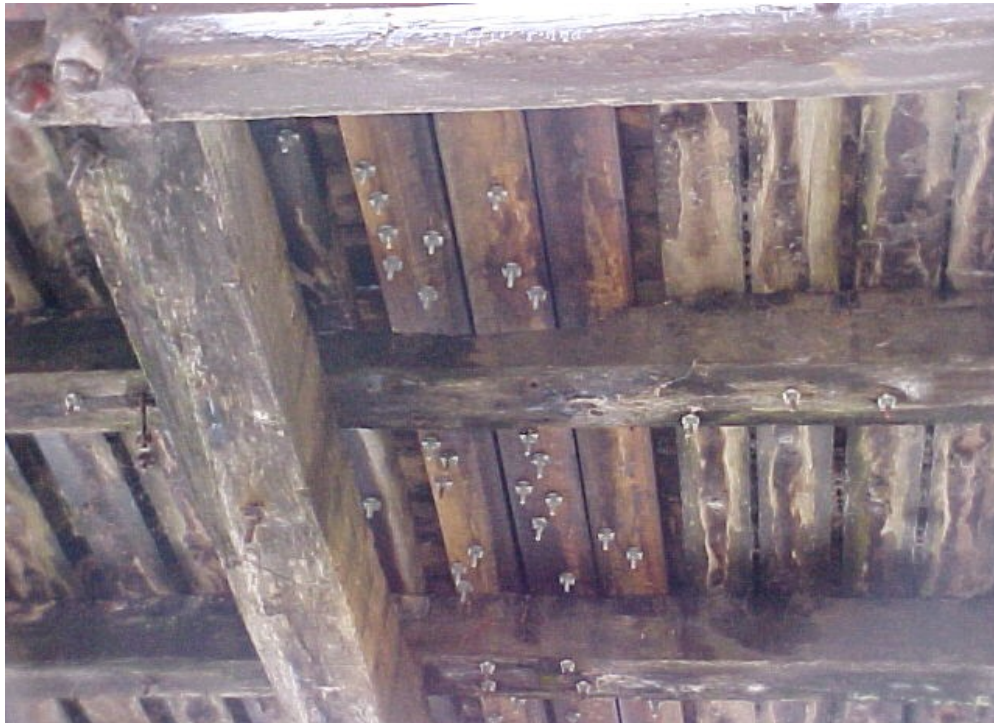
Medium decay of cross decking.

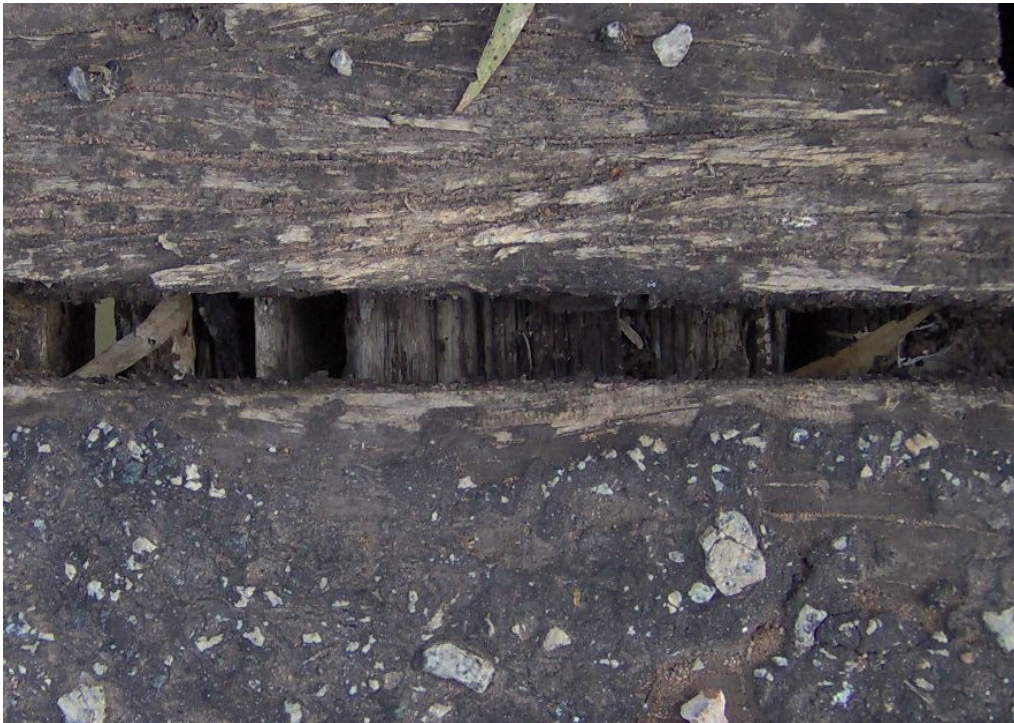
Advanced deterioration of transverse decking.

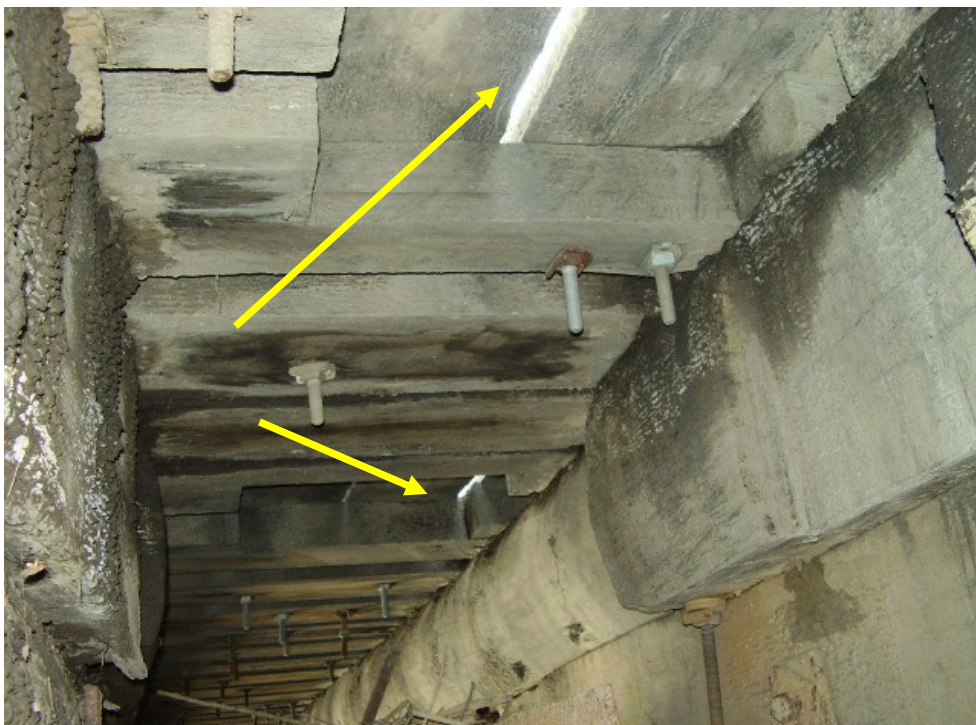
Missing sections of cross decking.

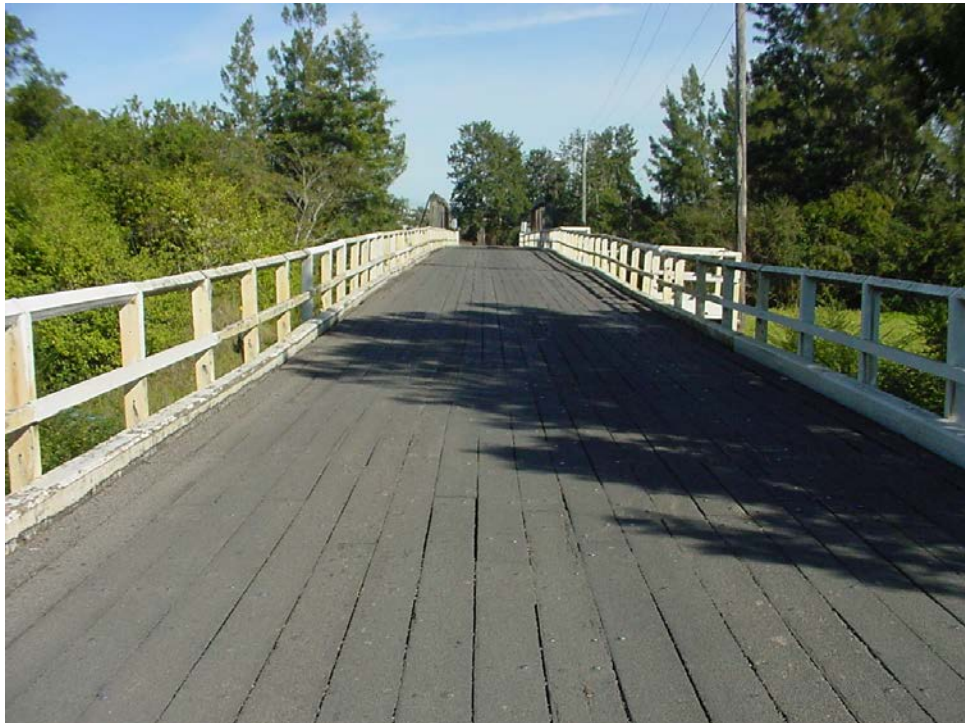
## Timber- Longitudinal Sheeting/Decking

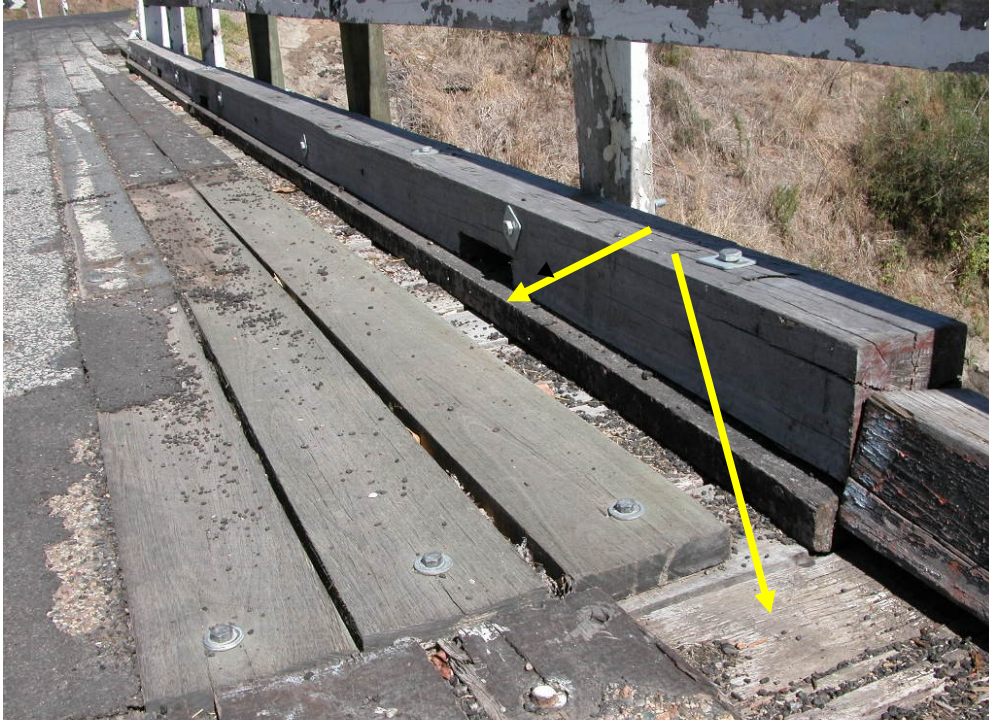
Longitudinal sheeting with minor splitting. Large gap near the kerb and a missing plank.

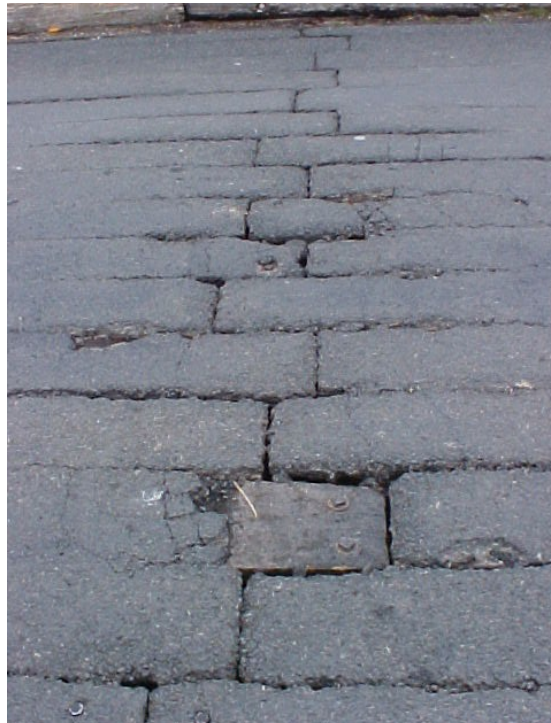
Damaged ends of longitudinal sheeting on rotten cross decking.

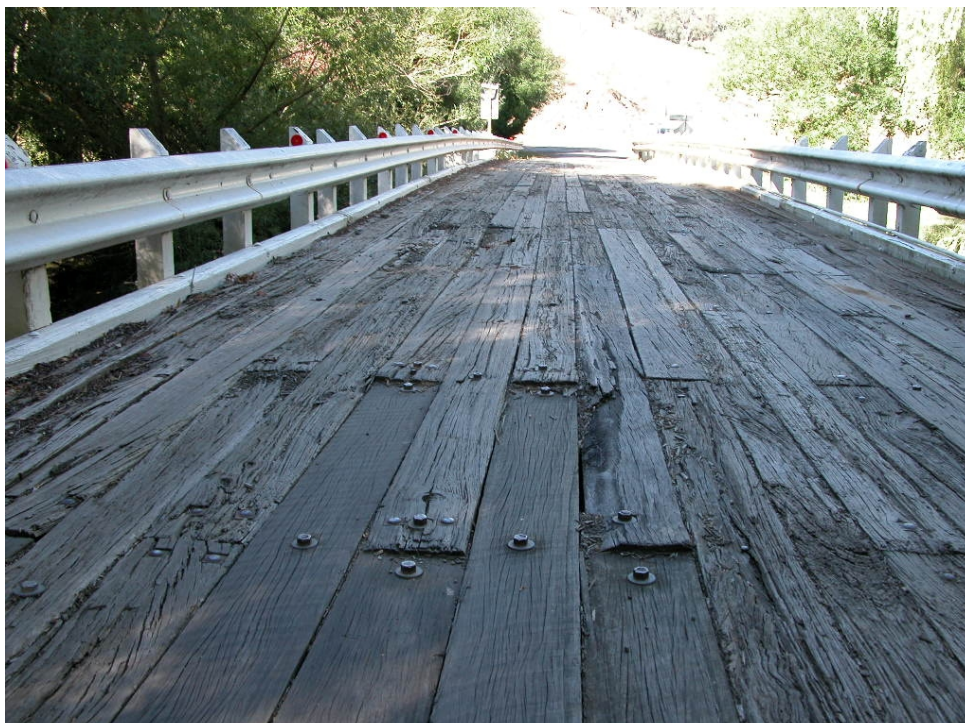
Deck in poor condition with loose bolts and damaged sheetings

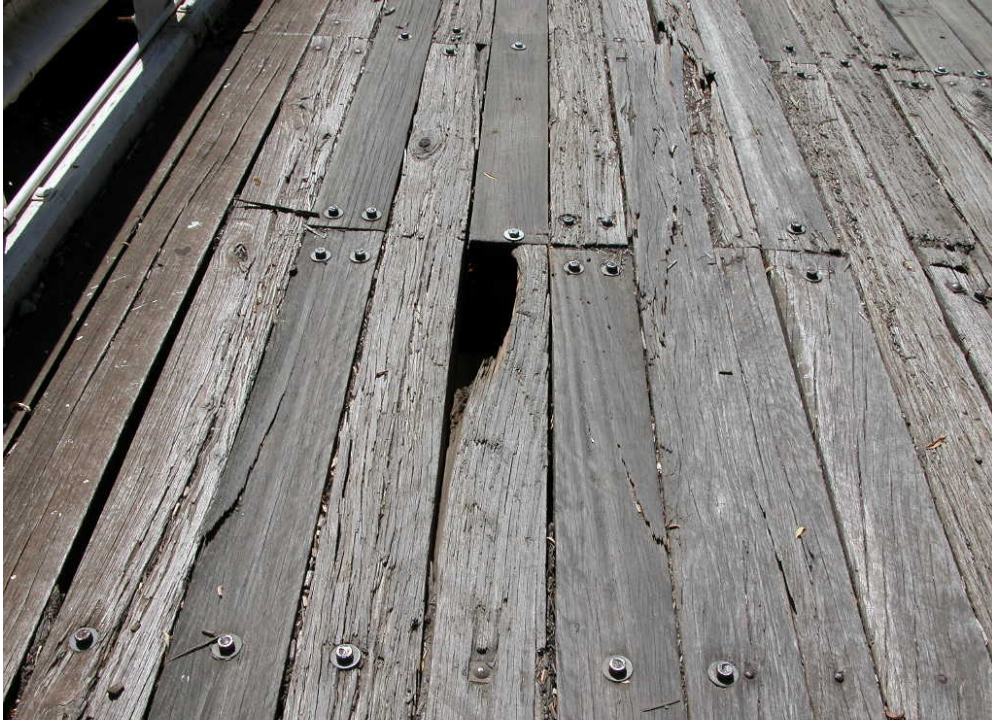
Unsafe longitudinal sheeting with holes, rot and splits.

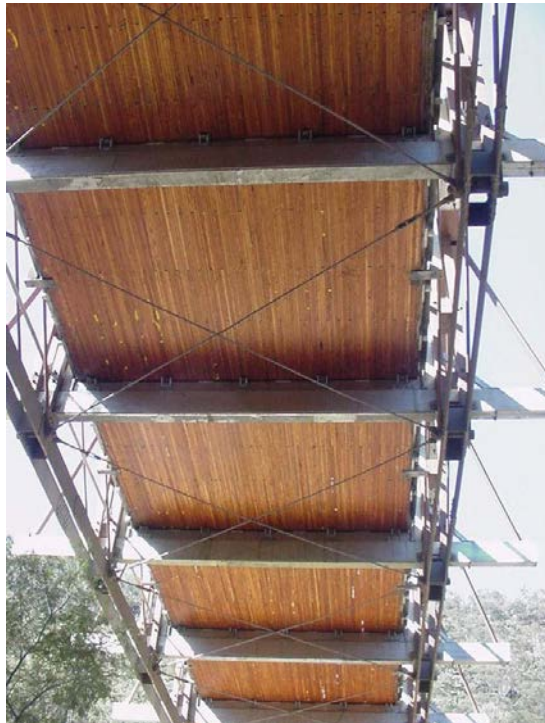
Stress laminated deck in good condition.

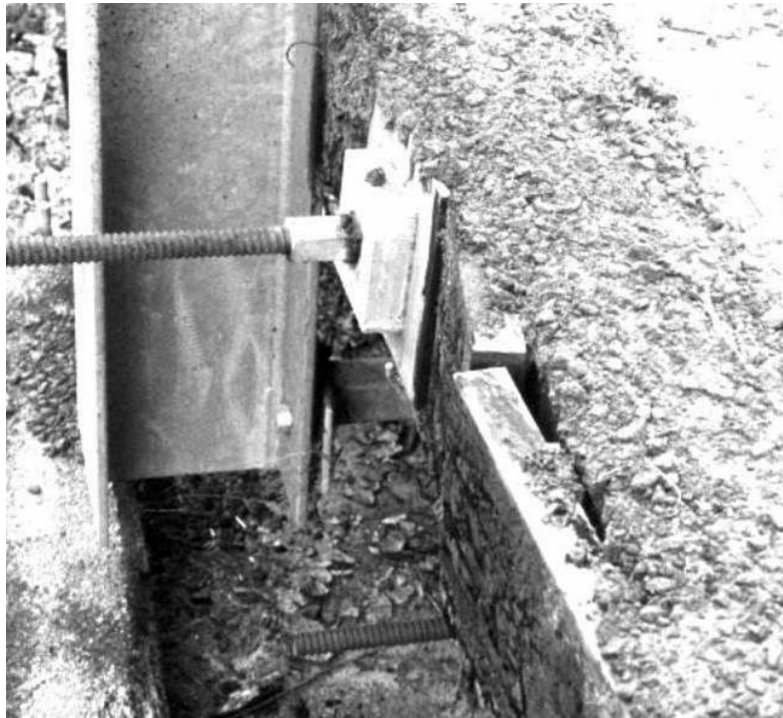
Edge laminates breaking away from the deck.

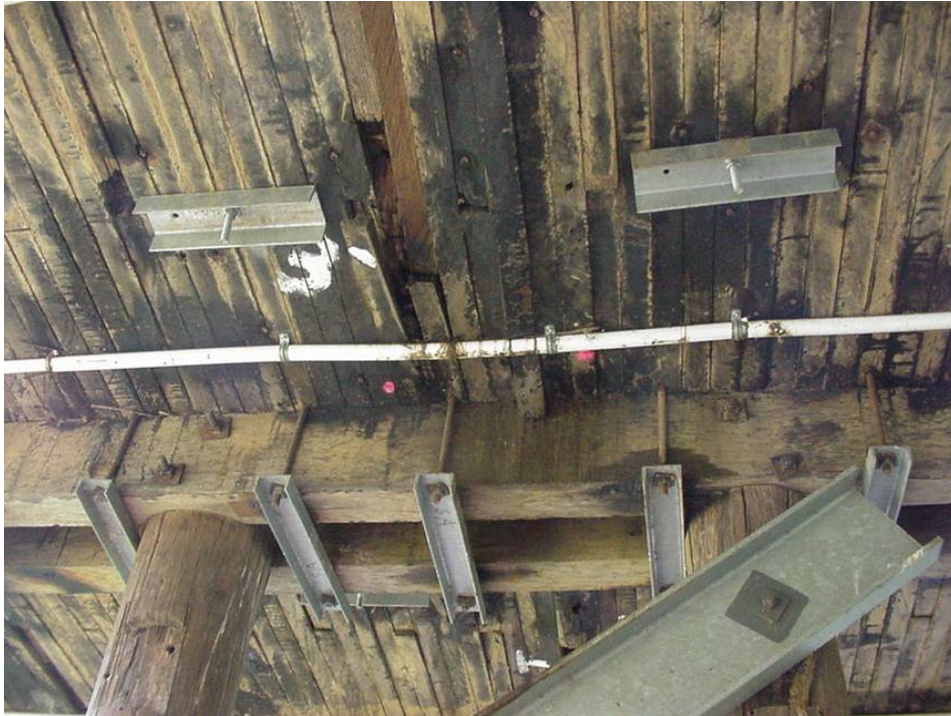
Stress laminated deck in poor condition.

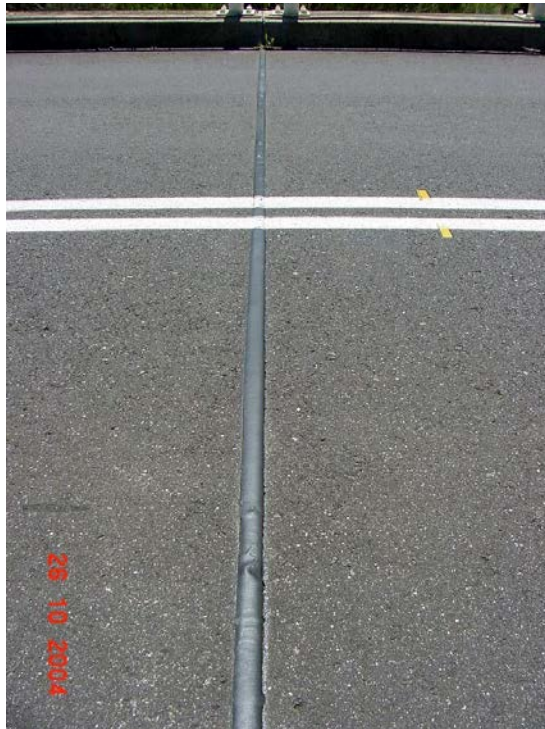
Joint in good condition.

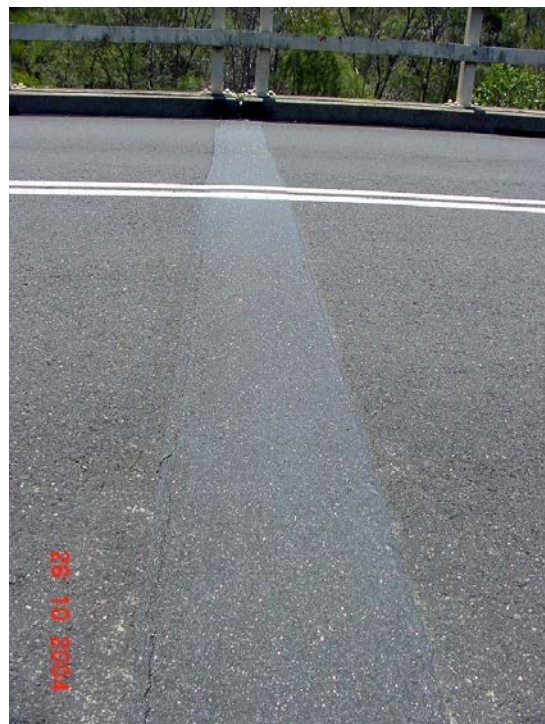
Joint in good condition.

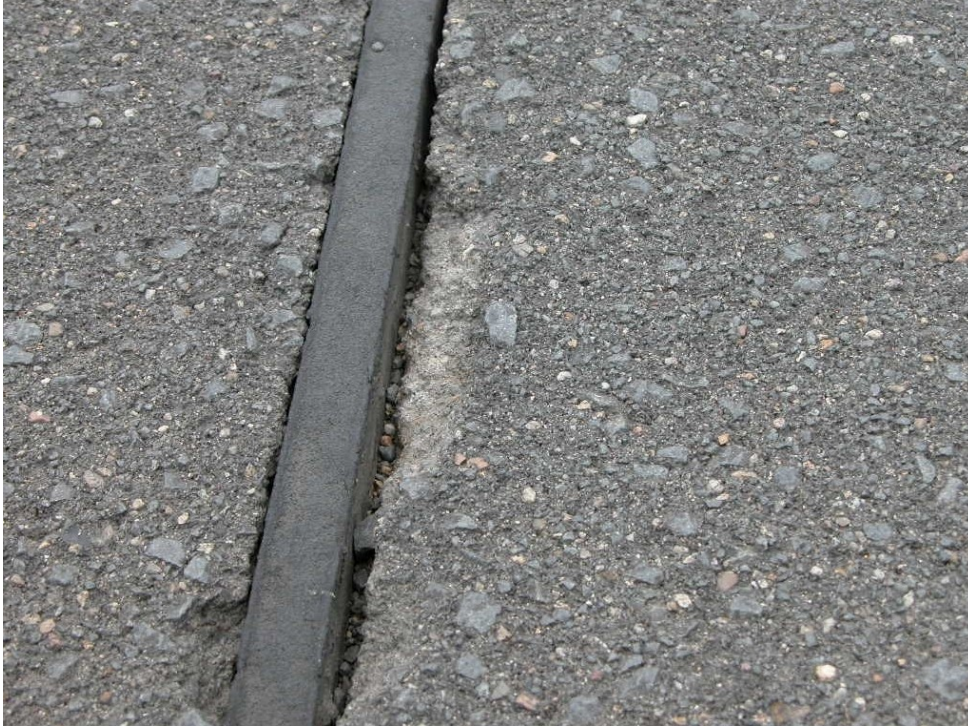
Joint with minor spalls not showing any major leakage under the bridge.

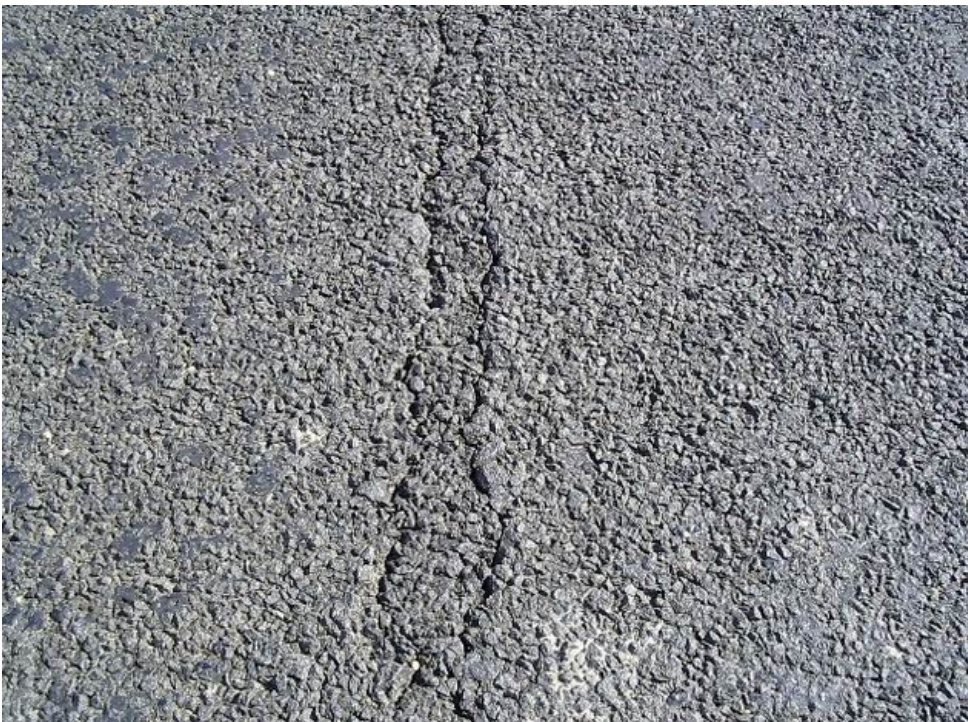
Asphaltic concrete above pourable joint is cracked indicating loss of adhesion

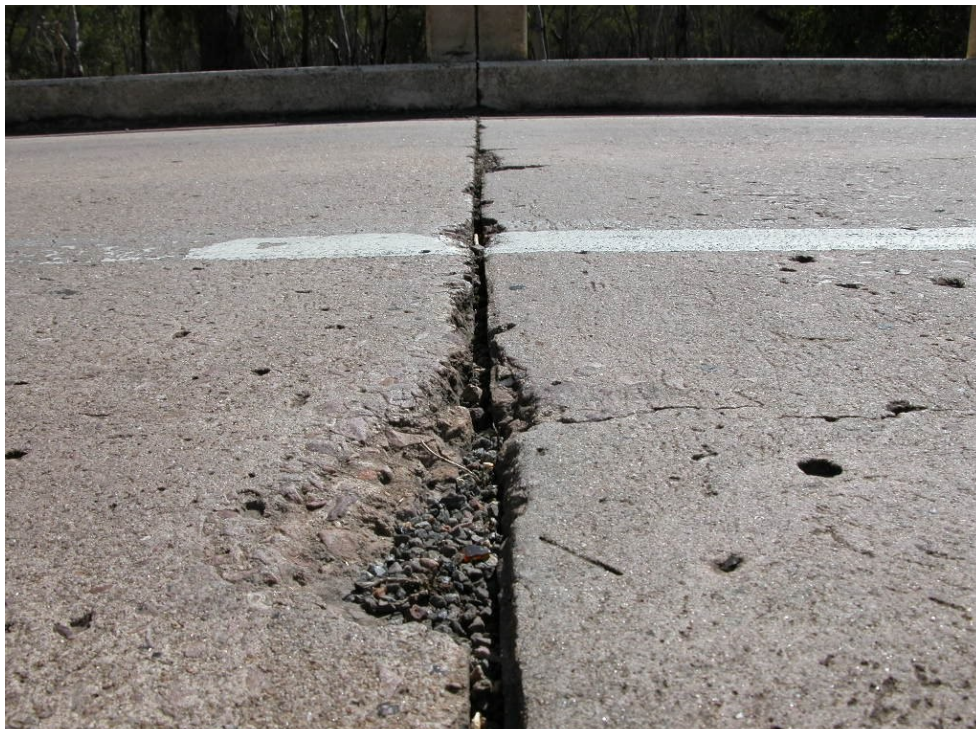
Large spall and debris blocking the joint.

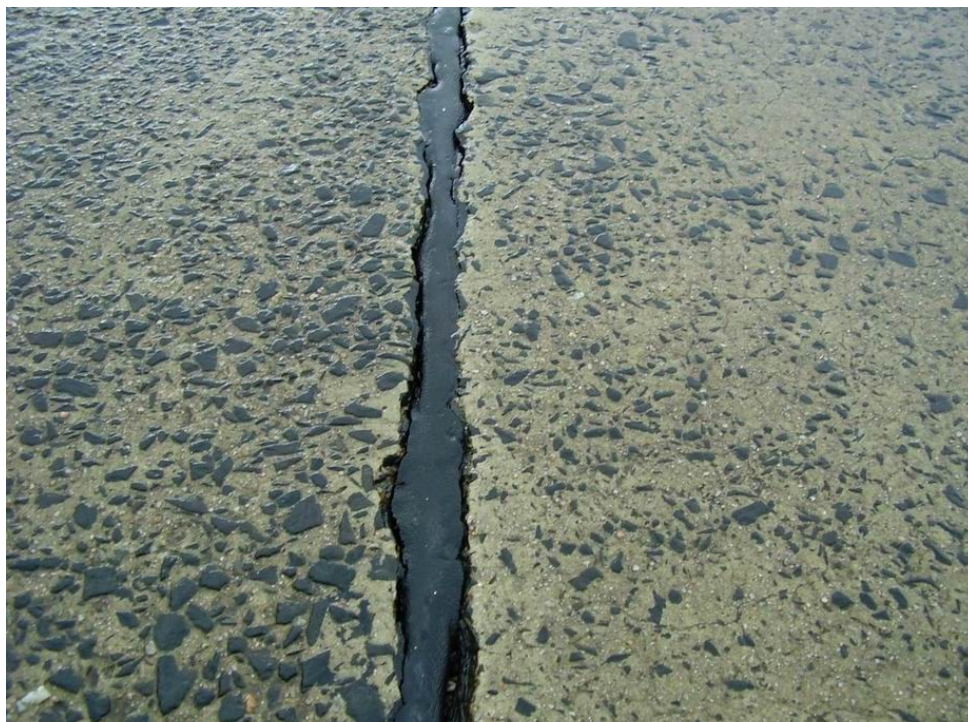
Moderate loss of adhesion allowing moisture onto the pier.

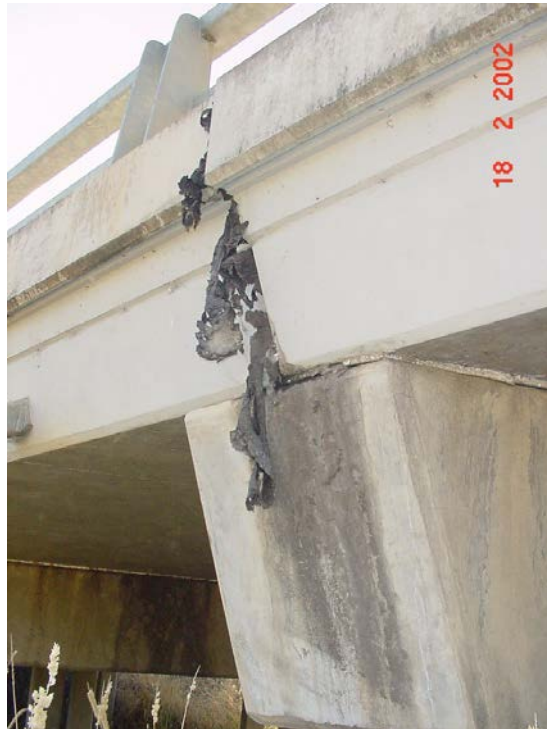
Significant loss of sealant.

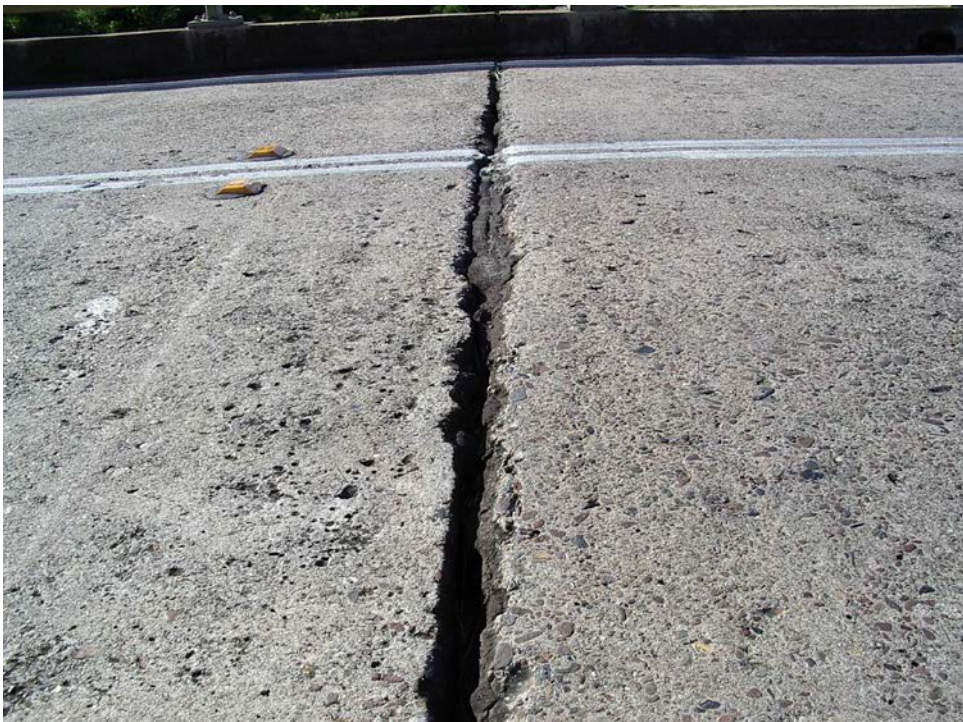
Seal has failed leading to extensive water leakage through the joint.
