Transport  
**Roads & Maritime  
Services**

# **BRIDGE INSPECTION PROCEDURE MANUAL**

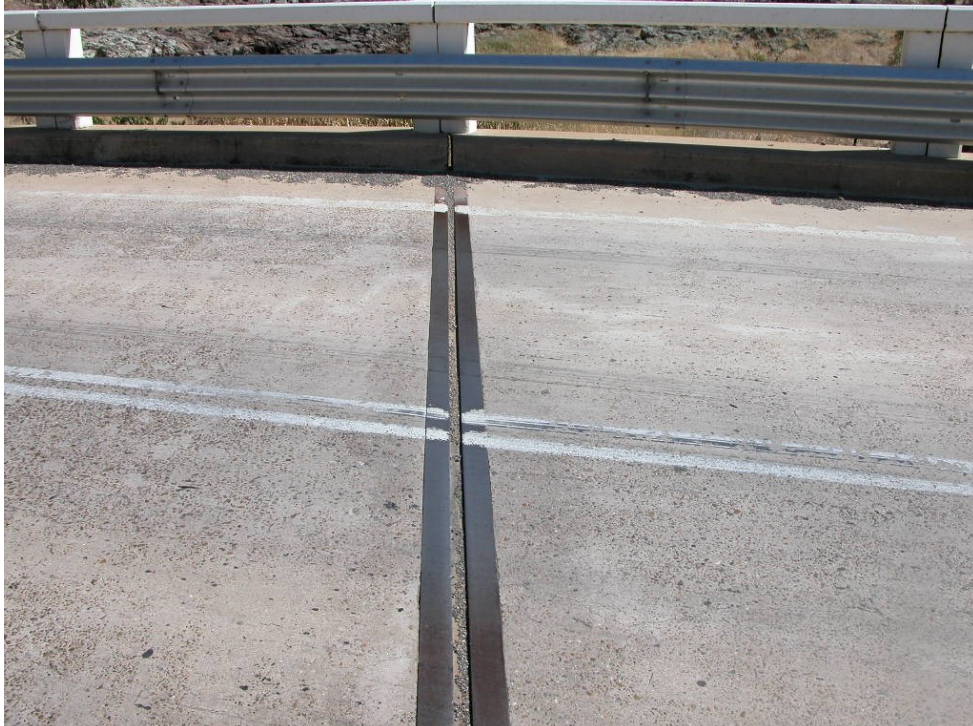
Compression joint in reasonably good condition.

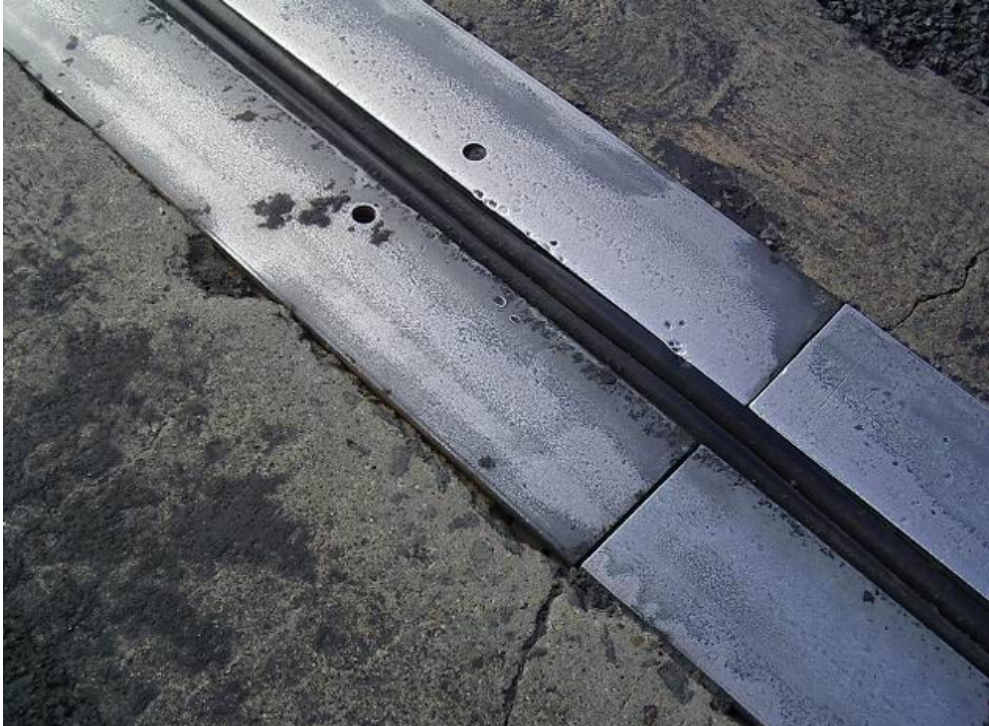
Loose protection angle and a level difference of about 10mm at the joint.

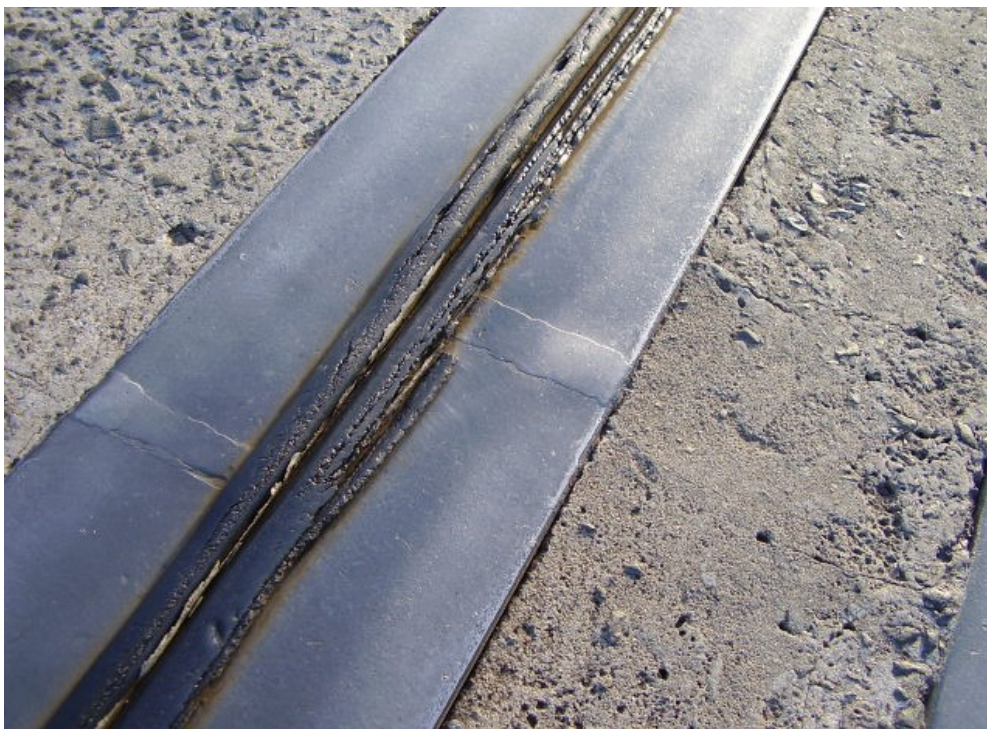
Moderate deterioration of the seal.

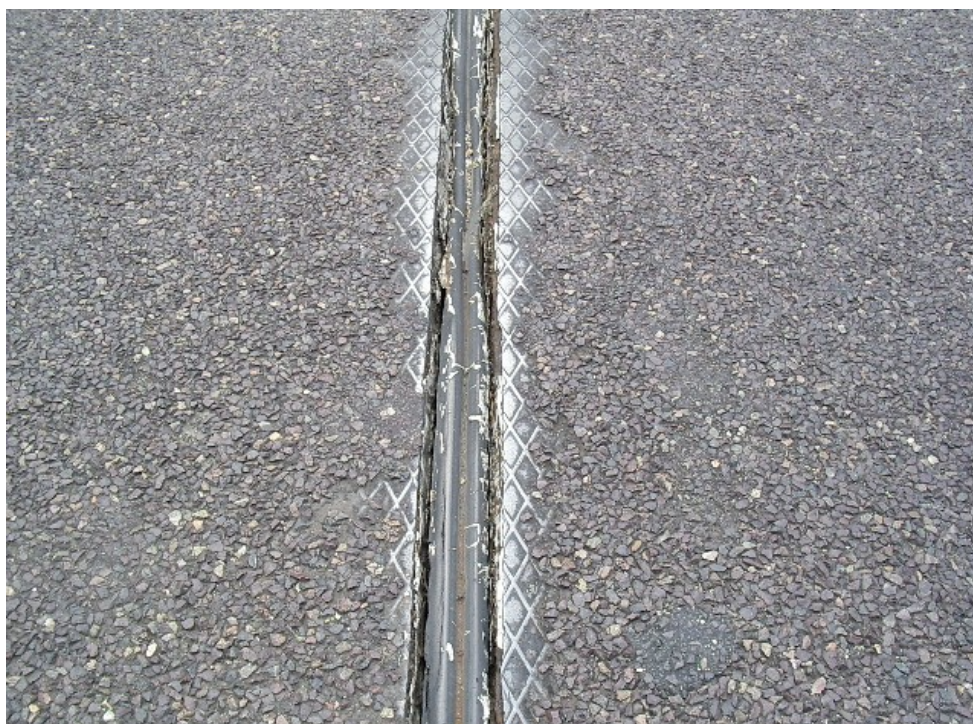
Moderate loss of adhesion on either side of the compression seal.

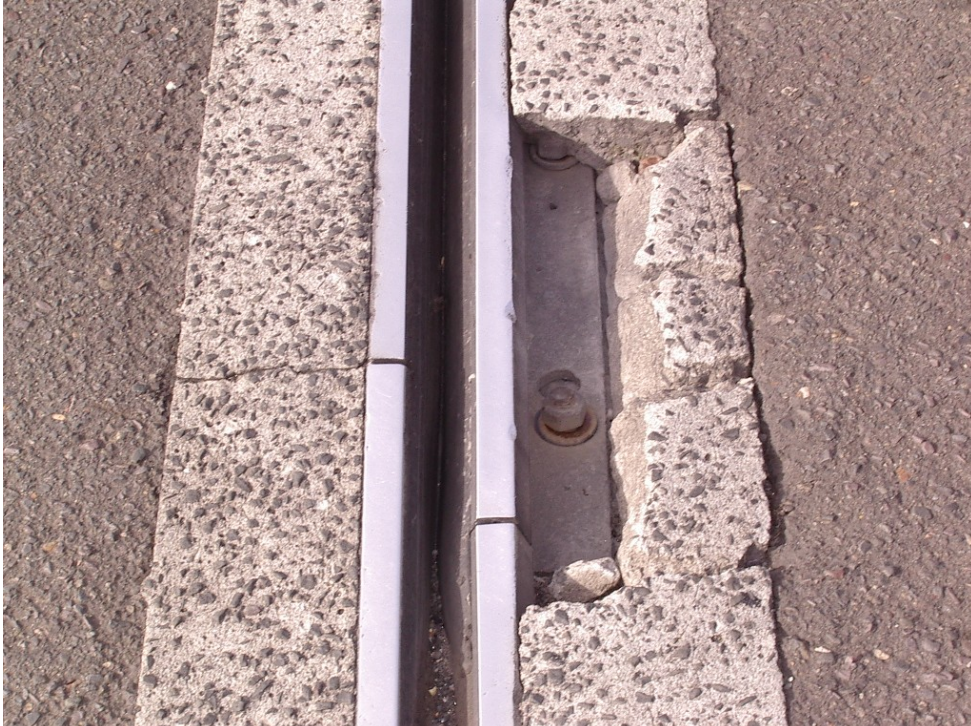
Significant spall and loose nut.

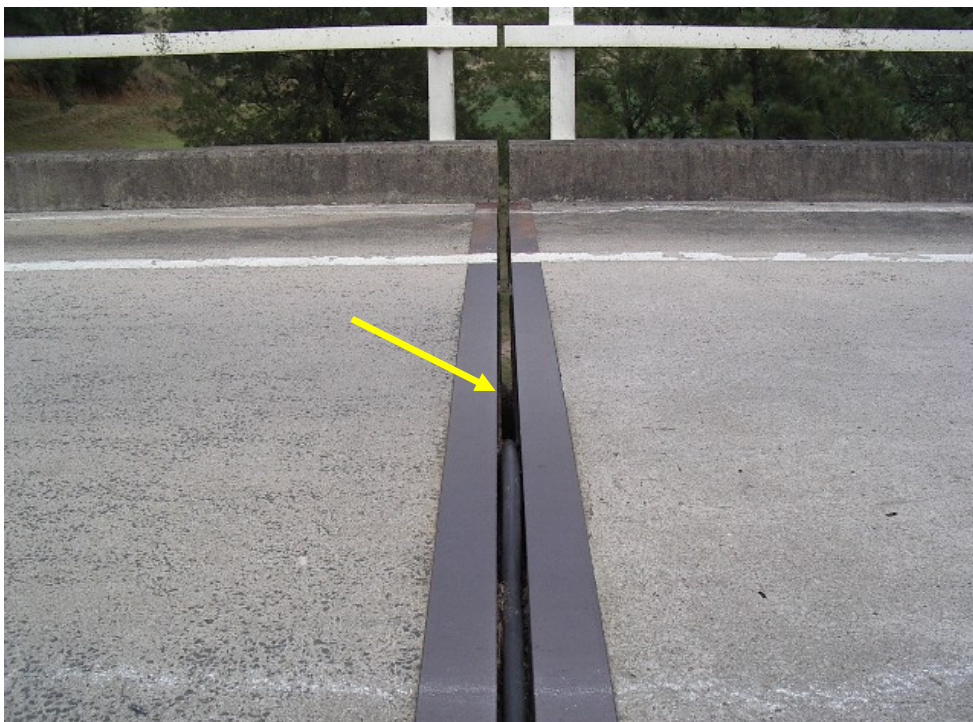
Part of the compression seal dropped down to the pier and significant loss of adhesion in the rest.

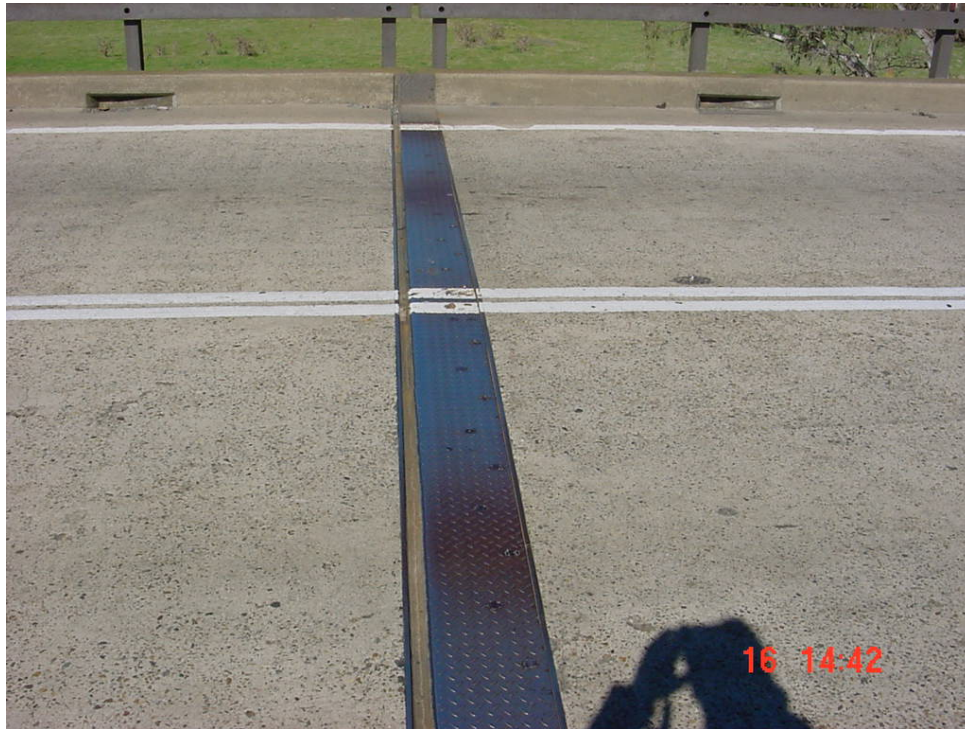
Joint in good condition.

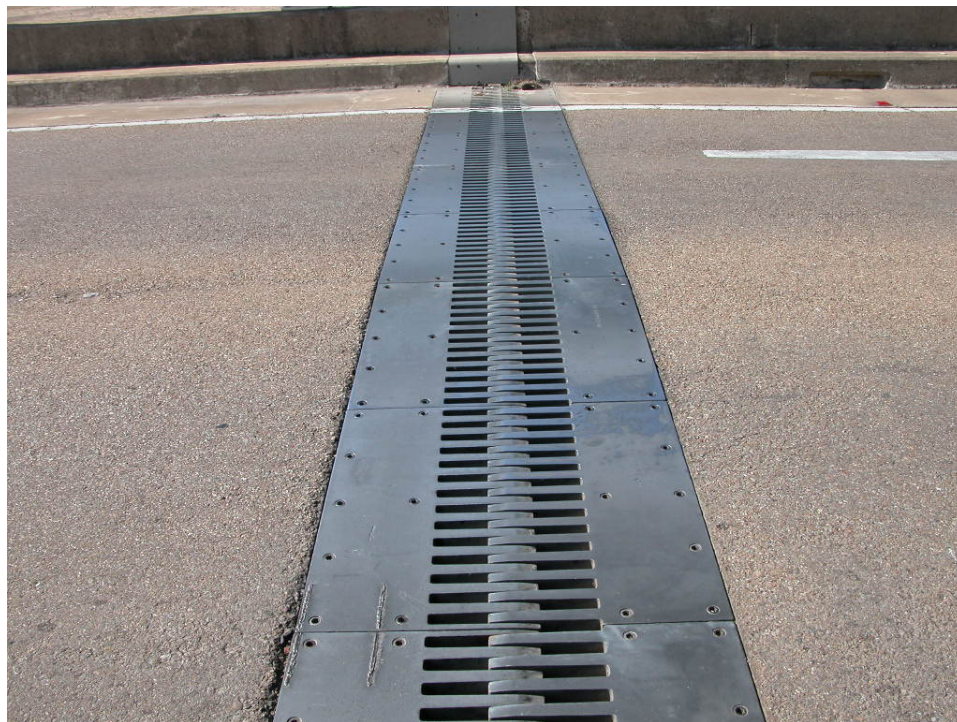
Joint in good condition.

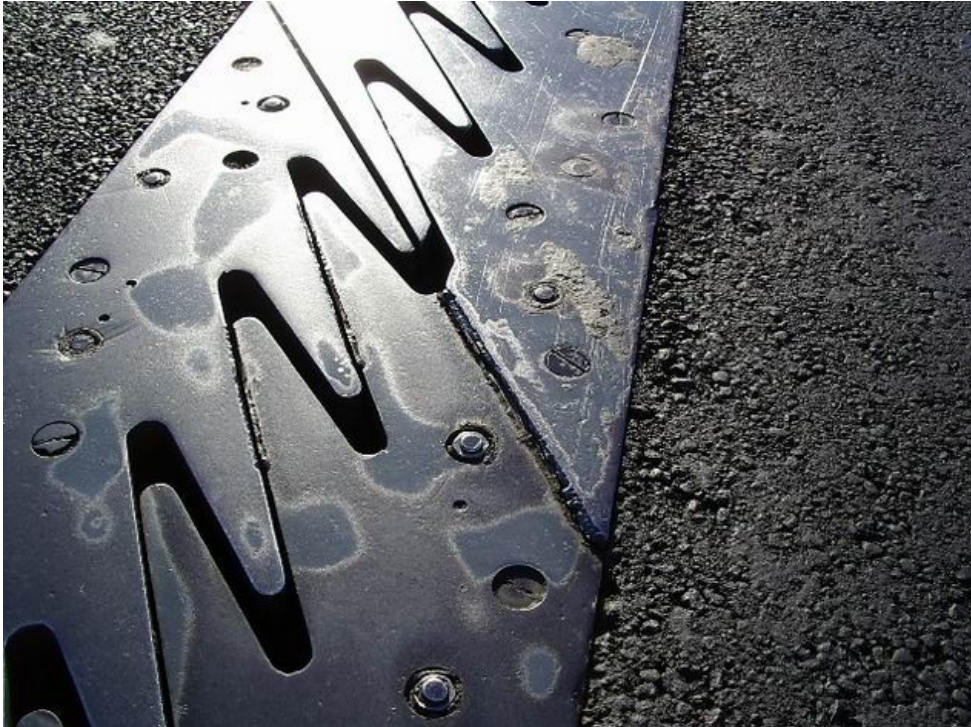
There may be minor weld cracking in non structural members. There are no untoward noises upon impact. The seal, if any, may show signs of abrasion or minor tearing. The adjacent deck shows no signs of anchors loosening. There may be minor spalling or cracking of the anchorage concrete. There may be minor misalignment of the fingers or transverse centre beams.

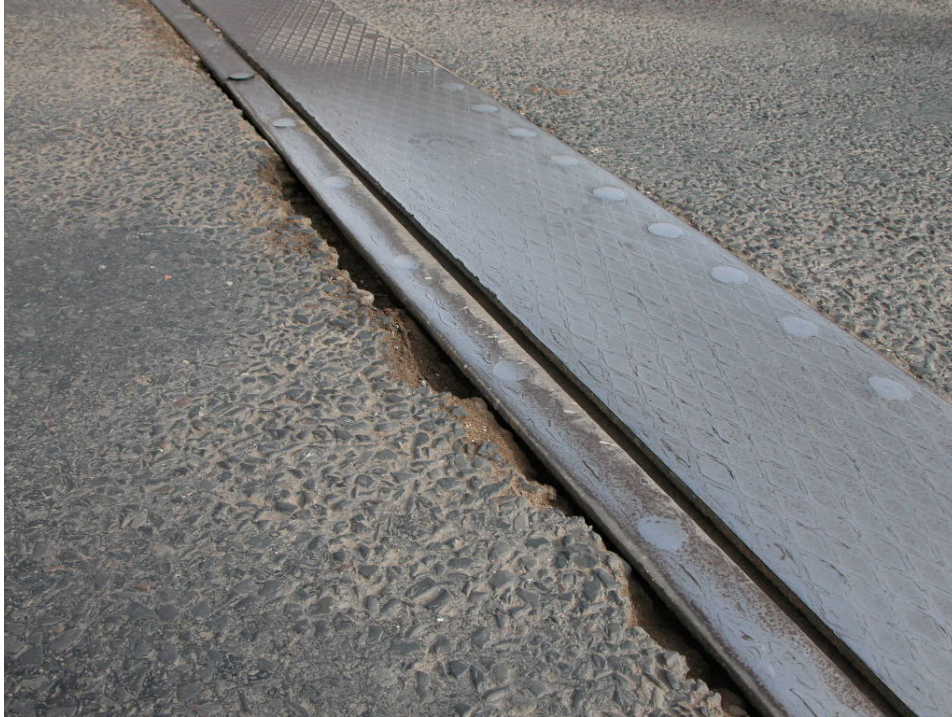
Significant spalling of concrete adjacent to the joint.

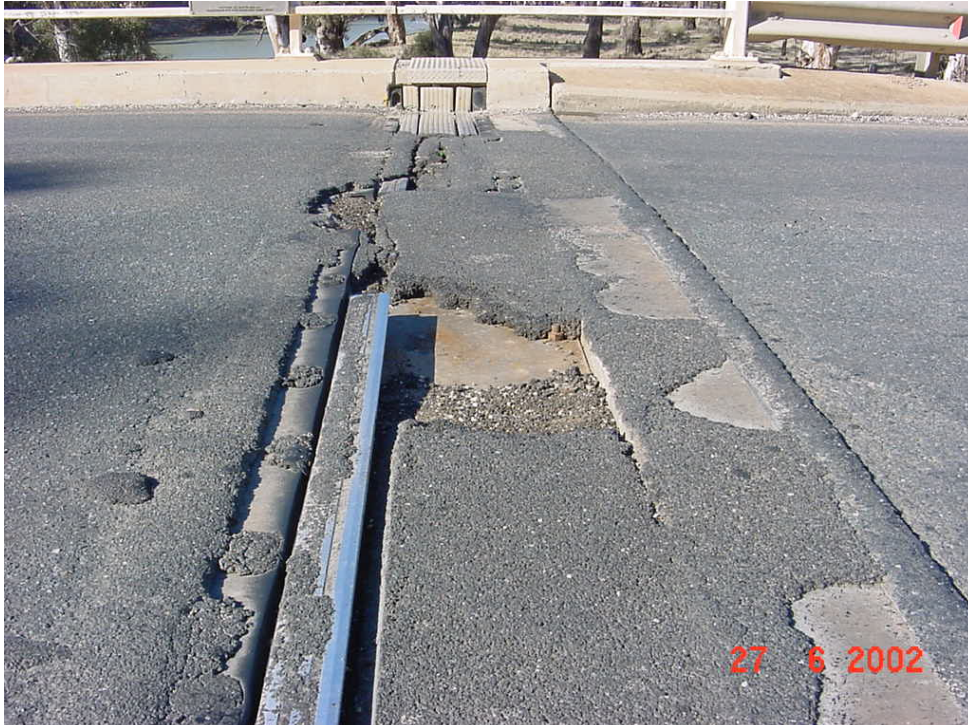
Joint in poor condition.

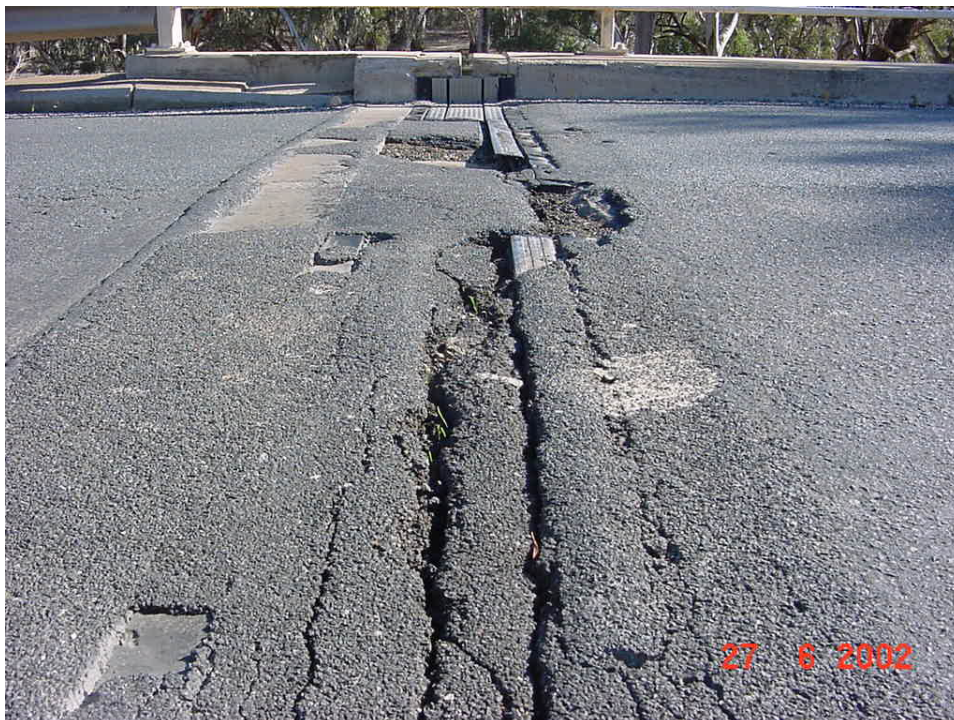
Joint in poor condition.

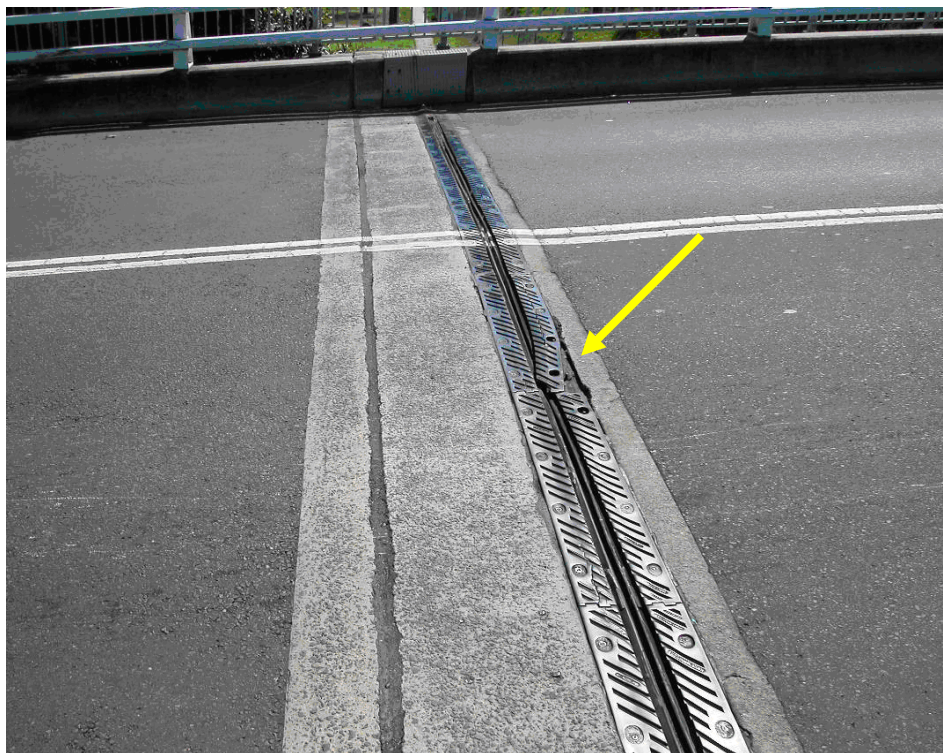
Broken anchor bolts and assembly breaking loose.

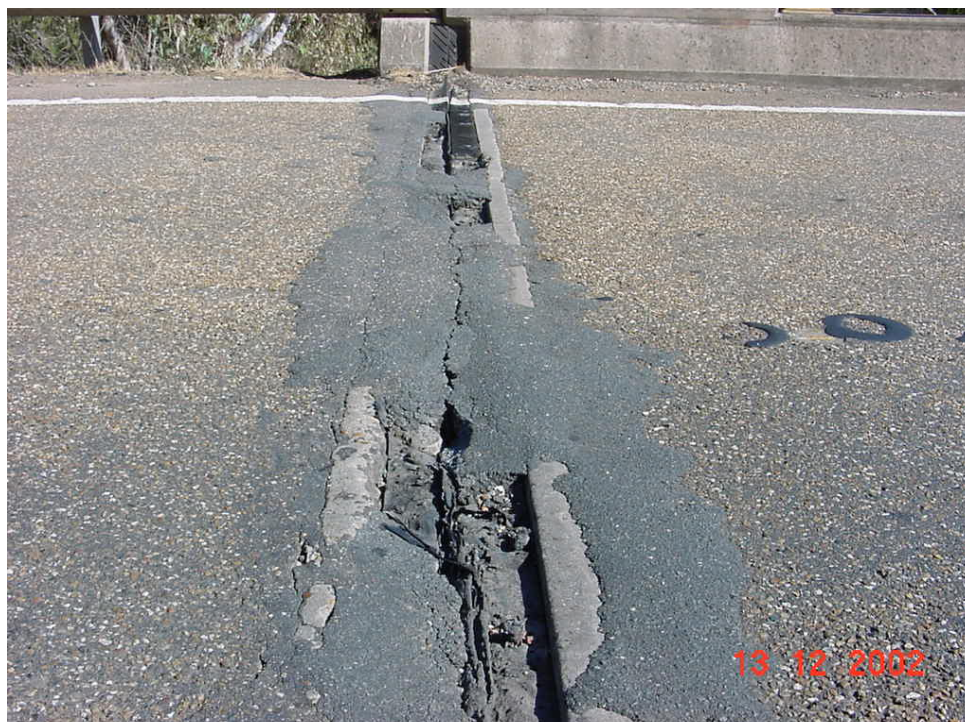
Joint in poor condition.

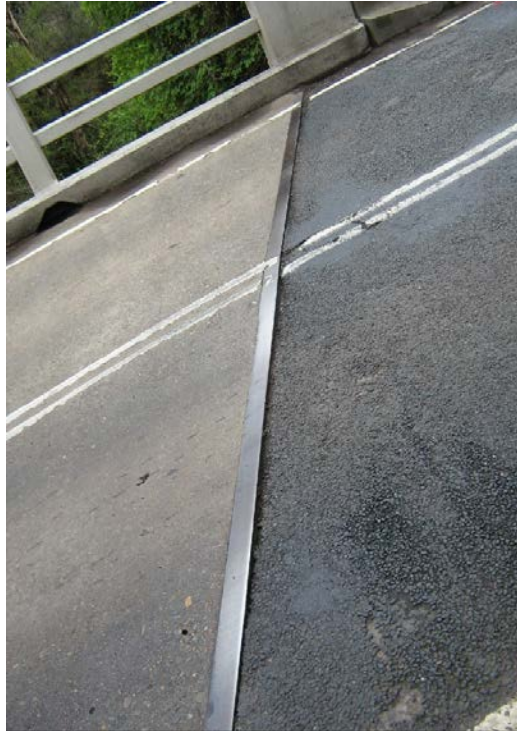
Joint in good condition.

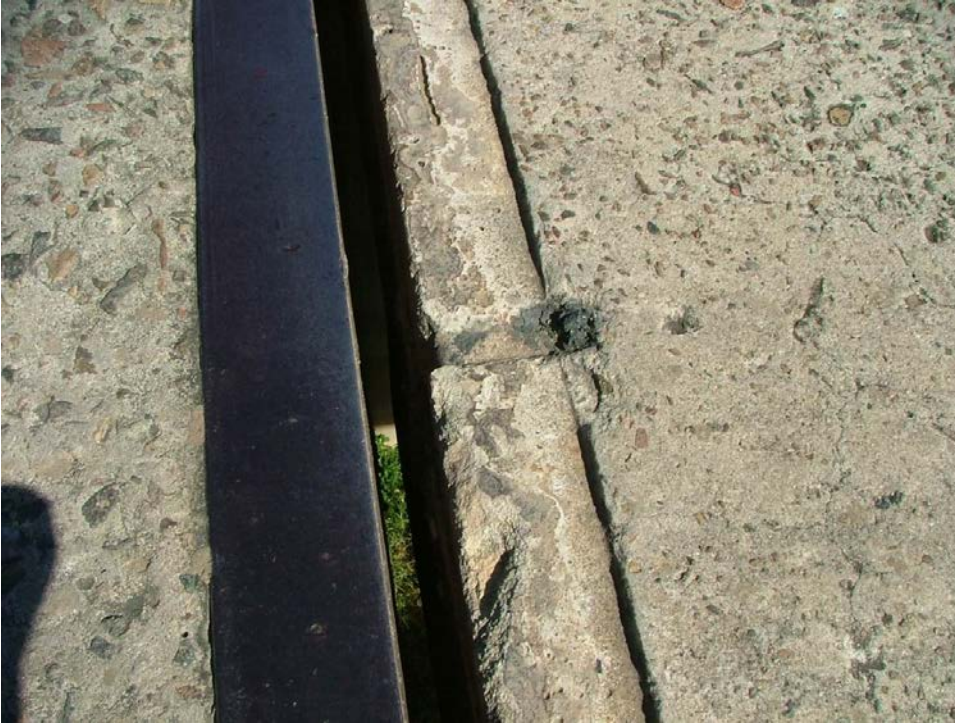
Loose protection angle removed. Minor spall at concrete edge.

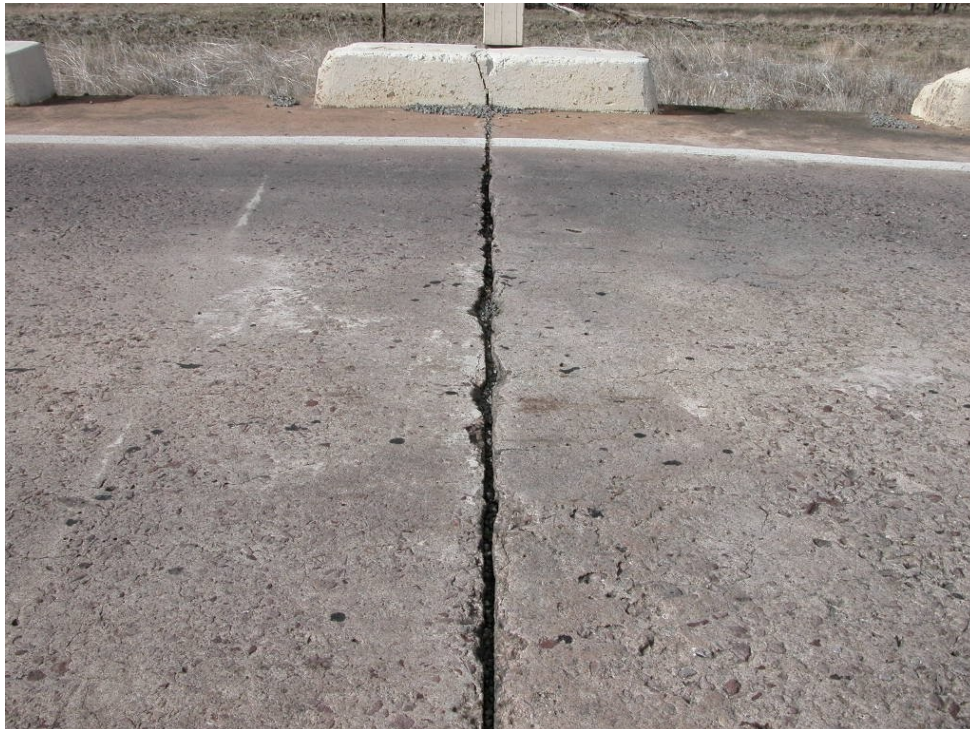
Joint blocked with debris. Minor spalls at joint edges.

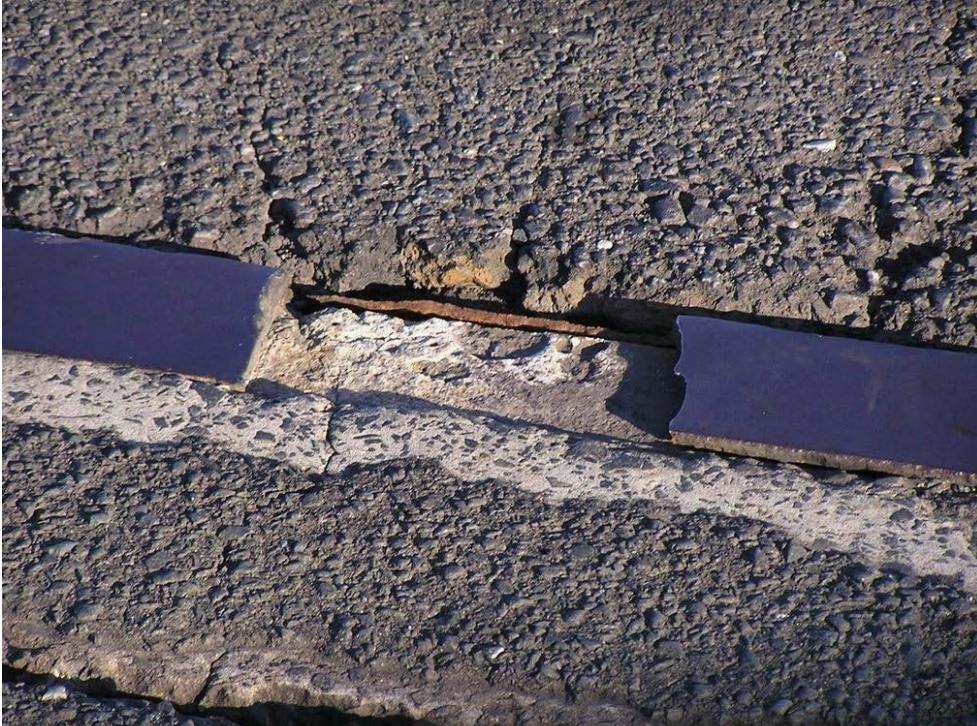
Loose and broken protection angle.

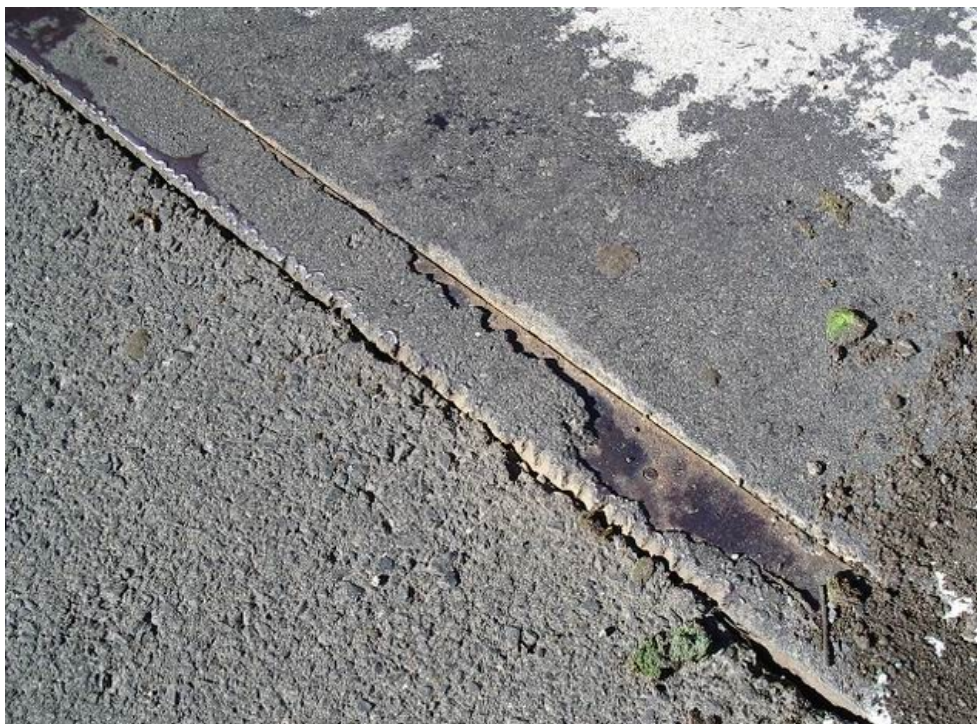
Protection angle is loose and noisy.

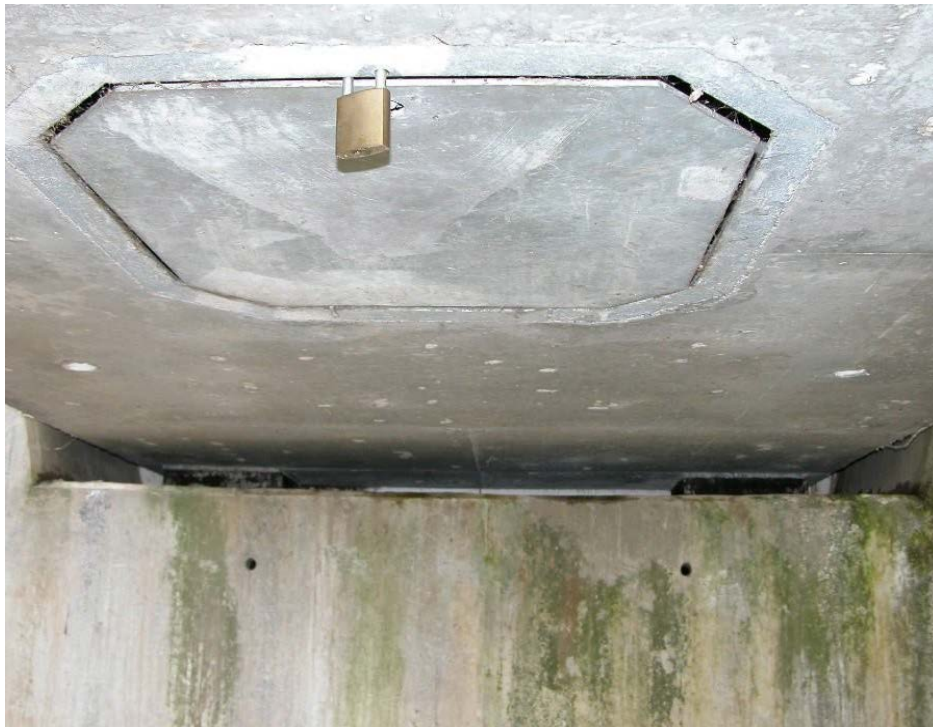
Elastomeric bearings in good condition

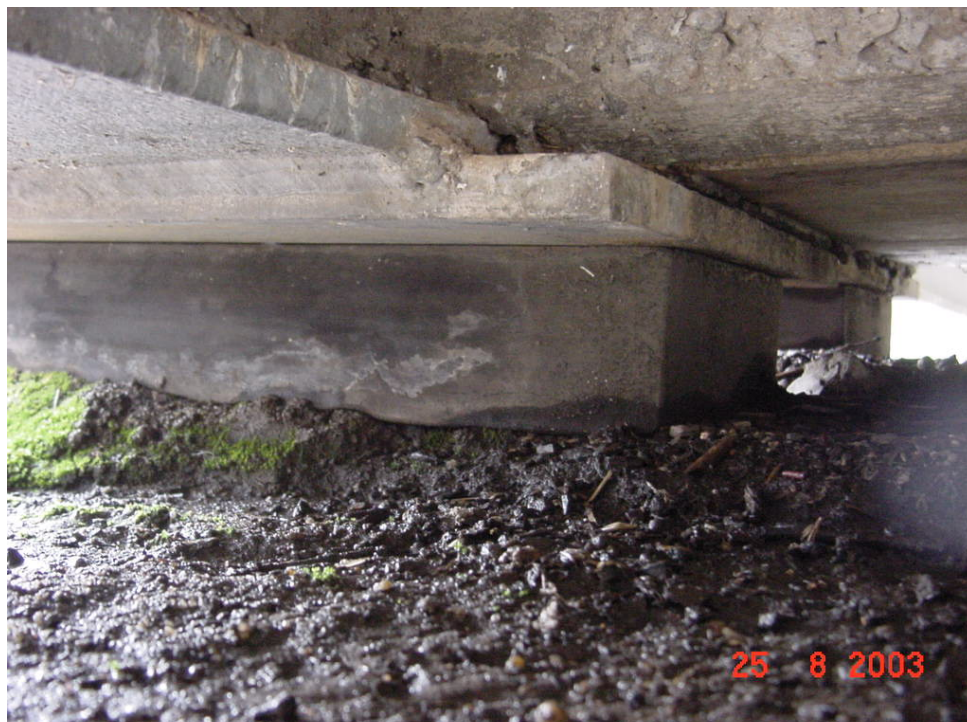
Elastomeric bearing in good condition. General cleaning required.

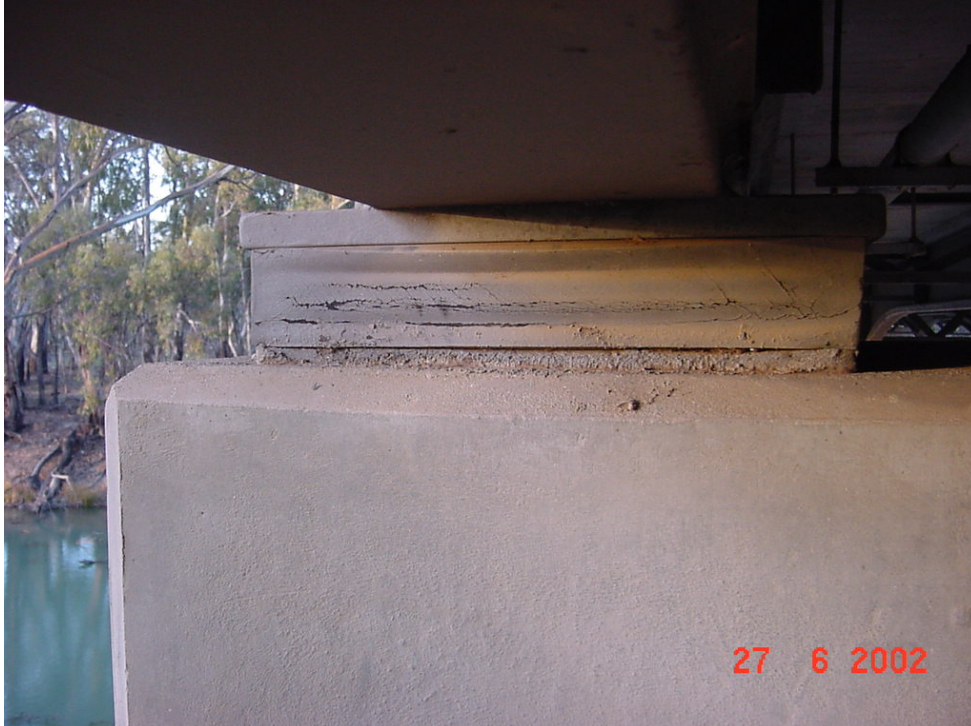
Minor cracking and splitting.

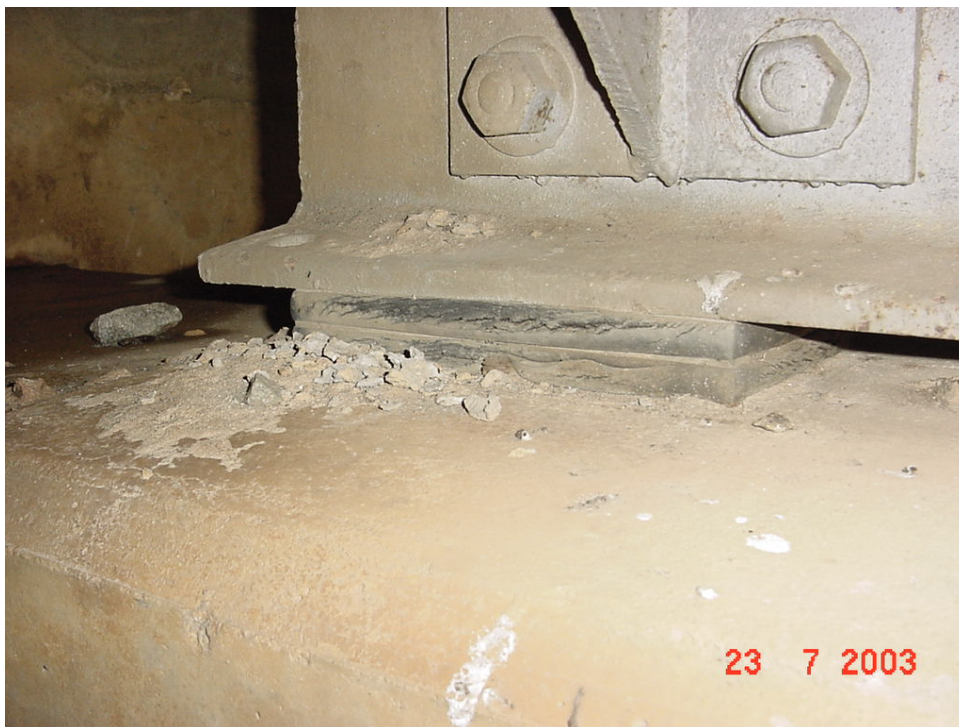
Significant splitting and bulging of bearing pads.

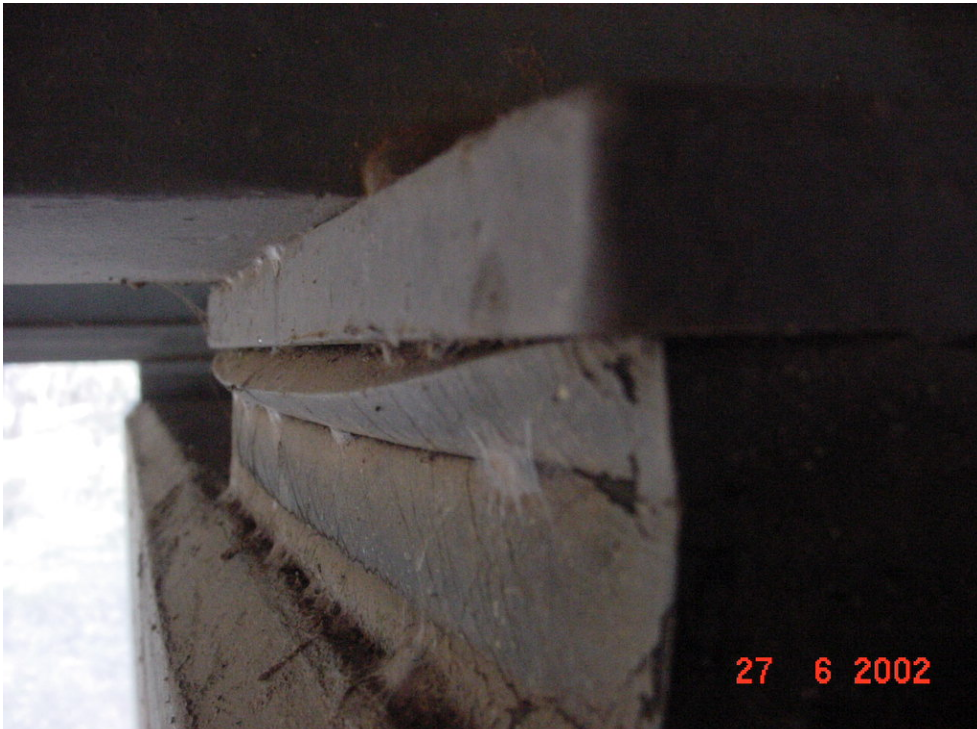
Significant bulging of bearing pad.

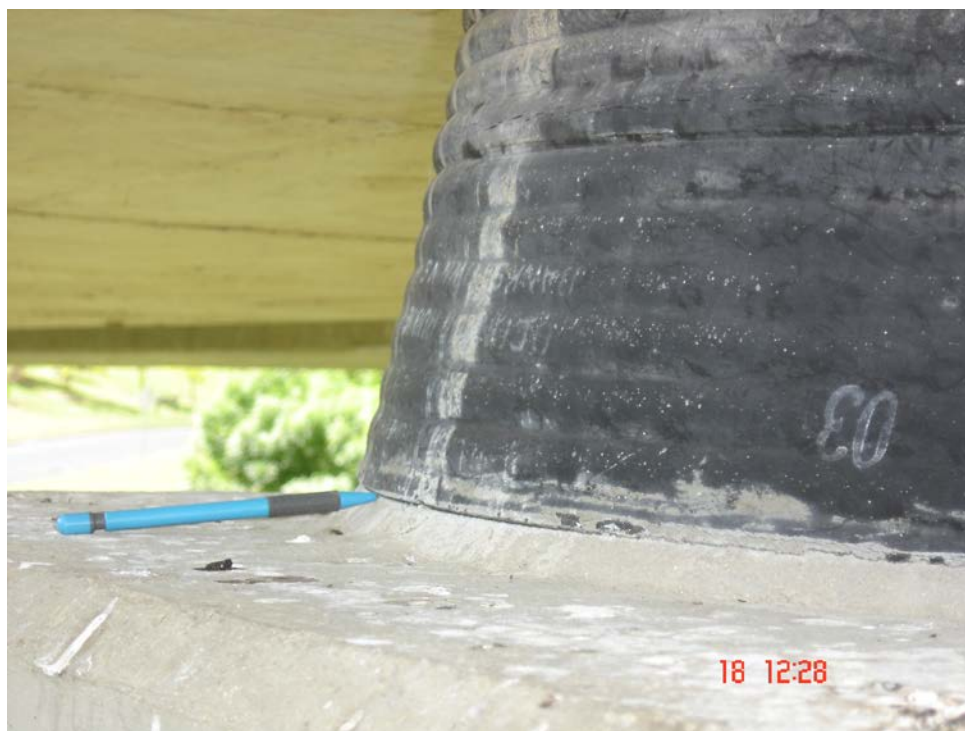
Elastomeric bearing showing excessive shear deformation.

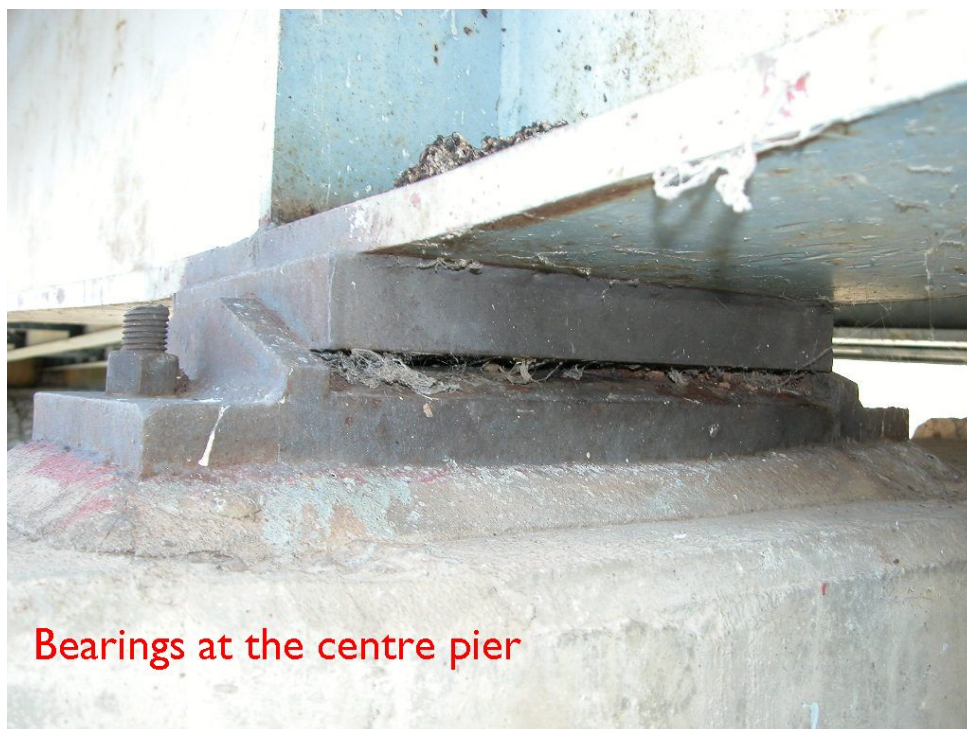
**Bearings at the centre pier**

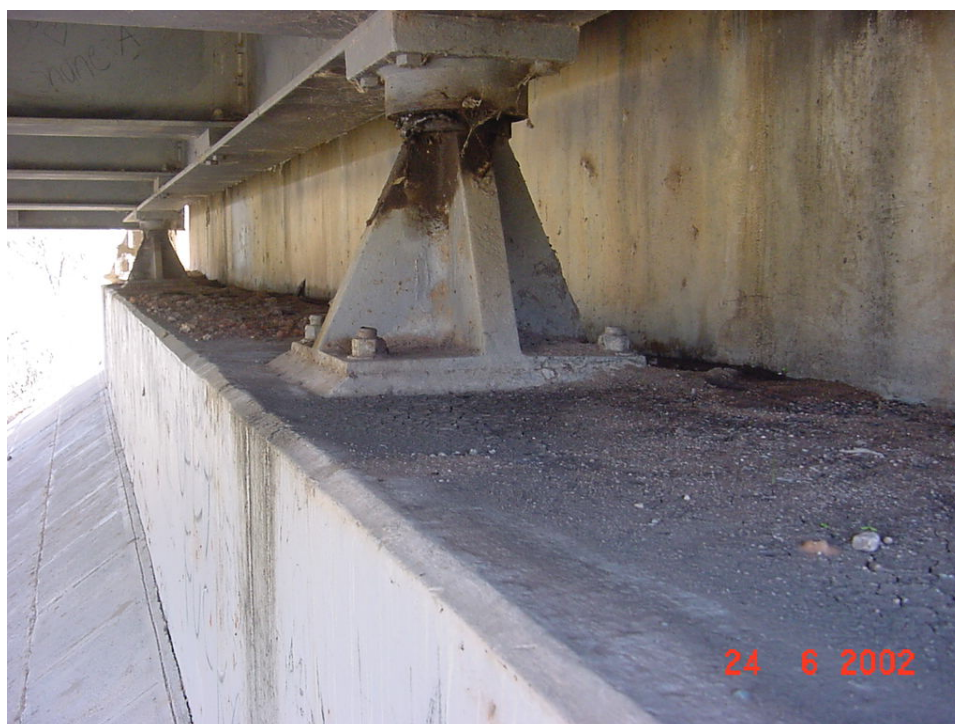
Bearing in good condition.

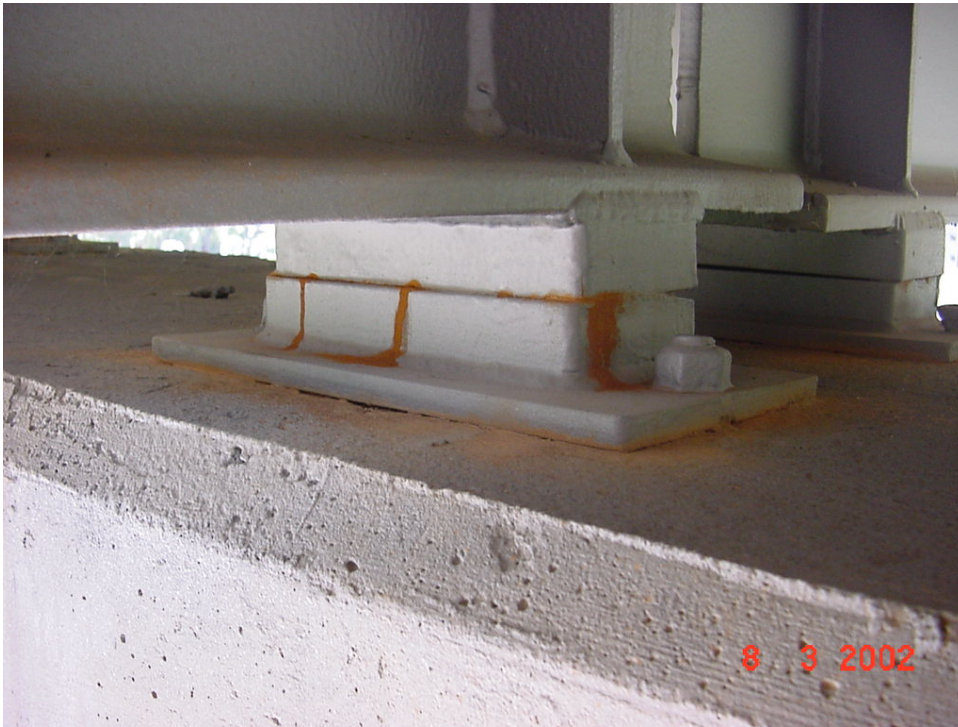
Signs of corrosion at the edges of interface.

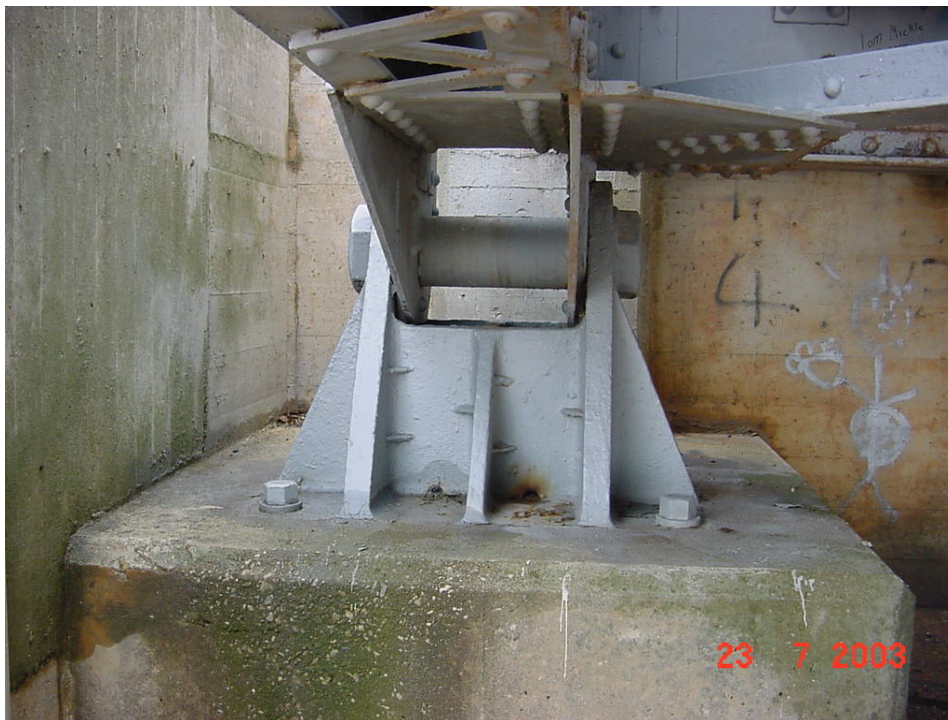
Signs of surface corrosion.

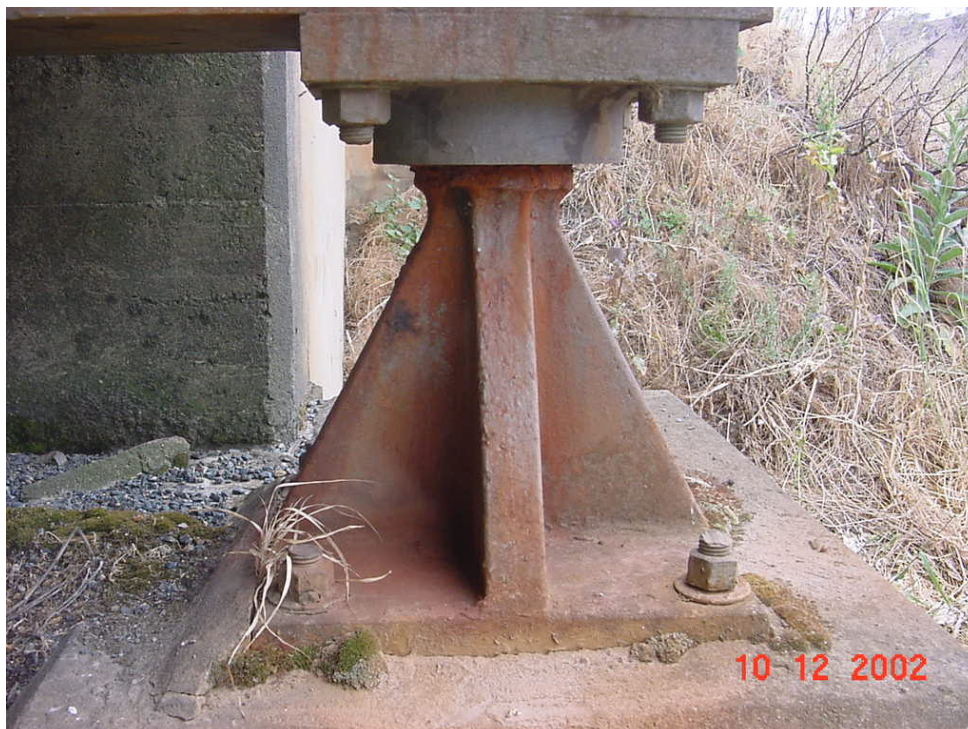
Surface corrosion of the bearing.

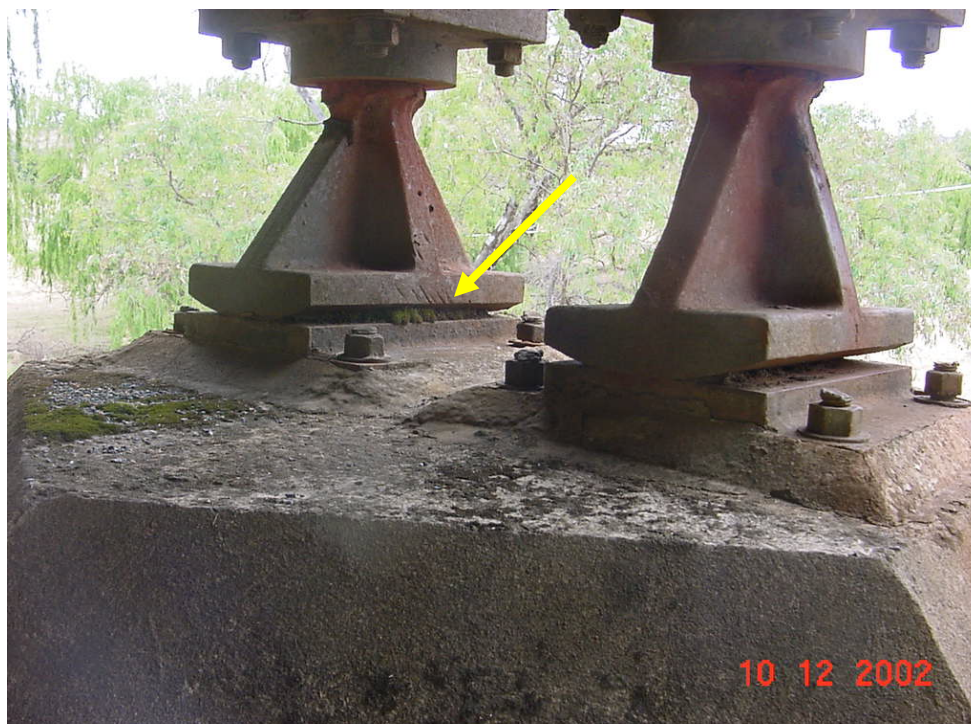
Surface corrosion and some accumulation material at the interface.

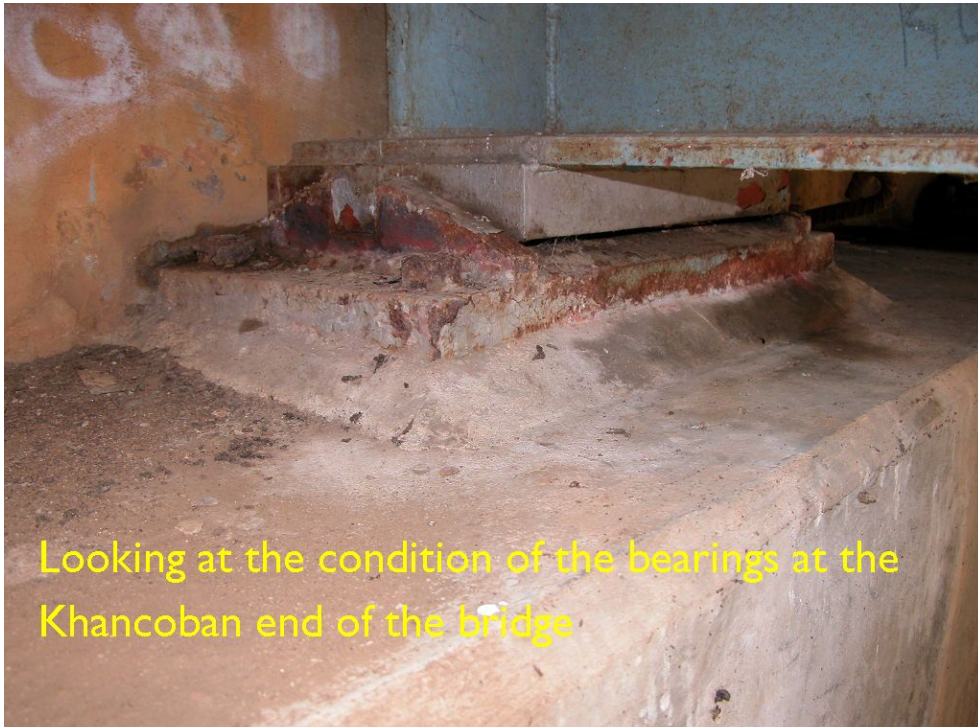
Corrosion of the base plate with minor pitting.

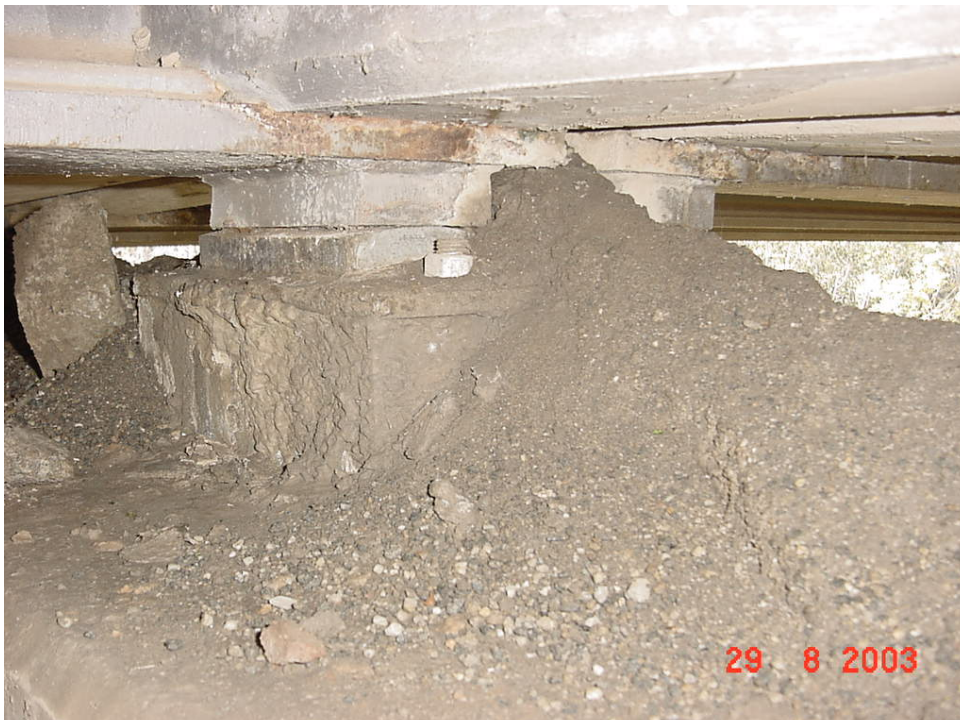
Significant buildup of debris.
