Transport  
**Roads & Maritime  
Services**

# **BRIDGE INSPECTION PROCEDURE MANUAL**

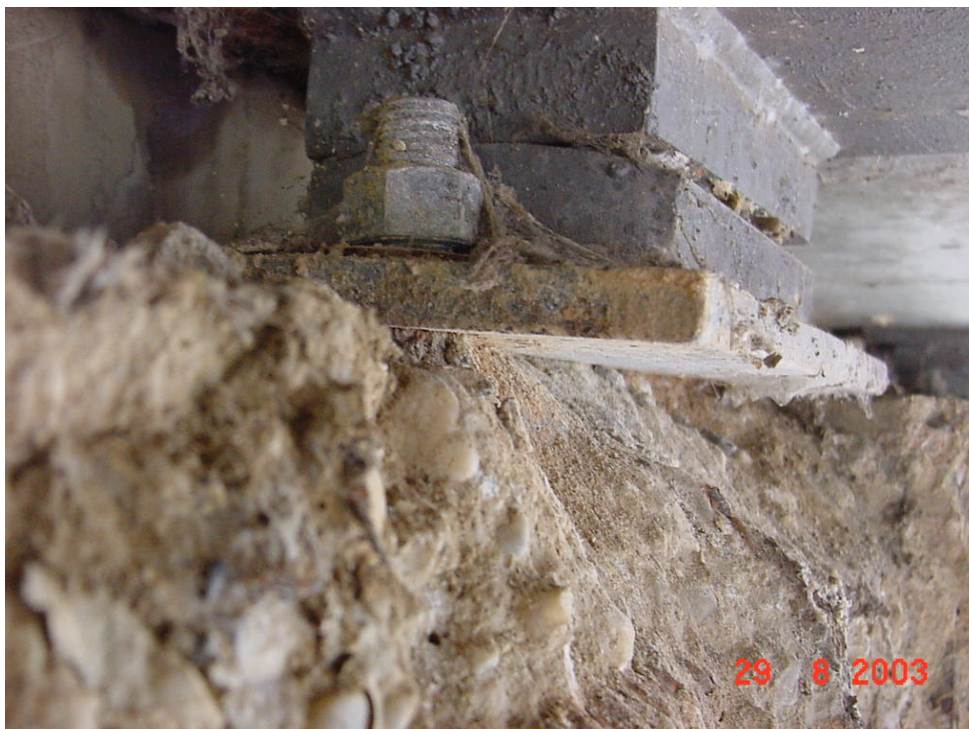
Significant loss of support under the bearing.

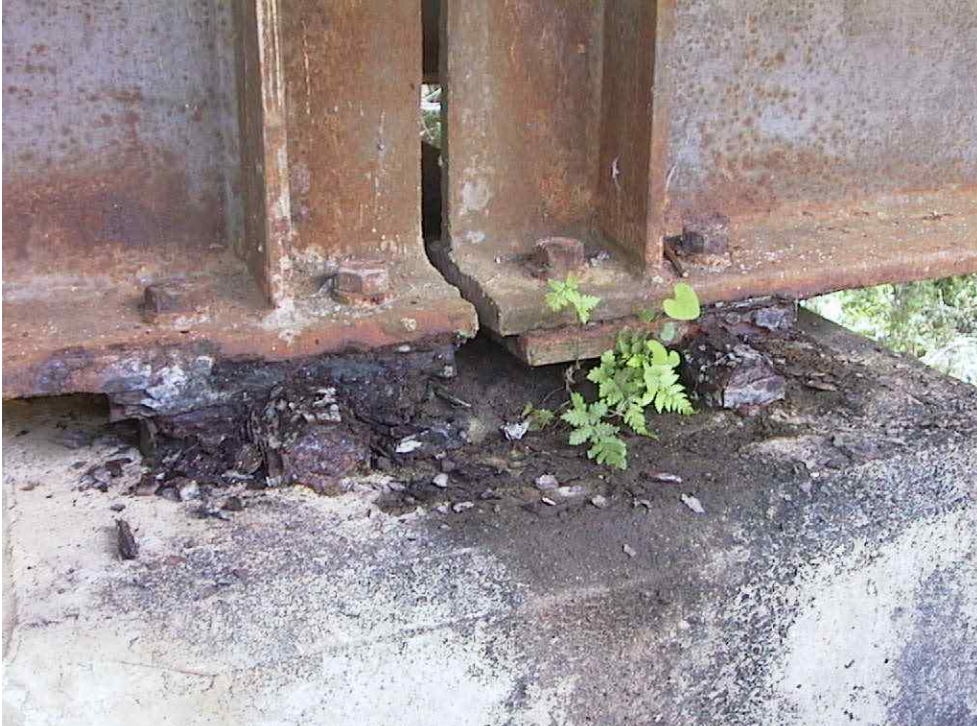
Advanced corrosion of the base plate.

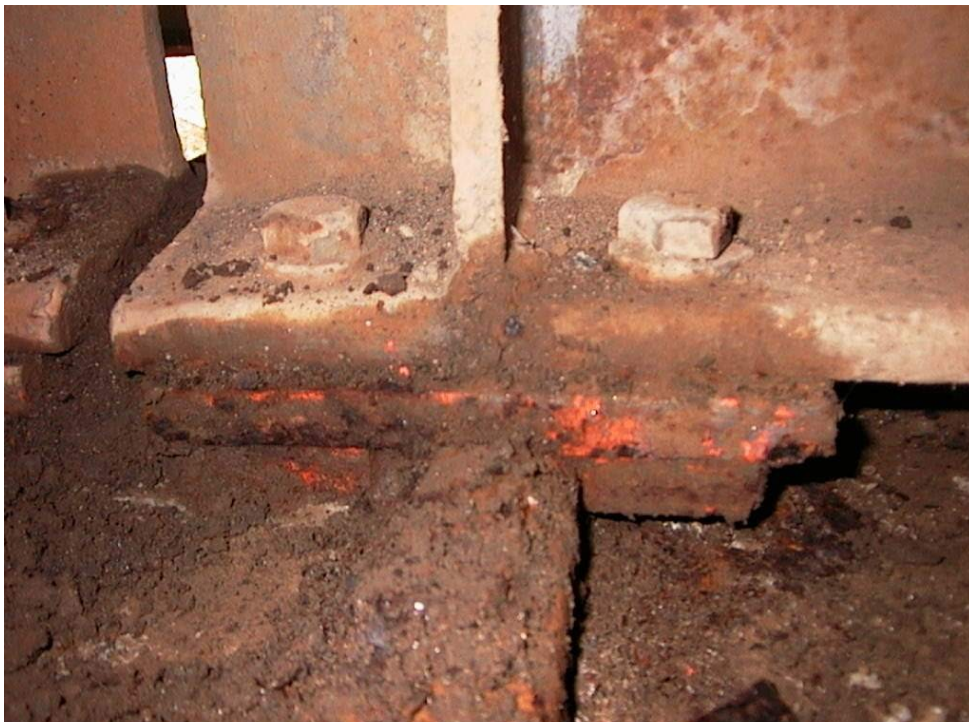
Significant corrosion with pitting.

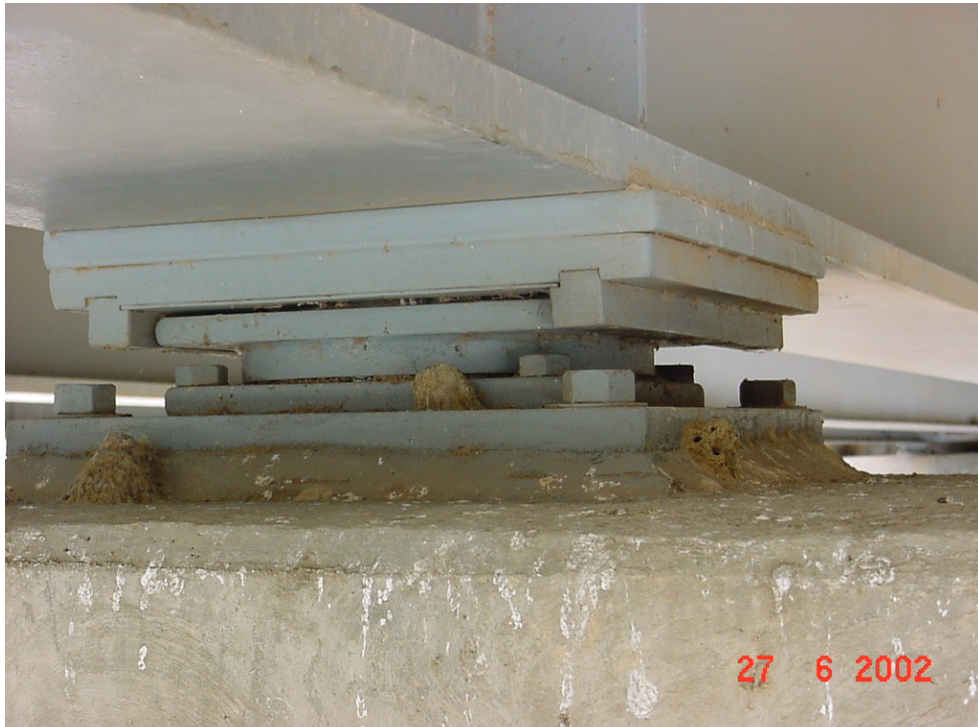
Enclosed bearing in good condition.

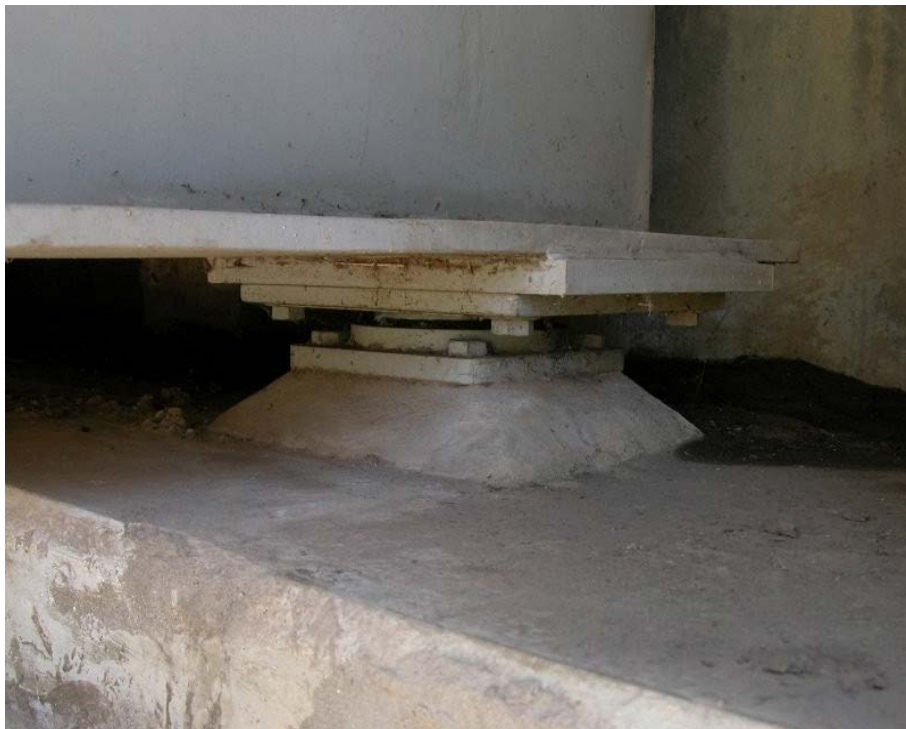
Enclosed bearing in good condition.

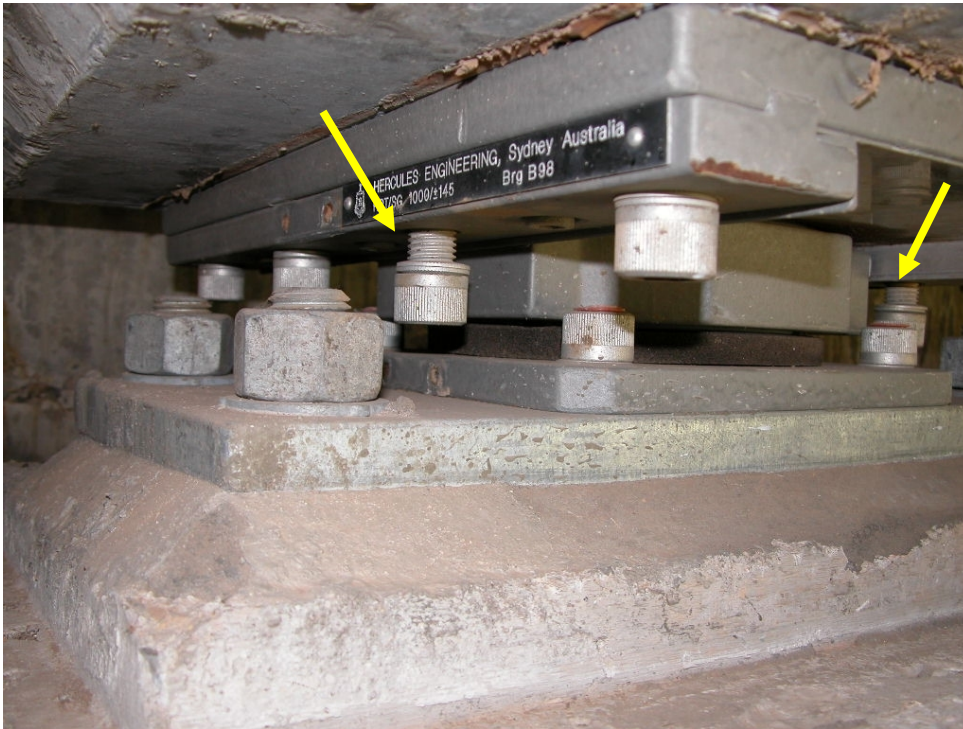
Loose studs on the top plate.

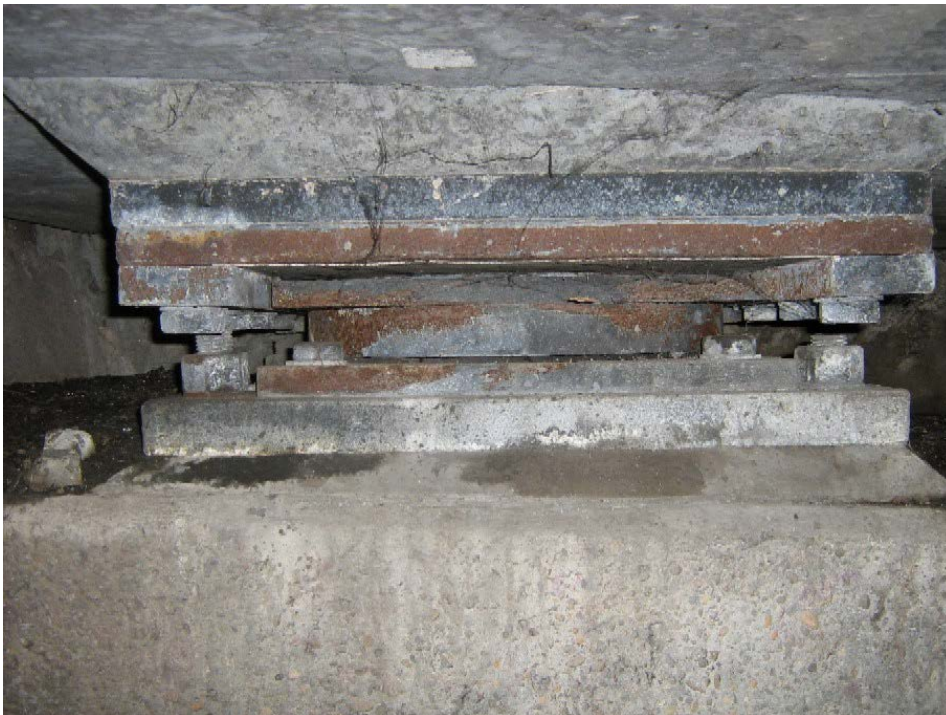
Enclosed bearing with surface corrosion.

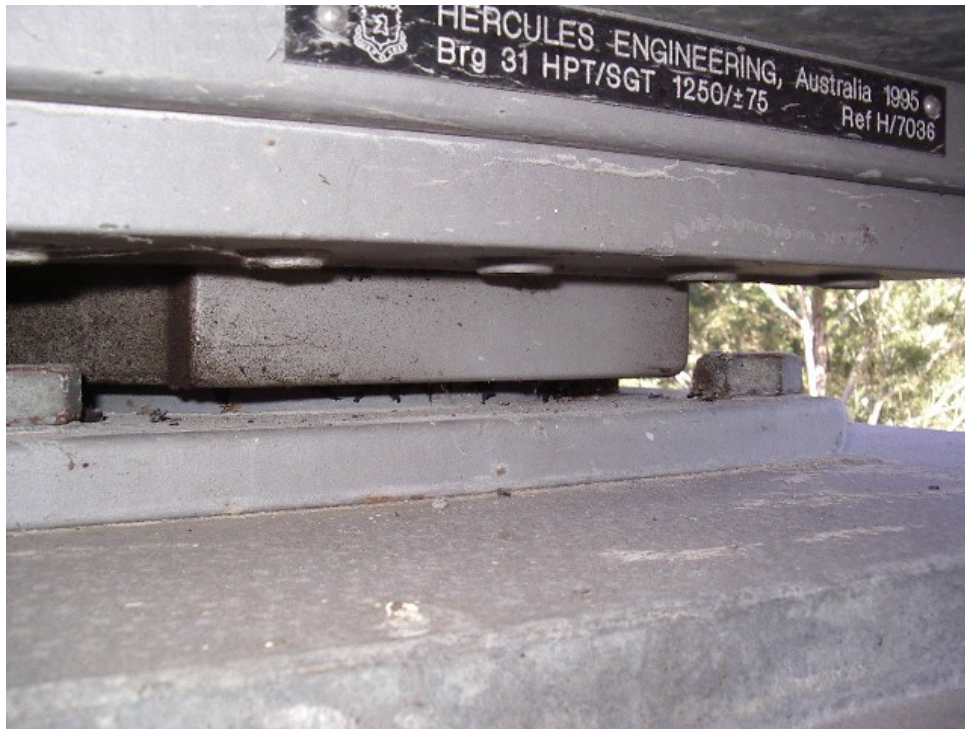
Minor leakage of rubber.

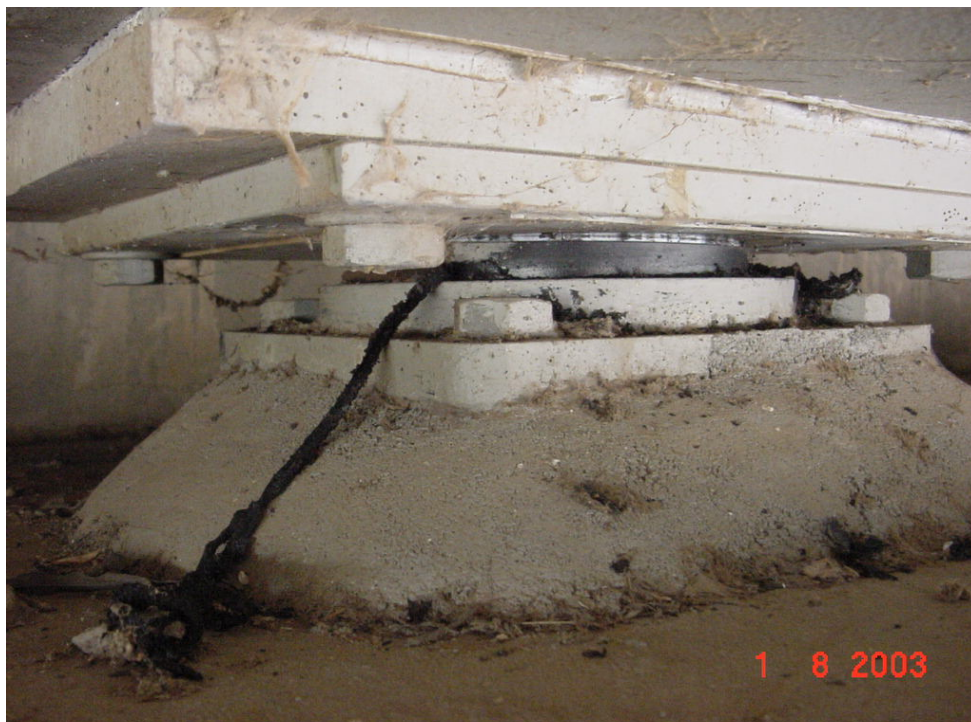
Moderate leakage of rubber.

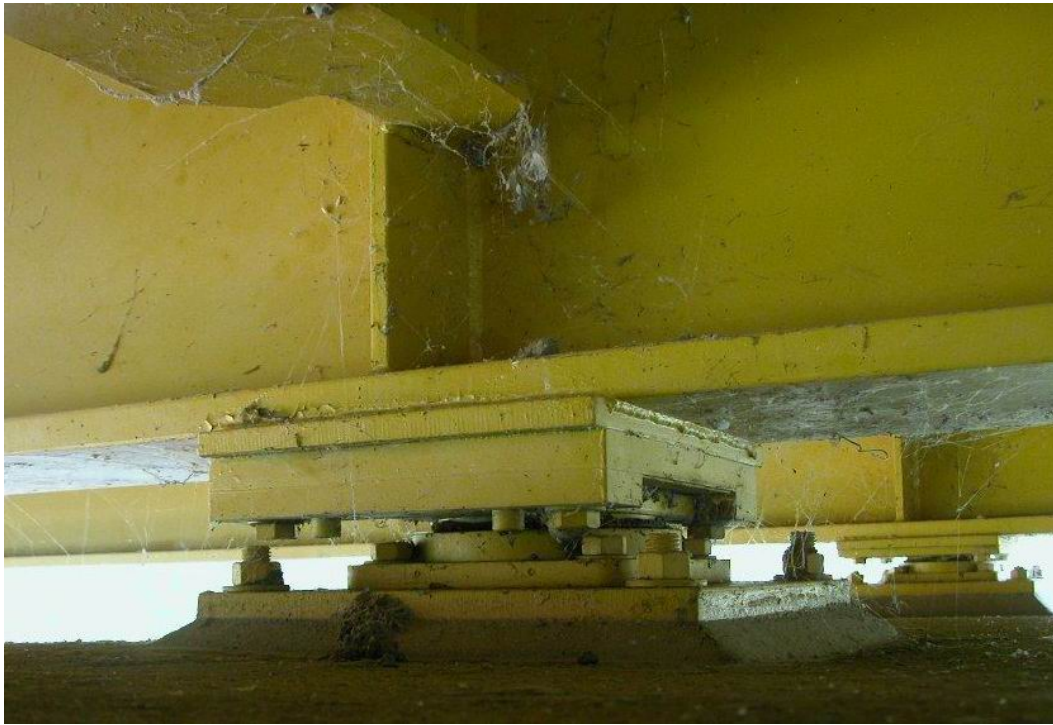
Bearings have reached their extension limit with possibility of further deck movement.

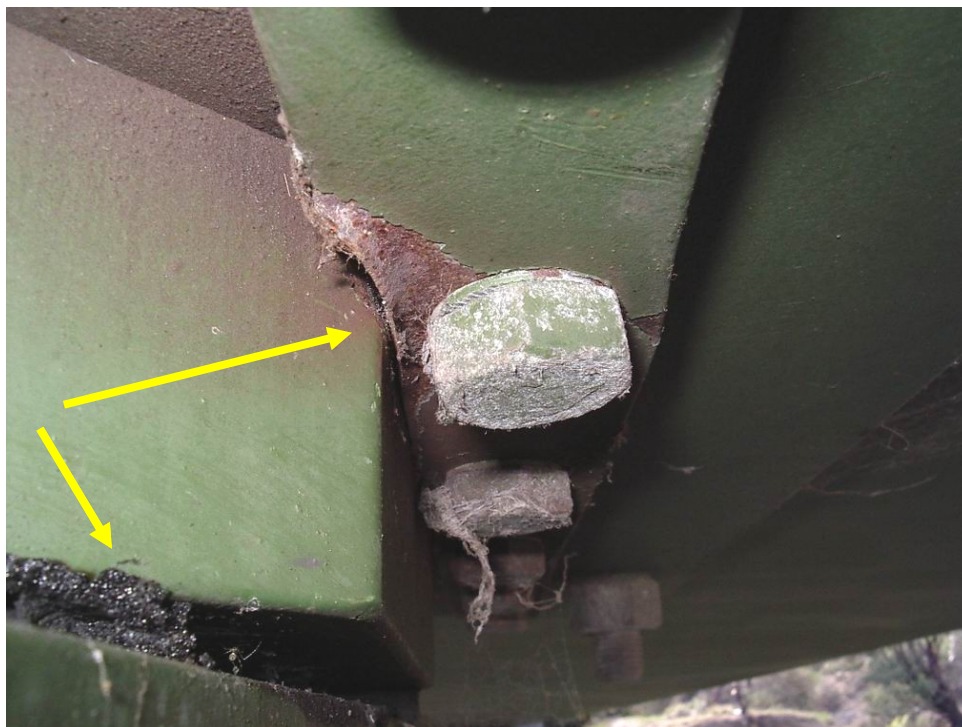
Excessive damage to the guide/shear key and significant leakage of rubber.

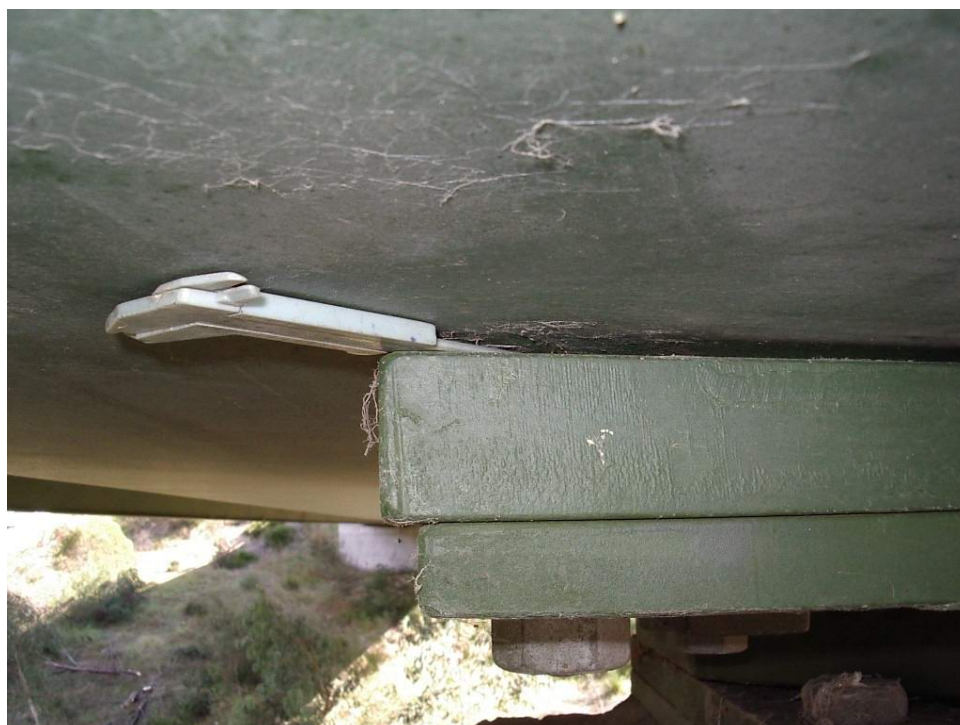
Excessive gap at the concrete bearing interface indicating rotational limits of the bearings may have been reached.

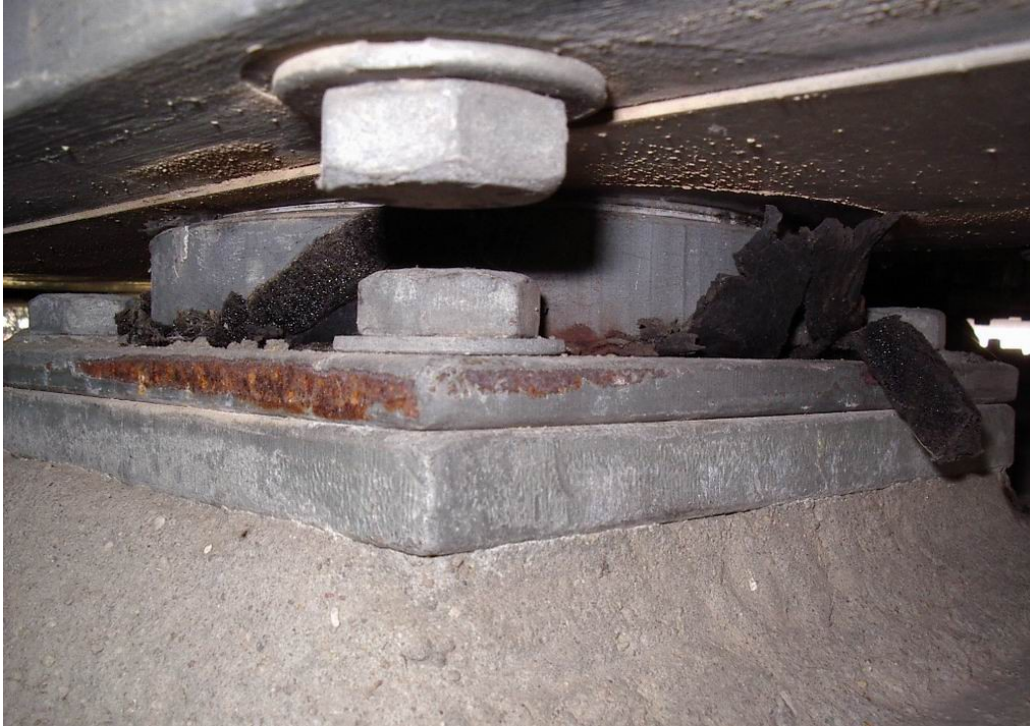
Significant leakage of rubber.

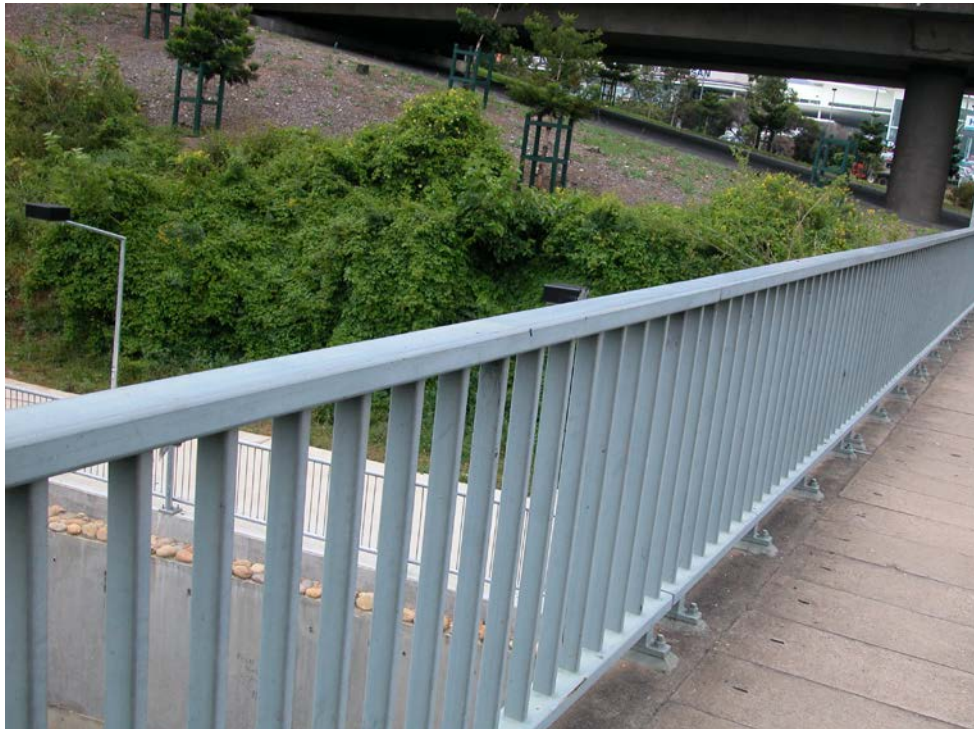
Metal railing in good condition.

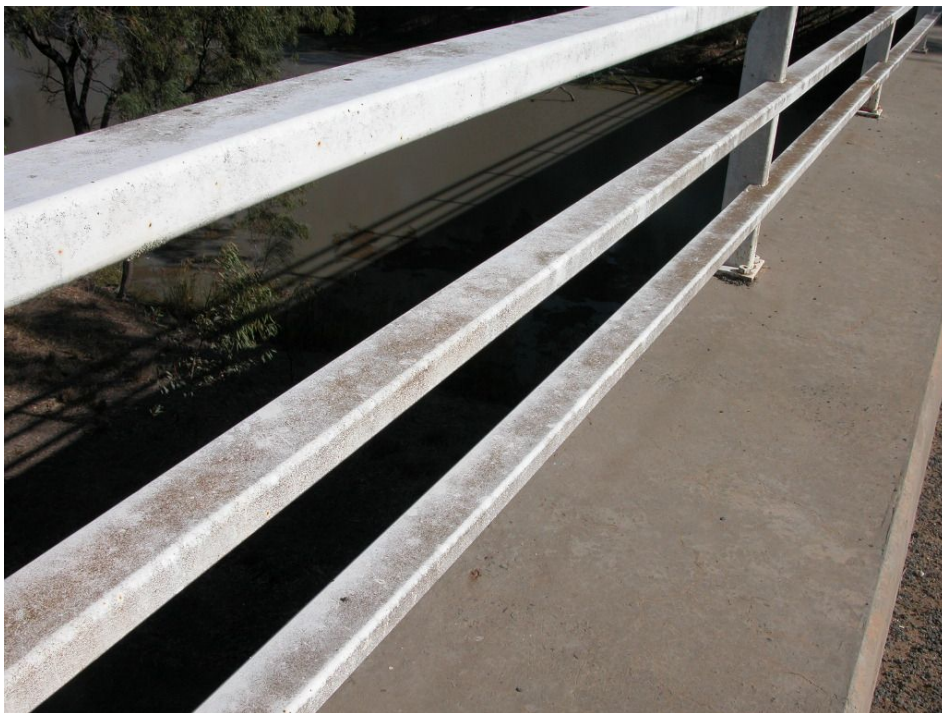
Protective coating showing signs of distress but is still reasonably effective.

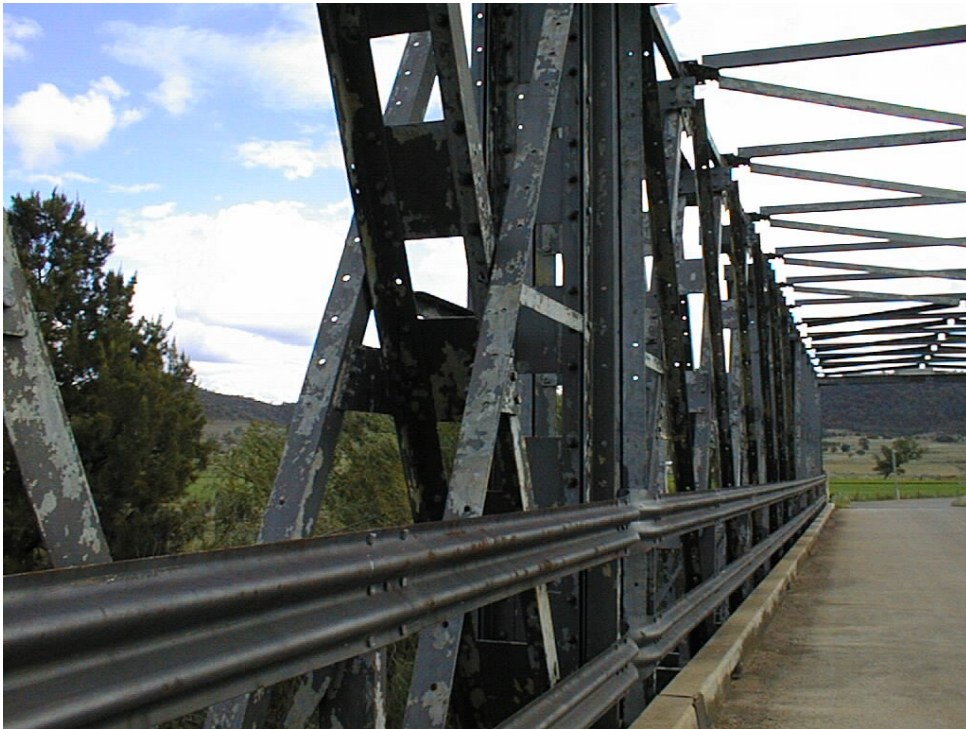
Minor corrosion and nicks.

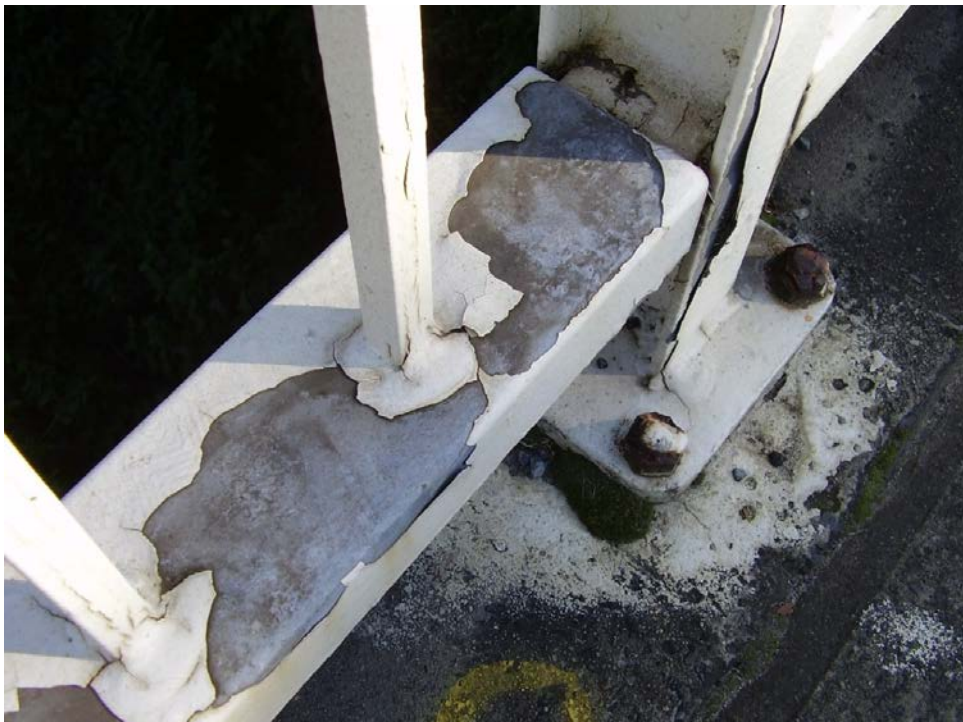
Corrosion of nuts at the base plate.

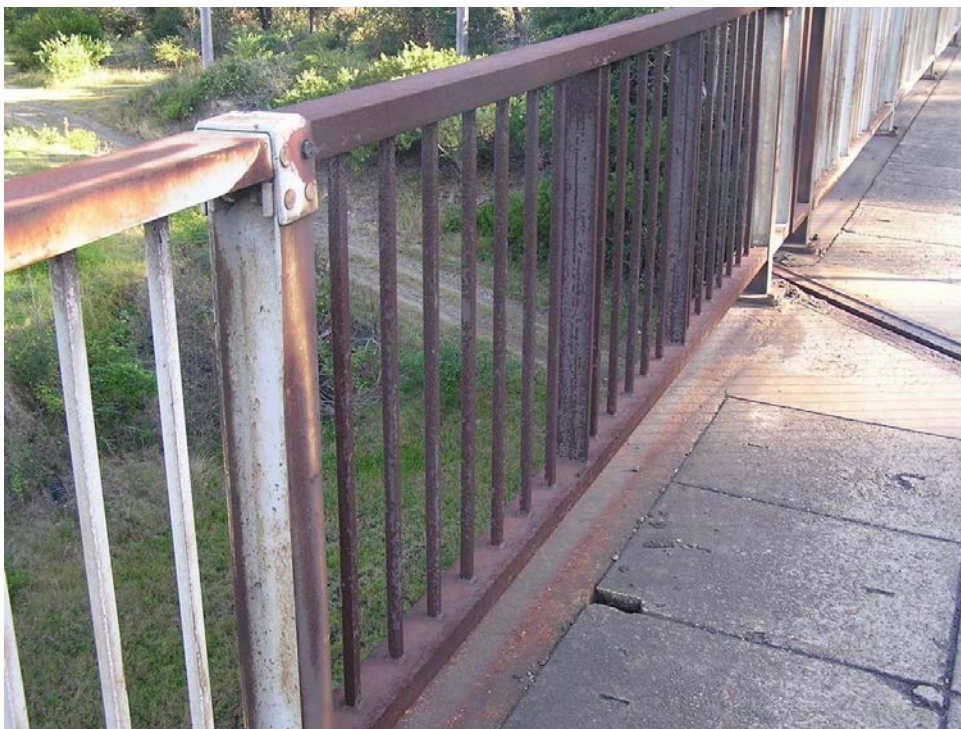
Significant rust and minor pitting.

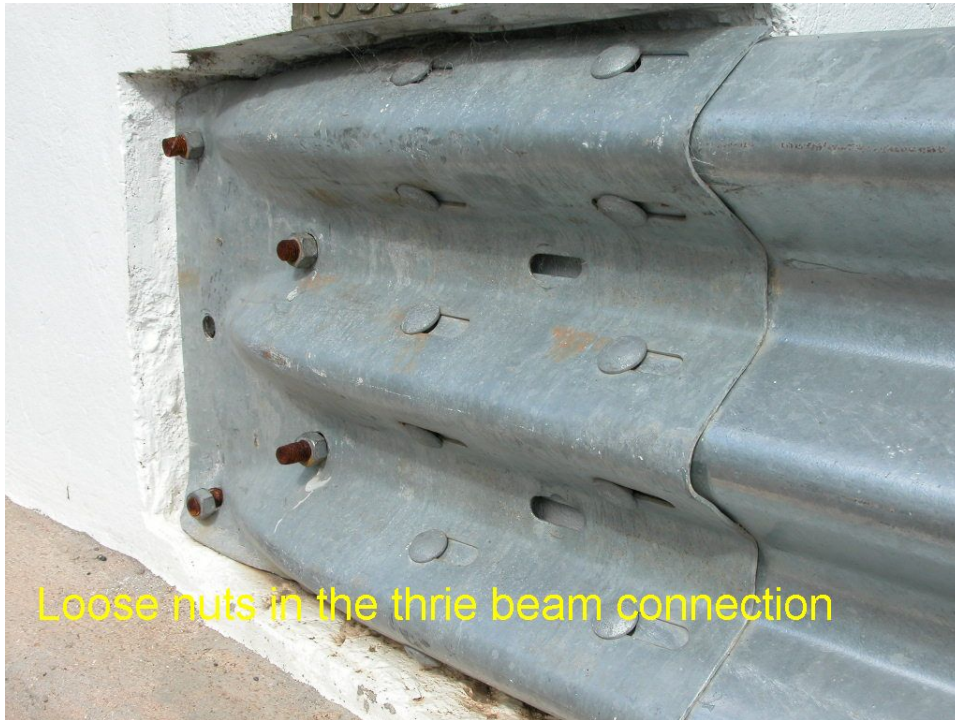
Loose and missing nuts in the connection.

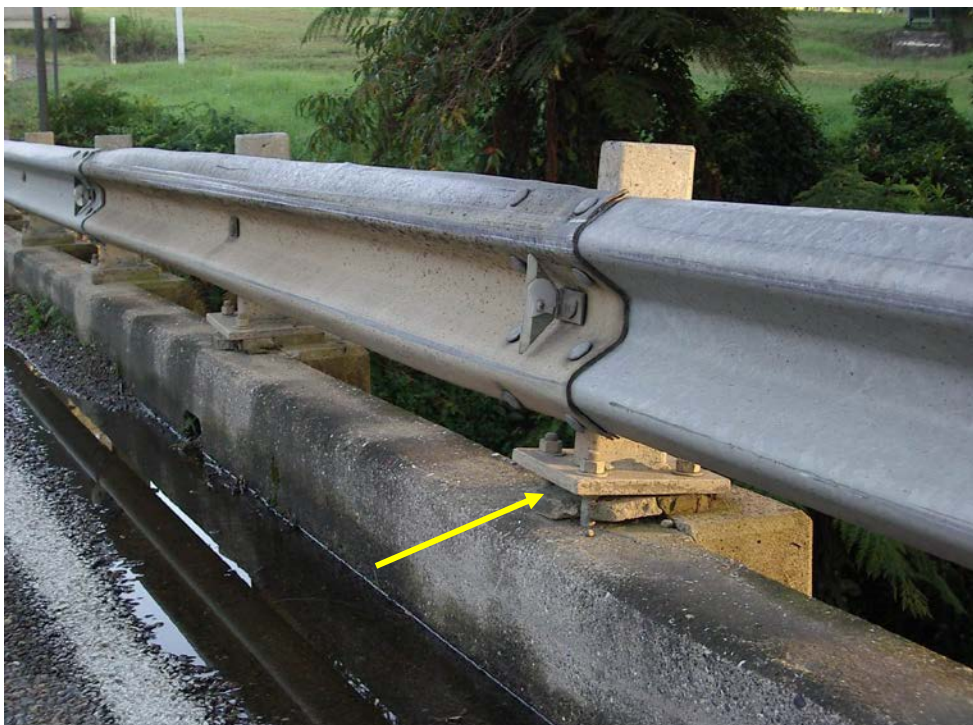
Damaged hold-down bolts and mortar pads.

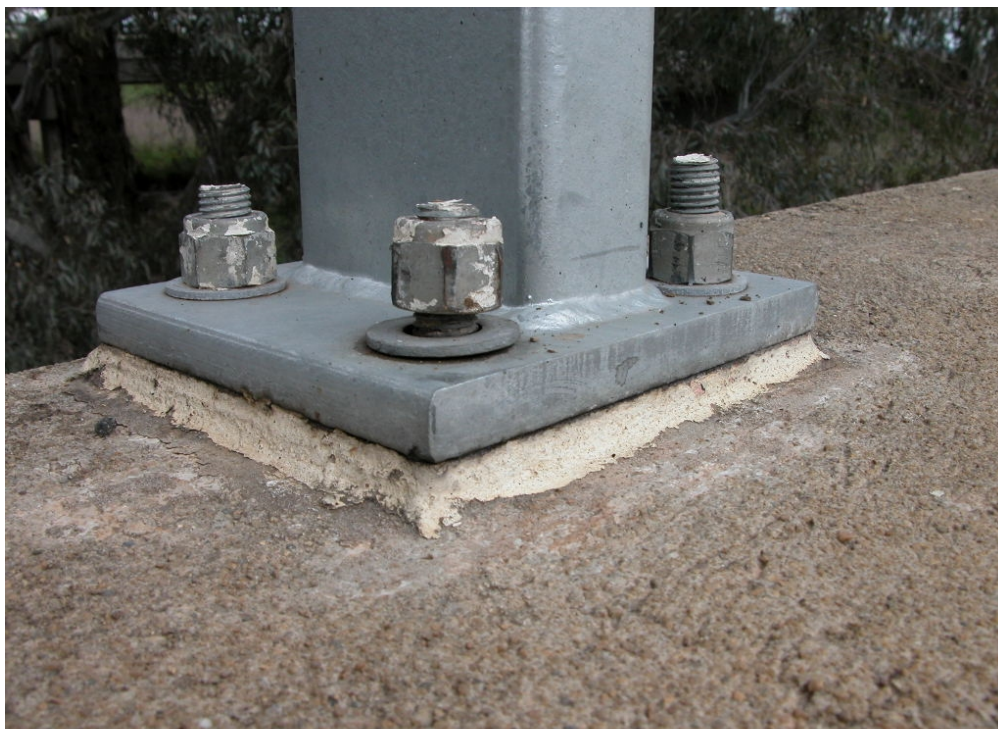
Any section loss is minor and does not affect the strength or serviceability of the element. There may be accident damage such as tearing or moderate deformation or the rail/posts. There may be minor cracking of the welds. Bolts may be loose.

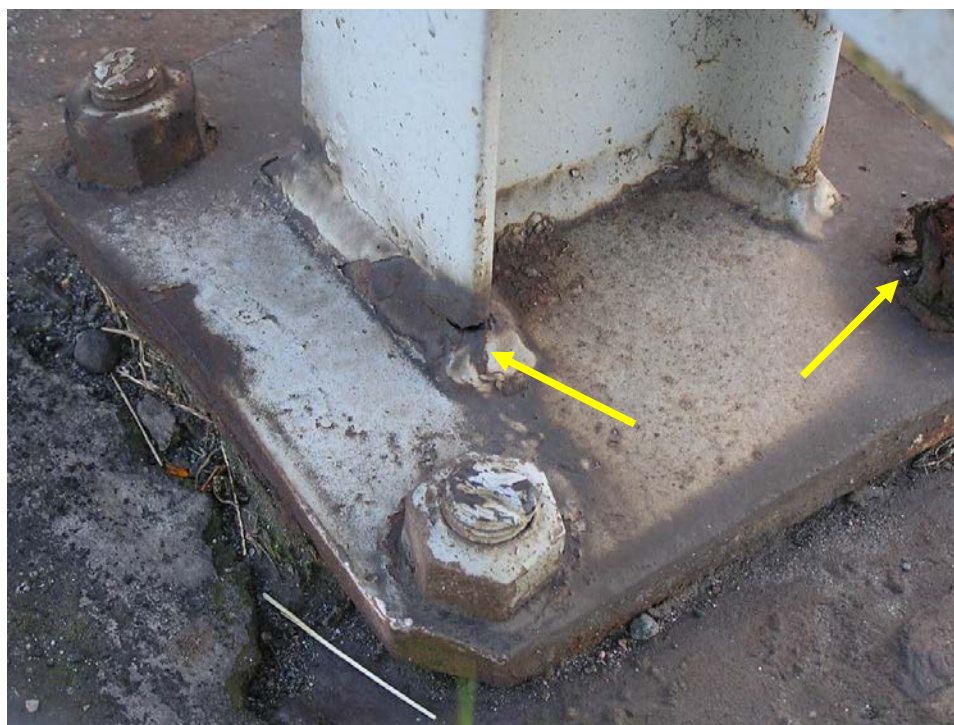
Weld crack at the base and corrosion of nut.

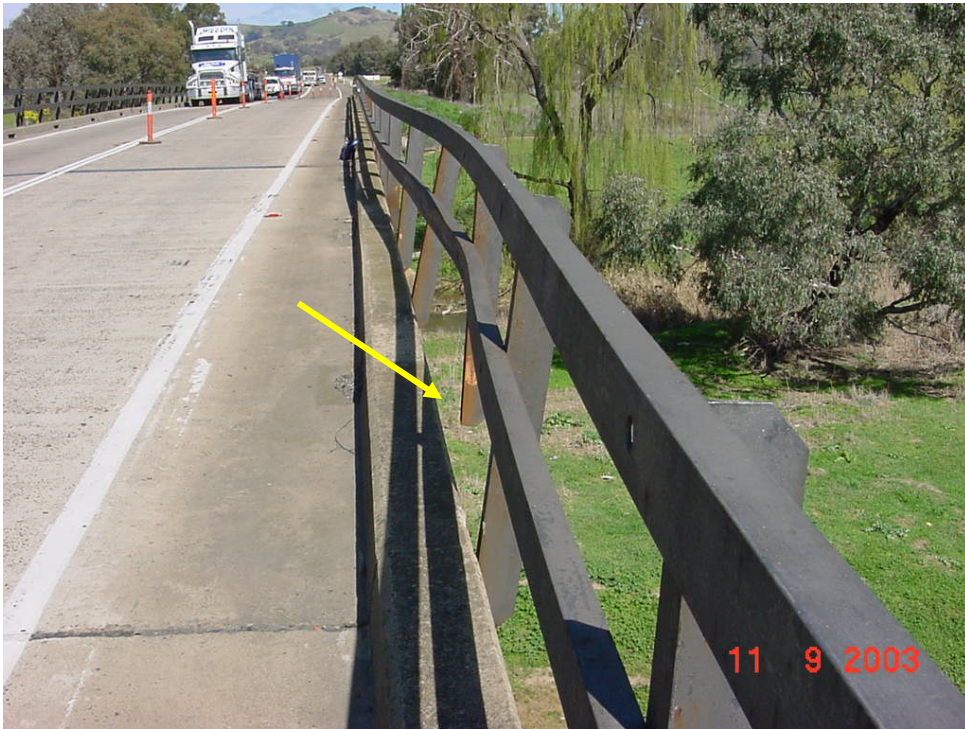
Accident damage with unsupported railing over a short length.

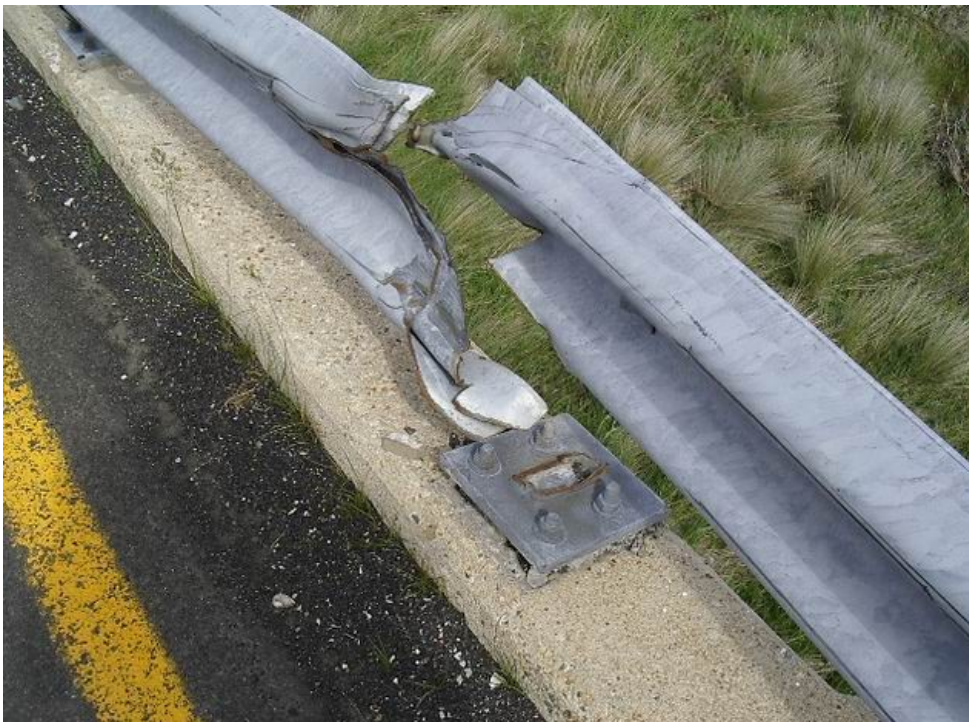
Badly damaged metal railing with missing post and torn guard fence rail.

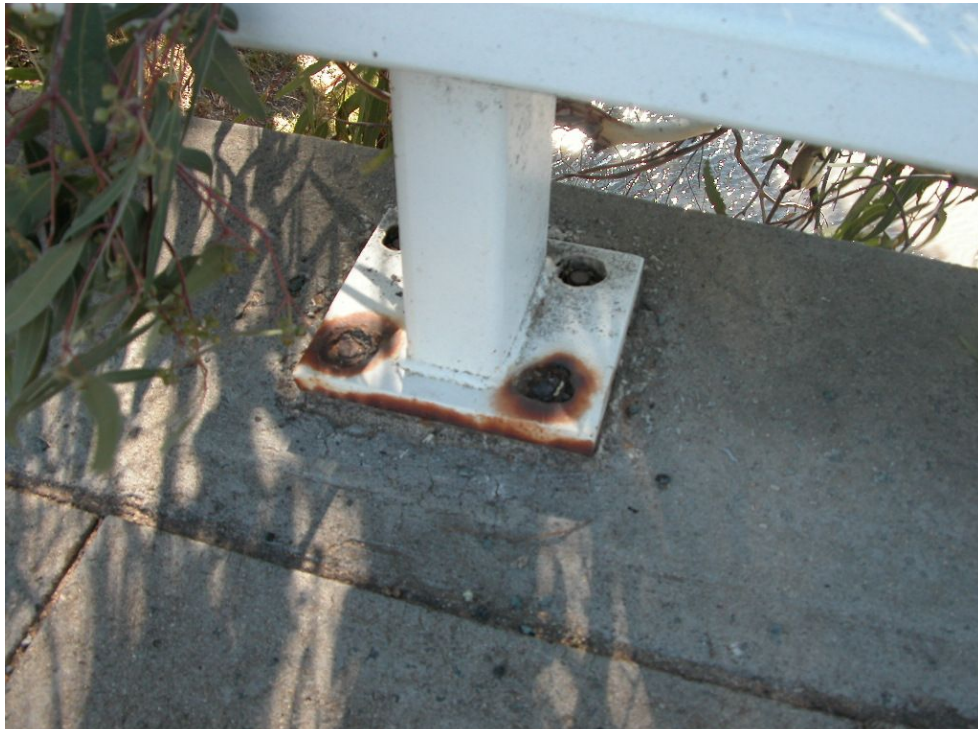
All the nuts and parts of bolts completely corroded off.

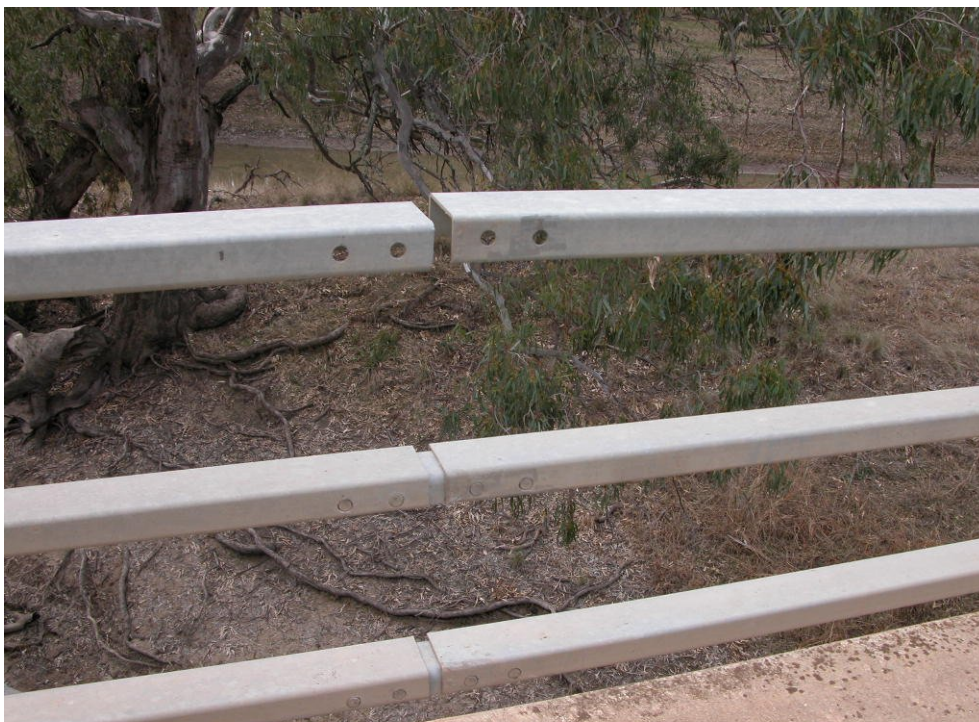
Rail connector missing

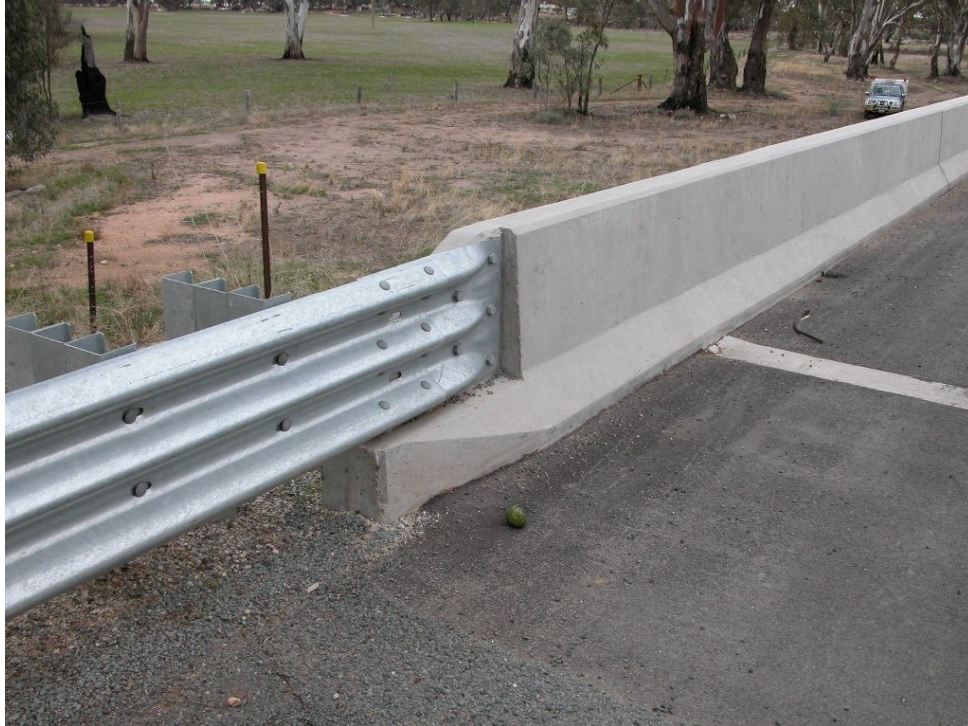
Concrete railing in good condition.

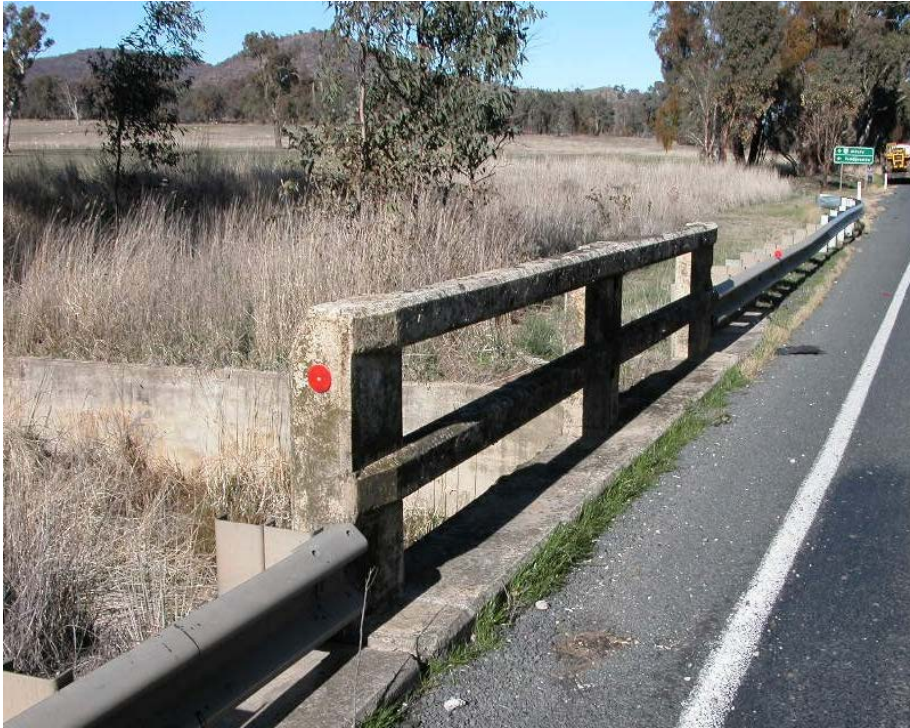
Concrete railing with minor spall.

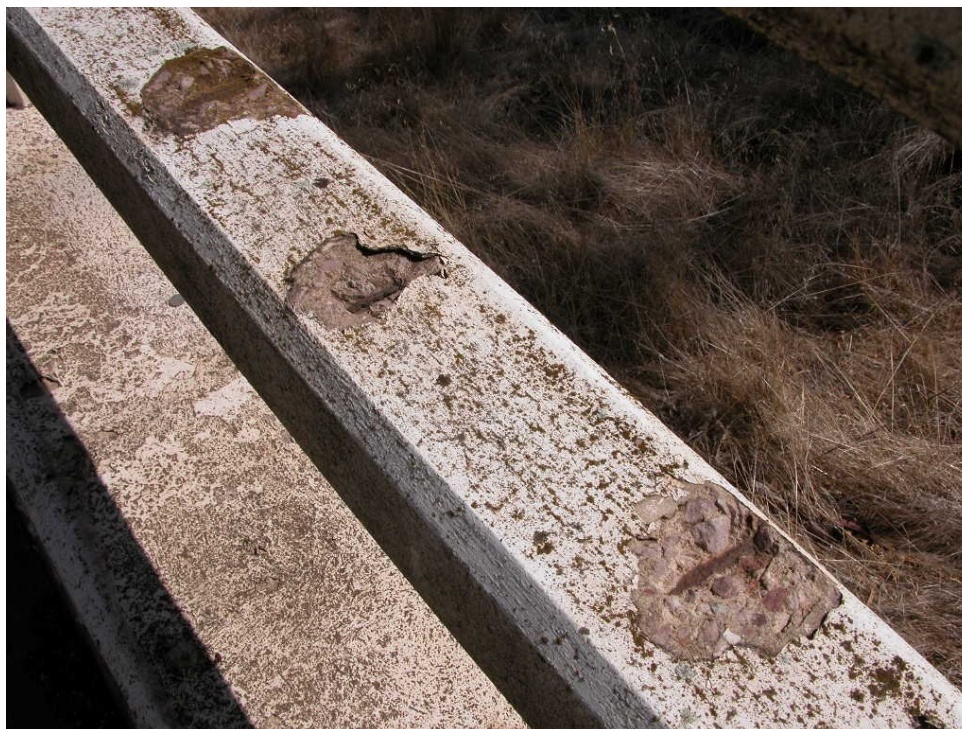
Spalls and exposed reinforcements.

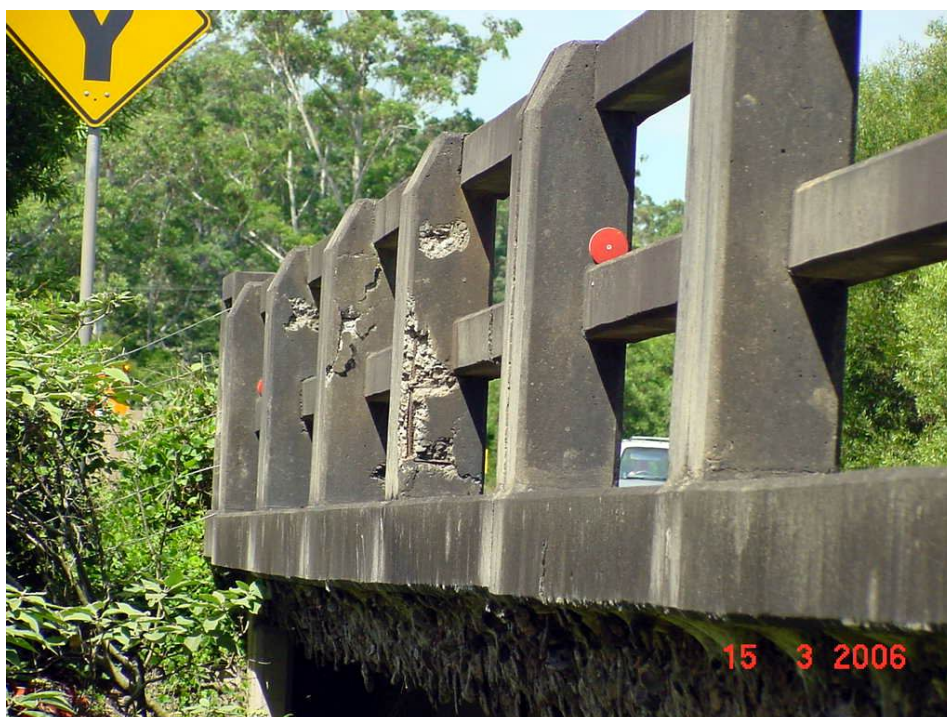
Spalls and exposed reinforcement.

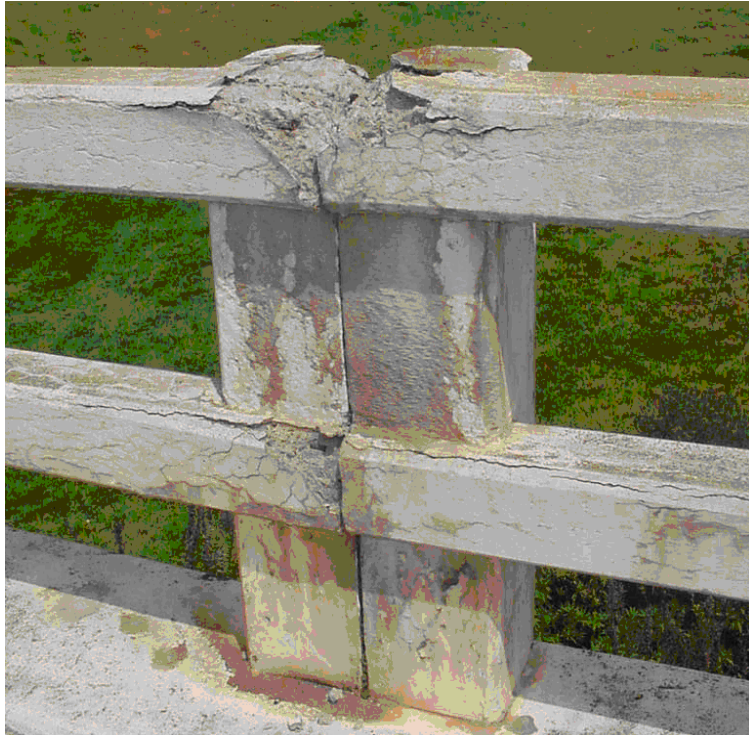
Advanced deterioration.

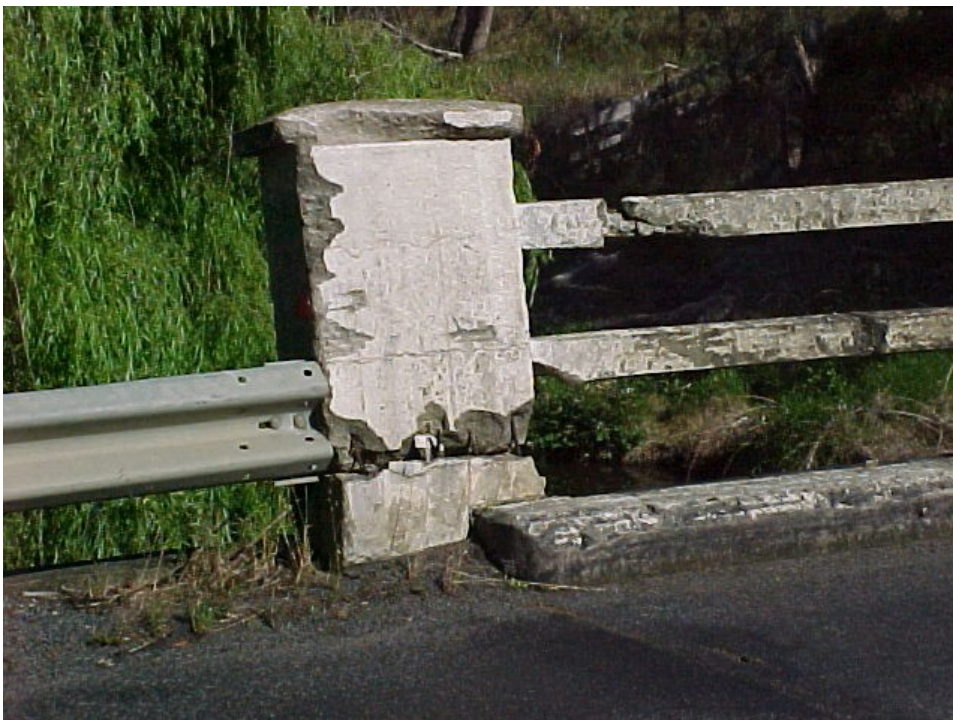
Badly damaged concrete end post and railing.
