Transport  
**Roads & Maritime  
Services**

# **BRIDGE INSPECTION PROCEDURE MANUAL**

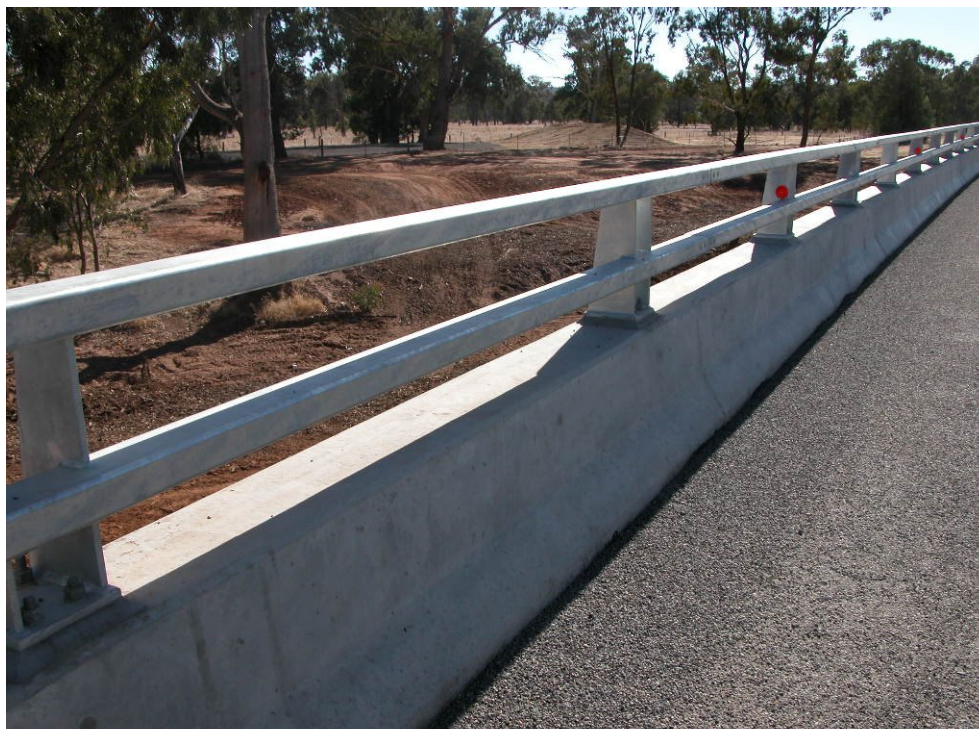
Combined railing in good condition.

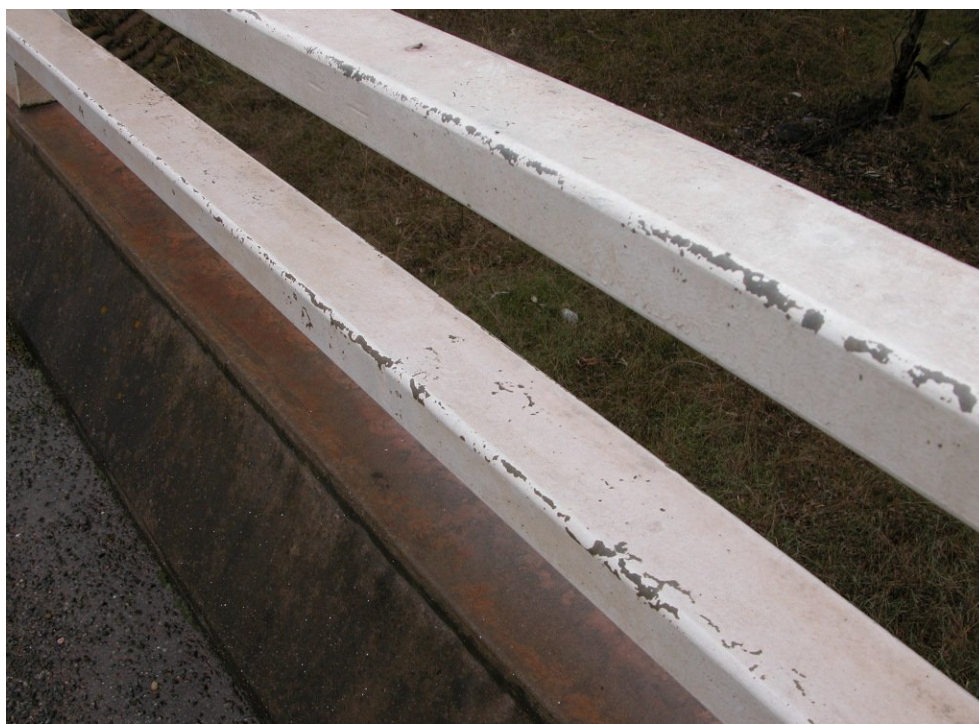
Railing in good condition.

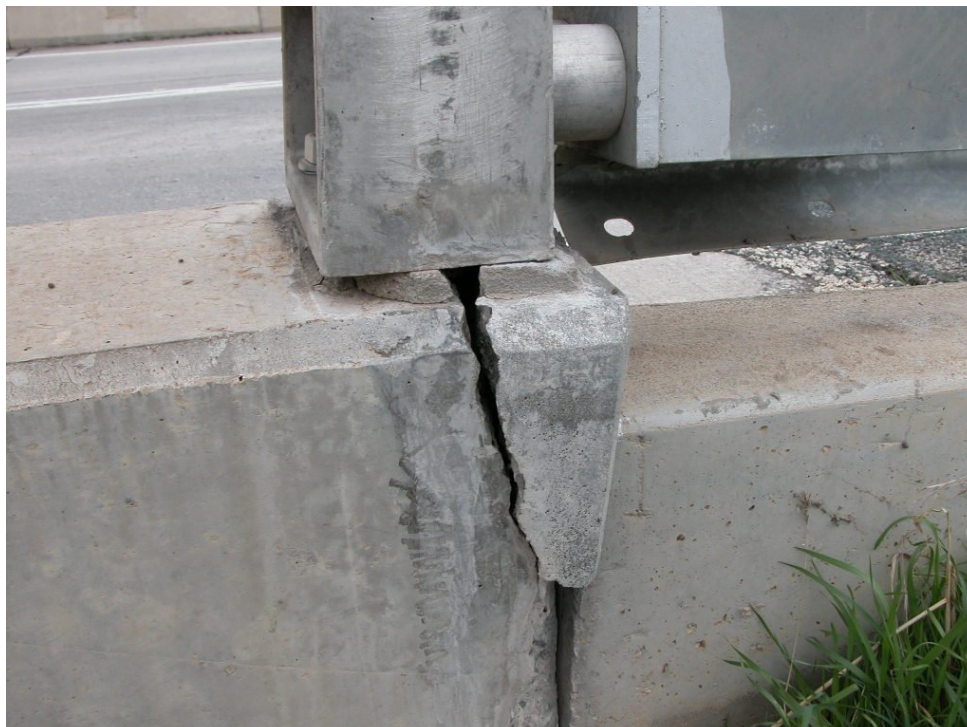
Damage to concrete support requiring repairs.

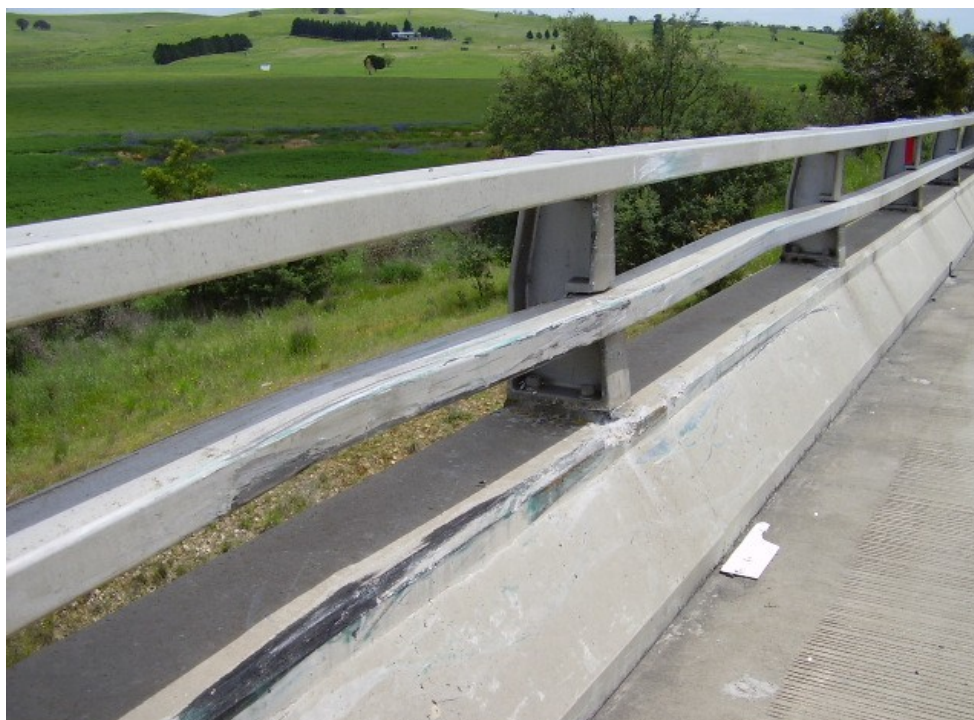
Moderate deformation of rails due to vehicular impact.

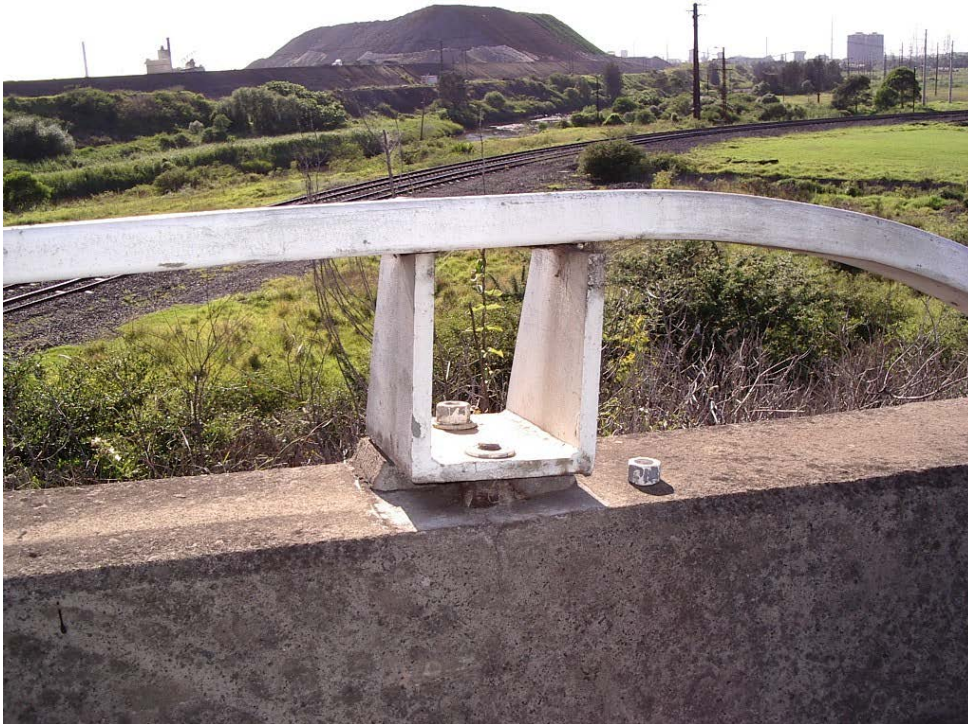
Significant damage to the metal rail base connection and moderate distortion at the end.

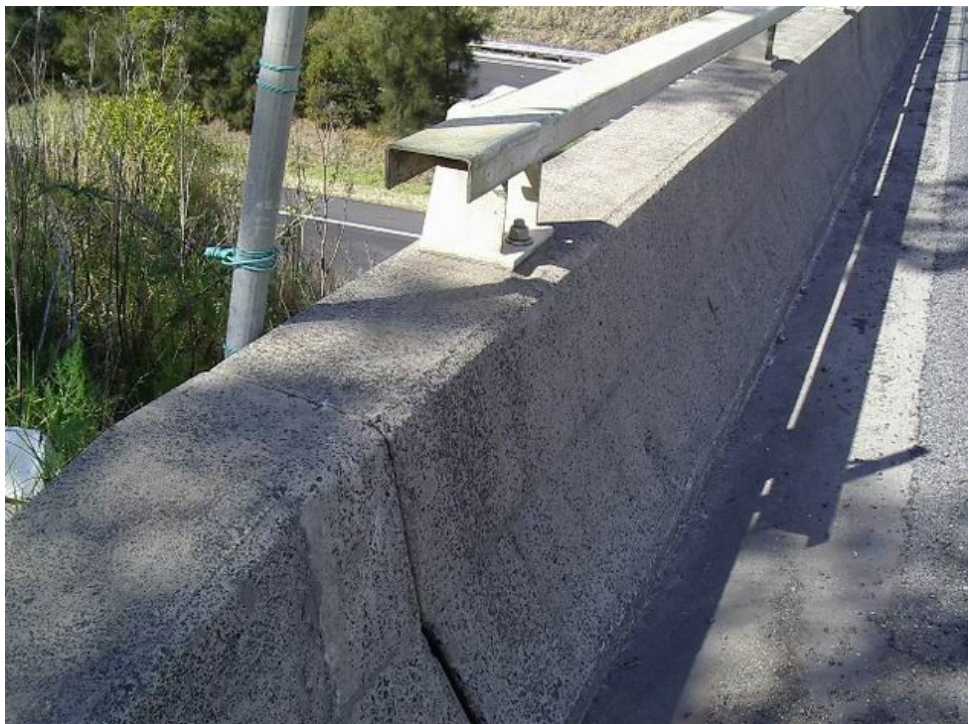
Metal railing without suitable end piece with significant risk to the safety of road users.

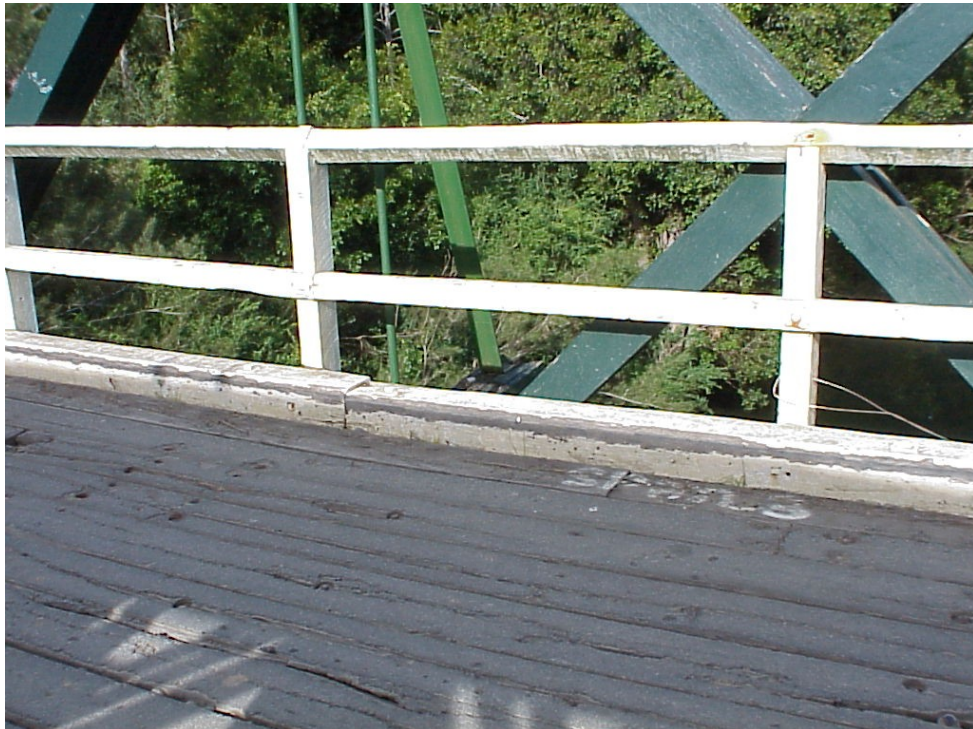
Timber railing in good condition.

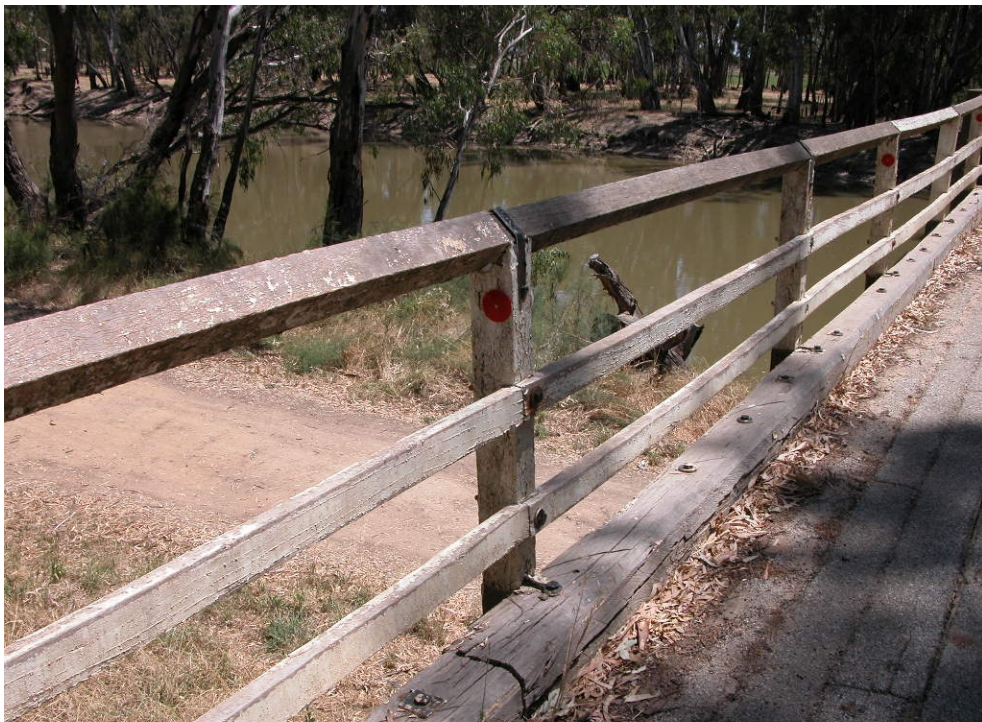
Timber railing in good condition with failed paint coating.

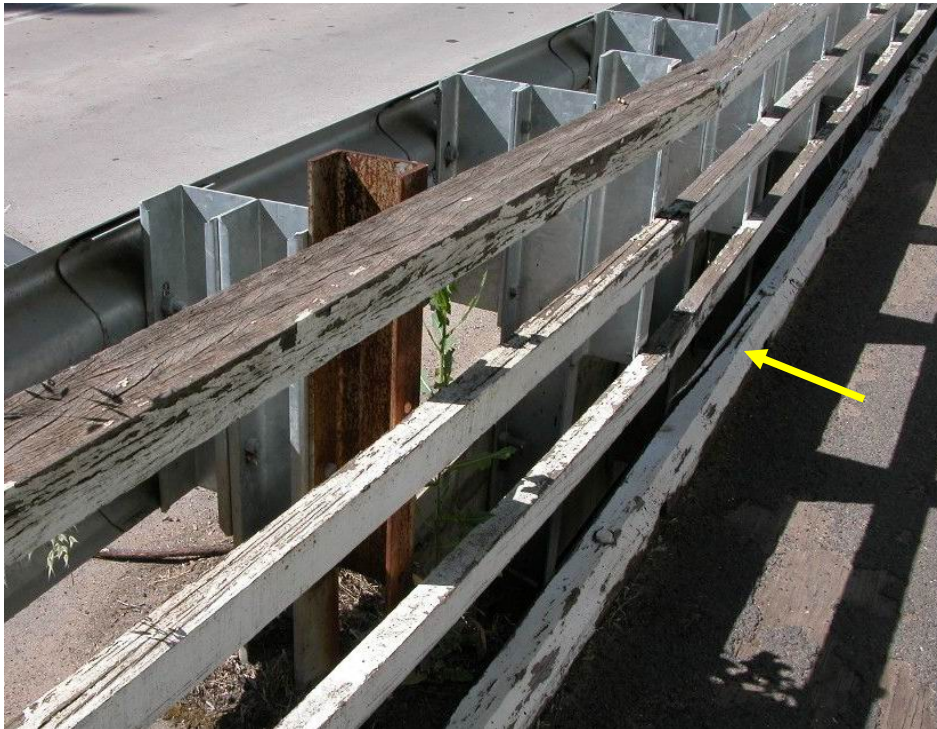
Minor decay, insect infestation, splitting, cracking, checking or crushing may exist but none is sufficiently advanced to affect serviceability. There may be vehicle impact damage or scores.

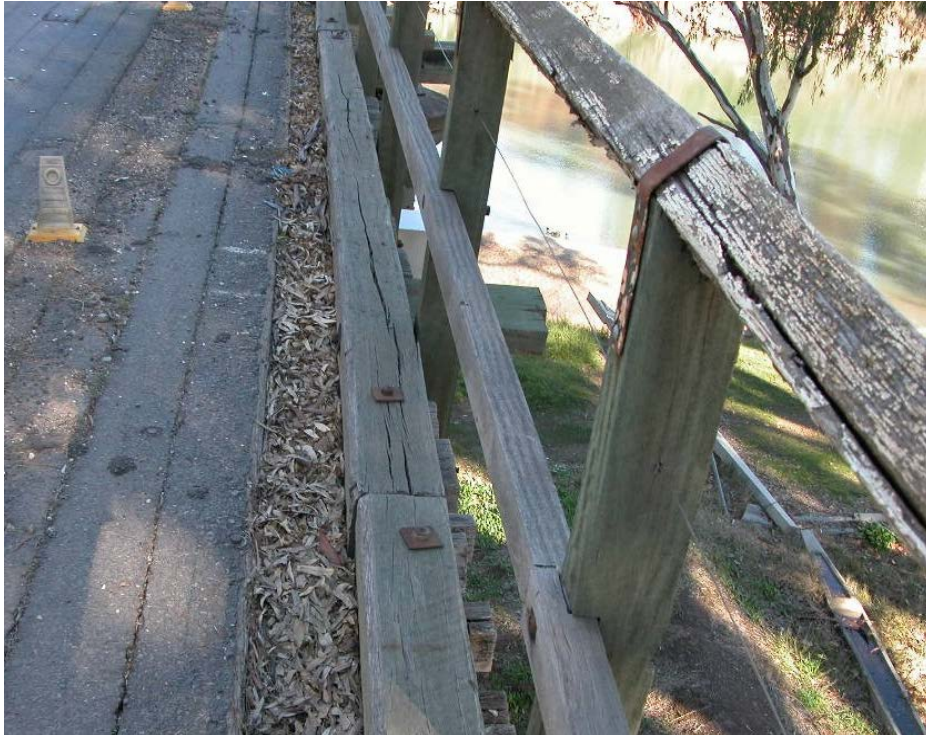
Timber railing and kerb with significant splits.

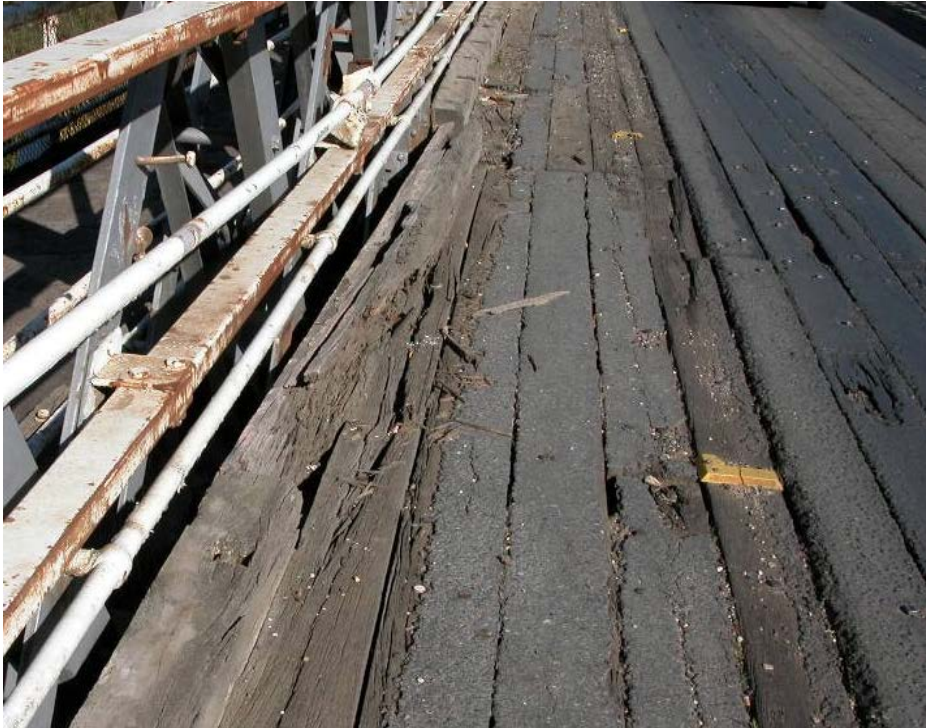
Timber kerbs split and rotten.

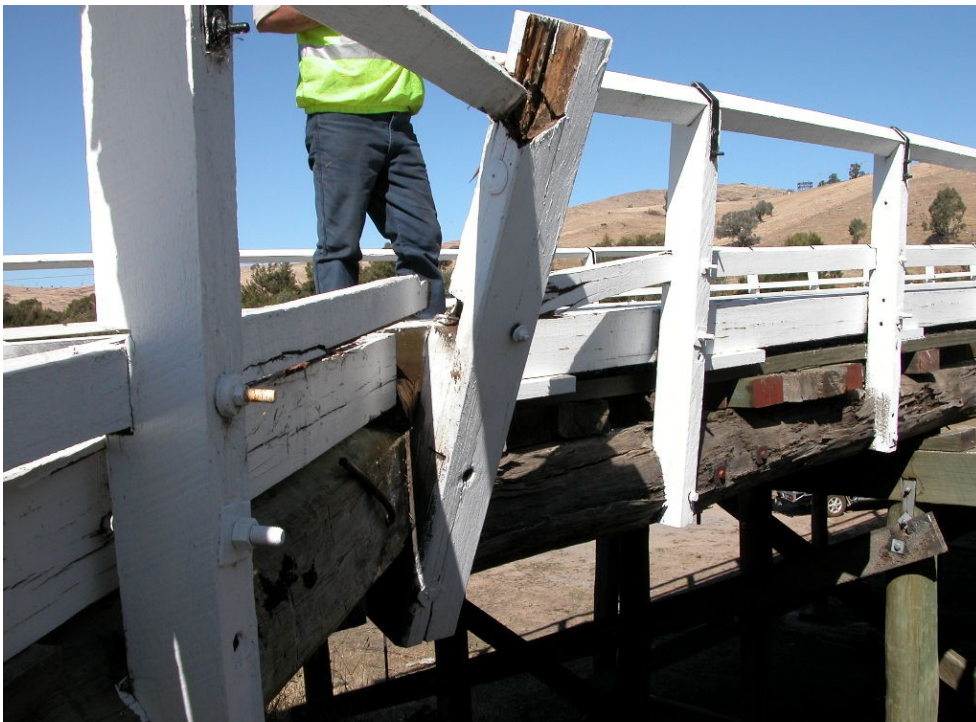
Timber railing requiring immediate repair.

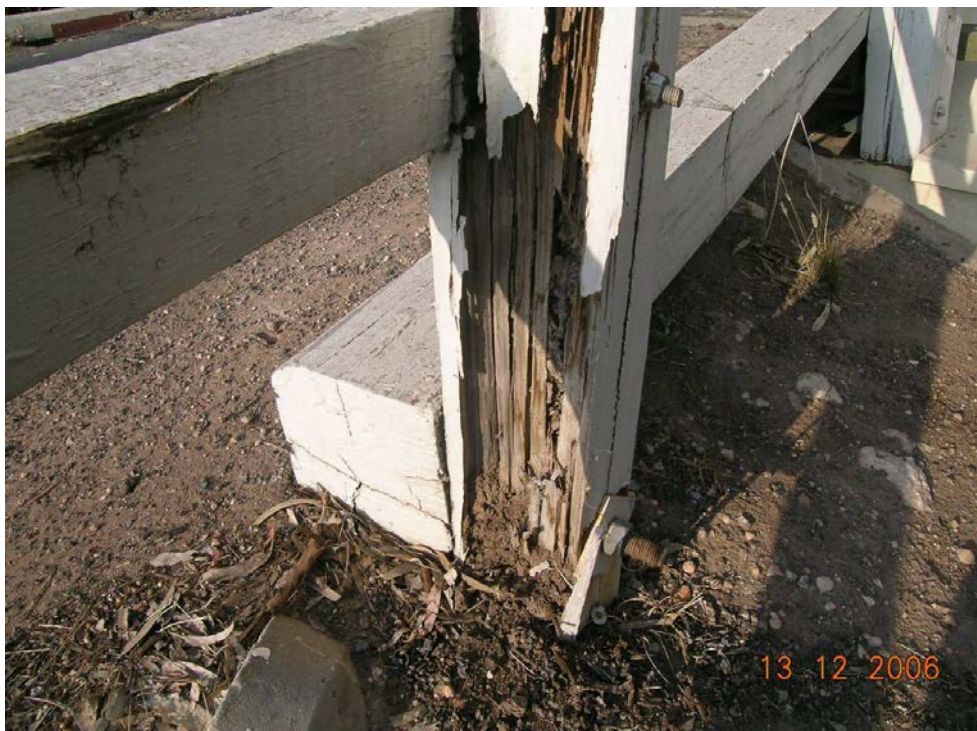
Badly deteriorated timber rail post.

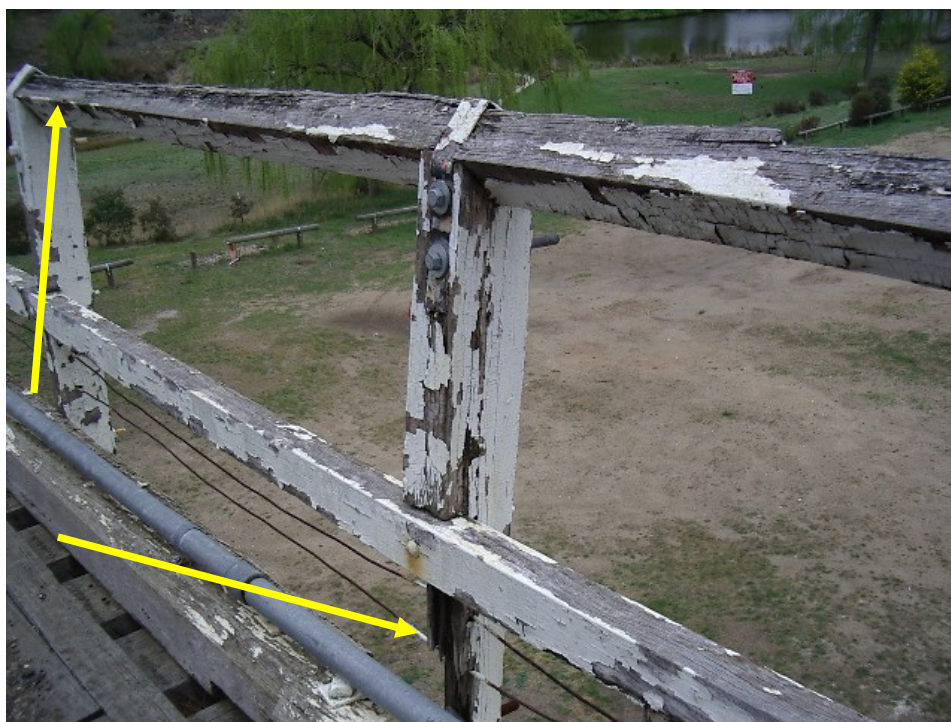
Rotten timber post and rails.

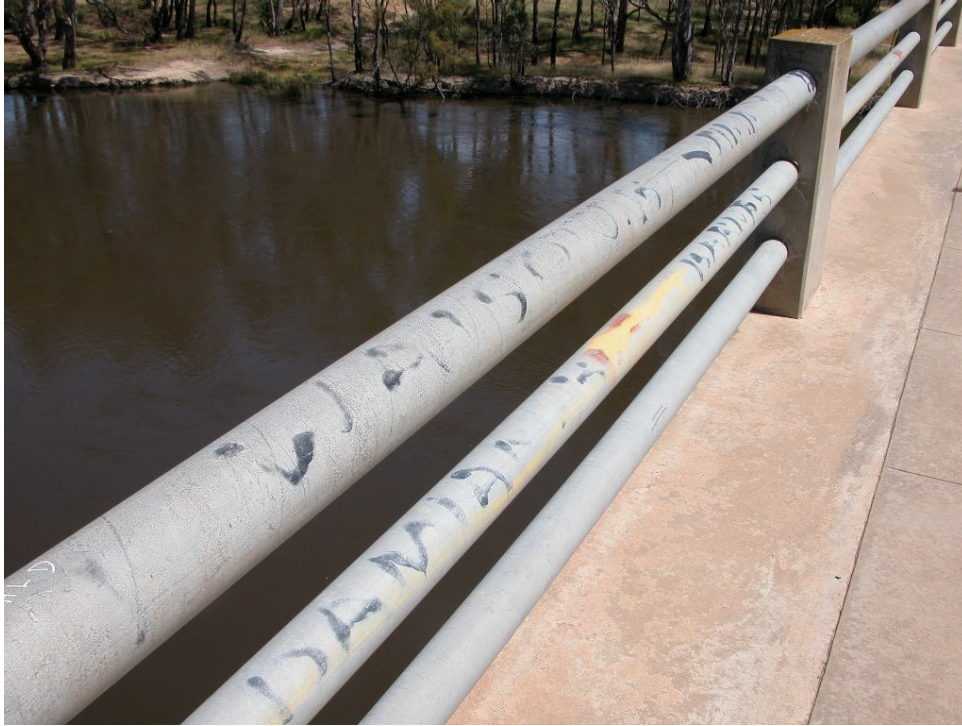
Miscellaneous railing in good condition.

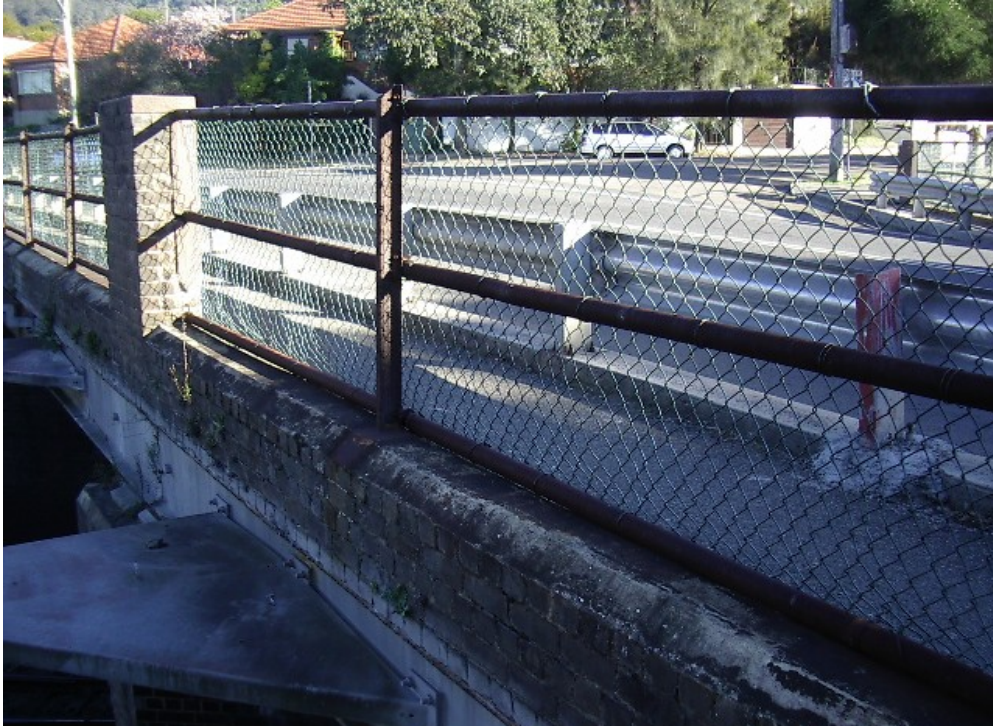
Corrosion of metal components.

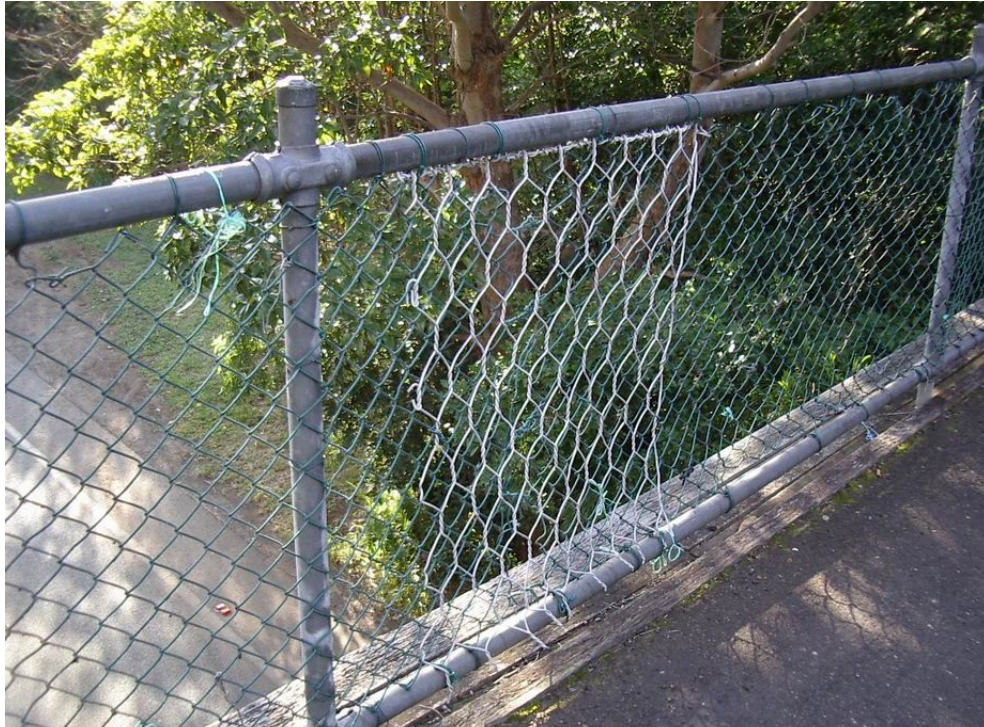
Some damage to the wire fence along the railing but the serviceability is not significantly affected. .

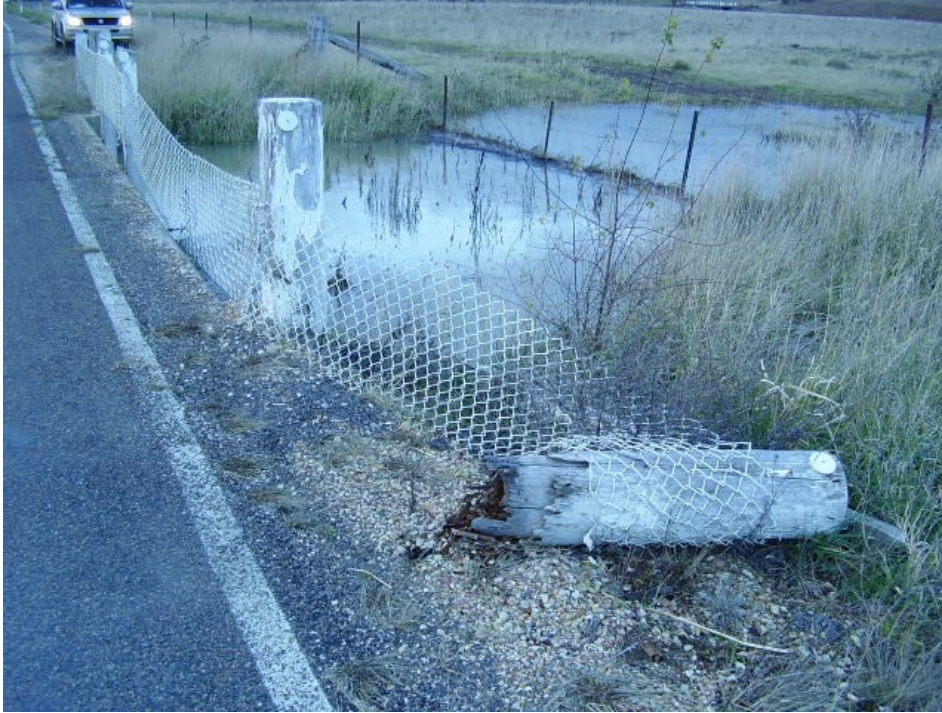
Miscellaneous railing with broken timber post,

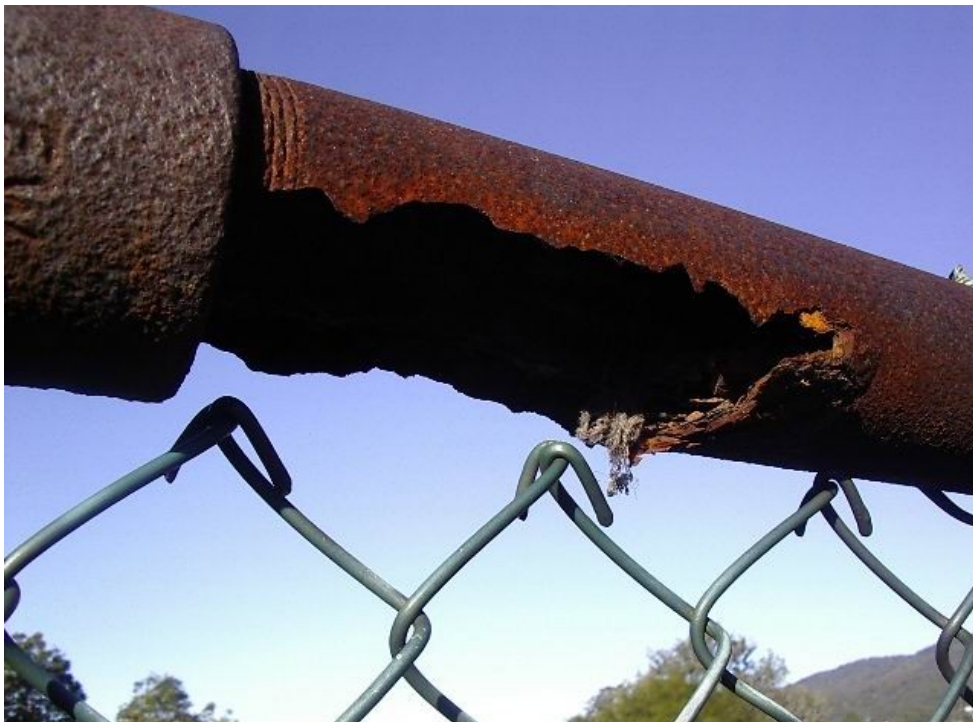
Badly corroded steel tube rail.

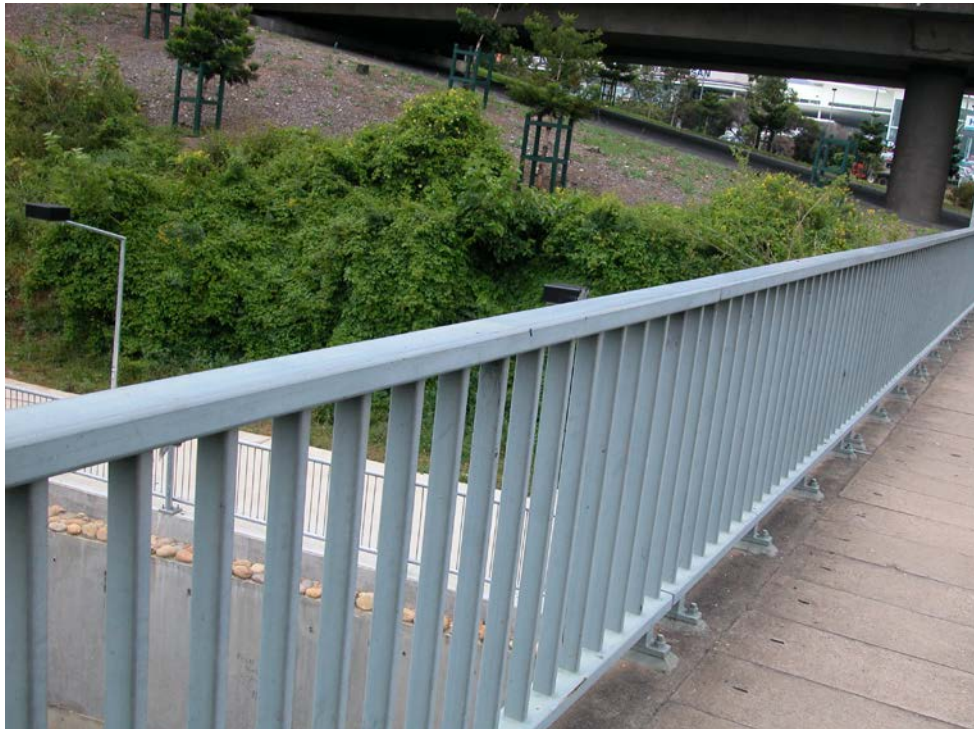
Paint work on metal railing in good condition.

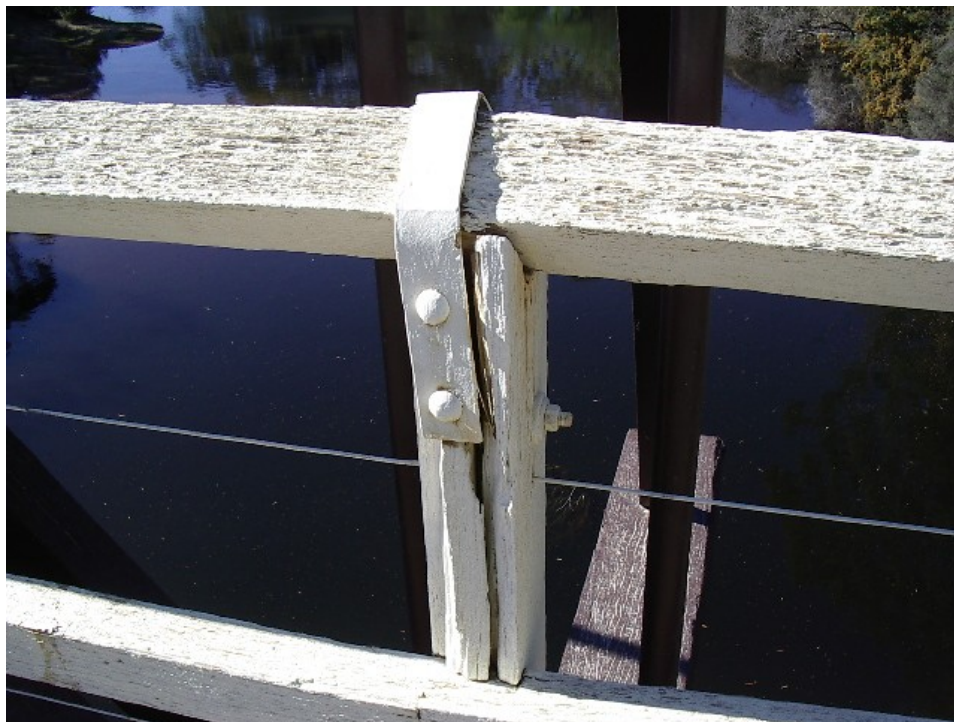
Timber railing with paint work in good condition.

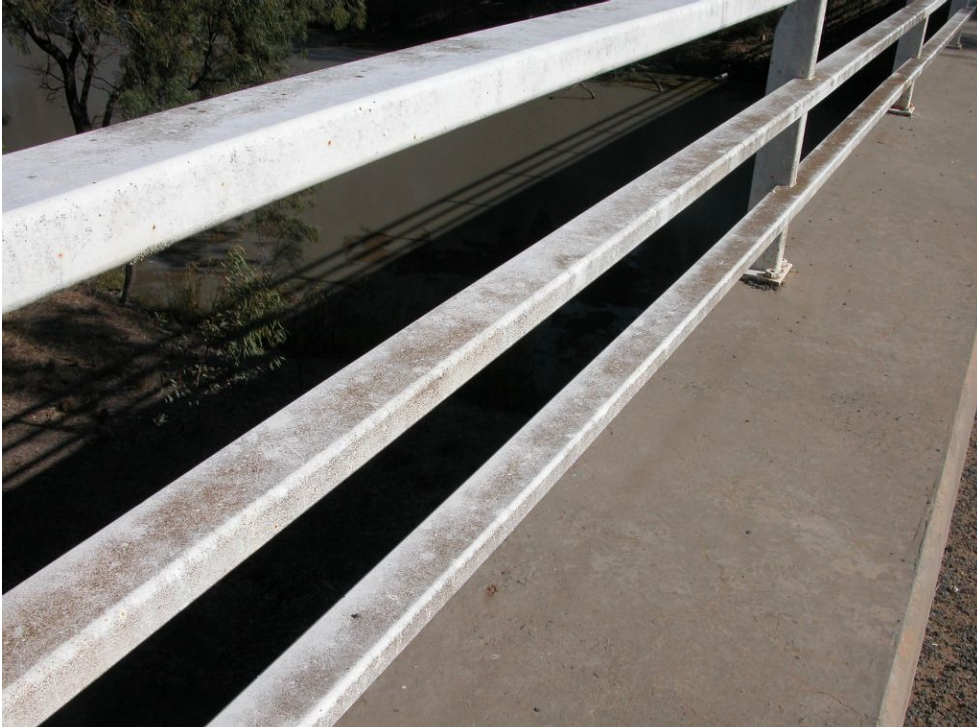
Protective coating showing signs of distress but is still reasonably effective.

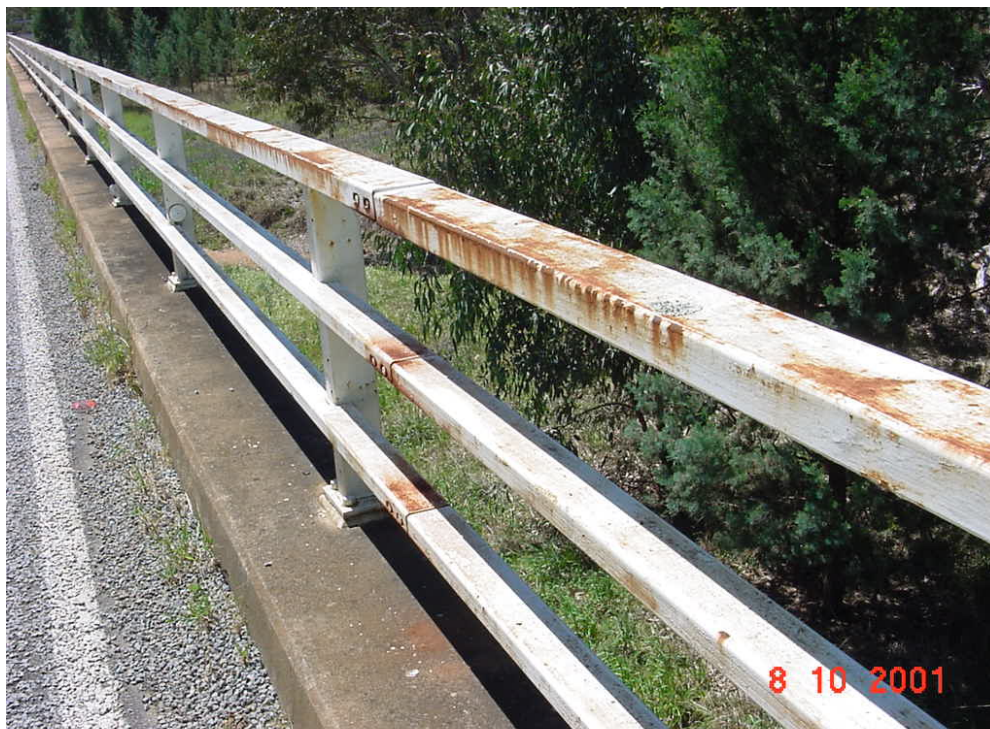
The paint work is no longer effective on significant areas.

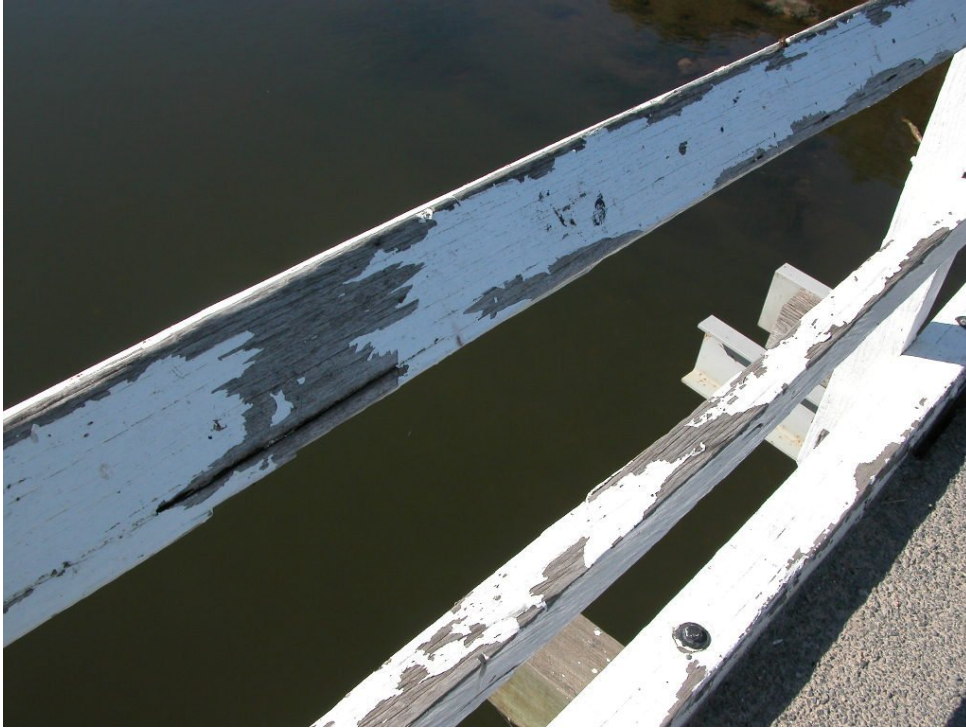
Paint work is no longer effective in significant areas.

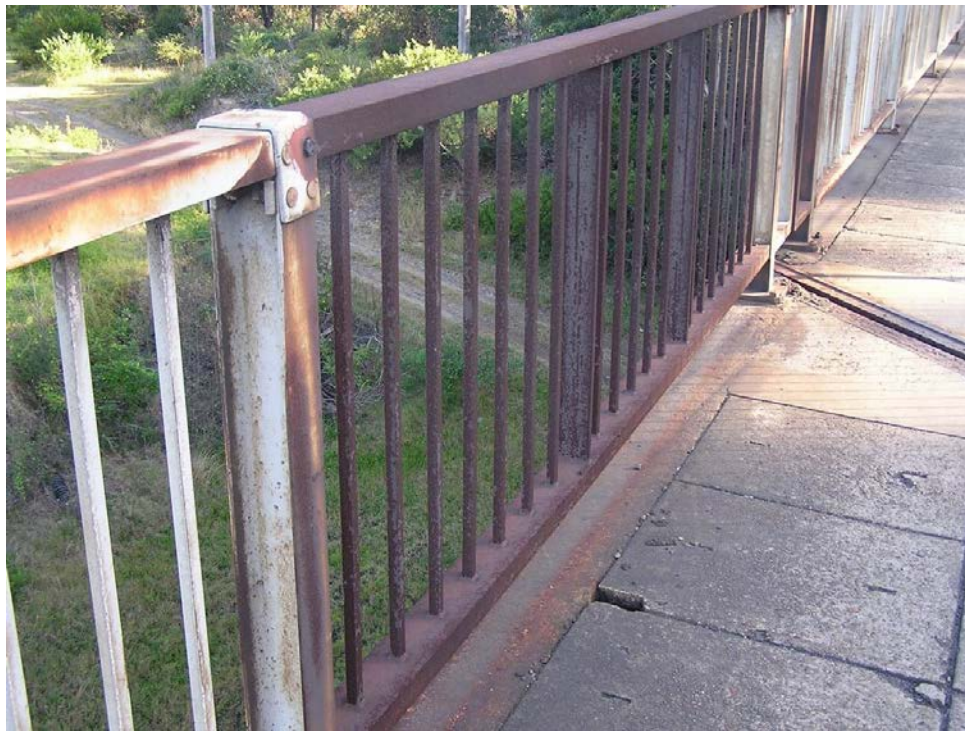
Failed paint work on a metal railing.

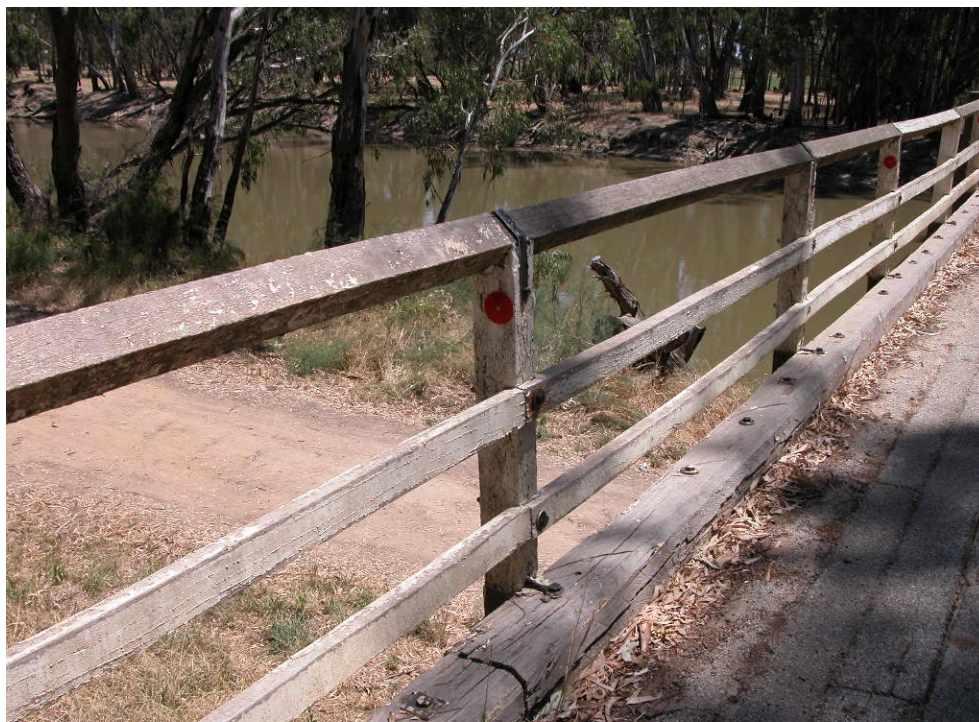
Failed paintwork on a timber railing.

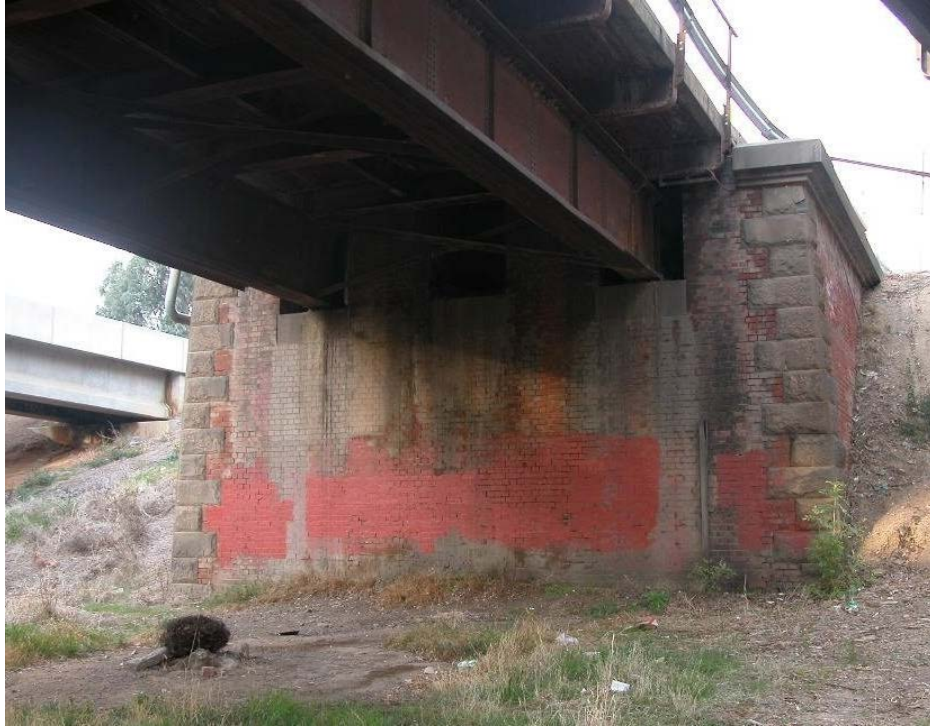
Masonry abutment on good condition.

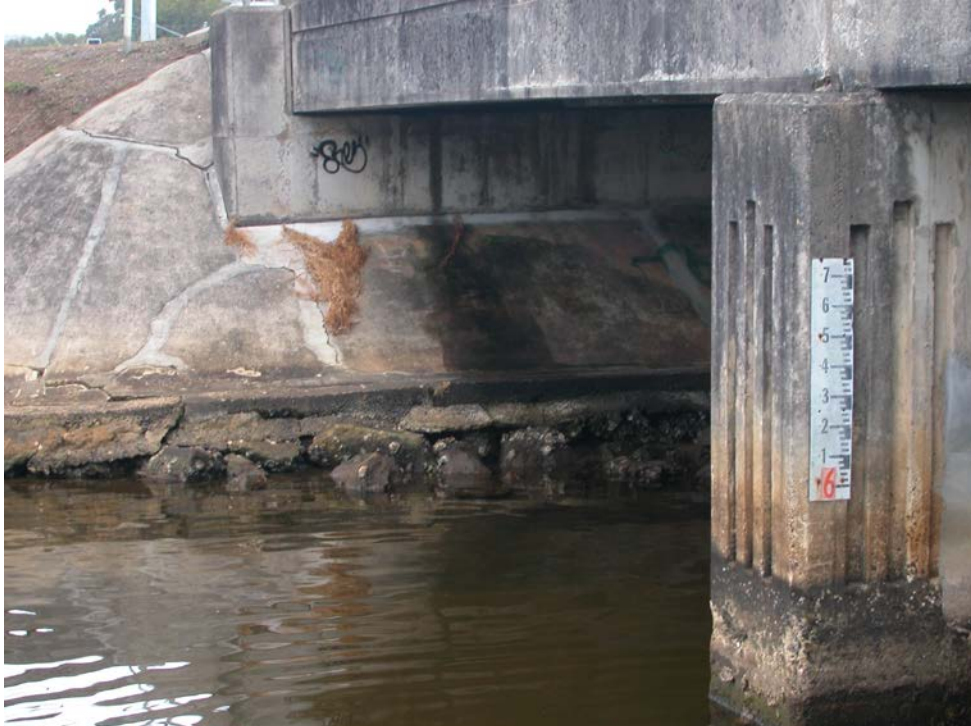
Moderate scour at the base of batter protection.

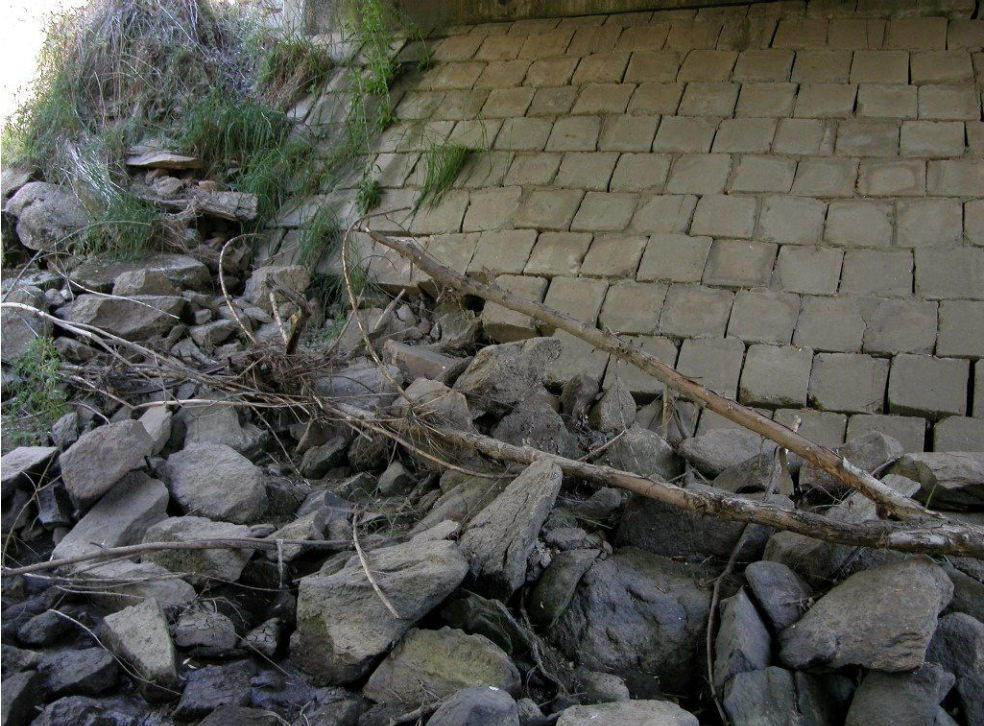
Batter protection undermined by scour at the base.

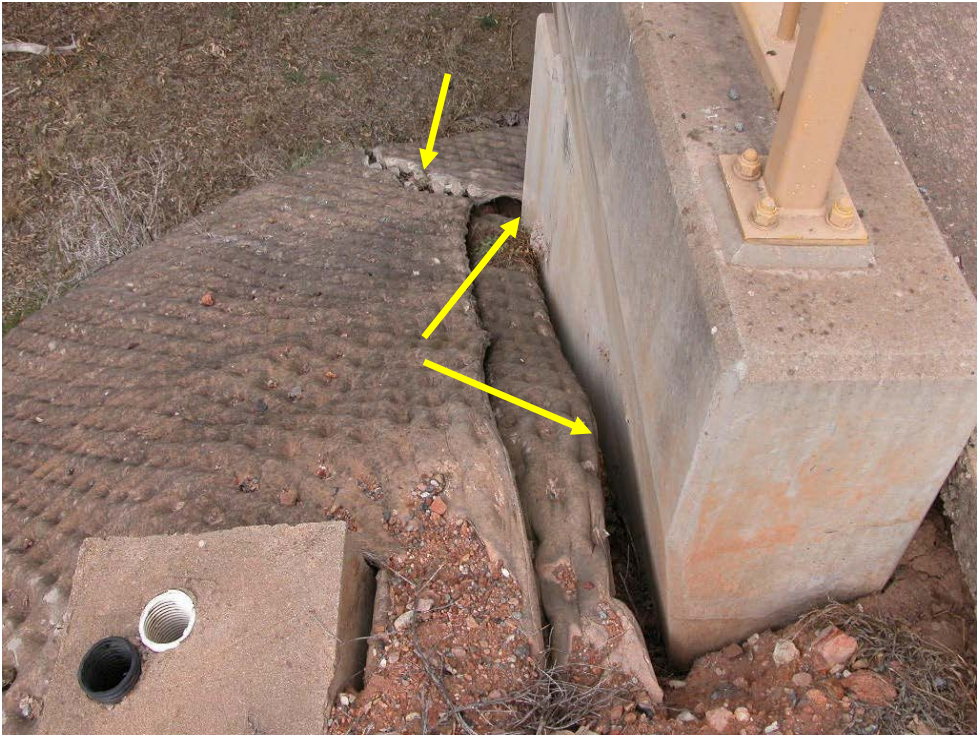
Cracked fabric protection and gaps allowing water to run under and erode the base

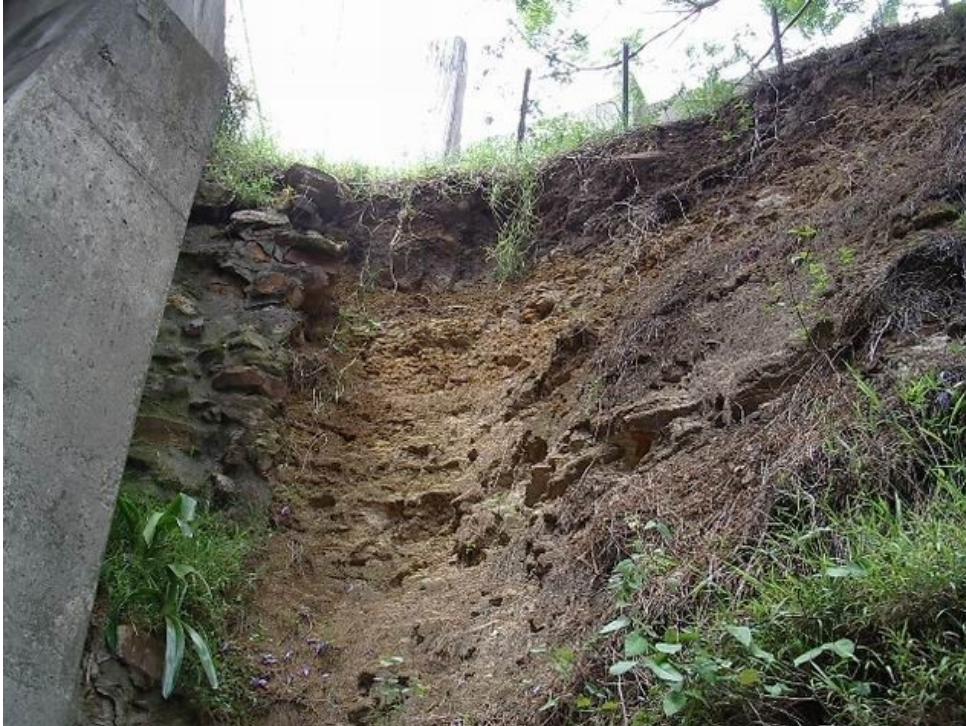
Significant erosion of embankment.

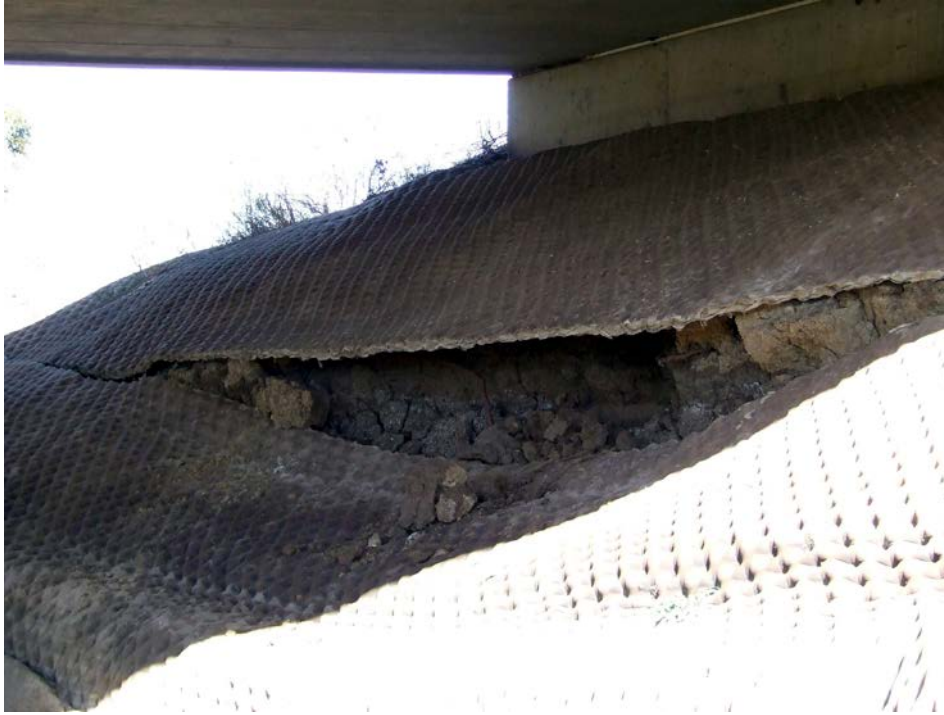
Fabric protection partially collapsed due to settlement.
