Transport  
**Roads & Maritime  
Services**

# **BRIDGE INSPECTION PROCEDURE MANUAL**

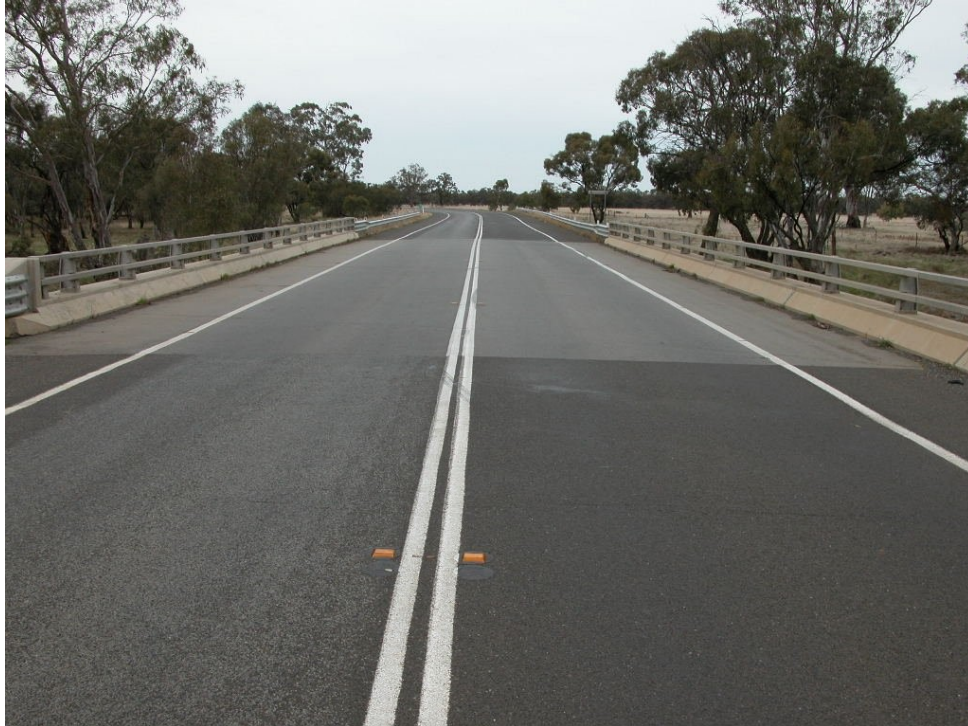
Wearing surface in good condition.

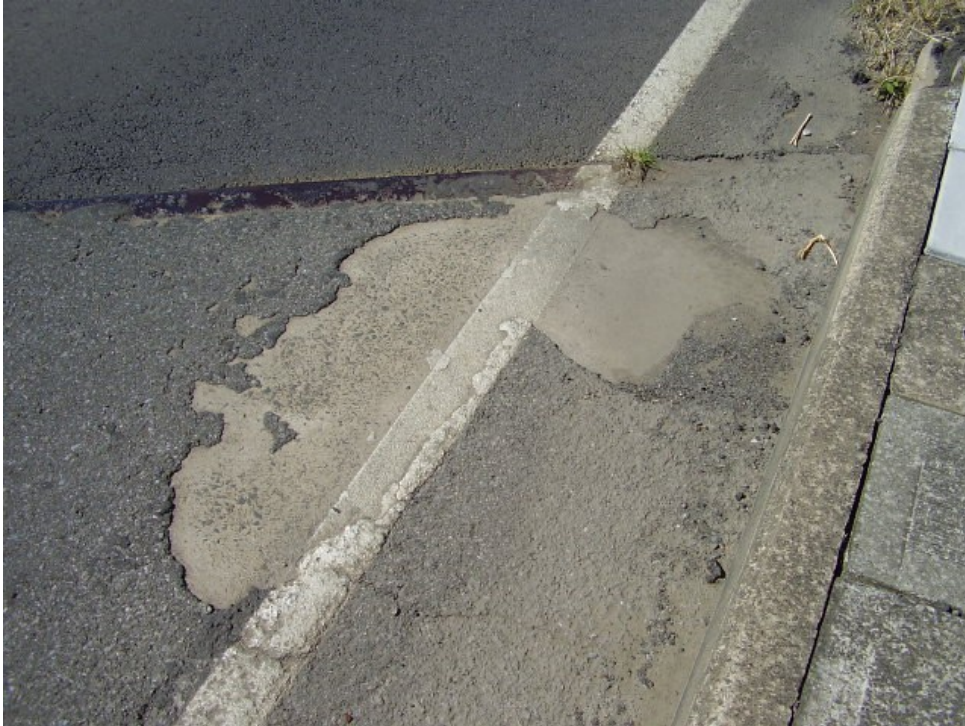
Stripping of wearing surface in small area.

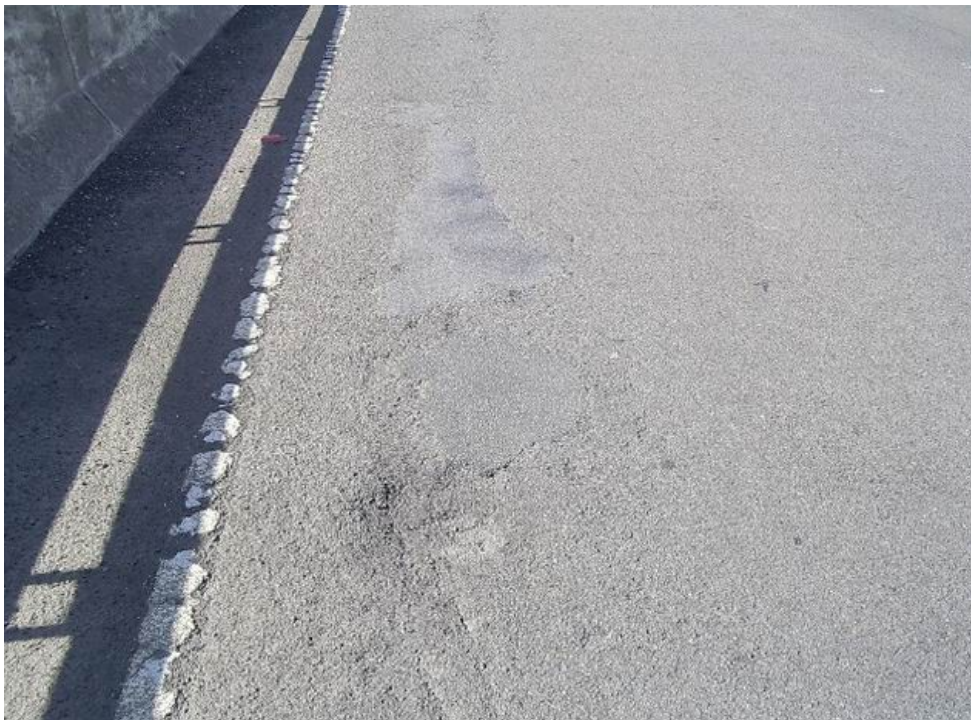
Wearing surface breaking up near some repaired areas.

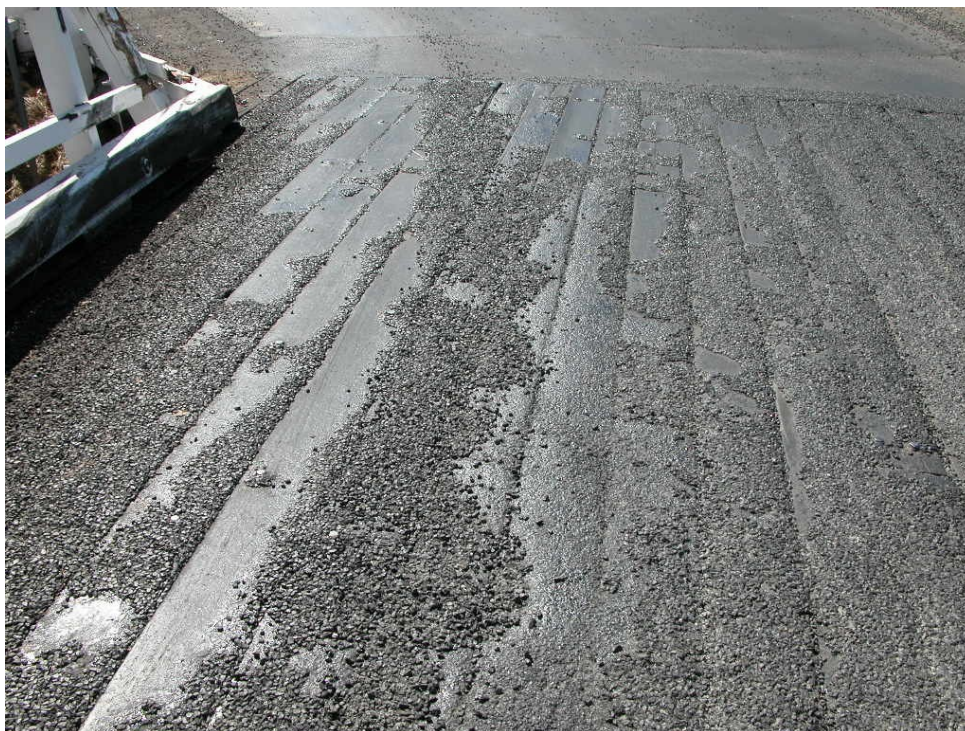
Stripped and bleeding wearing surface.

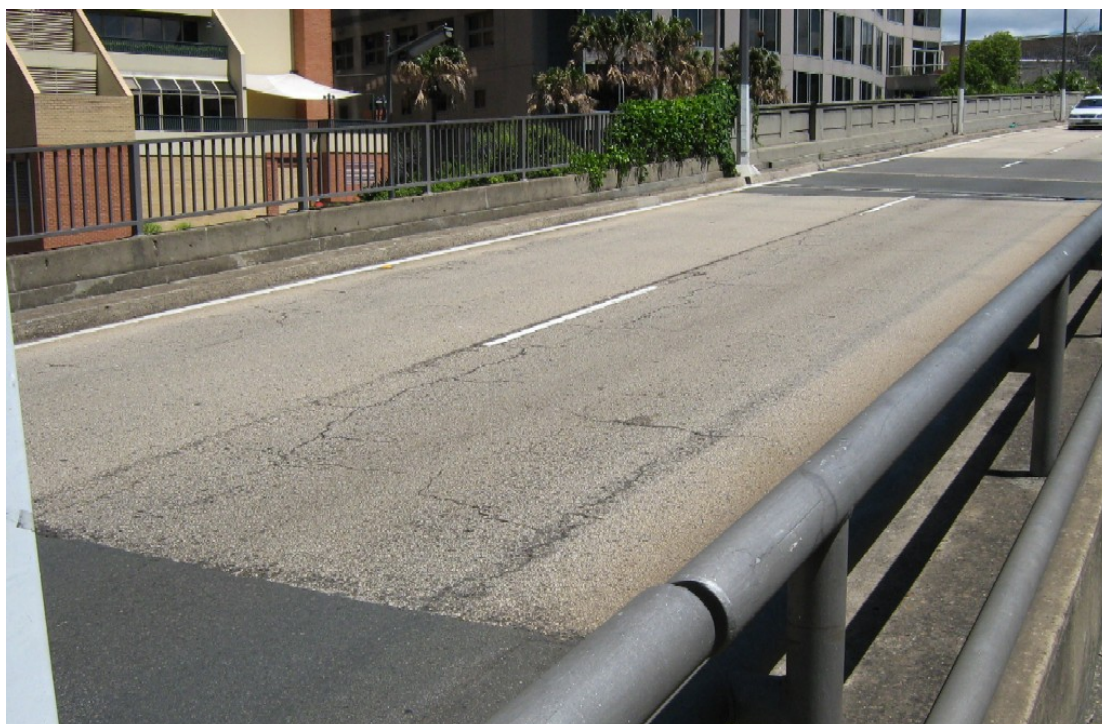
Cracking of large areas of the wearing surface on the bridge.

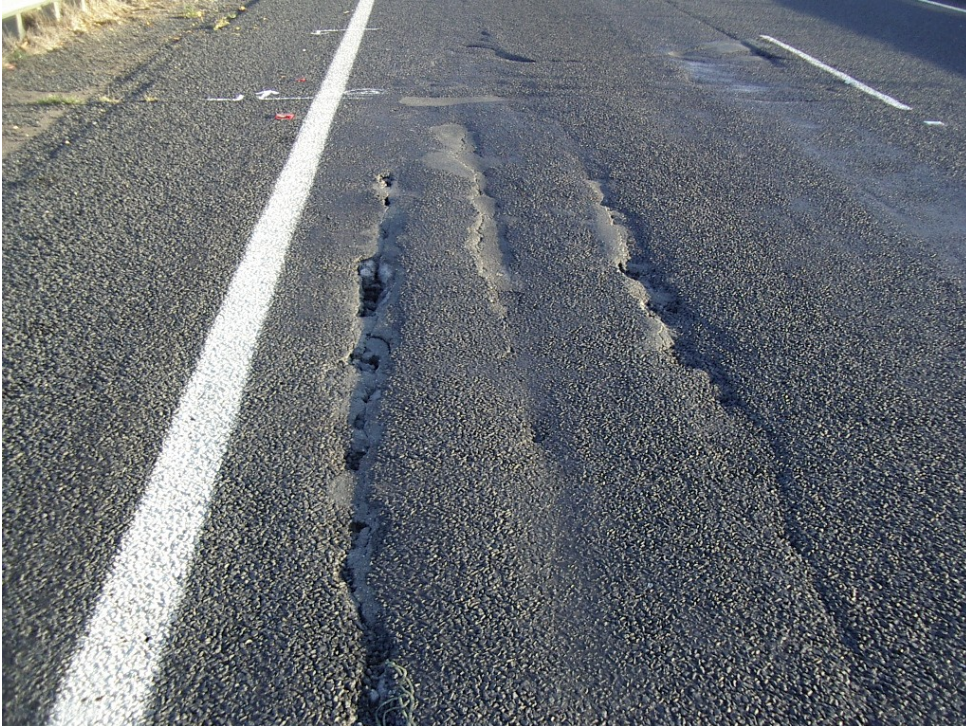
Wearing surface with extensive damage.

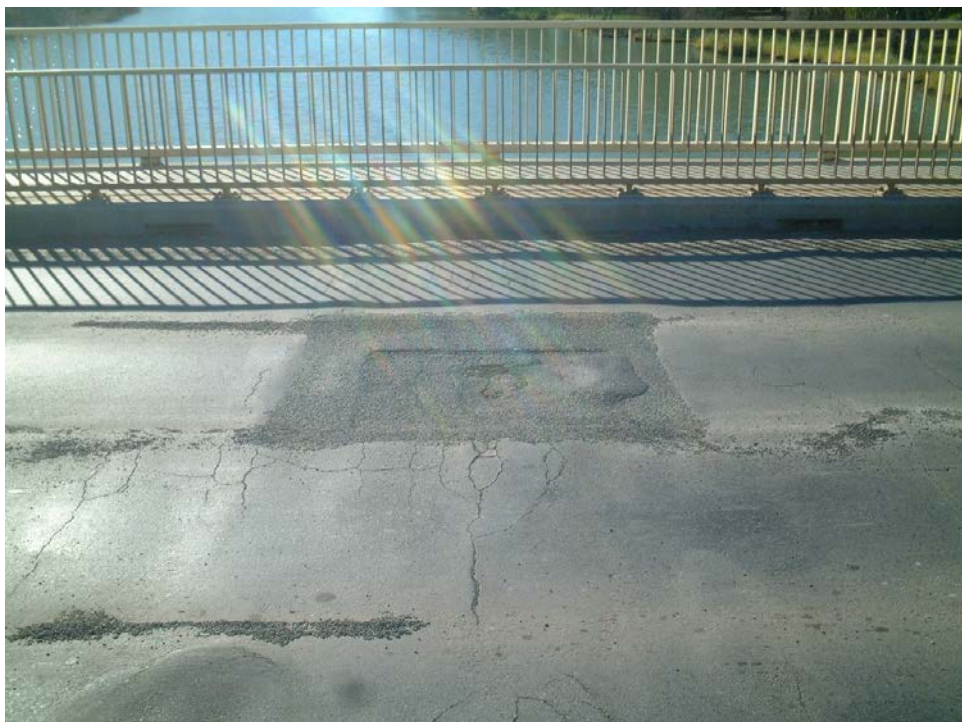
Wearing surface in poor condition.

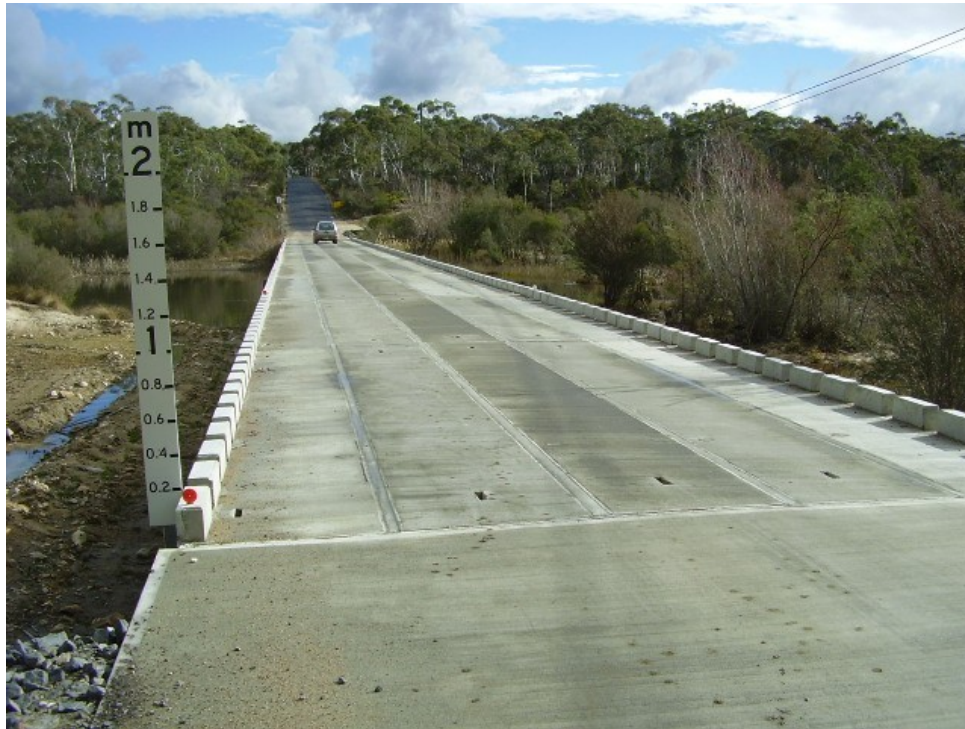
Approach carriageway in good condition.

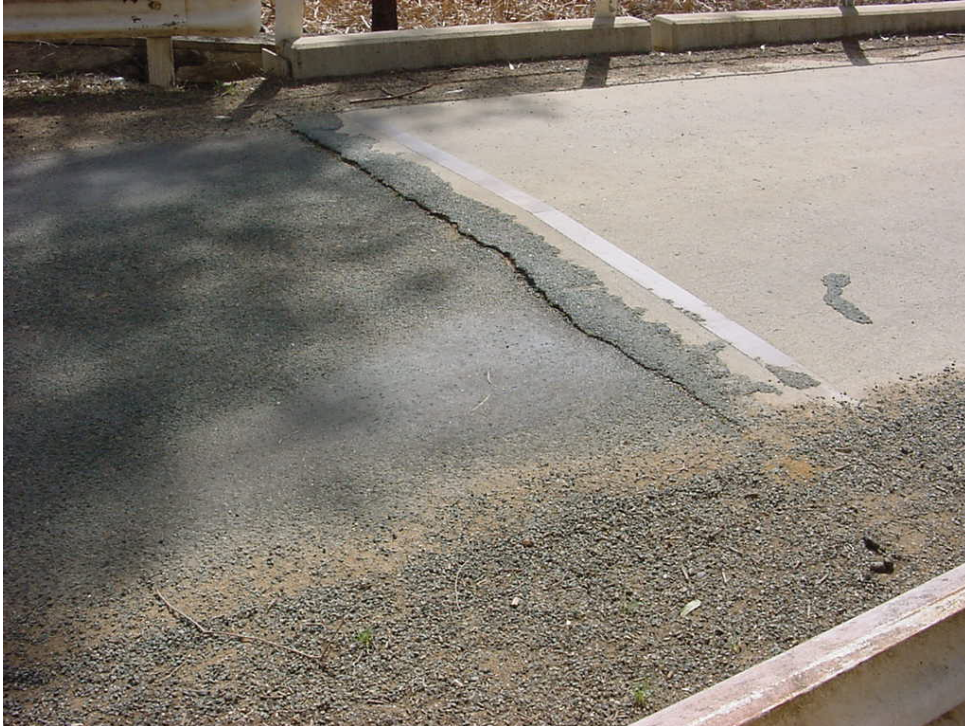
Nominal drop of the approach carriageway.

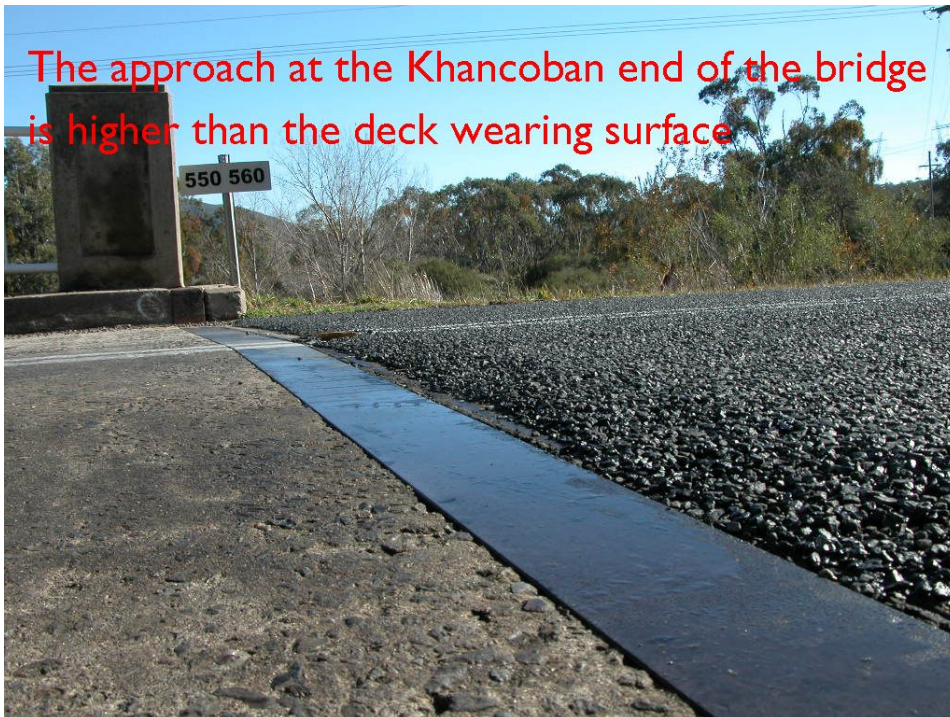
A noticeable drop of the approach carriageway wearing surface level at the bridge.

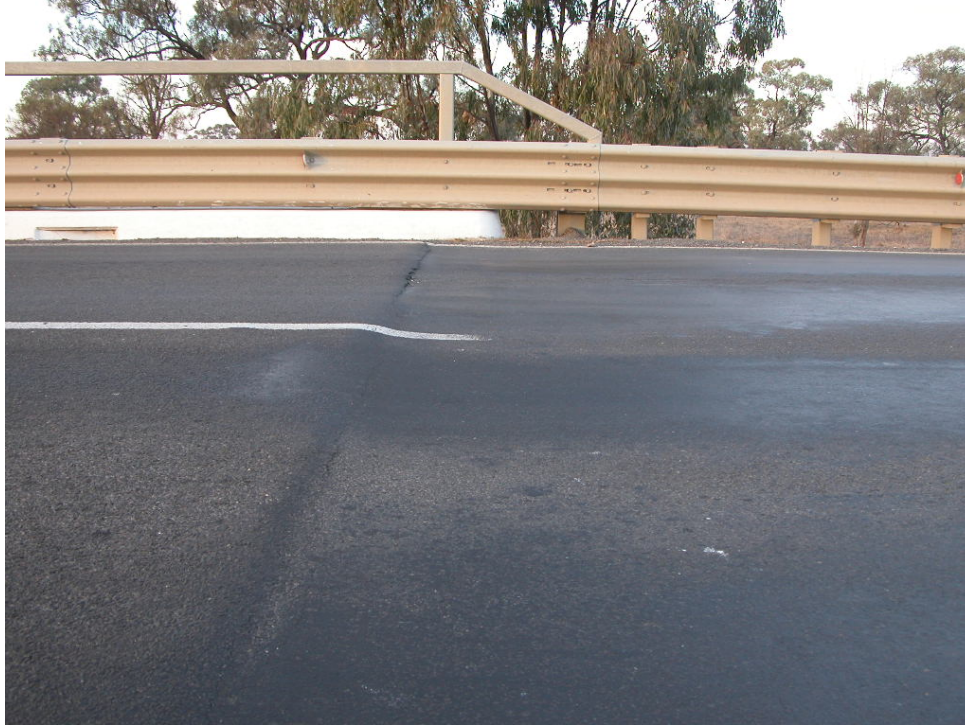
Significant settlement of approach carriageway.

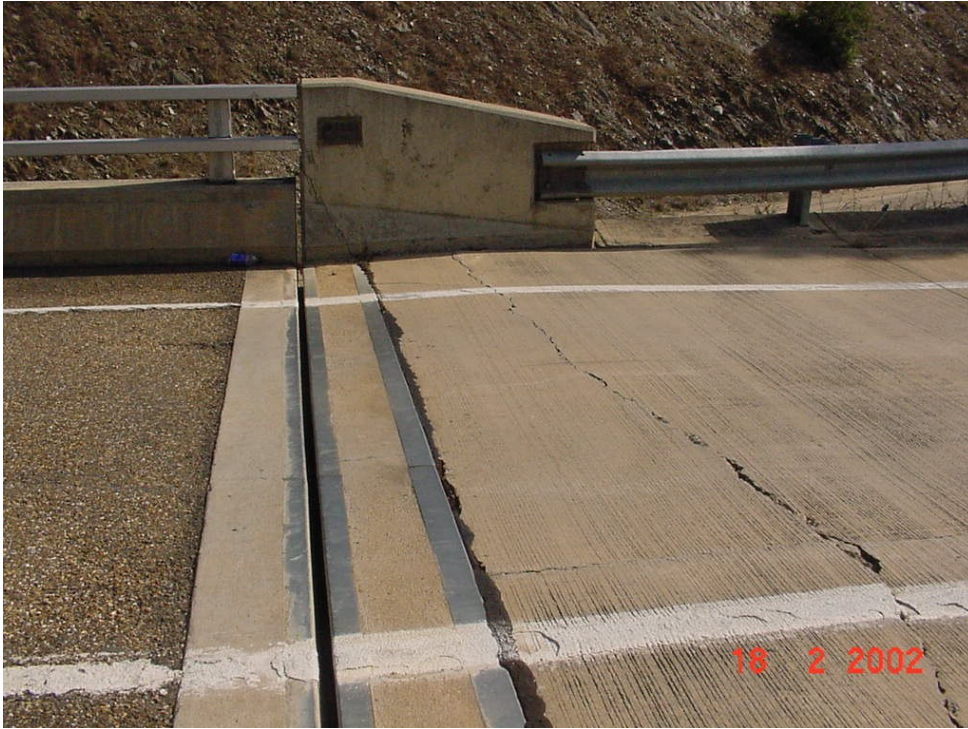
Settlement cracking of approach slab.

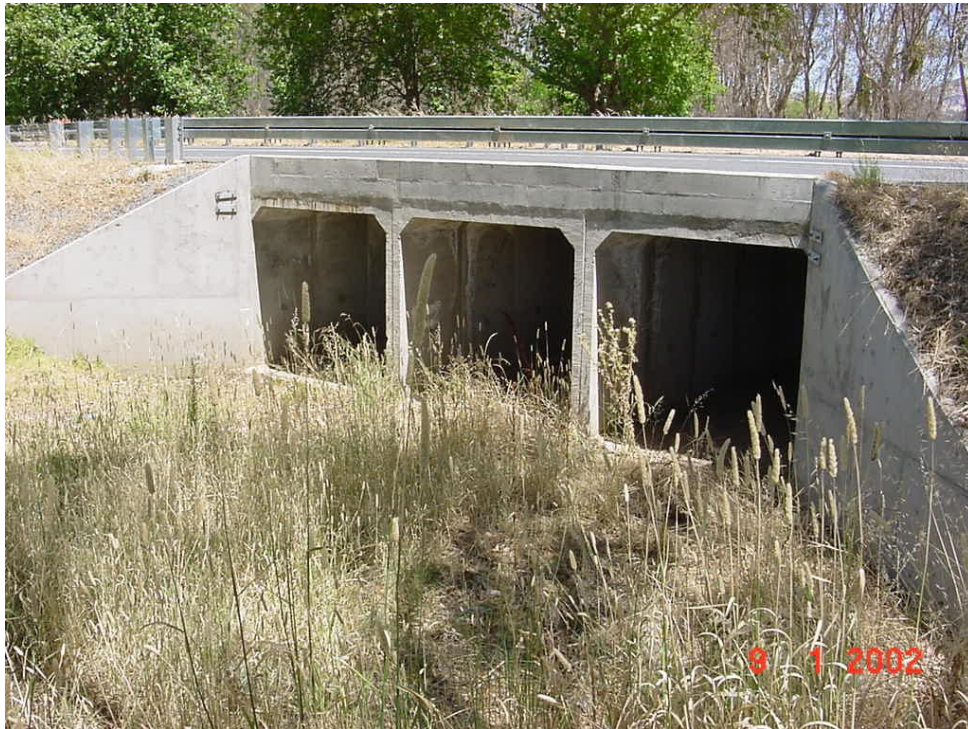
Waterway clear except for reeds which help stabilise.

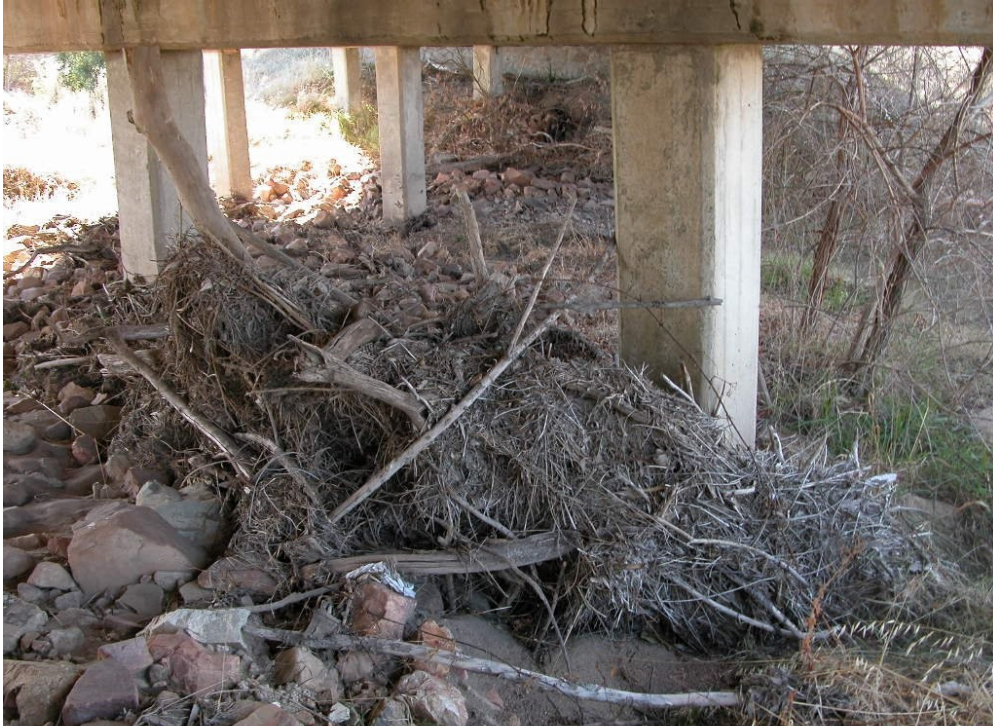
Waterway with some debris but not significant.

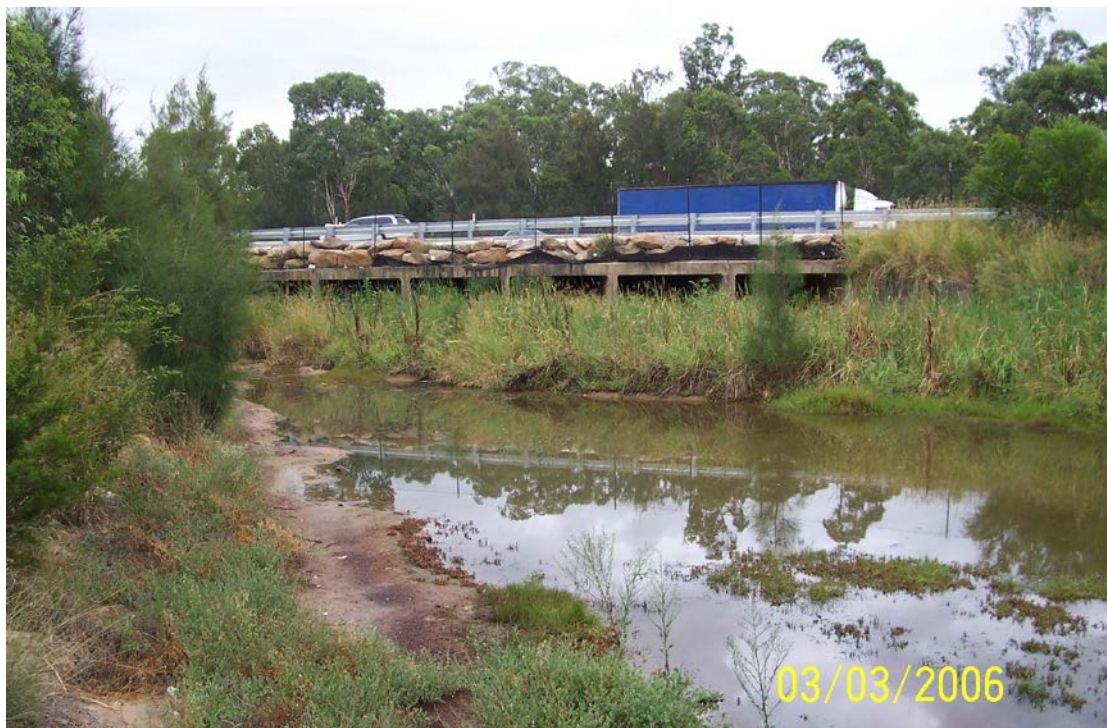
Waterway showing about 20% siltation with ponding water.

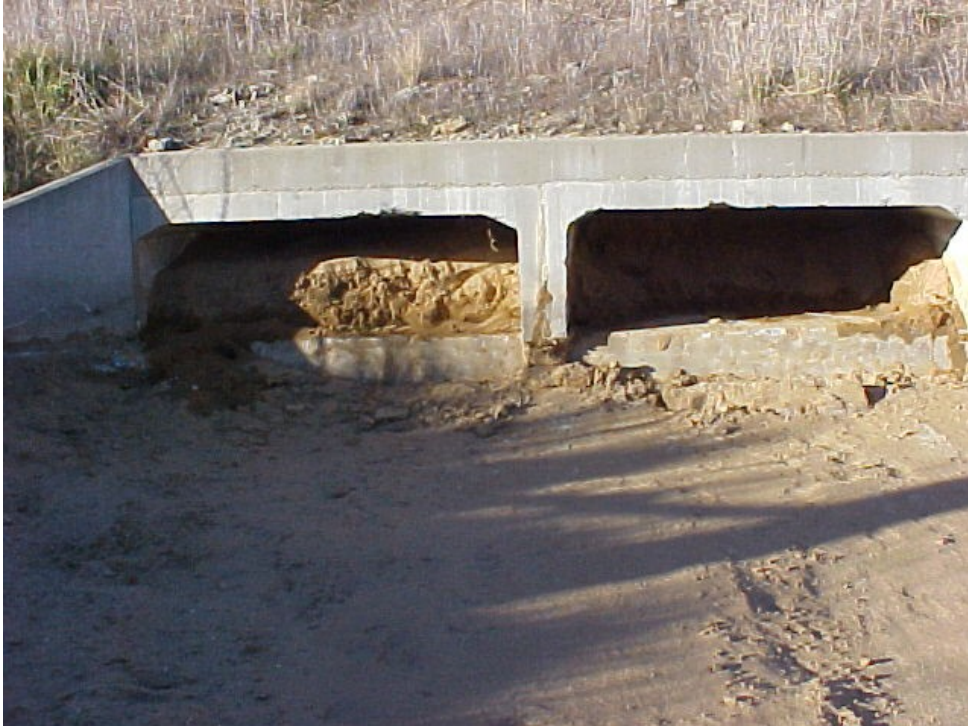
Waterway almost completely blocked inside culvert.

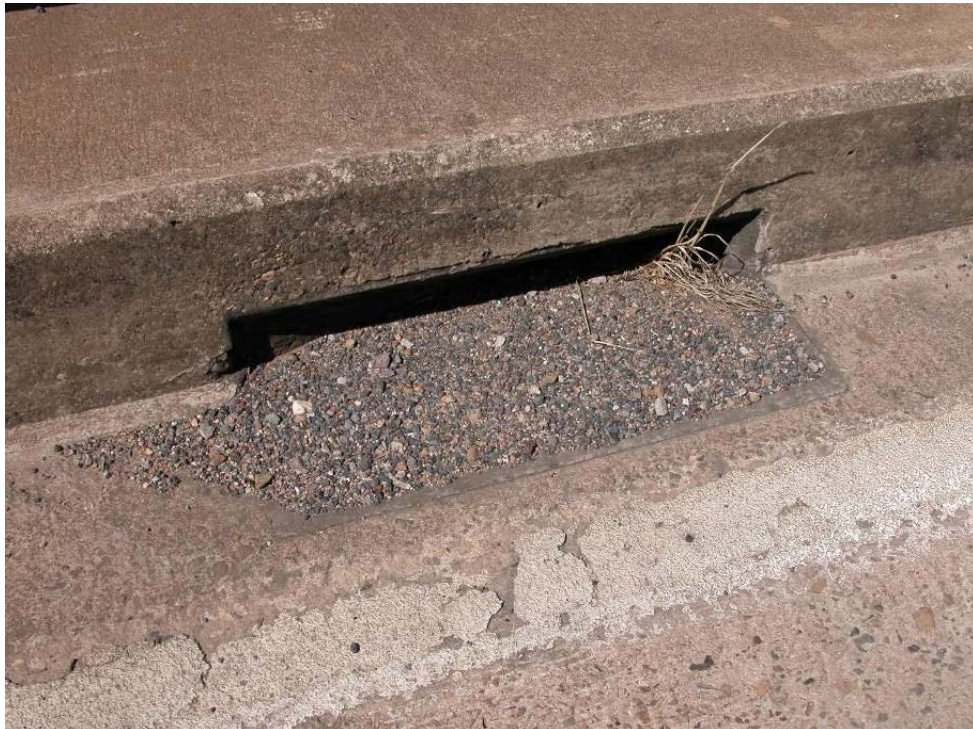
Clear scuppers and stormwater system.

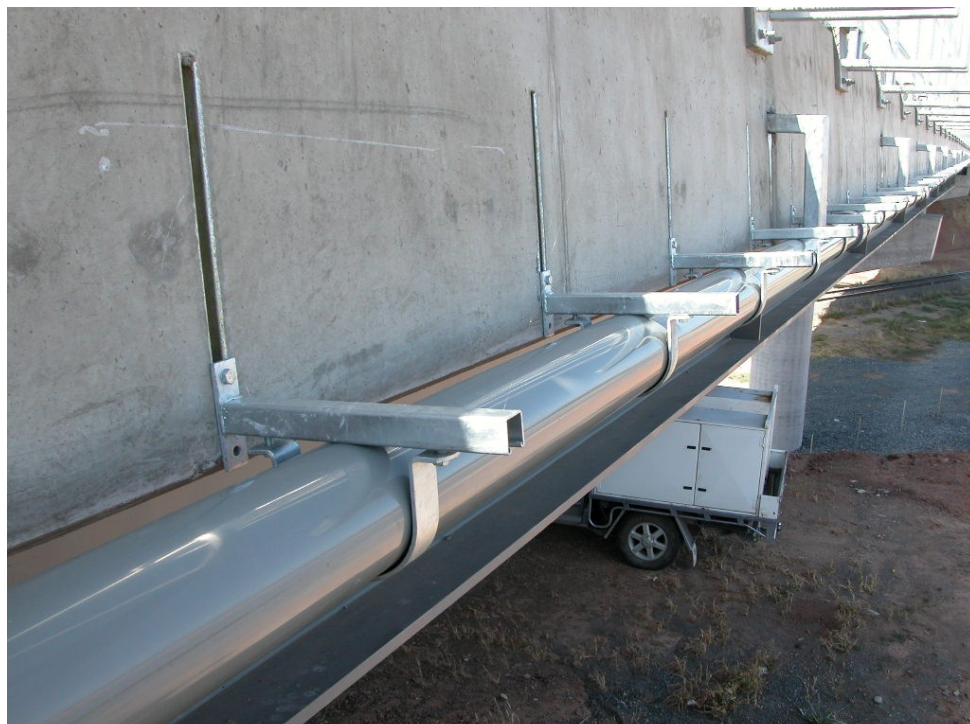
External storm water attachment in good condition.

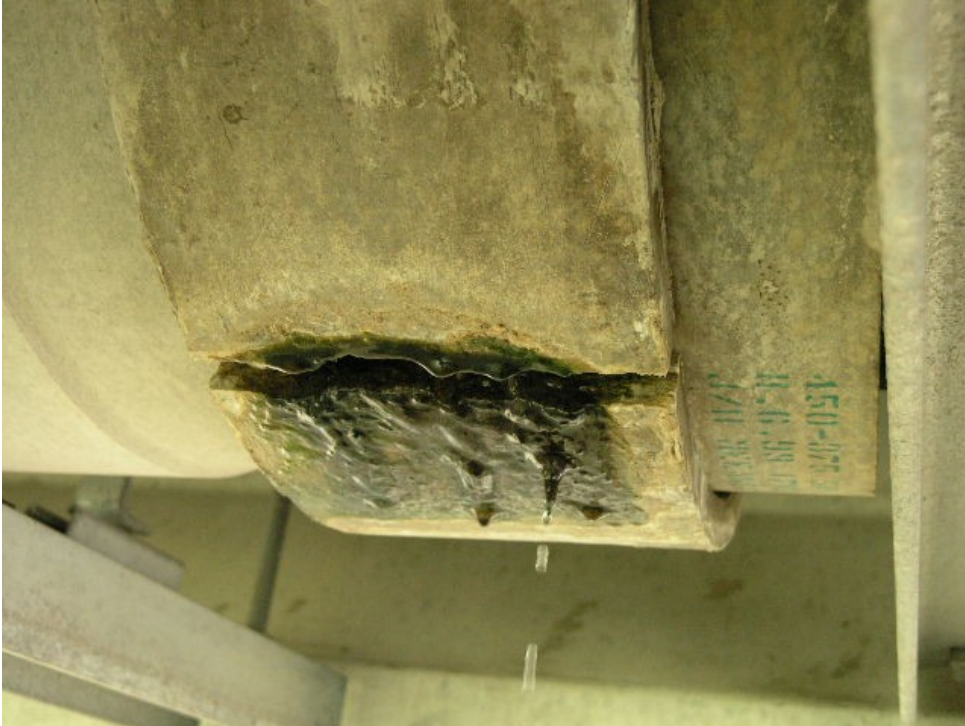
Minor leak at joint with broken collar on a drainage pipe attachment.

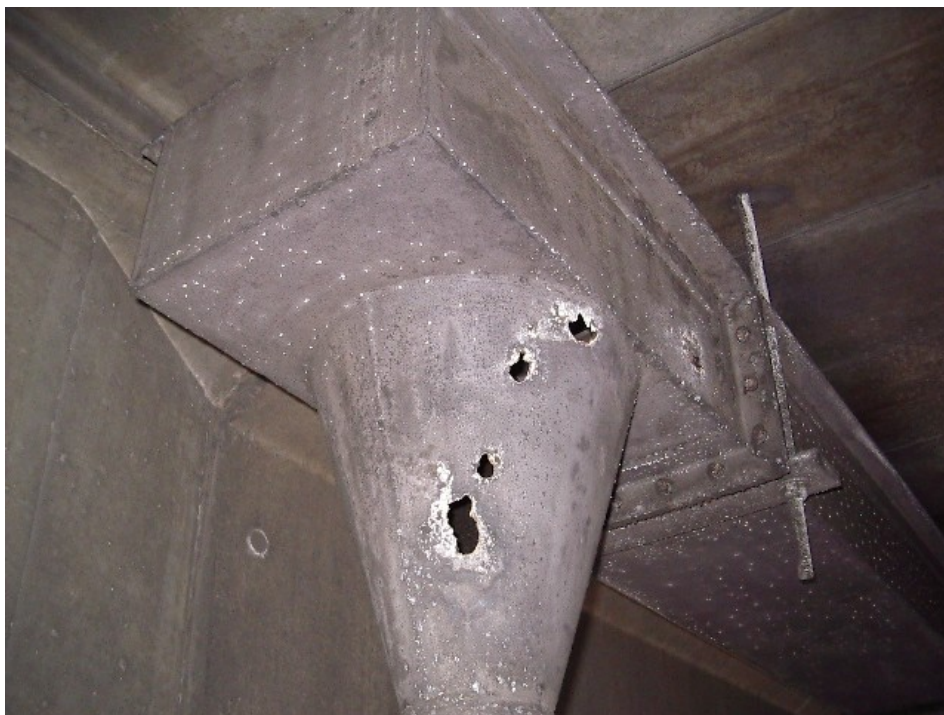
Drainage downpipe with holes.

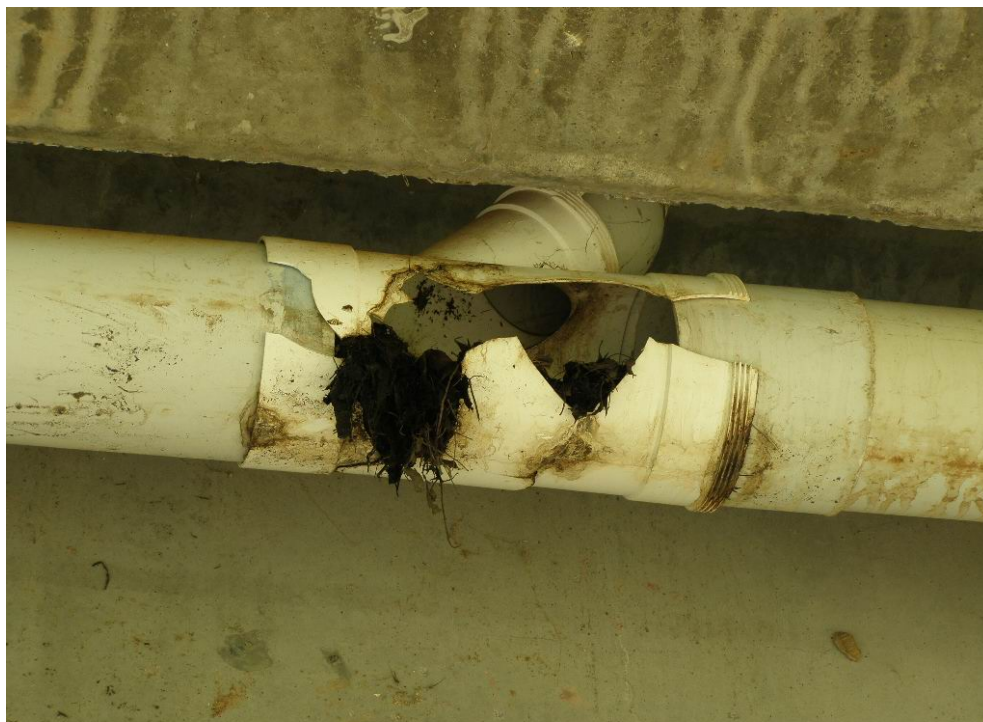
Broken joint in the drainage system.

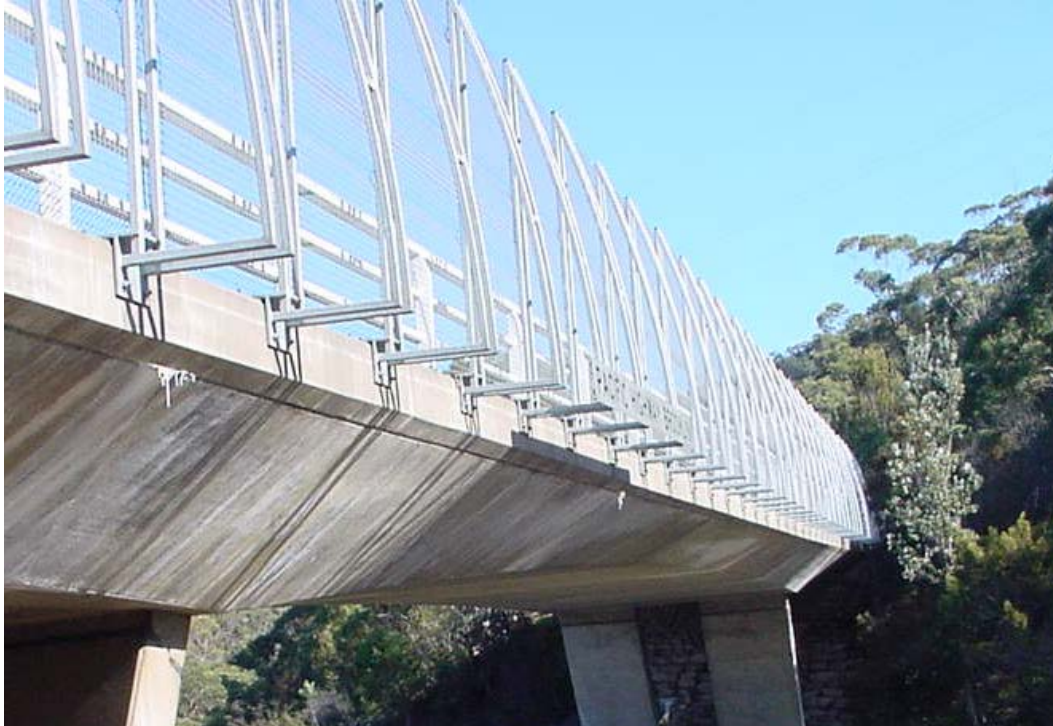
Safety screen in good condition.

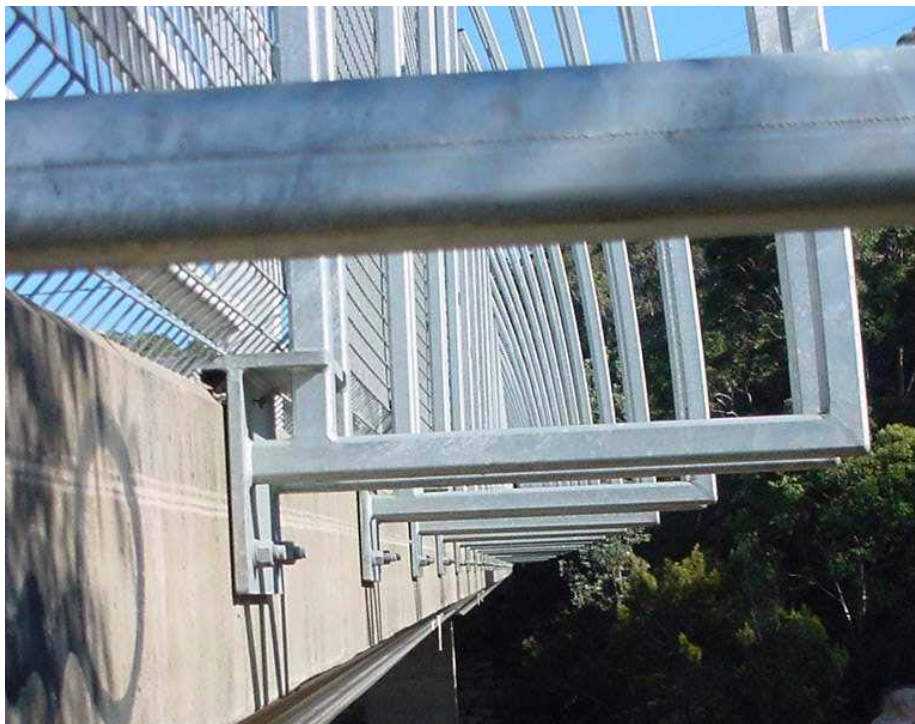
Safety screen in good condition.

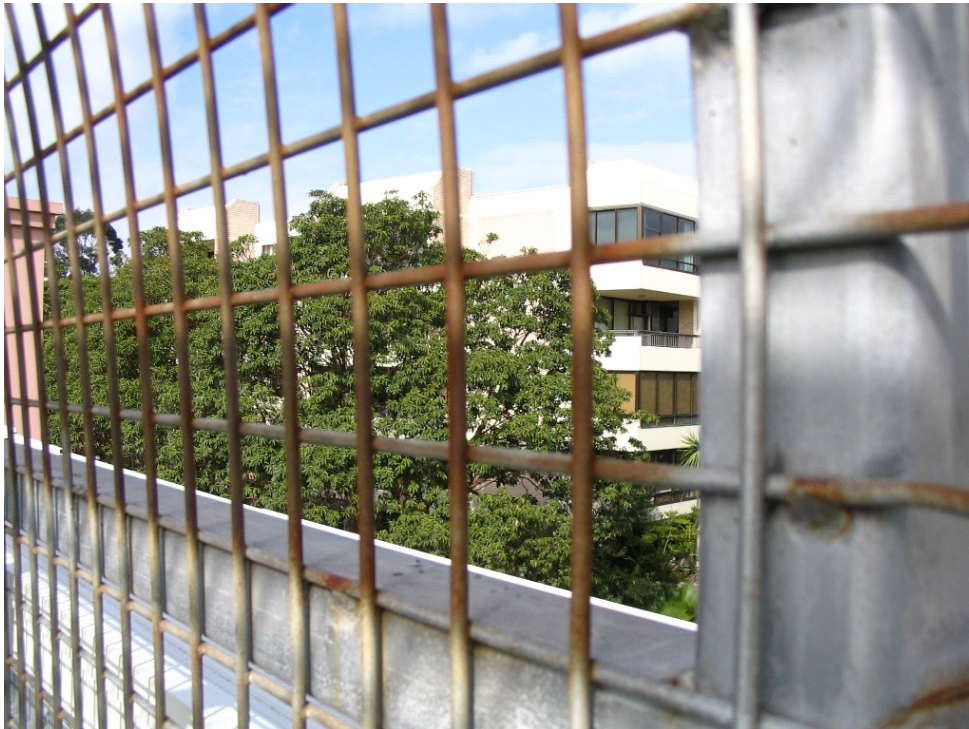
Rust forming on the screen.

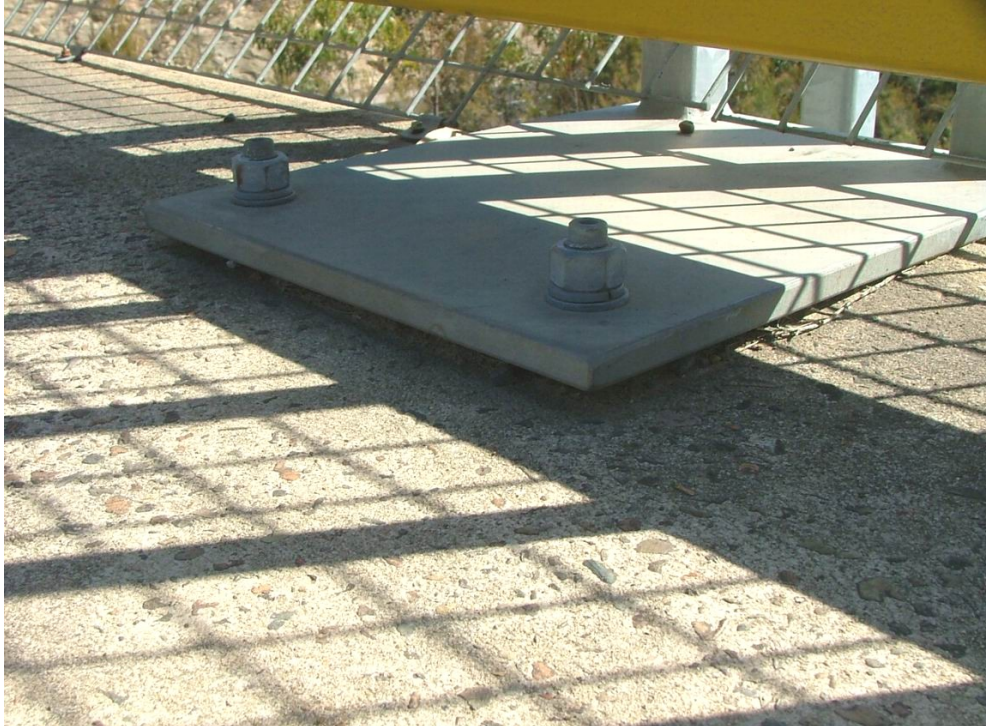
No mortar pad under the screen post.

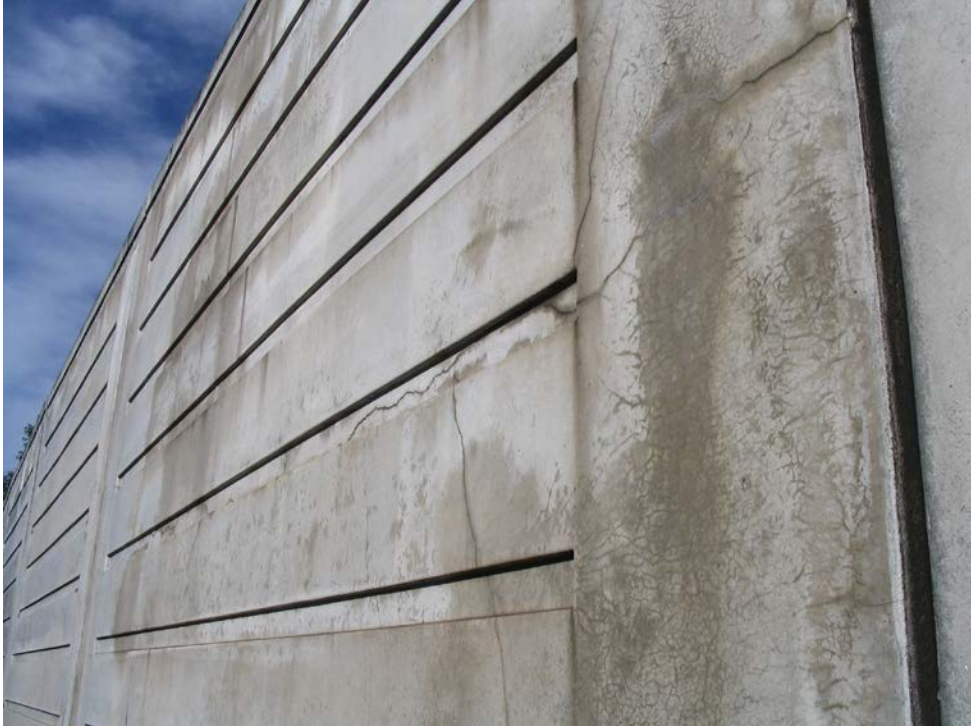
Cracks on a noise wall and supporting frame.

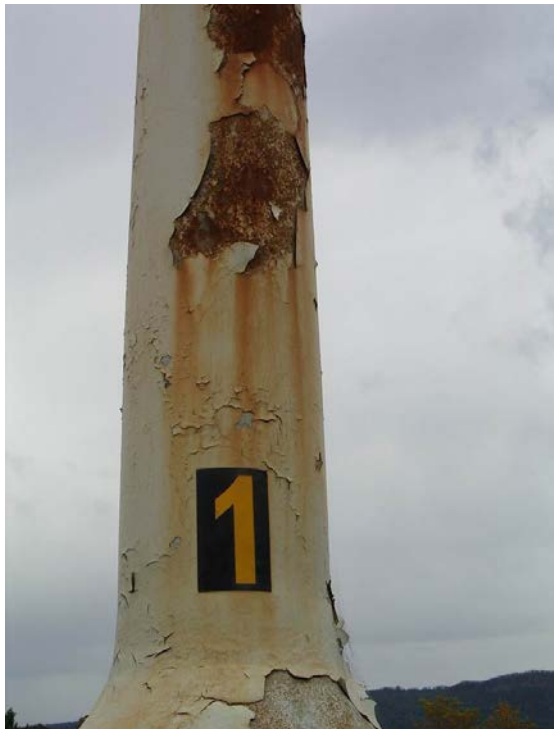
Minor pitting corrosion of the light pole.

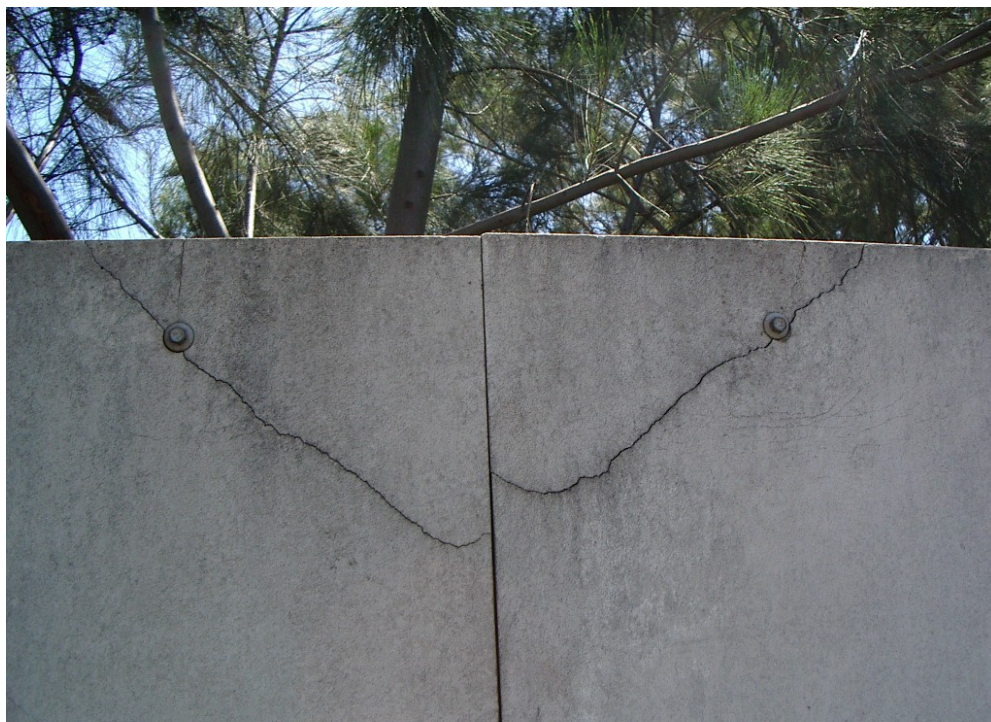
Noise wall attachment with cracks running along the holding bolts.

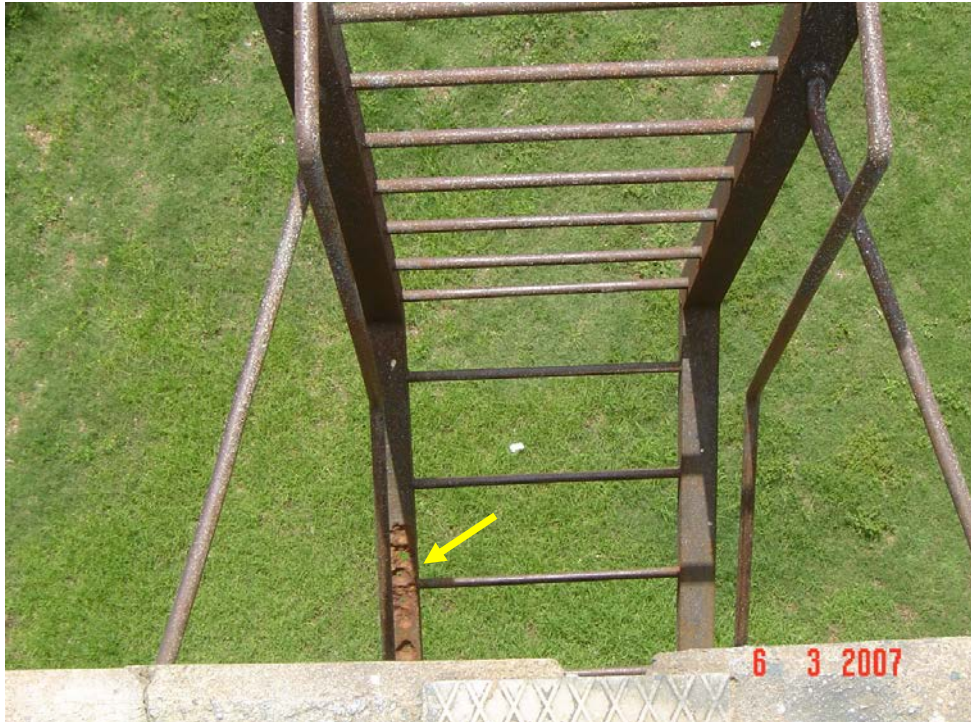
There is significant loss of section on one side of the ladder rendering it unsafe for use.

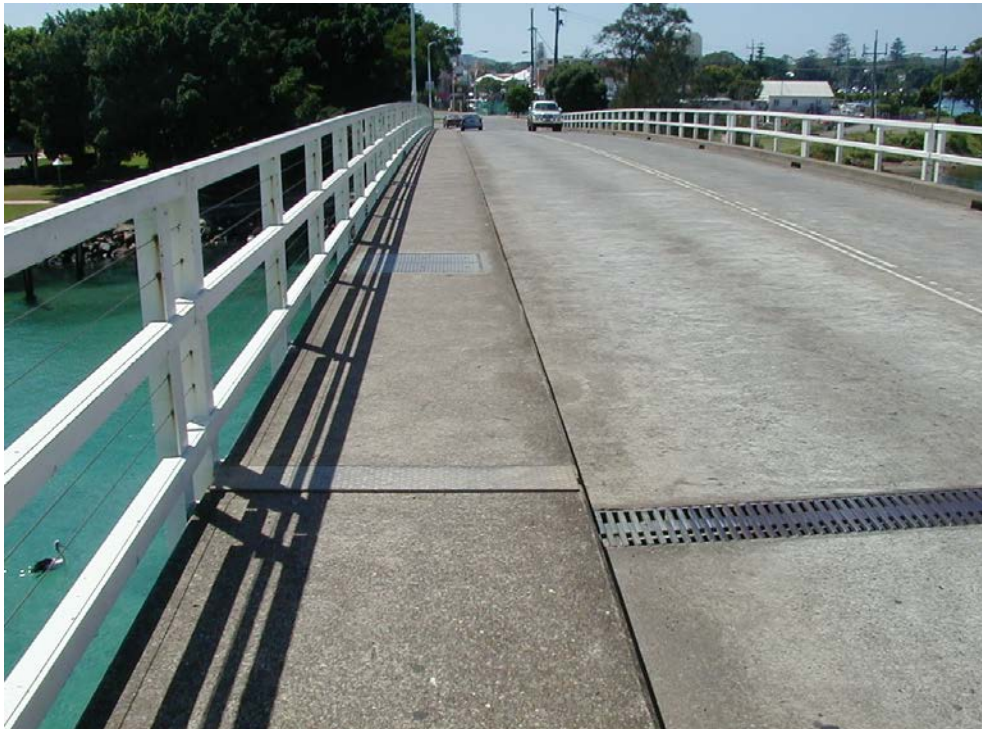
No buildup of dirt or vegetation. No Graffiti.

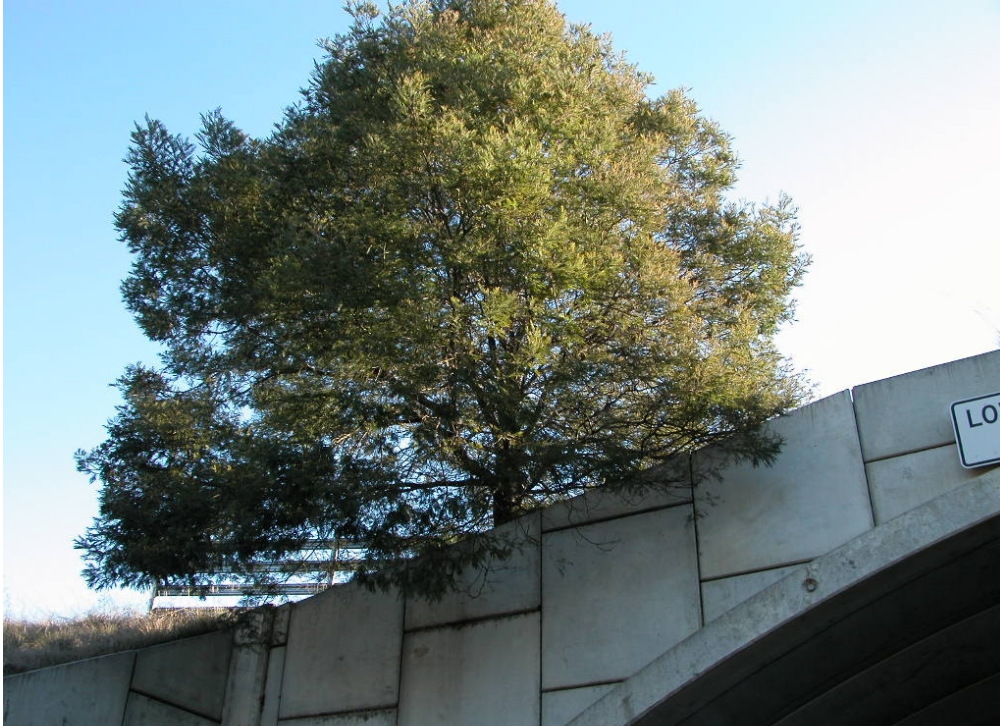
Tree close to the structure. To be removed.

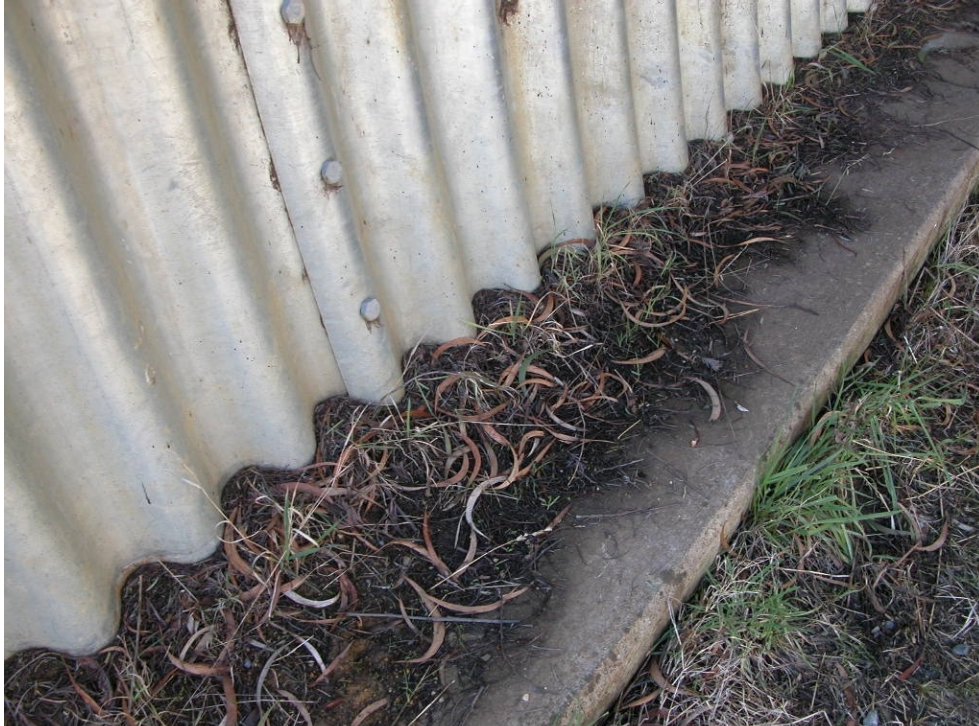
Dirt buildup retaining moisture that can result in corrosion at the base.
