Transport  
**Roads & Maritime  
Services**

# **BRIDGE INSPECTION PROCEDURE MANUAL**

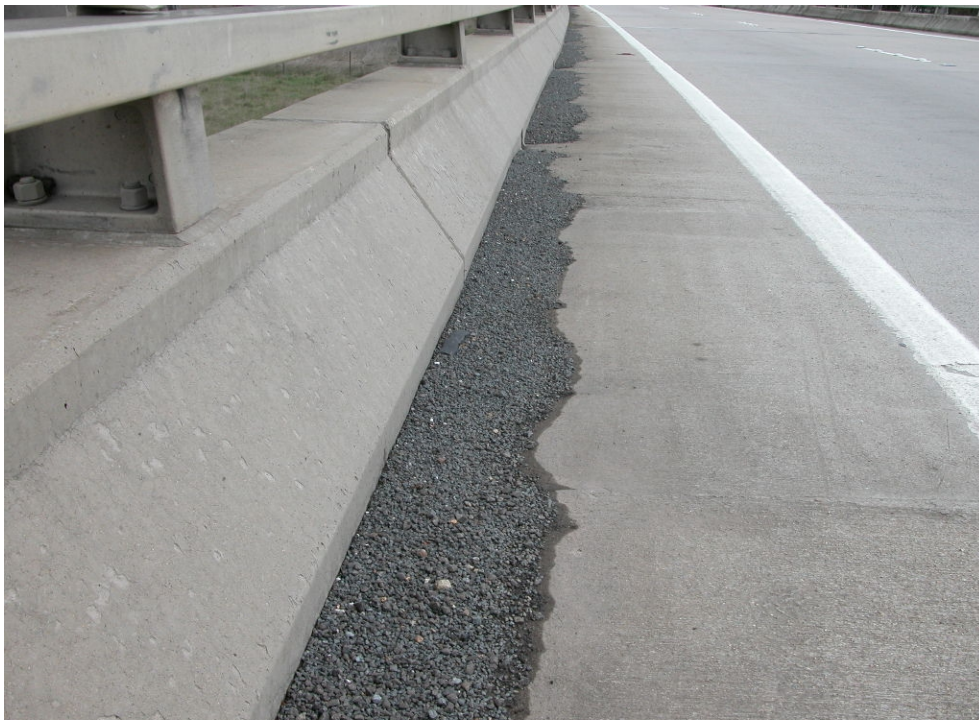
Moderate build up of dirt.

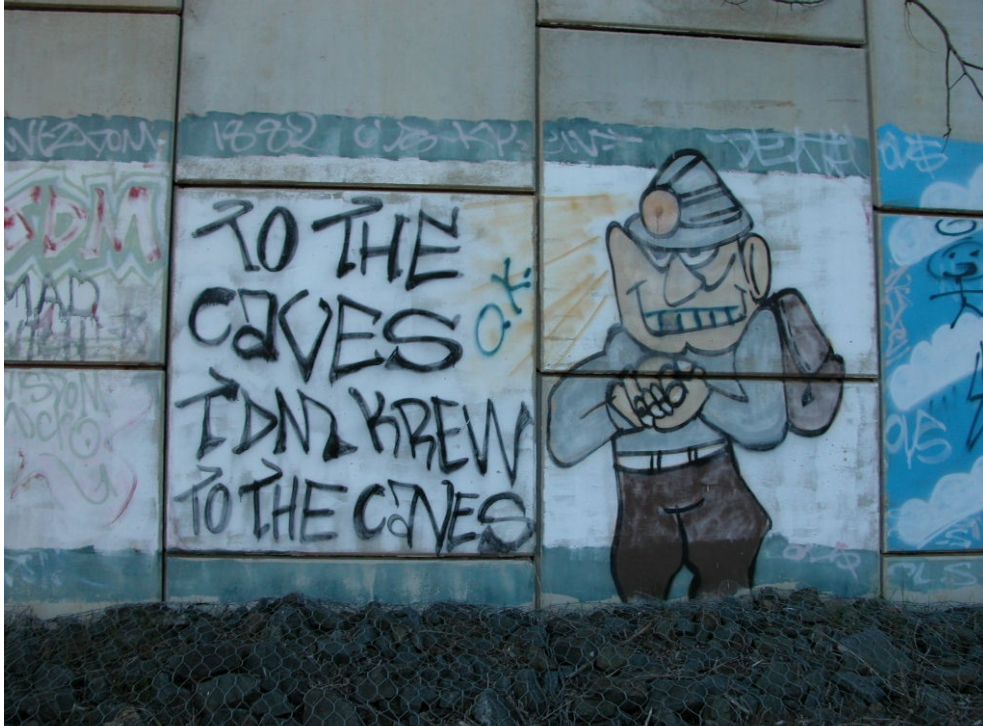
Graffiti is of some concern.

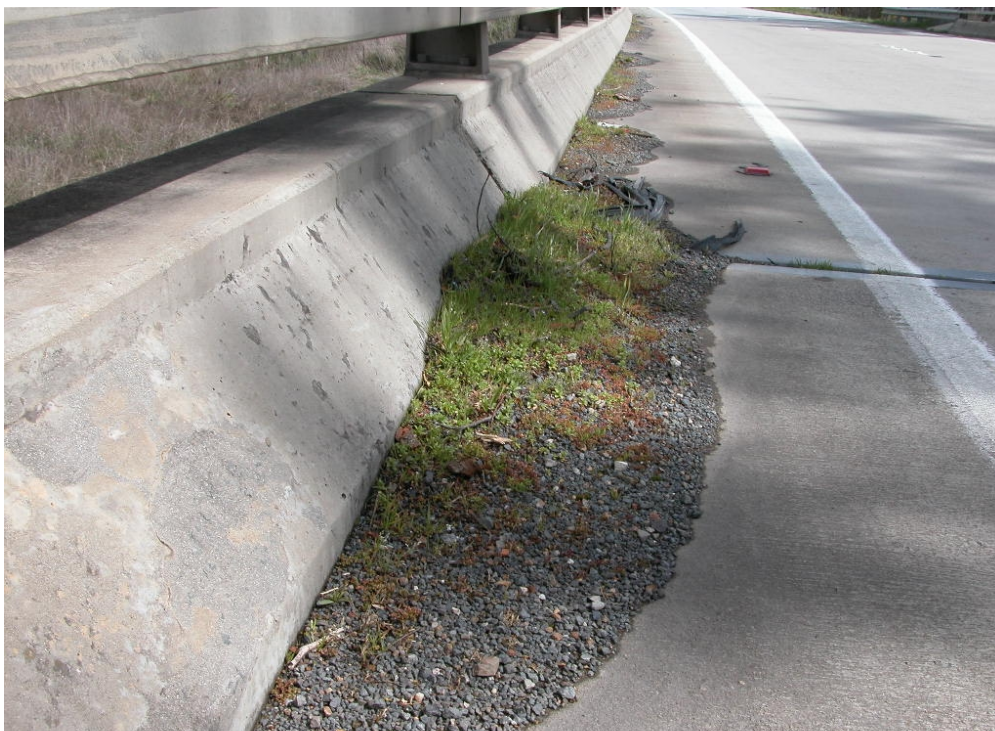
Significant buildup of dirt affecting drainage movement.
